OCCUPANT RESPONSE  
AND  
VEHICLE ACCELERATION  
IN A  
30 MPH FRONTAL IMPACT TEST

GENERAL MOTORS CORPORATION  
1978 CHEVROLET CHEYENNE BLAZER K5 (4 + 4)  
NHTSA 780605

DECEMBER 1978

FINAL REPORT

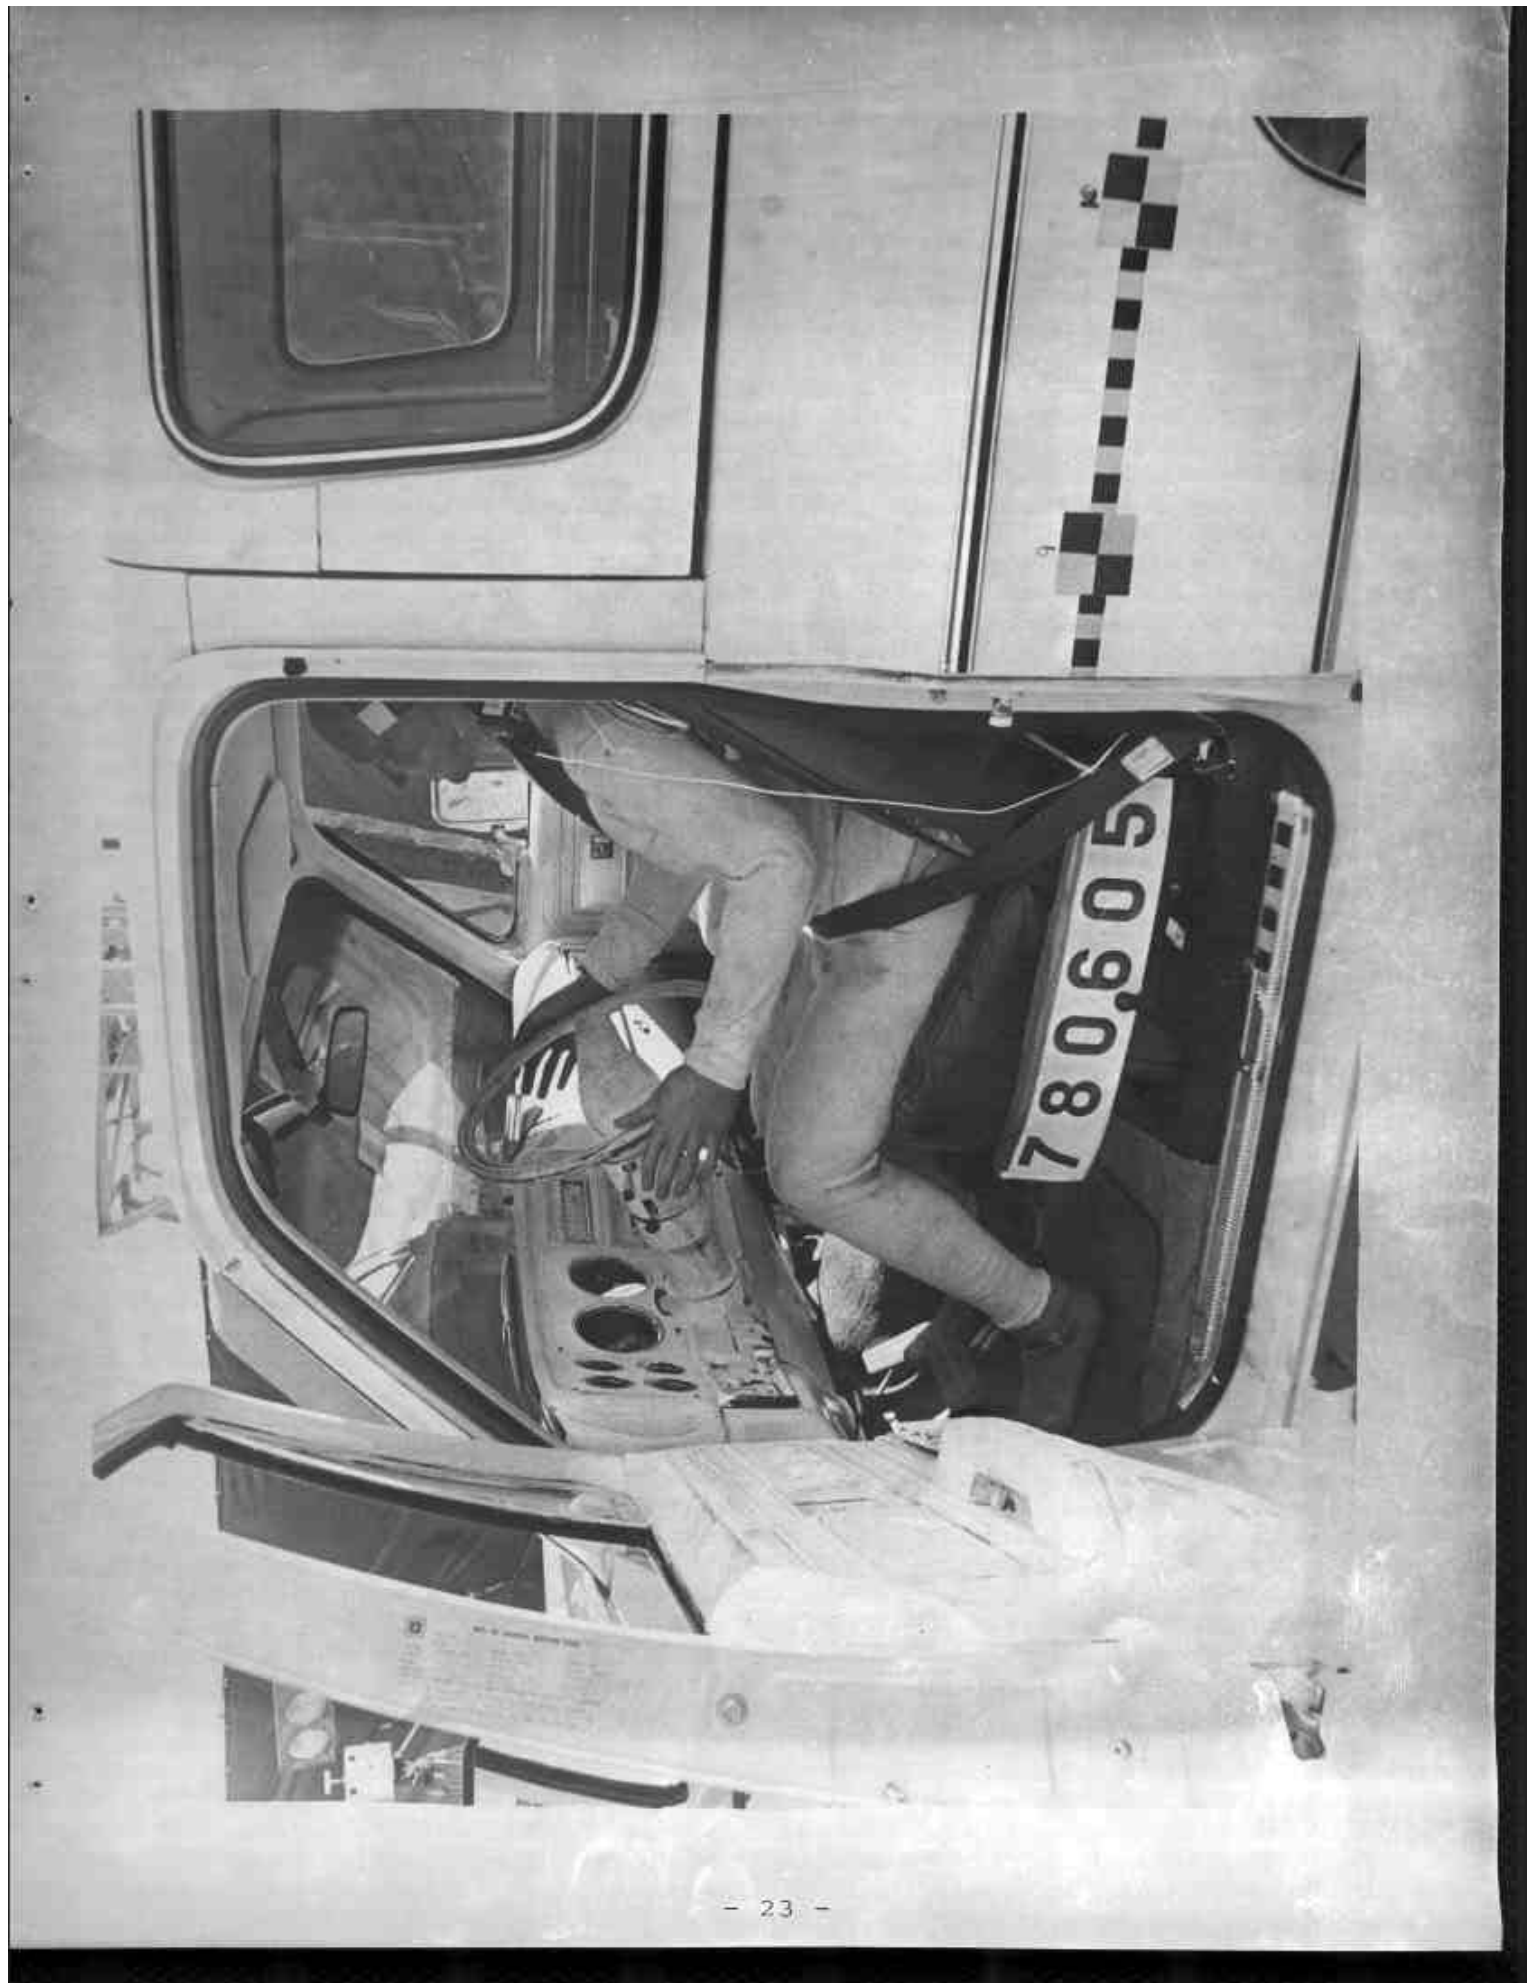
Figure 3-1  
1978 Chevrolet Cheyenne Blazer K5 (4 + 4)  
NHTSA 780605  
Pre-Test, Driver Dummy View

Figures 3-1 through 3-4 are pre-test and post-test views of the occupant compartment, restraint system and dummies.

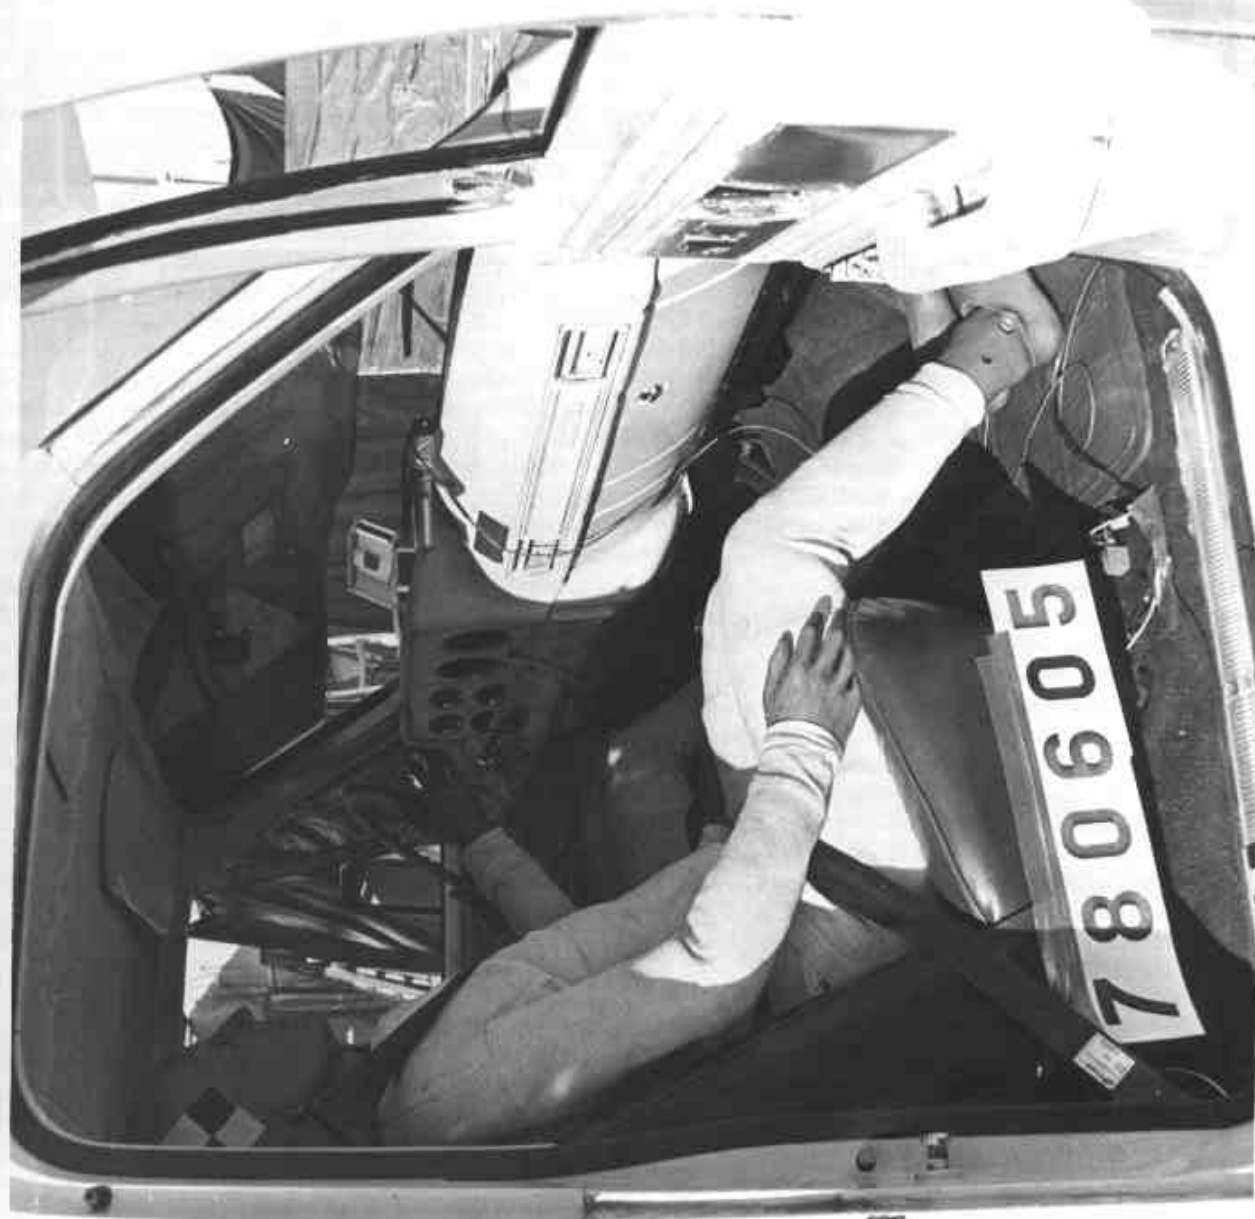
Figure 3-2

Pre-Test, Passenger Dummy View

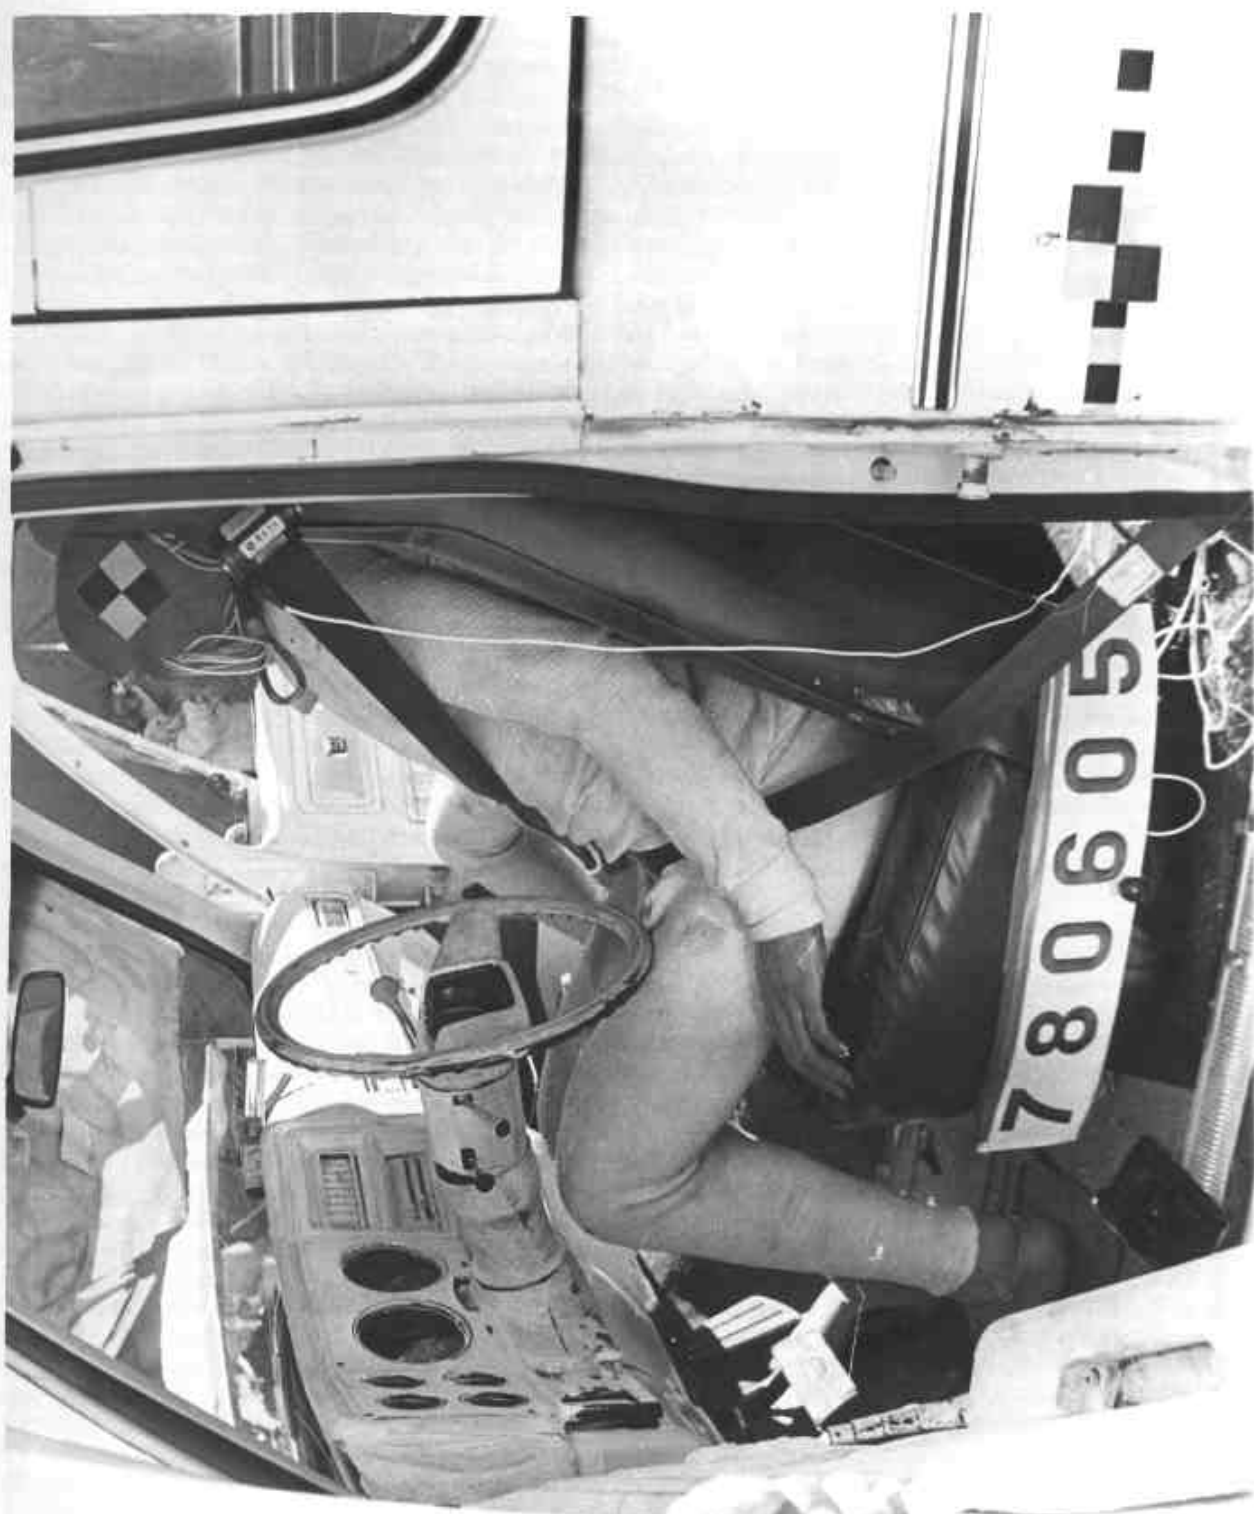
Figure 3-3  
1978 Chevrolet Cheyenne Blazer K5 (4 + 4)  
NHTSA 780605  
Post-Impact, Driver Dummy View

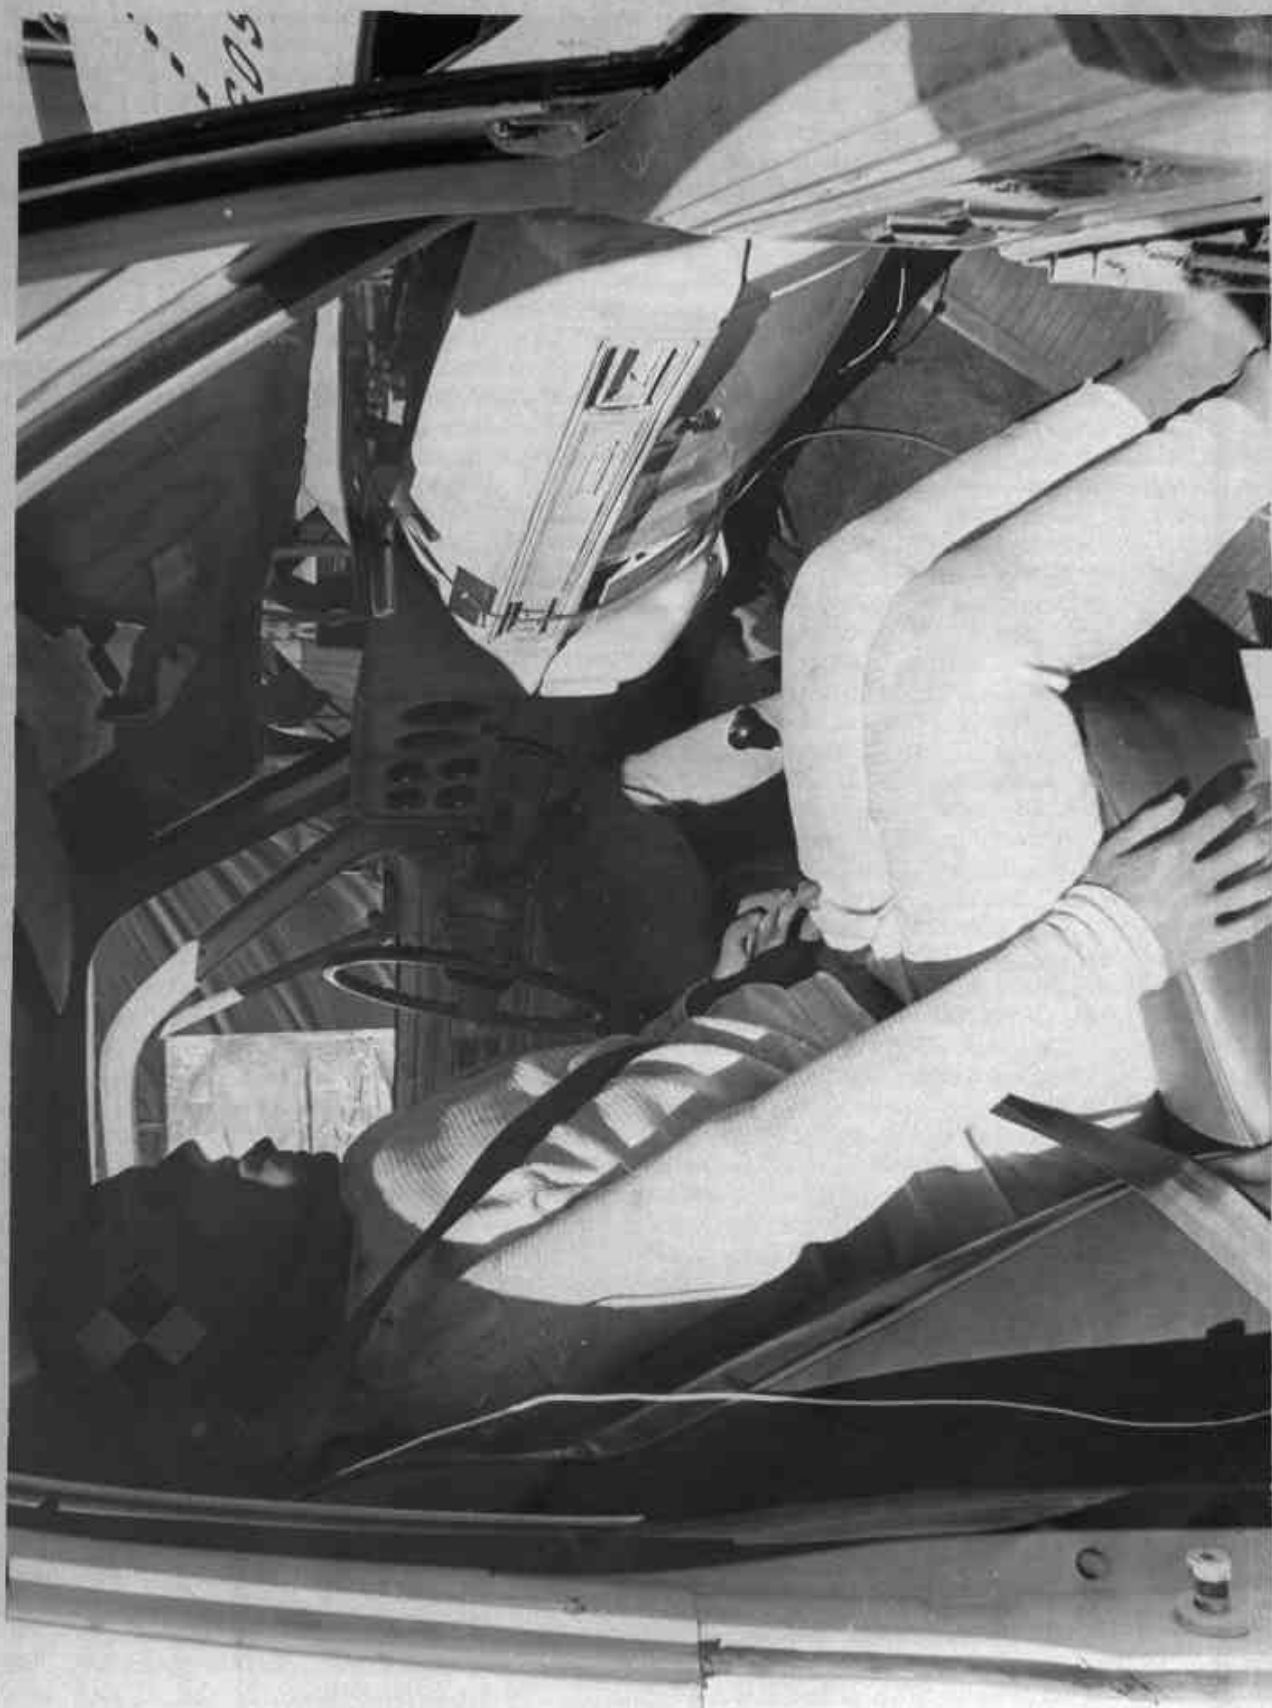
Figure 3-4  
1978 Chevrolet Cheyenne Blazer K5 (4 + 4)  
NHTSA 780605  
Post-Impact, Passenger Dummy View
