**OCCUPANT RESPONSE  
AND  
VEHICLE ACCELERATION  
IN A  
30 MPH FRONTAL IMPACT TEST**

**CHRYSLER CORPORATION  
1978 DODGE TRADESMAN B200 - VAN  
NHTSA 780608**

**FINAL REPORT**

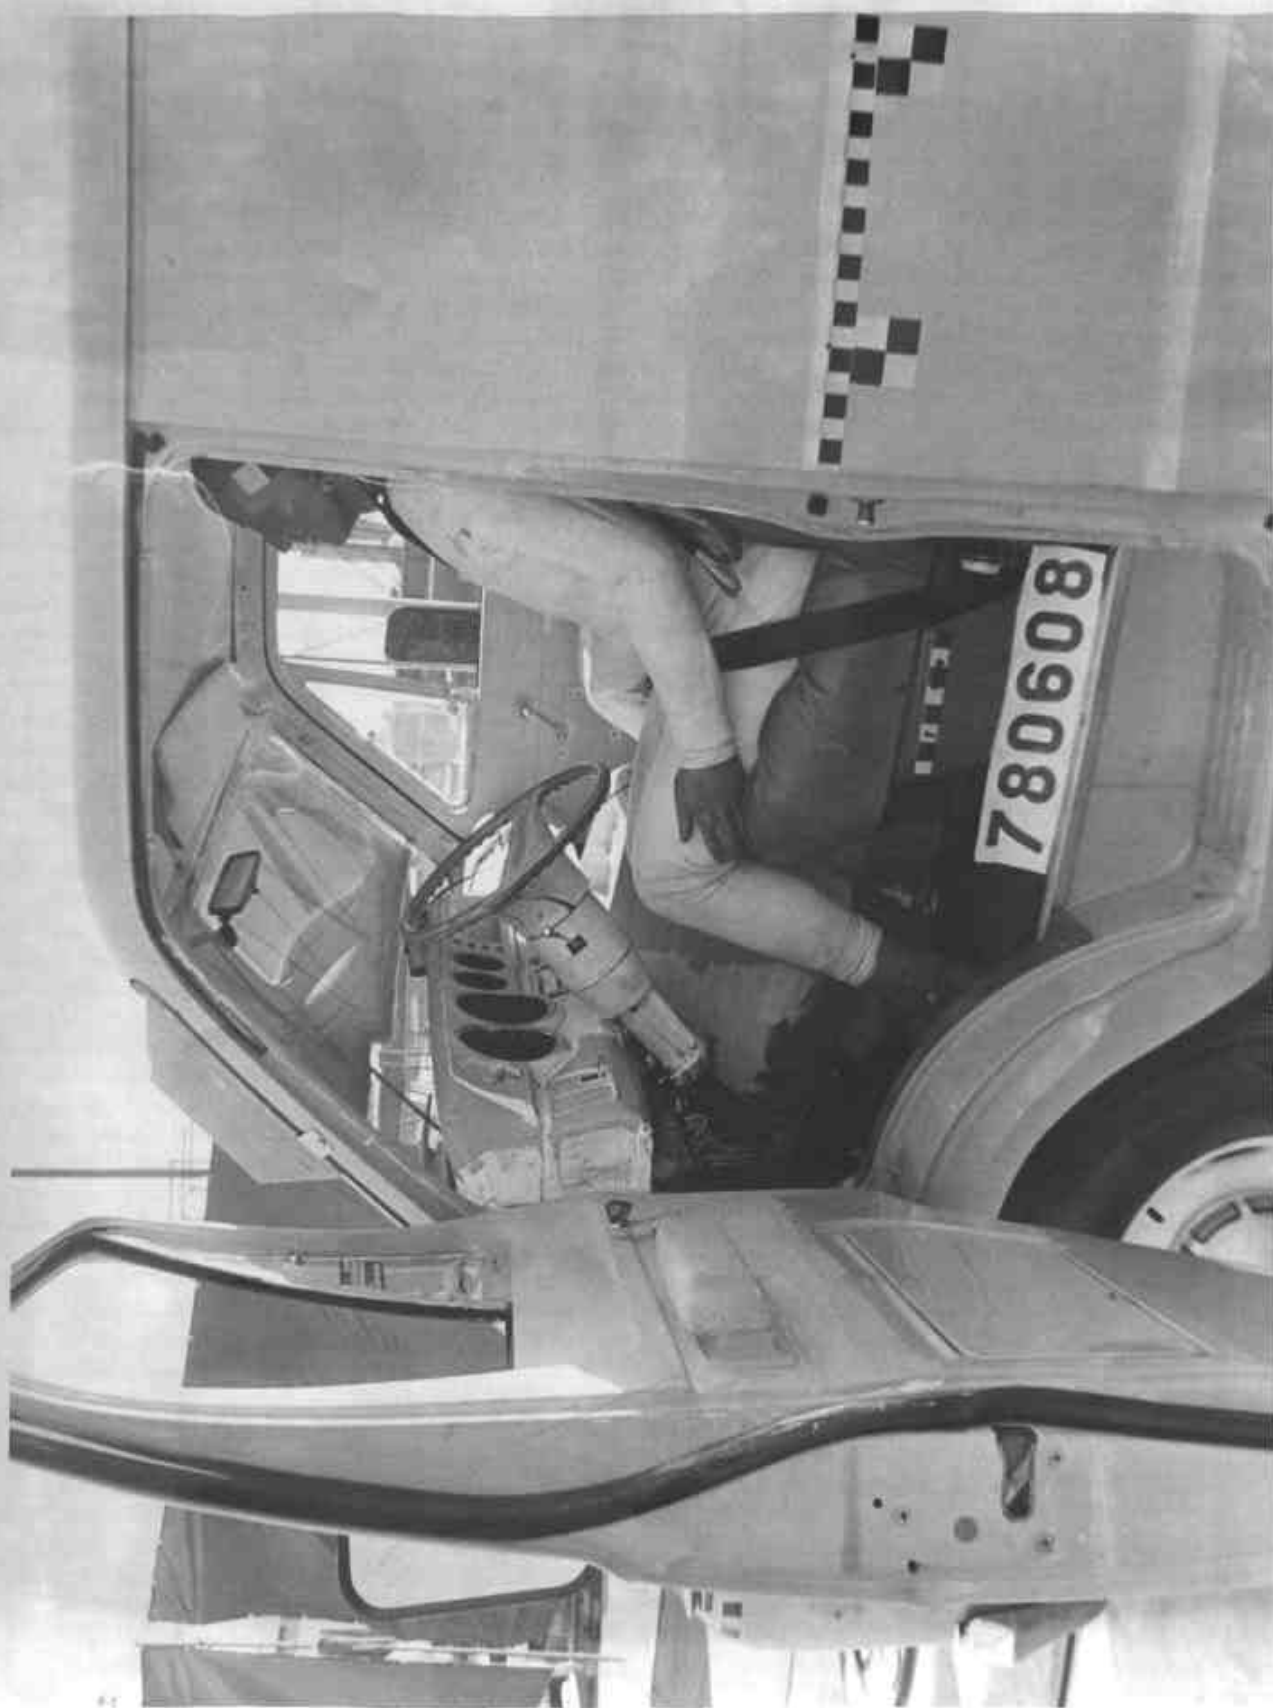
Figure 3-1  
1978 Dodge Tradesman B200 - Van  
NHTSA 780608  
Pre-Test, Driver Dummy View

Figure 3-1 through 3-4 are pre-test and post-test views of the occupant compartment, restraint system, and dummies.

The driver and right front passenger dummies were placed in the center of the seat cushion and pushed into the seat back. The shoulders were pushed back against the seat back and the head centered on the head restraint. The thighs were pushed down on the seat cushion and the heels placed on the floor. The thumbs and index fingers of the driver dummy were positioned around the steering wheel rim at the 3 and 9 o'clock positions. The upper portion of the passenger dummy arms were pushed against the seat back and the hands placed to the side of the thighs.

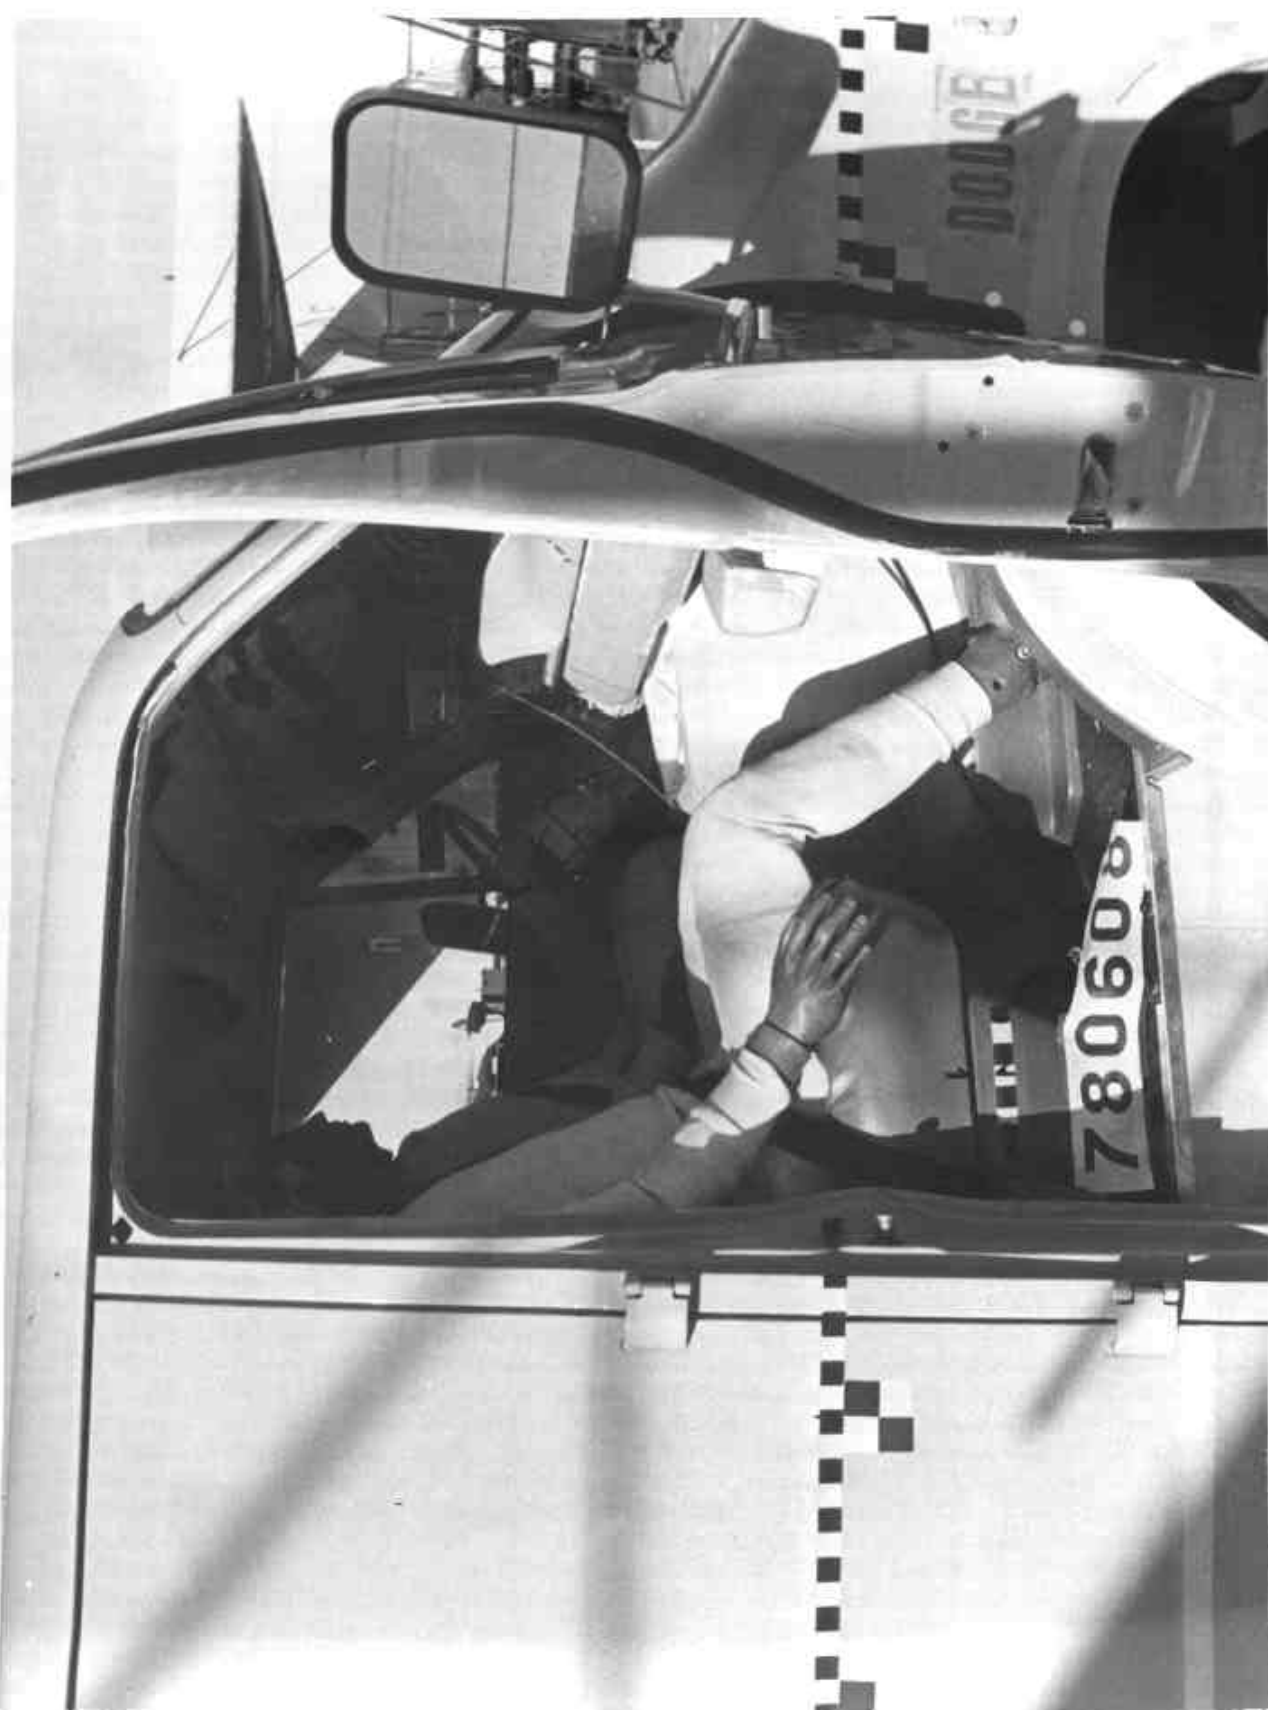
Figure 3-2  
1978 Dodge Tradesman B200 - Van  
NHTSA 780608  
Pre-Test, Passenger Dummy View

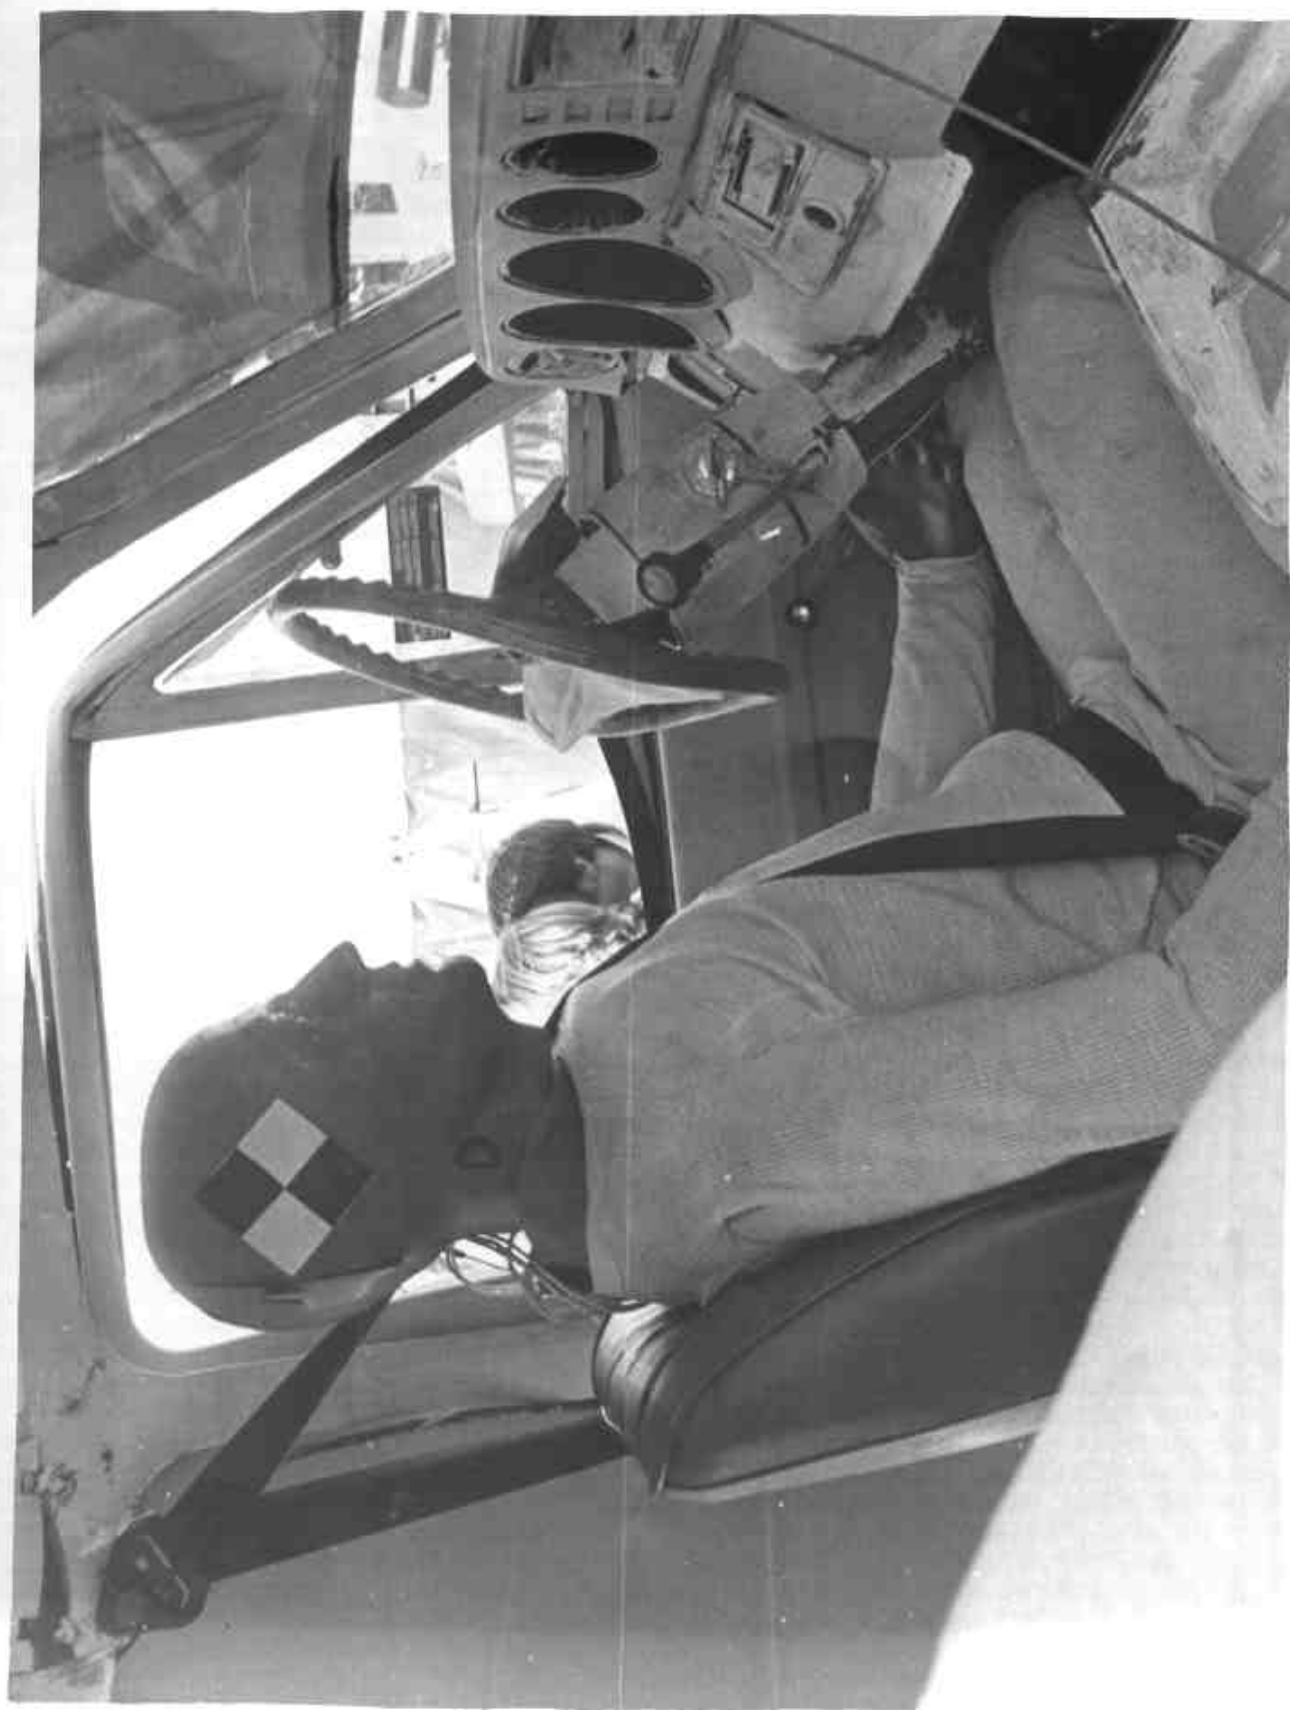
Figure 3-3  
1978 Dodge Tradesman B200 - Van  
NHTSA 780608  
Post-Impact, Driver Dummy View

Post-impact inspection of the vehicle revealed almost all crush occurred forward of the front doors. The hood was jammed against the cowl and both front fenders pushed back into the doors. The steering wheel rim was severely bent forward by driver dummy contact and the steering wheel sector shaft broke. The passenger dummy impacted the dash assembly. The roof buckled over both "B" pillars and the left and right frame rails buckled in the vicinity of the "B" pillars.

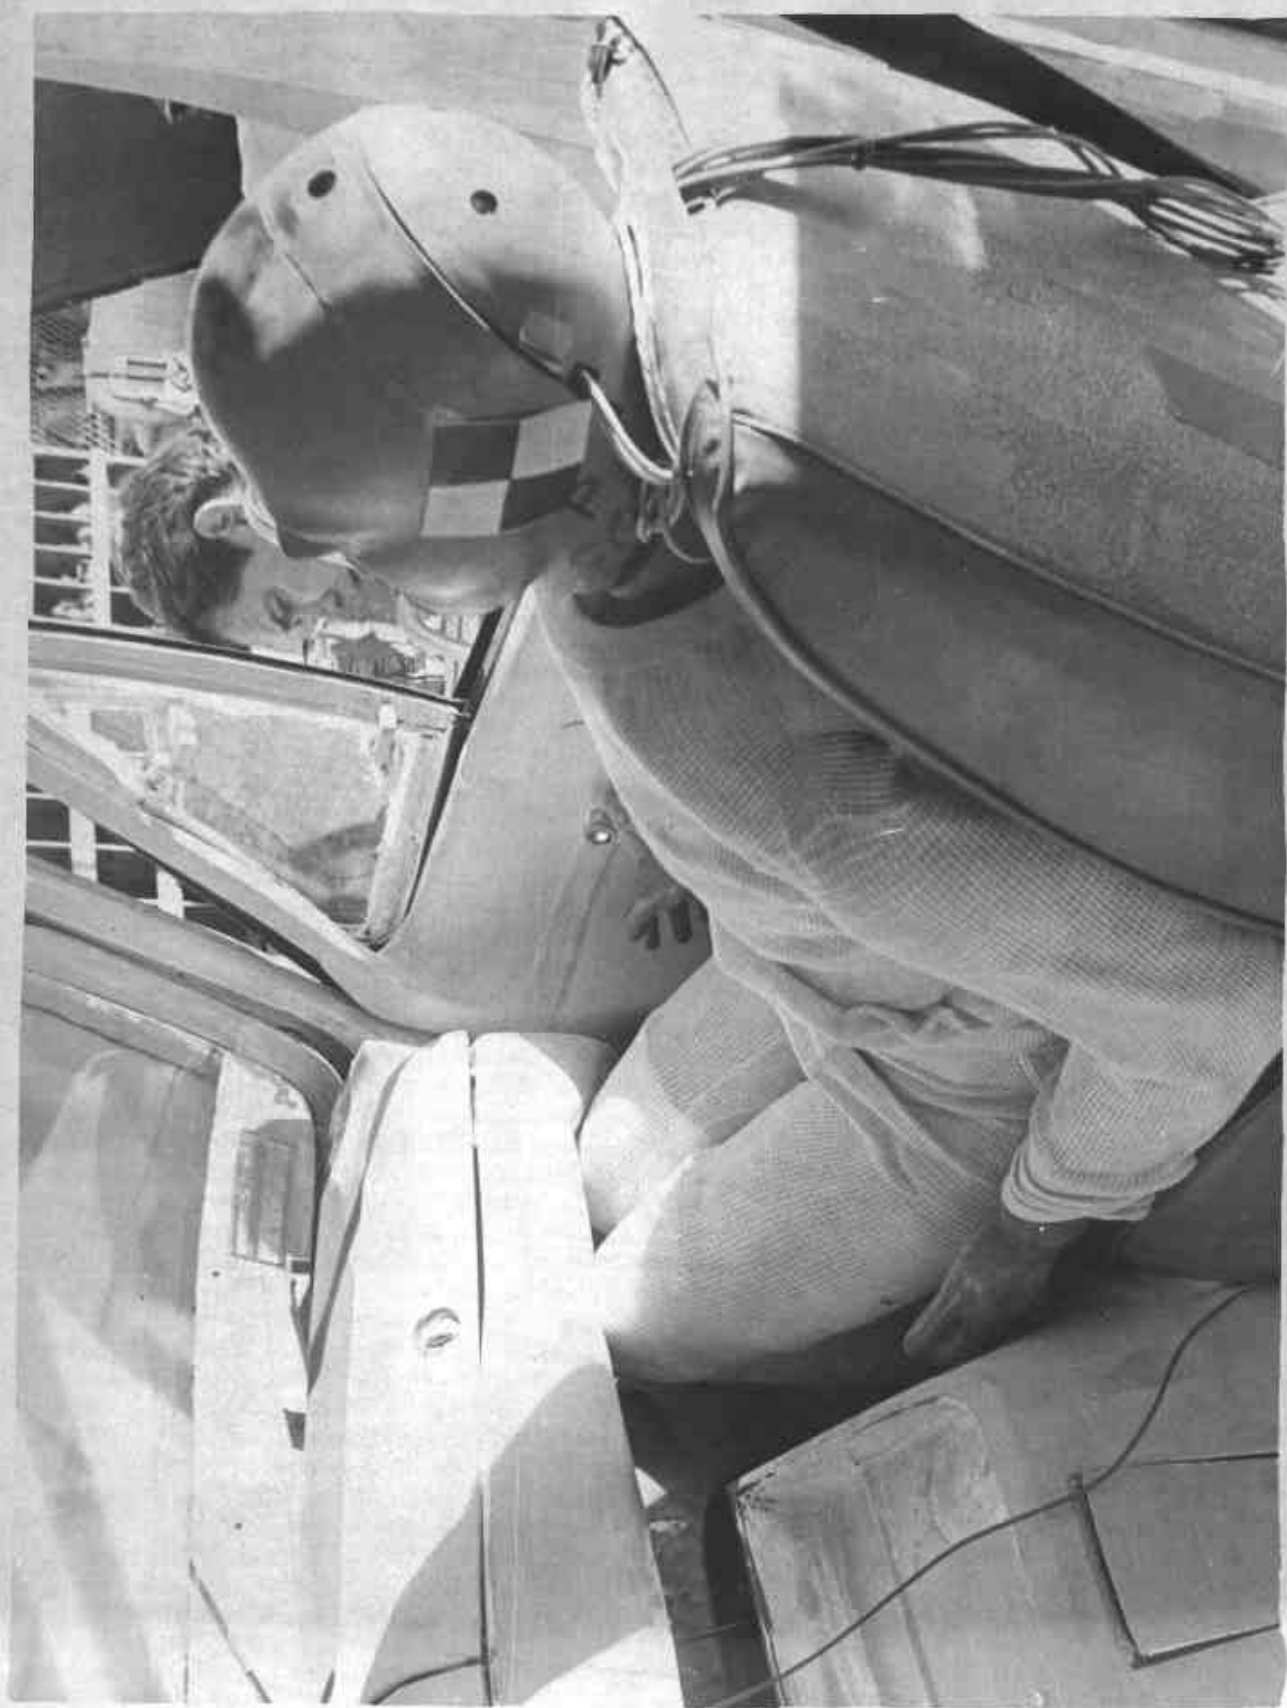
Figure 3-4  
1978 Dodge Tradesman B200 - Van  
NHTSA 780608  
Post-Impact, Passenger Dummy View
