OCCUPANT RESPONSE  
AND  
VEHICLE ACCELERATION  
IN A  
30 MPH FRONTAL IMPACT TEST

GENERAL MOTORS CORPORATION  
1978 CHEVROLET G20 - SPORT VAN  
NHTSA 781304

FINAL REPORT

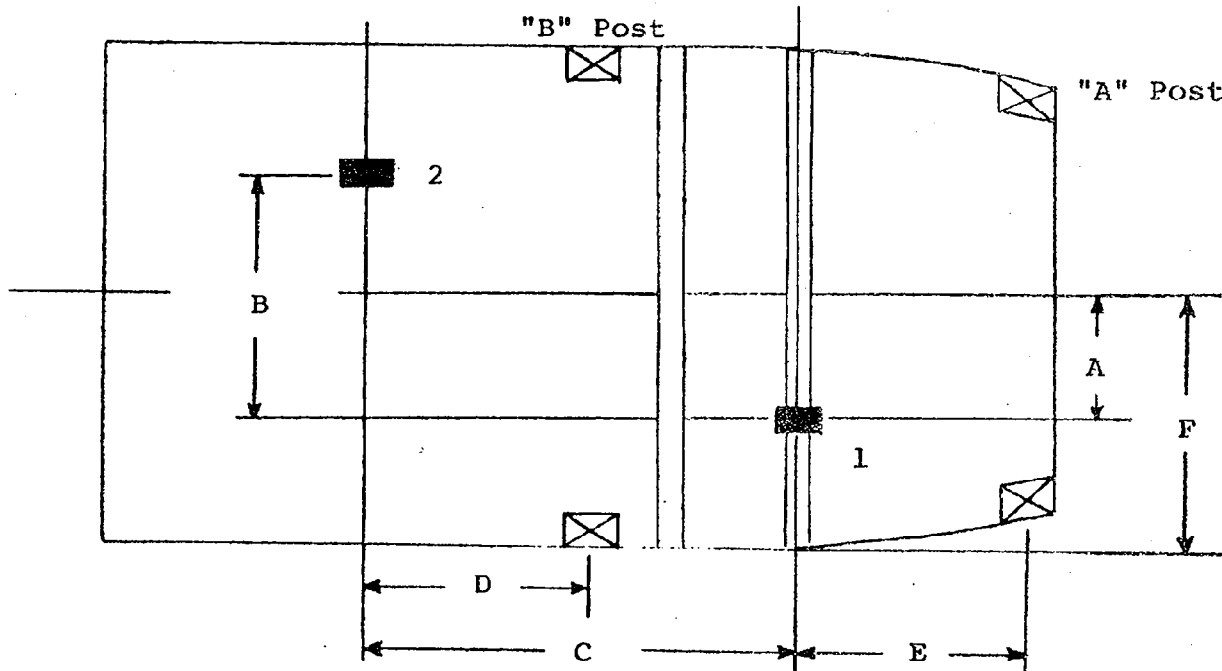
# VEHICLE STRUCTURAL DATA

Average Vehicle Impact Speed 29.410 mph; Test Weight 5,259 lb

Steering Column Movement Upward 1.8", Leftward 1.0", Rearward 2.5"  
 Vehicle Rebound Distance 12.1 in.  
 Overall Vehicle Crush 15.1 in

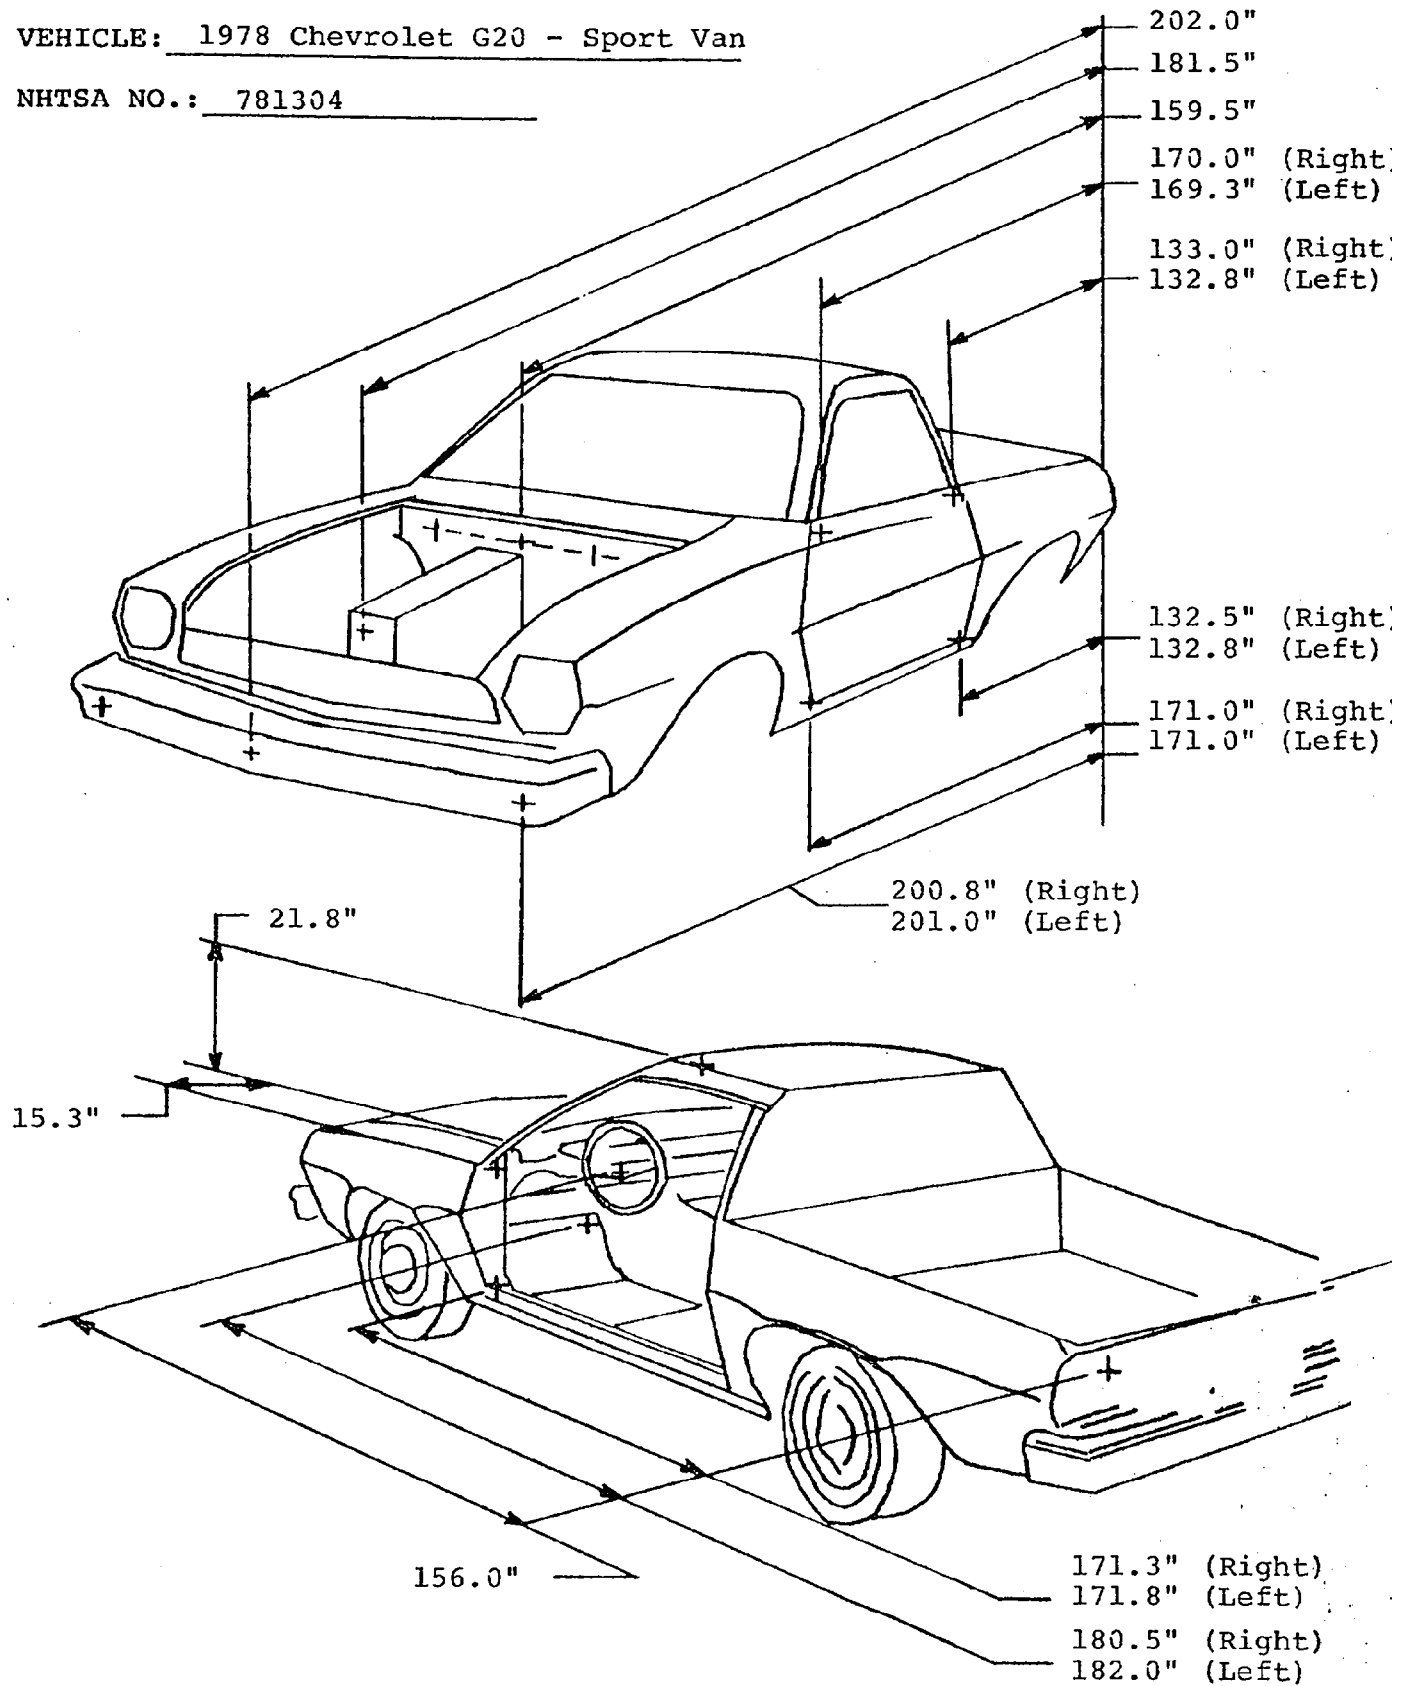
PRE-TEST

VEHICLE STRUCTURAL DATA

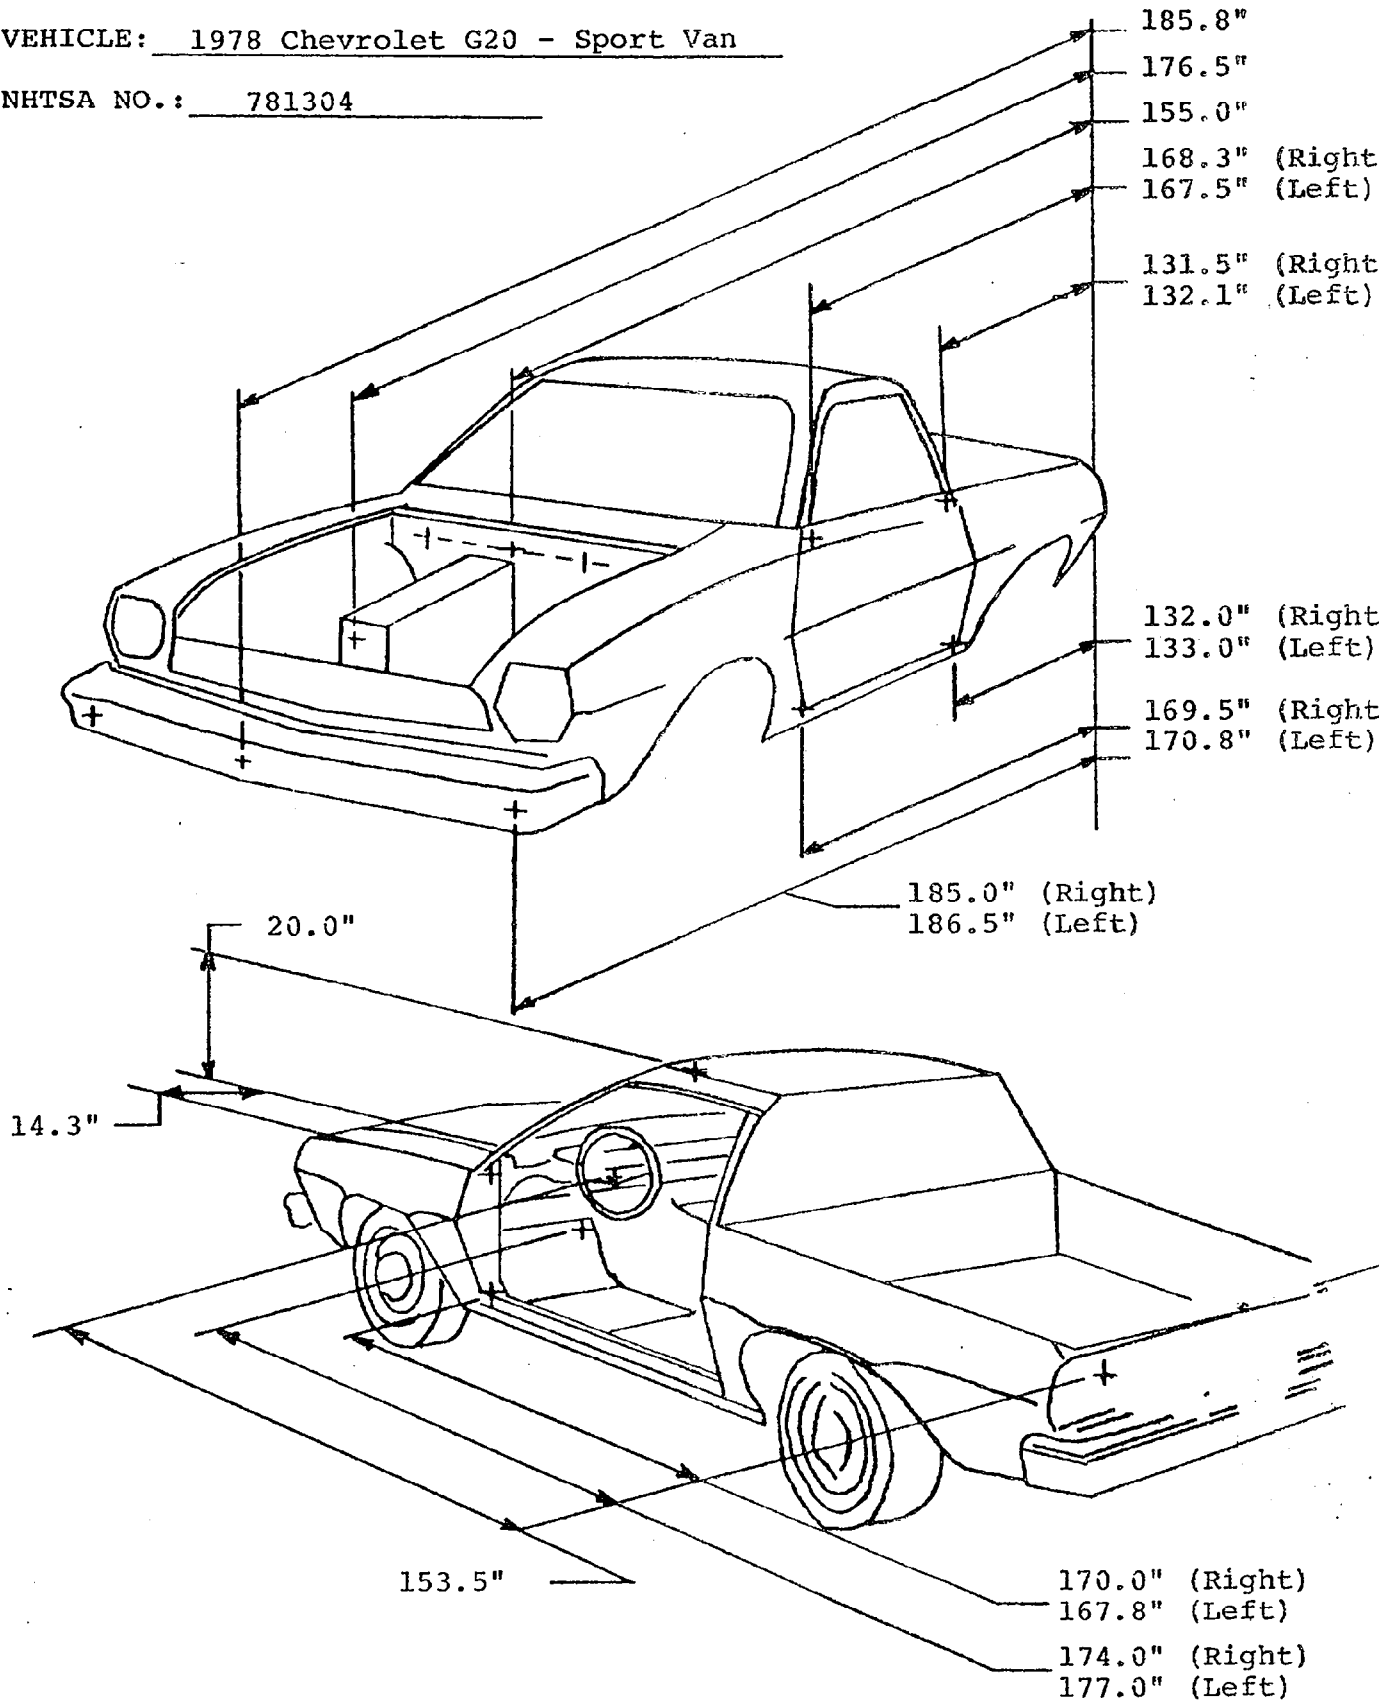
POST-TEST

VEHICLE STRUCTURAL DATA

The test vehicle performance was determined by a frontal fixed barrier impact at an average speed of 29.410 mph. The vehicle rebound distance from the barrier face was 12.1 inches and the average vehicle static crush was 15.1 inches.

Post-impact inspection of the vehicle revealed almost all crush occurred forward of the front doors. The hood was jammed against the cowl and both front fenders pushed back into the doors. The steering wheel rim was severely bent forward by driver dummy contact. The passenger dummy impacted the dash assembly. The right front tire was flat and the windshield came completely out of the body opening. The roof buckled over both "B" and "C" pillars and the transmission rear cross member severed.

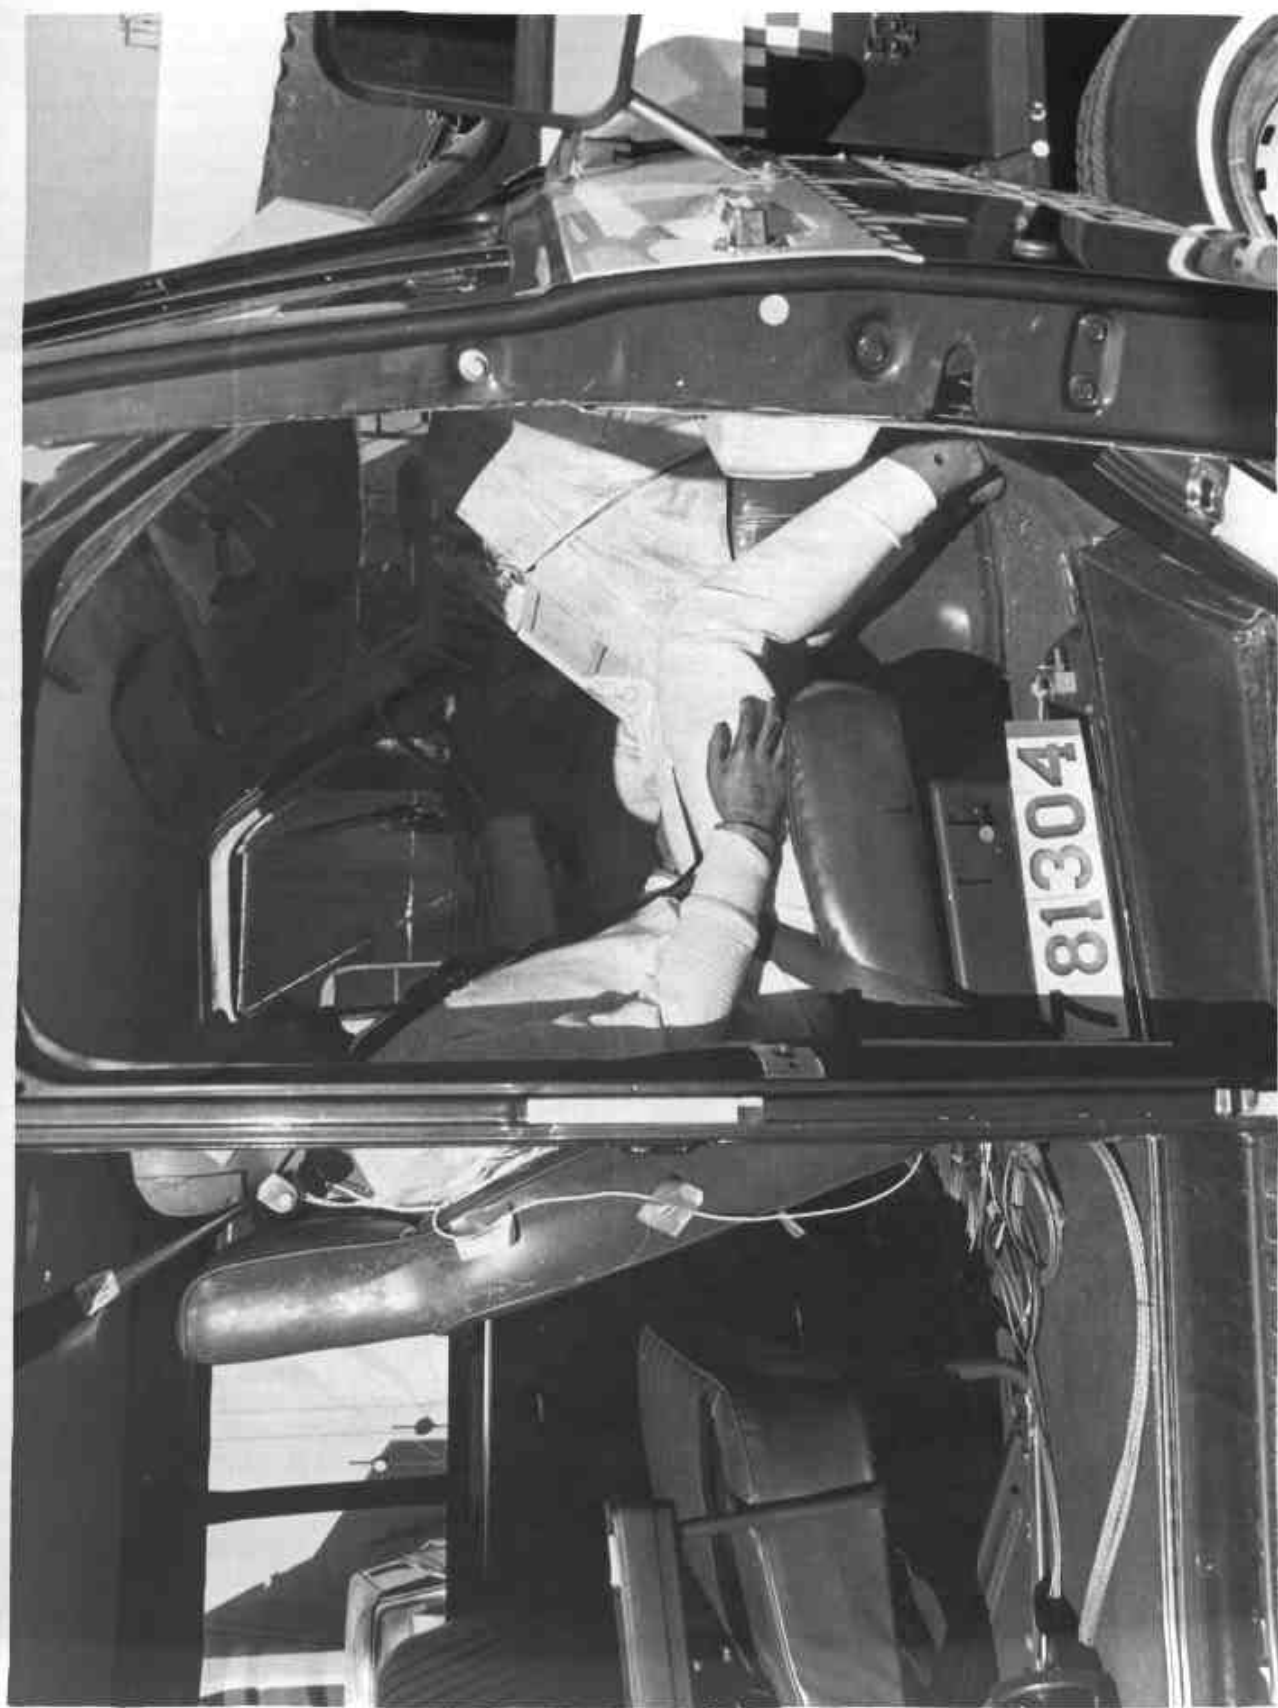
Figure 3-2

Pre-Test, Passenger Dummy View

Figure 3-1 through 3-4 are pre-test and post-test views of the occupant compartment, restraint system, and dummies.

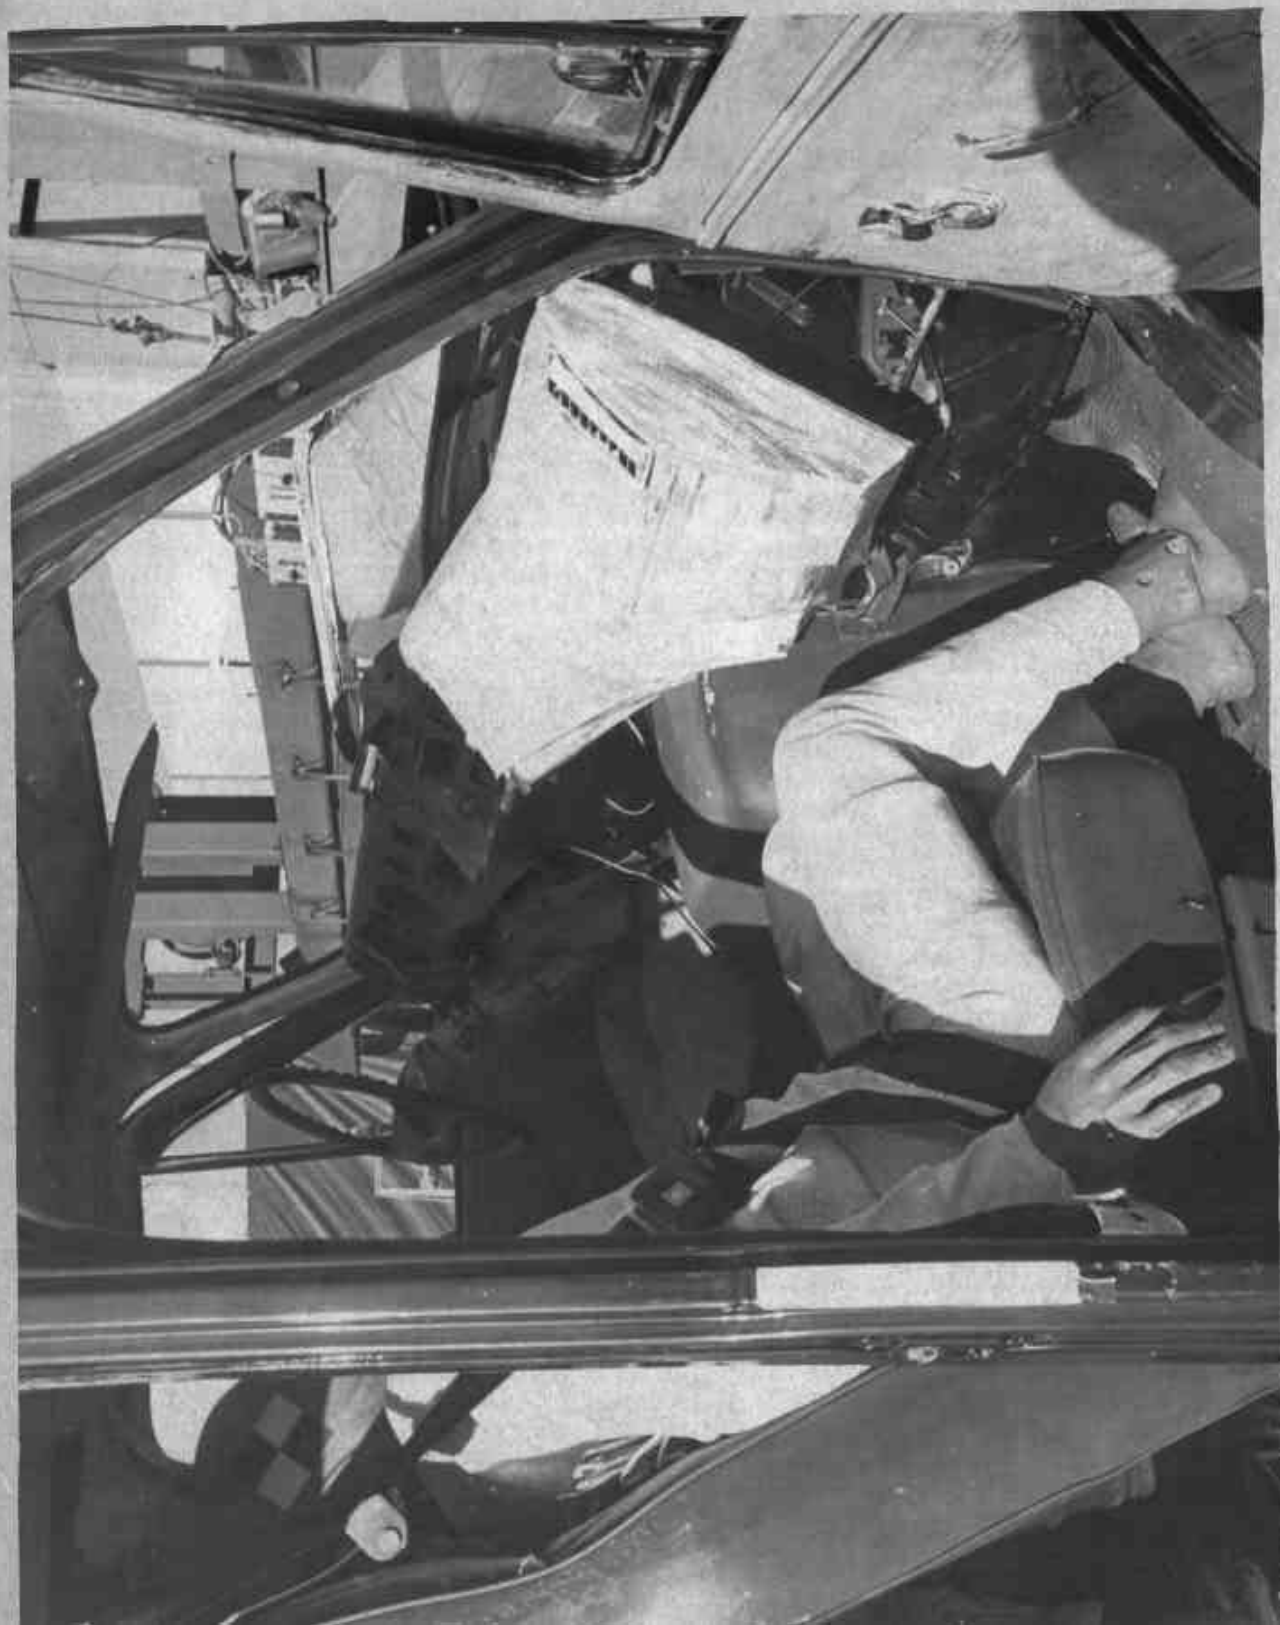
Figure 3-4

Post-Impact, Passenger Dummy View

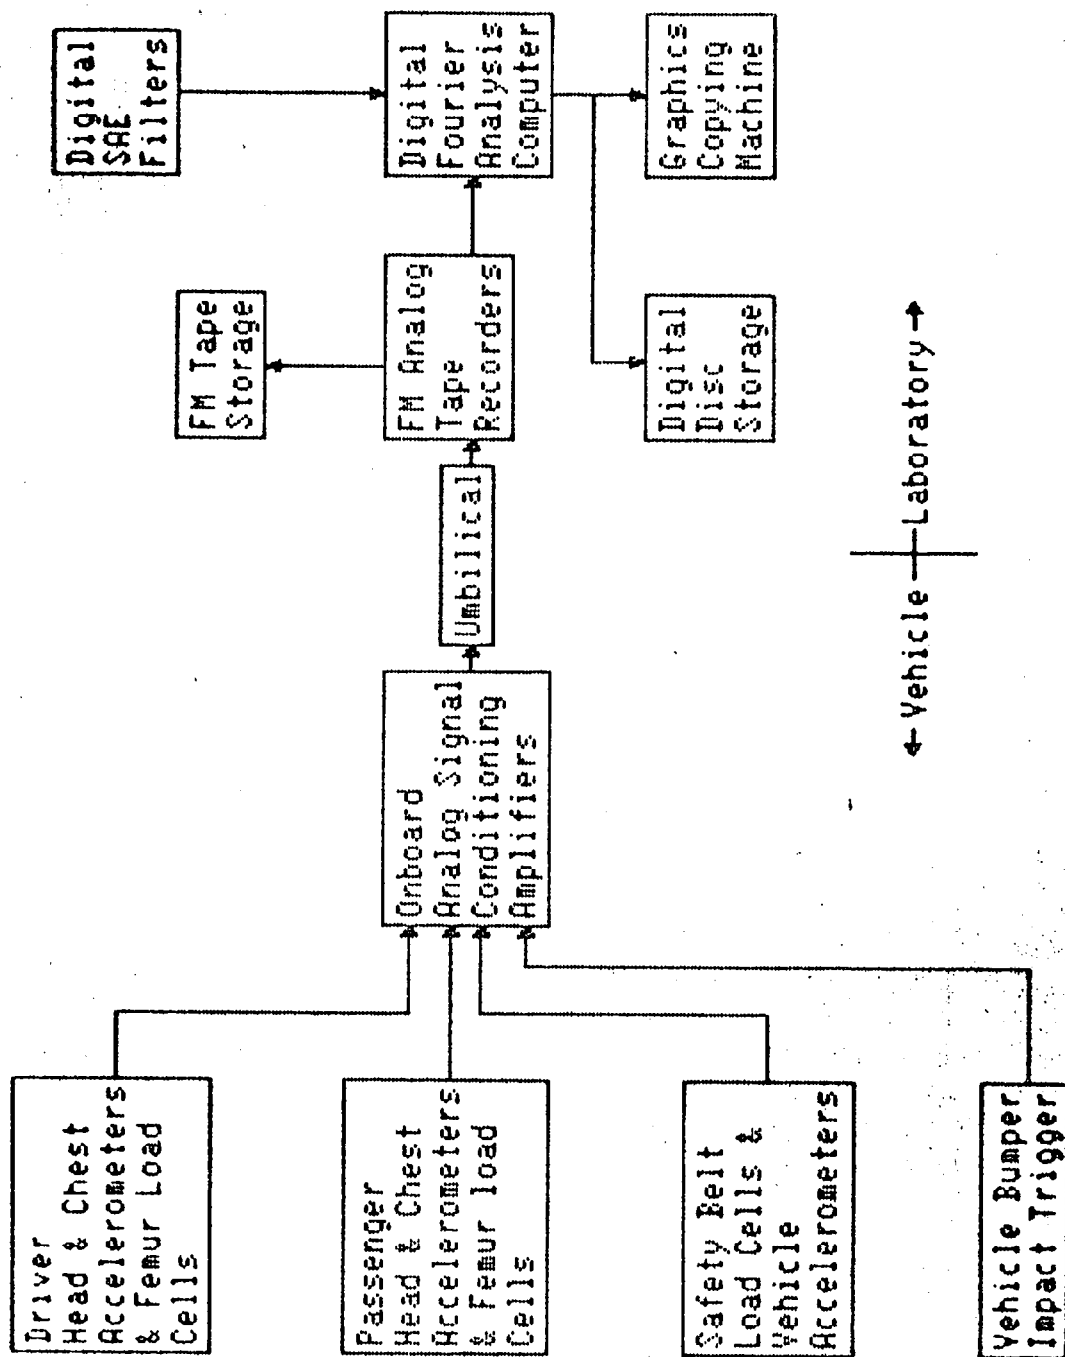
VEHICLE AND OCCUPANT CRASH IMPACT DATA ACQUISITION SYSTEM

The data acquisition and analysis system used for acquiring occupant response and vehicle acceleration are shown schematically in Figure 4-1. A complete list of instrumentation is provided in Table 4-1. An itemized procedure for acquiring data is provided on Table 4-2.

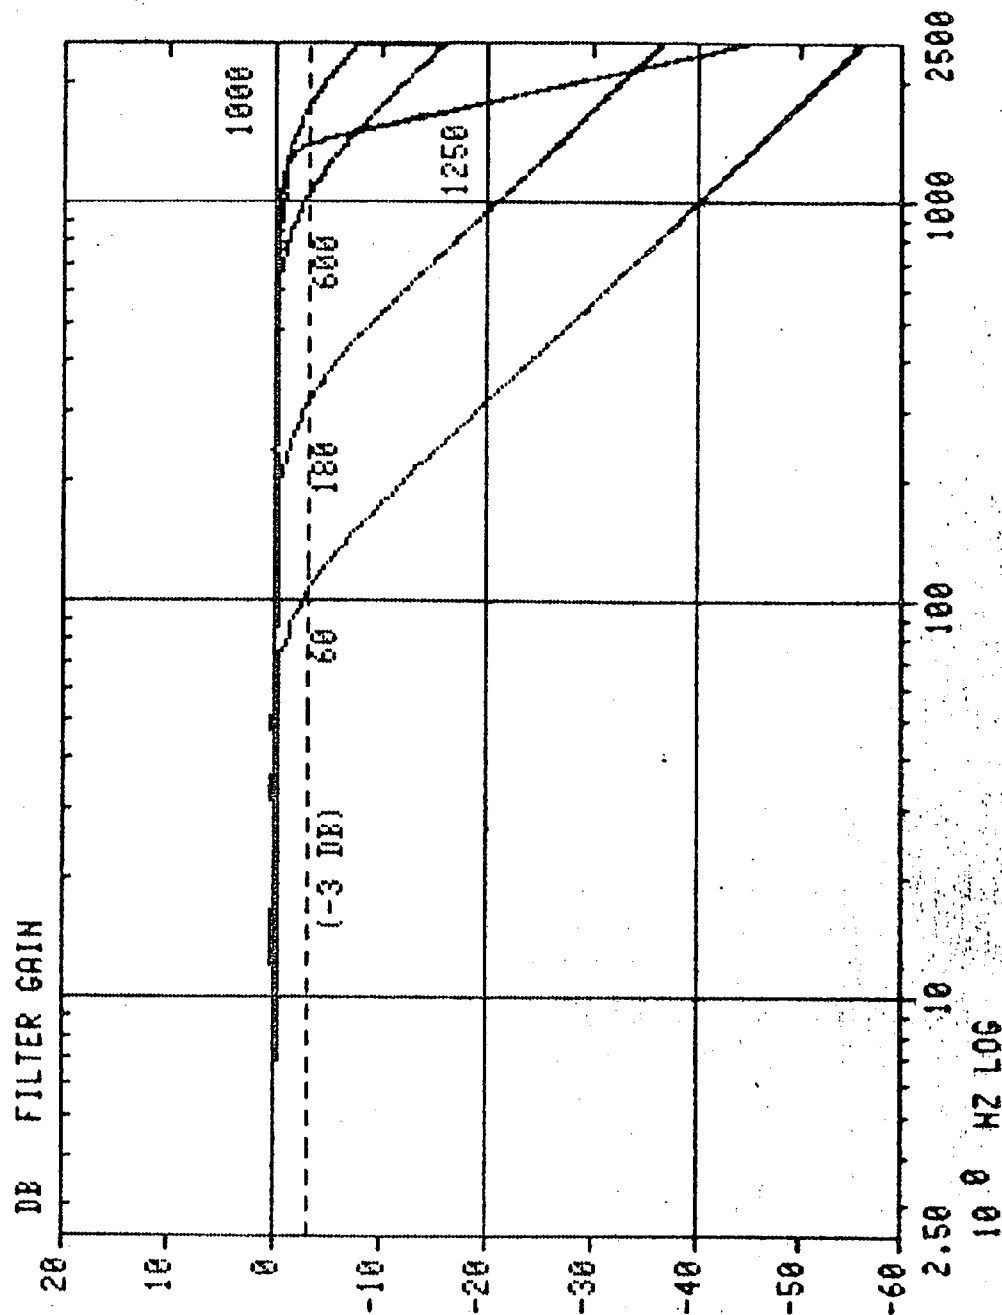
FIGURE 4-2

COMPARISON PLOT OF SAE CLASS 60, 180, 600, 1000 FILTERS AND  
THE DATA ANALYSIS 1250 HZ PREDIGITIZING ANALOG FILTER.

SAE FILTERS ROLL OFF IS 12DB/OCT, ANALOG FILTER ROLL OFF IS 60DB/OCT

The SAE recommended filters are quadratic double pole filters with 65% damping and 12 db/octave rolloff. They are applied to the data using a Fast Fourier Transform (FFT) of the data, frequency domain multiplication, and inverse FFT operation on the product.

It should be noted in Figure 4-2 that the predigitizing analog filter attenuates all signals above the 1250 Hz cutoff frequency. This has no effect on the class 60 or class 180 data. The class 600 data is within SAE J211a recommendation to 1900 Hz and -20 db. Above 1900 Hz the class 600 data was attenuated at 60 db/octave instead of 24 db/octave. This had very negligible effect on the class 600 data. The modification of class 1000 data by the predigitizing filter is attenuation of 60 db/octave above 1250 Hz instead of 24 db/octave above 1650 Hz. Examination of typical class 1000 data shows the high frequency components between 1250 Hz and 1650 Hz are uniformly less than 3 percent of the largest components at lower frequencys. The effect of the predigitizing filter has a very slight smoothing of the plotted data.

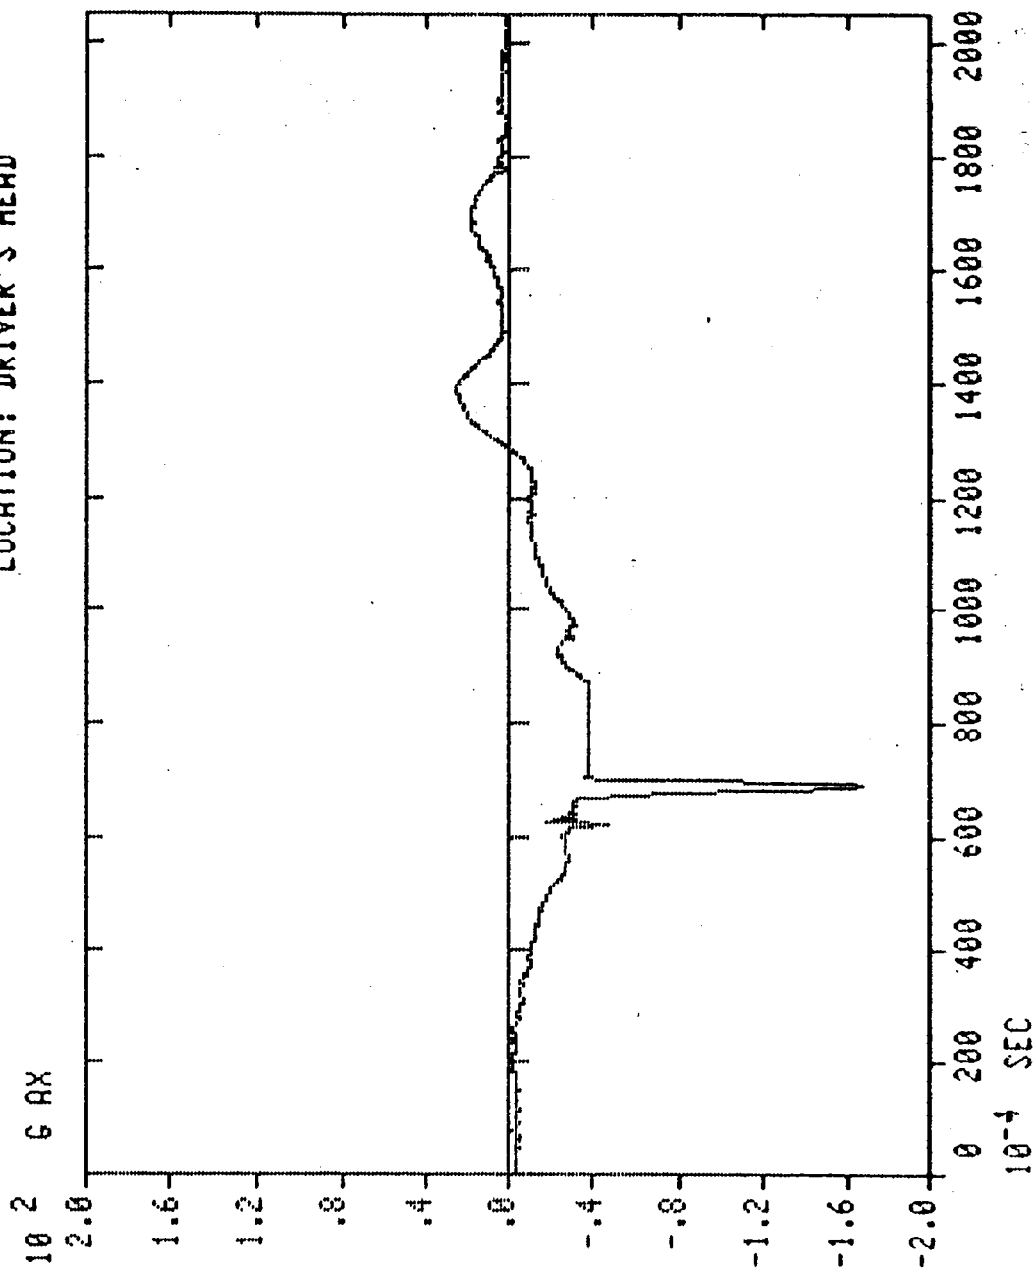
MJO NO.: 671-1489-54  
FILTER: CLASS 1000  
ACCELEROMETER: TAPE 1, CH 1  
DIRECTION: FORWARD  
LOCATION: DRIVER'S HEAD

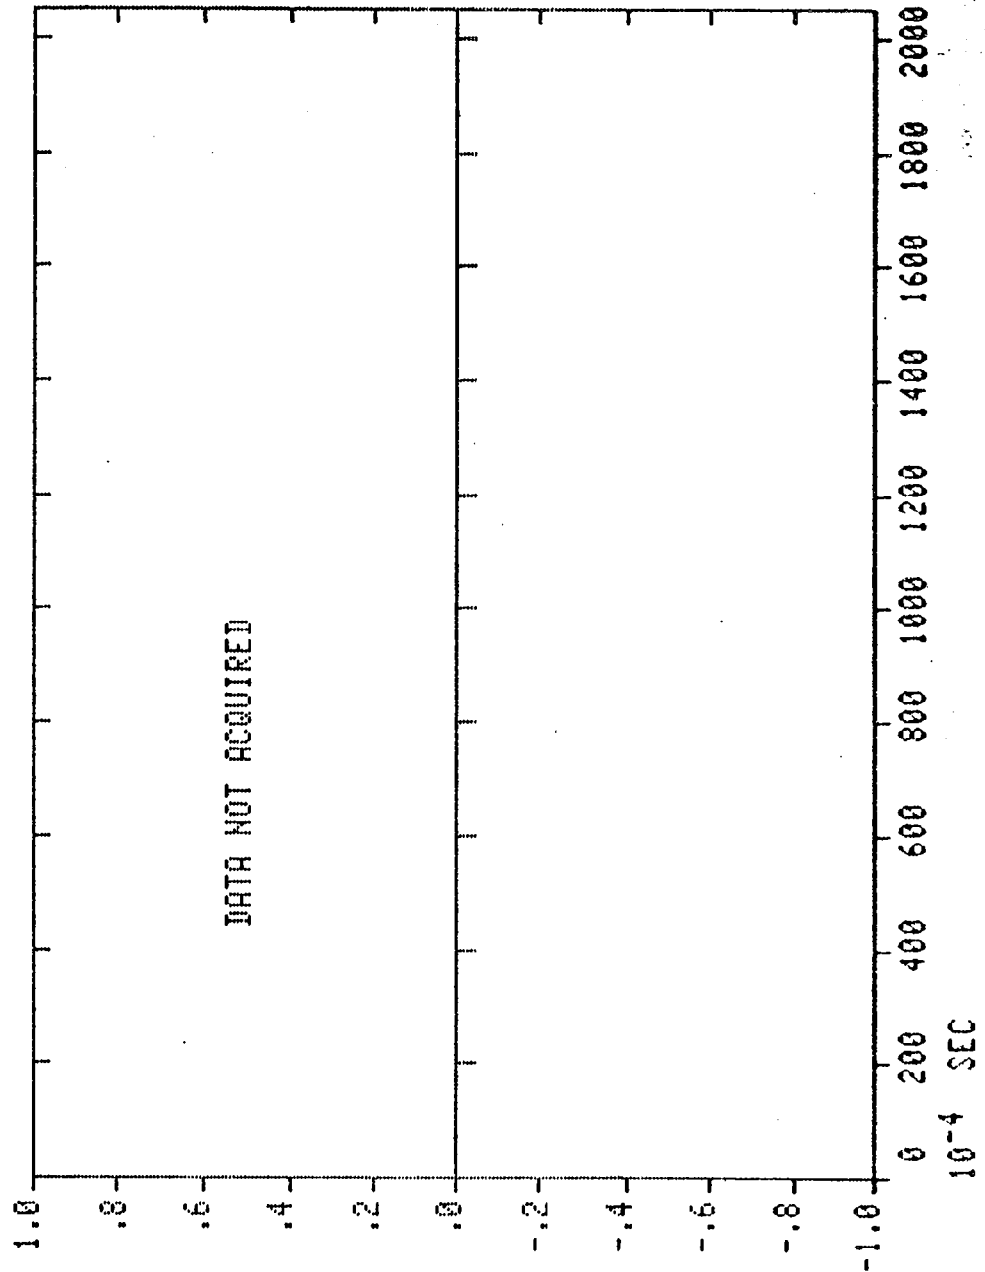
HJO NO.: 671-1489-54  
FILTER: CLASS 1000  
ACCELEROMETER: TAPE 1, CH 2  
DIRECTION: LEFT  
LOCATION: DRIVER'S HEAD

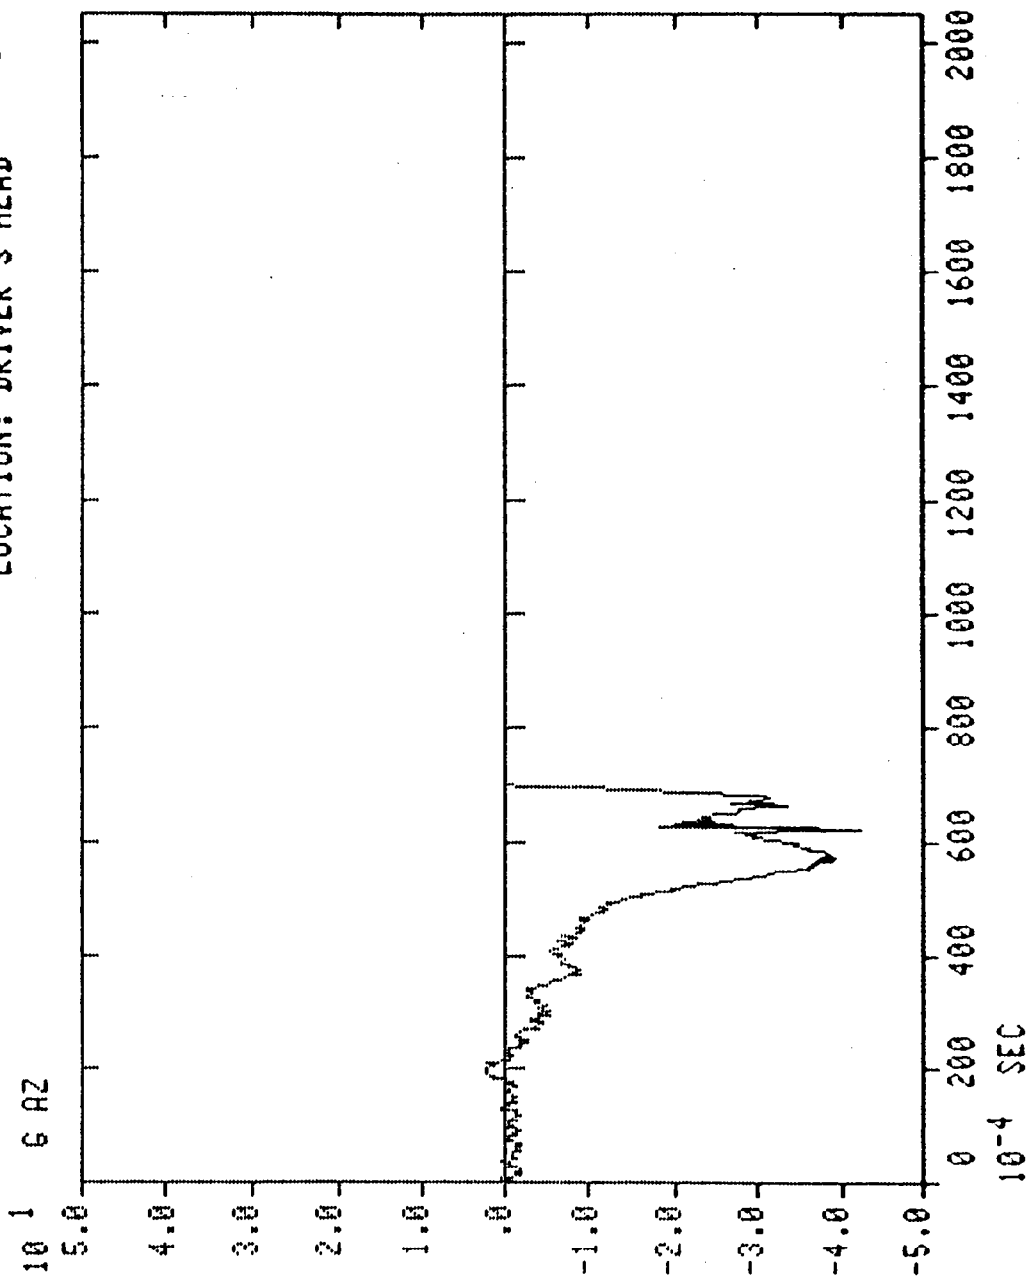
HJO NO.: 671-1489-54  
FILTER: CLASS 1000  
ACCELEROMETER: TAPE 1, CH 3  
DIRECTION: UPWARD  
LOCATION: DRIVER'S HEAD

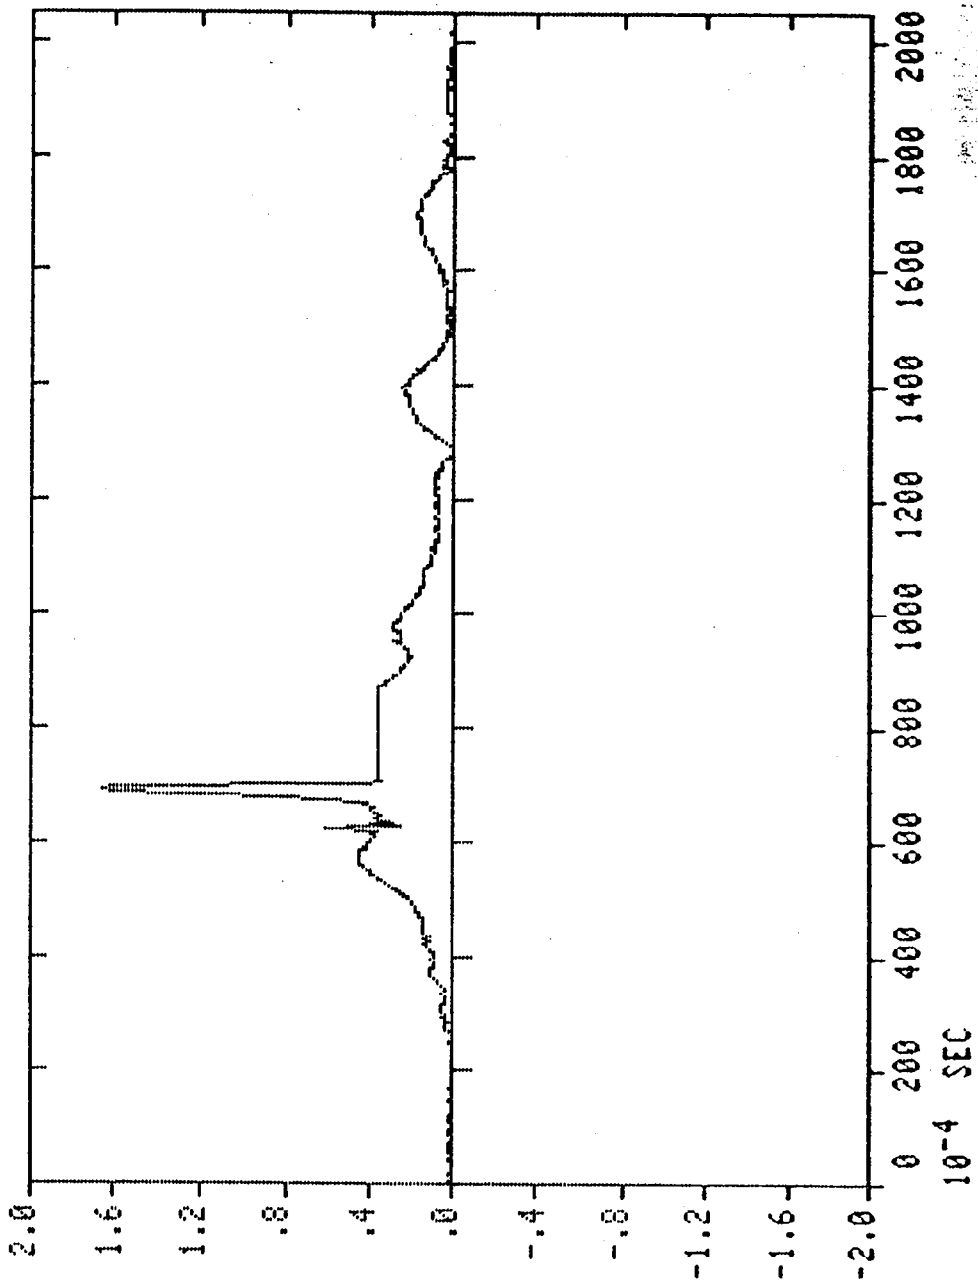
HJO NO.: 671-1489-54  
FILTER: CLASS 1000  
ACCELEROMETER: TAPE 1, CH 1-3  
DIRECTION: RESULTANT OF XYZ  
LOCATION: DRIVER'S HEAD

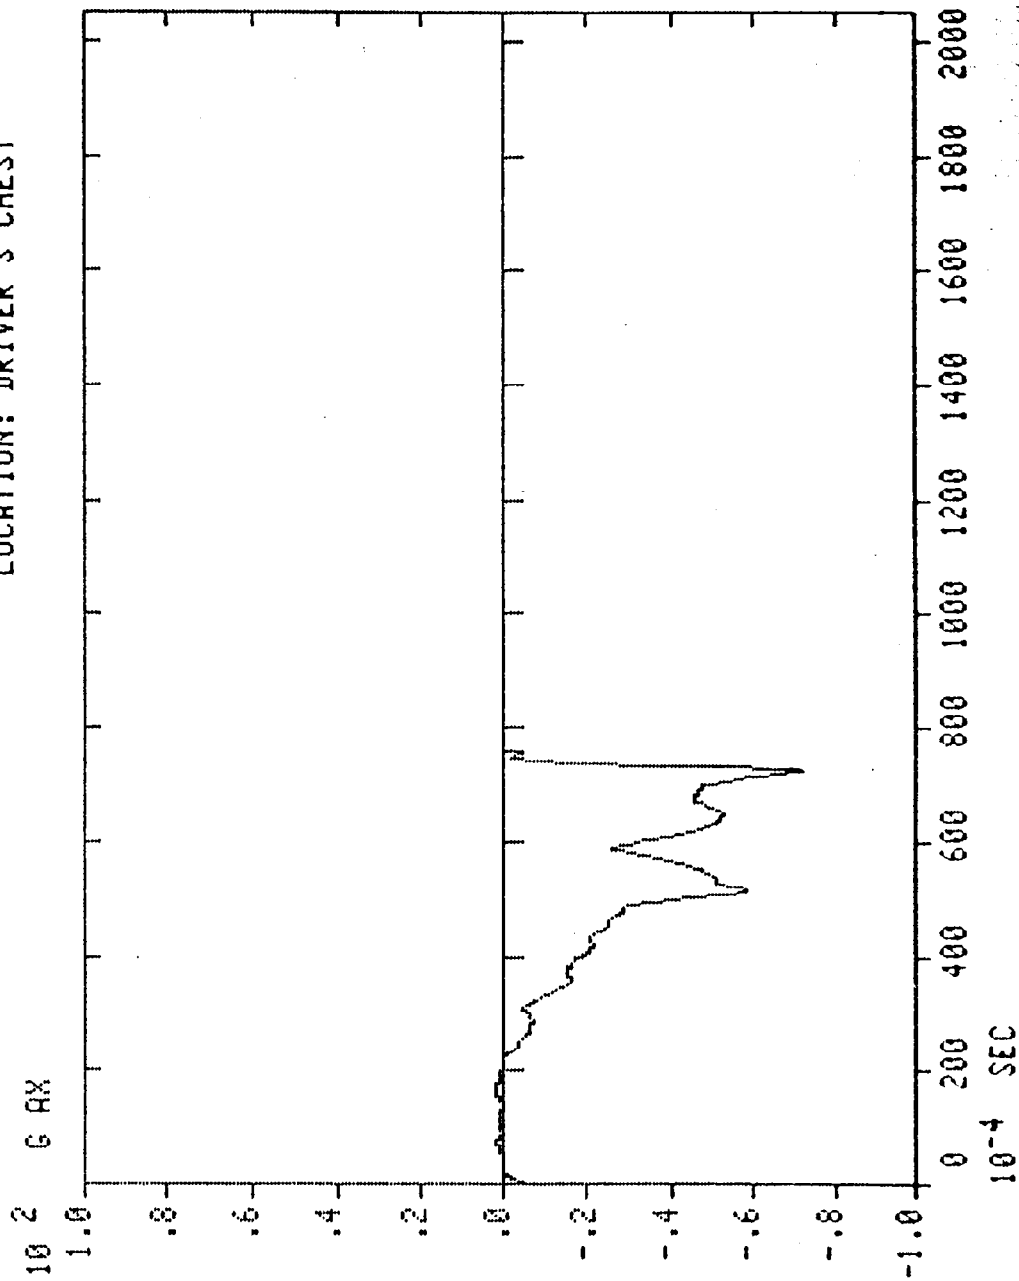
MJO NO.: 671-1489-54  
FILTER: CLASS 180  
ACCELEROMETER: TAPE 1, CH 5  
DIRECTION: FORWARD  
LOCATION: DRIVER'S CHEST

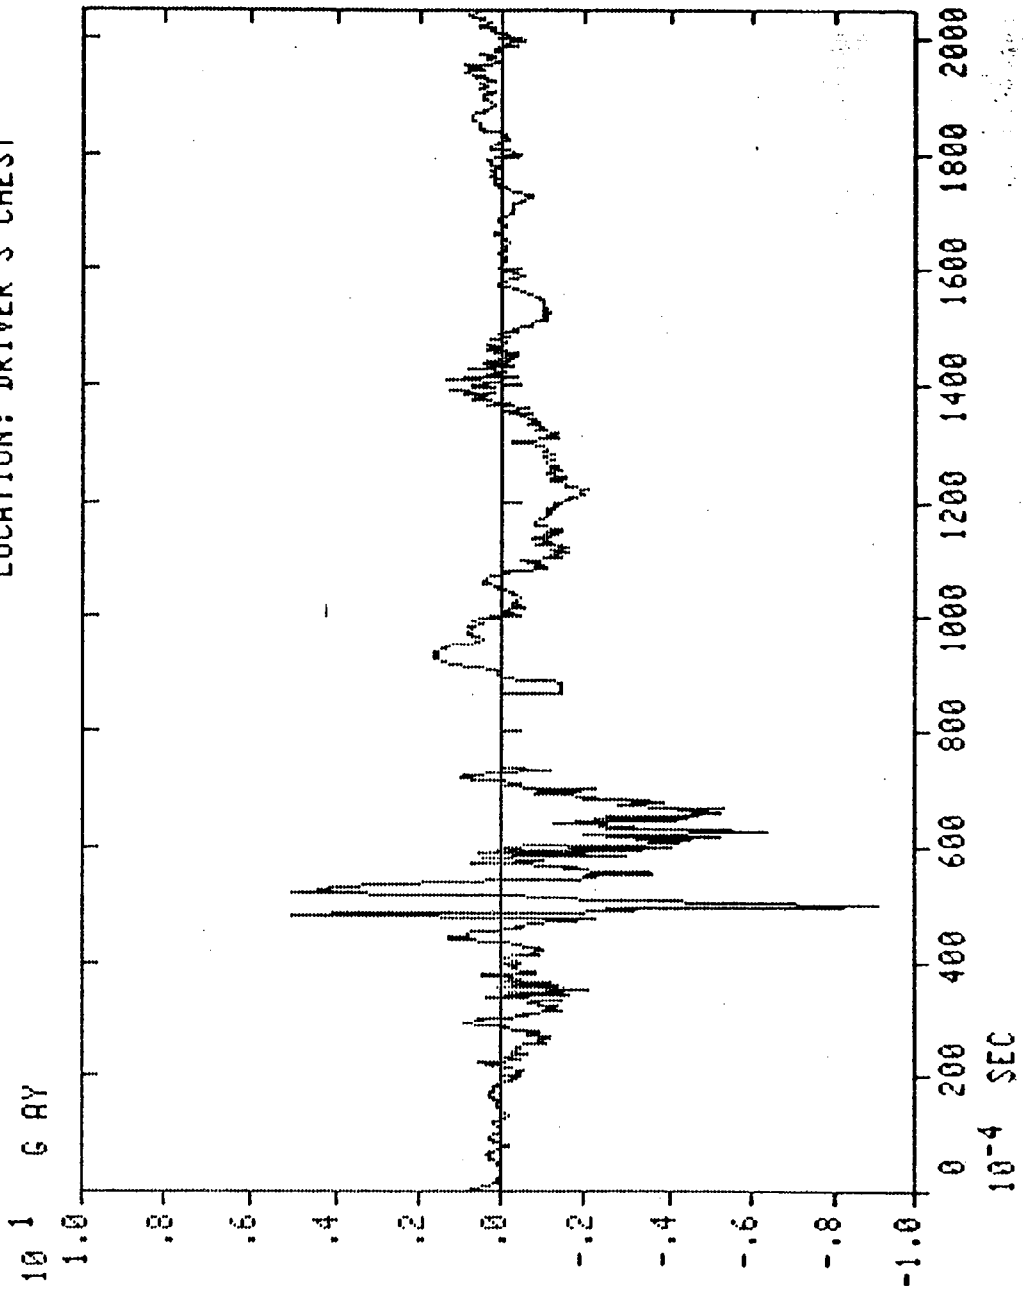
MJO NO.: 671-1489-54  
FILTER: CLASS 180  
ACCELEROMETER: TAPE 1, CH 6  
DIRECTION: LEFT  
LOCATION: DRIVER'S CHEST

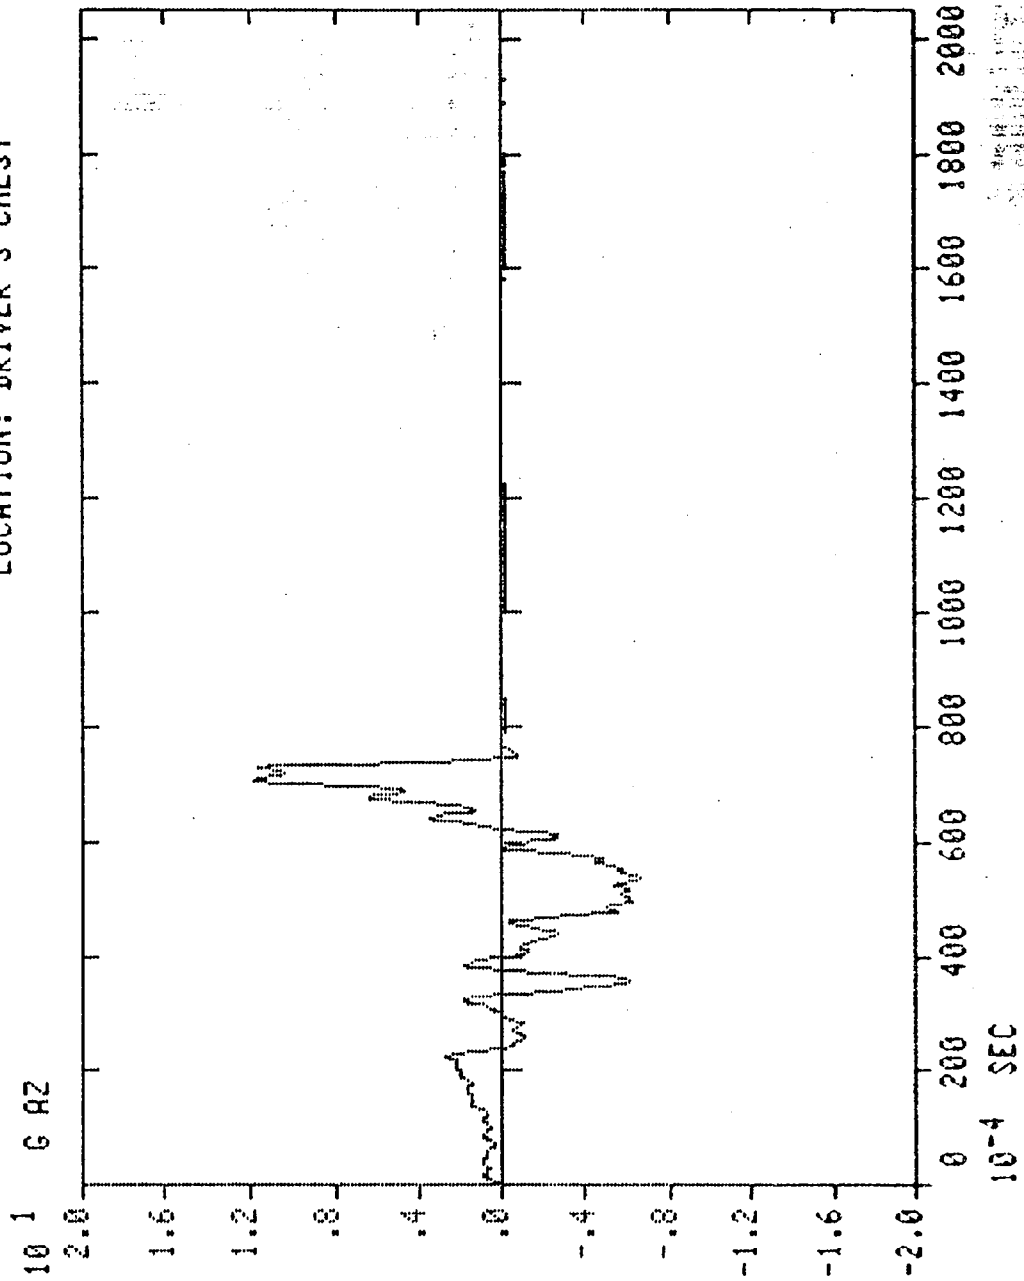
MJO NO.: 671-1489-54  
FILTER: CLASS 180  
ACCELEROMETER: TAPE 1, CH 7  
DIRECTION: UPWARD  
LOCATION: DRIVER'S CHEST
