OCCUPANT RESPONSE  
AND  
VEHICLE ACCELERATION  
IN A  
30 MPH FRONTAL IMPACT TEST

GENERAL MOTORS CORPORATION  
1978 CHEVROLET G20 - SPORT VAN  
NHTSA 781304

FINAL REPORT

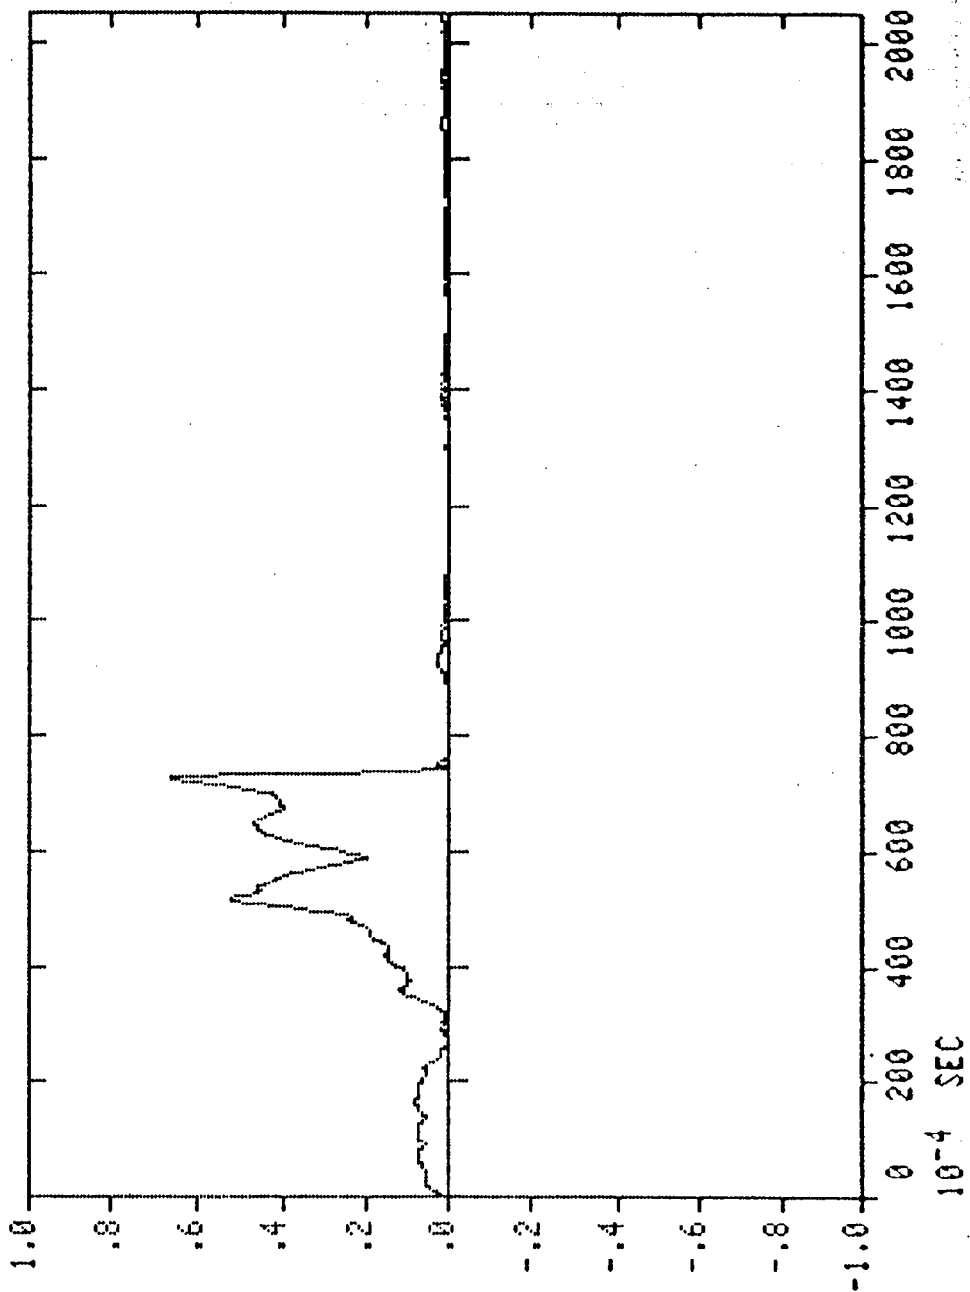
MJO NO.: 671-1489-54  
FILTER: CLASS 180  
ACCELEROMETER: TAPE 1, CH 5-7  
DIRECTION: RESULTANT OF XYZ  
LOCATION: DRIVER'S CHEST

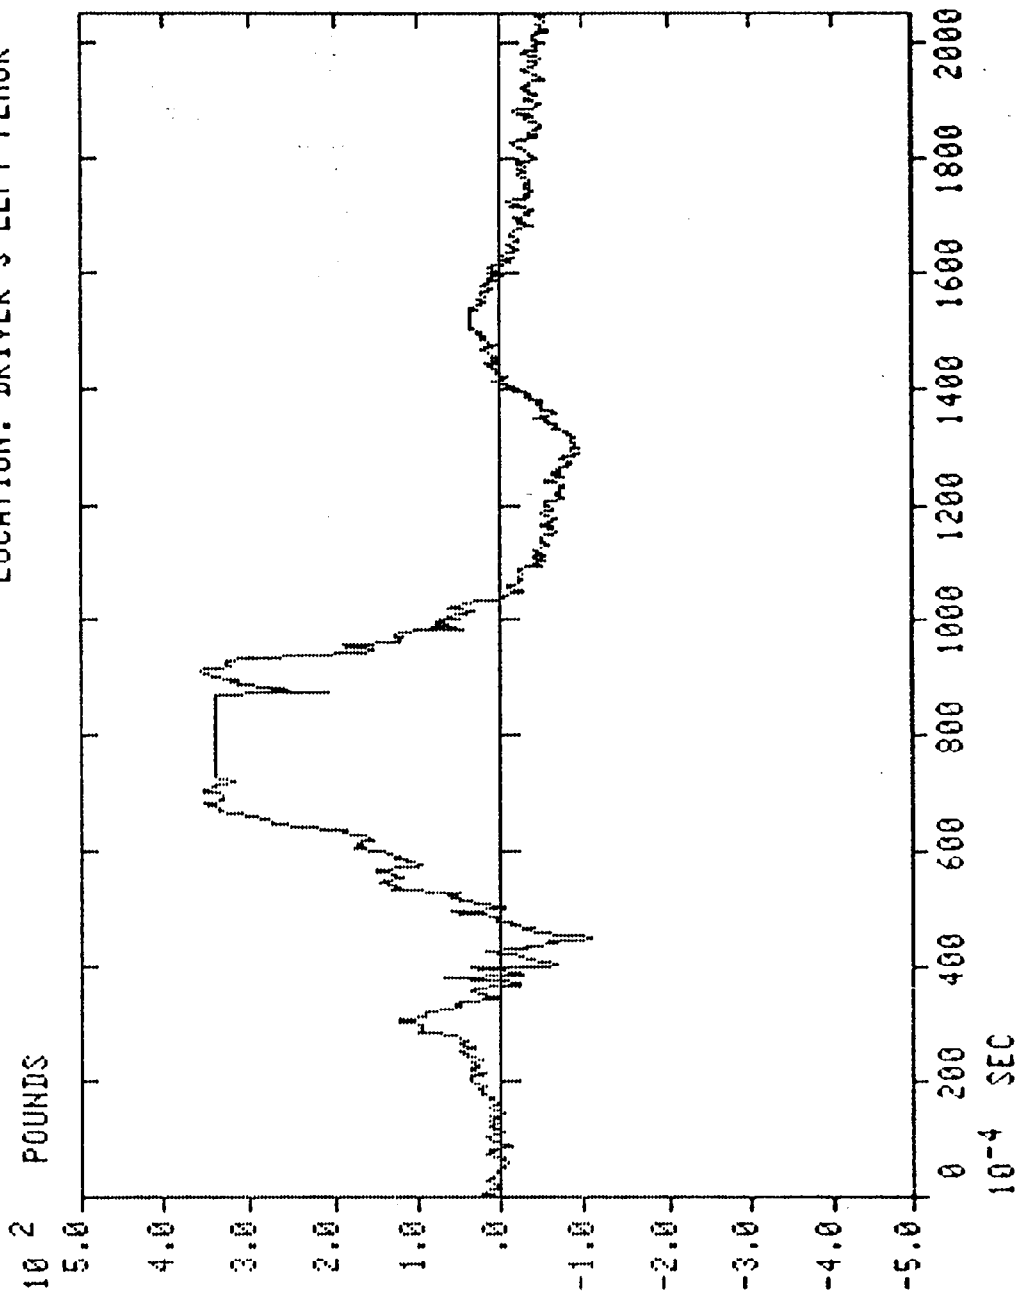
MJO NO.: 671-1489-54  
FILTER: CLASS 600  
LOAD CELL: TAPE 1, CH 8  
DIRECTION: TENSION  
LOCATION: DRIVER'S LEFT FEMUR

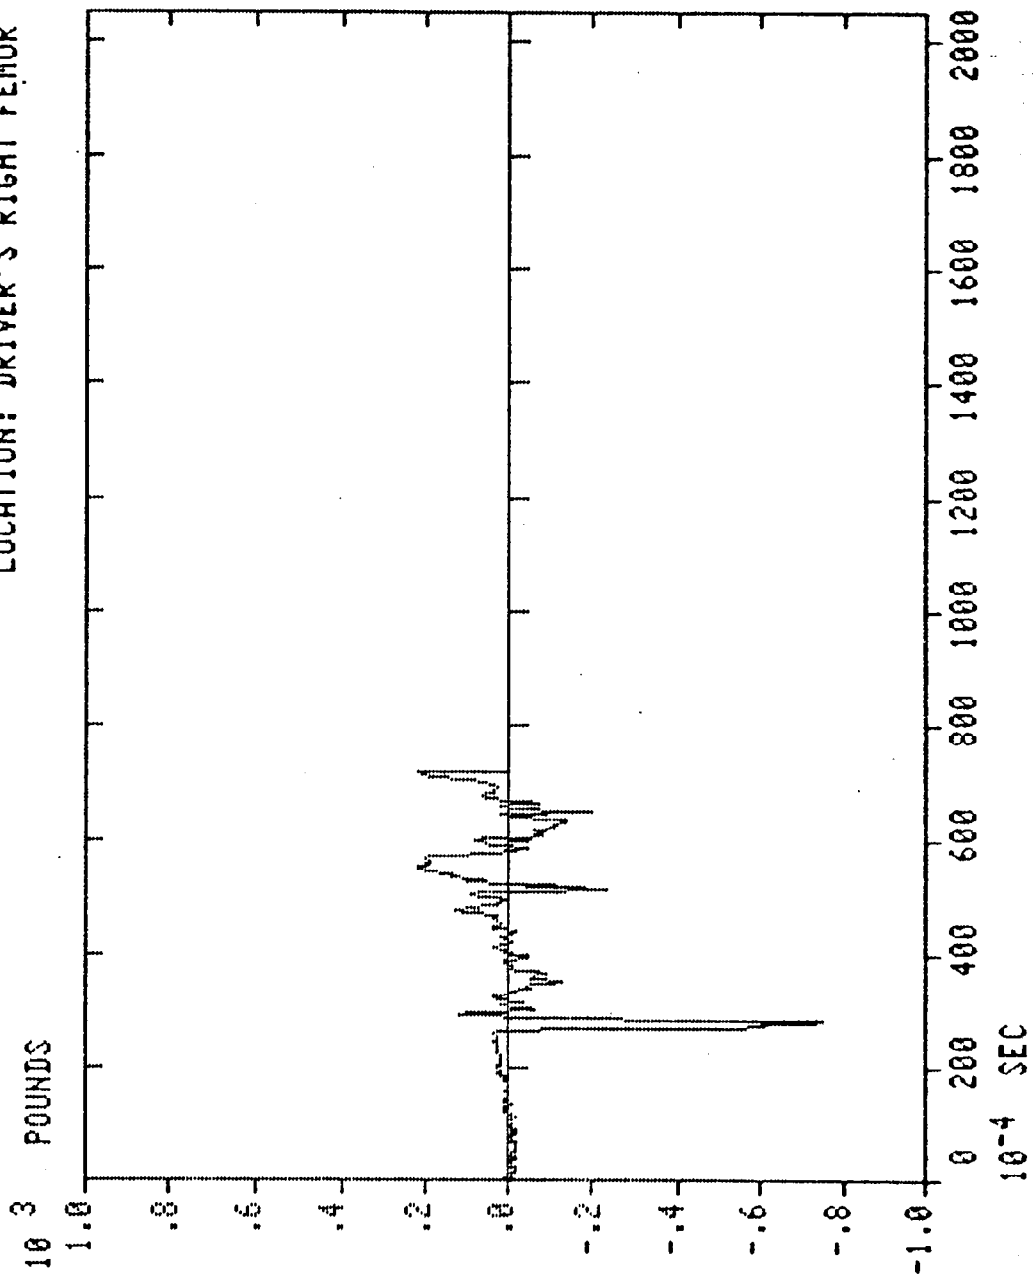
HJO NO.: 671-1489-54  
FILTER: CLASS 600  
LOAD CELL: TAPE 1, CH 4  
DIRECTION: TENSION  
LOCATION: DRIVER'S RIGHT FEMUR

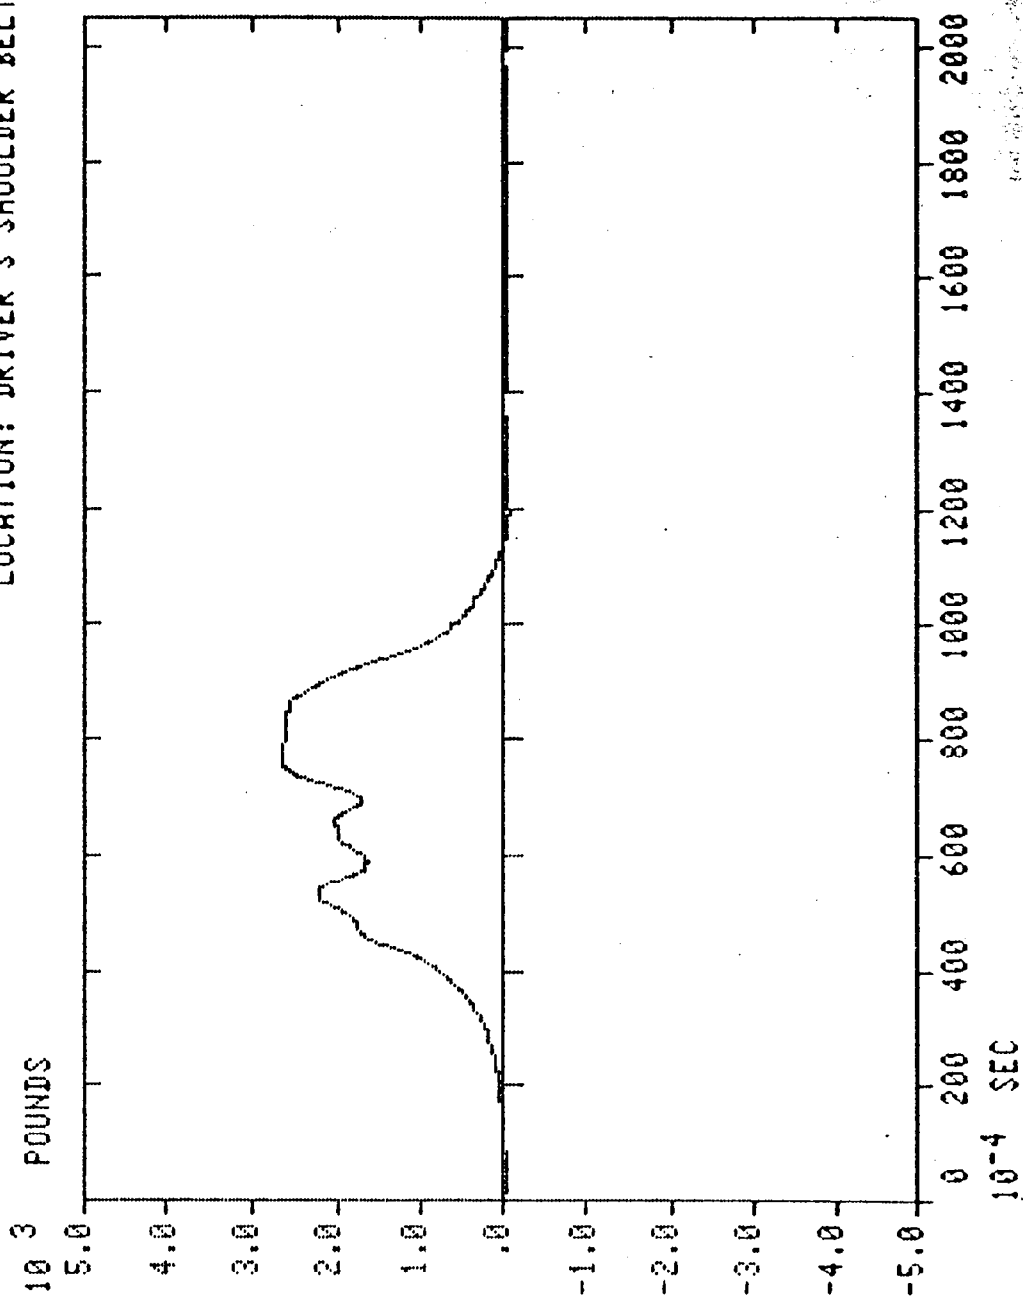
MJO NO.: 671-1489-54  
FILTER: CLASS 60  
LOAD CELL: TAPE 1, CH 9  
DIRECTION: TENSION  
LOCATION: DRIVER'S SHOULDER BELT

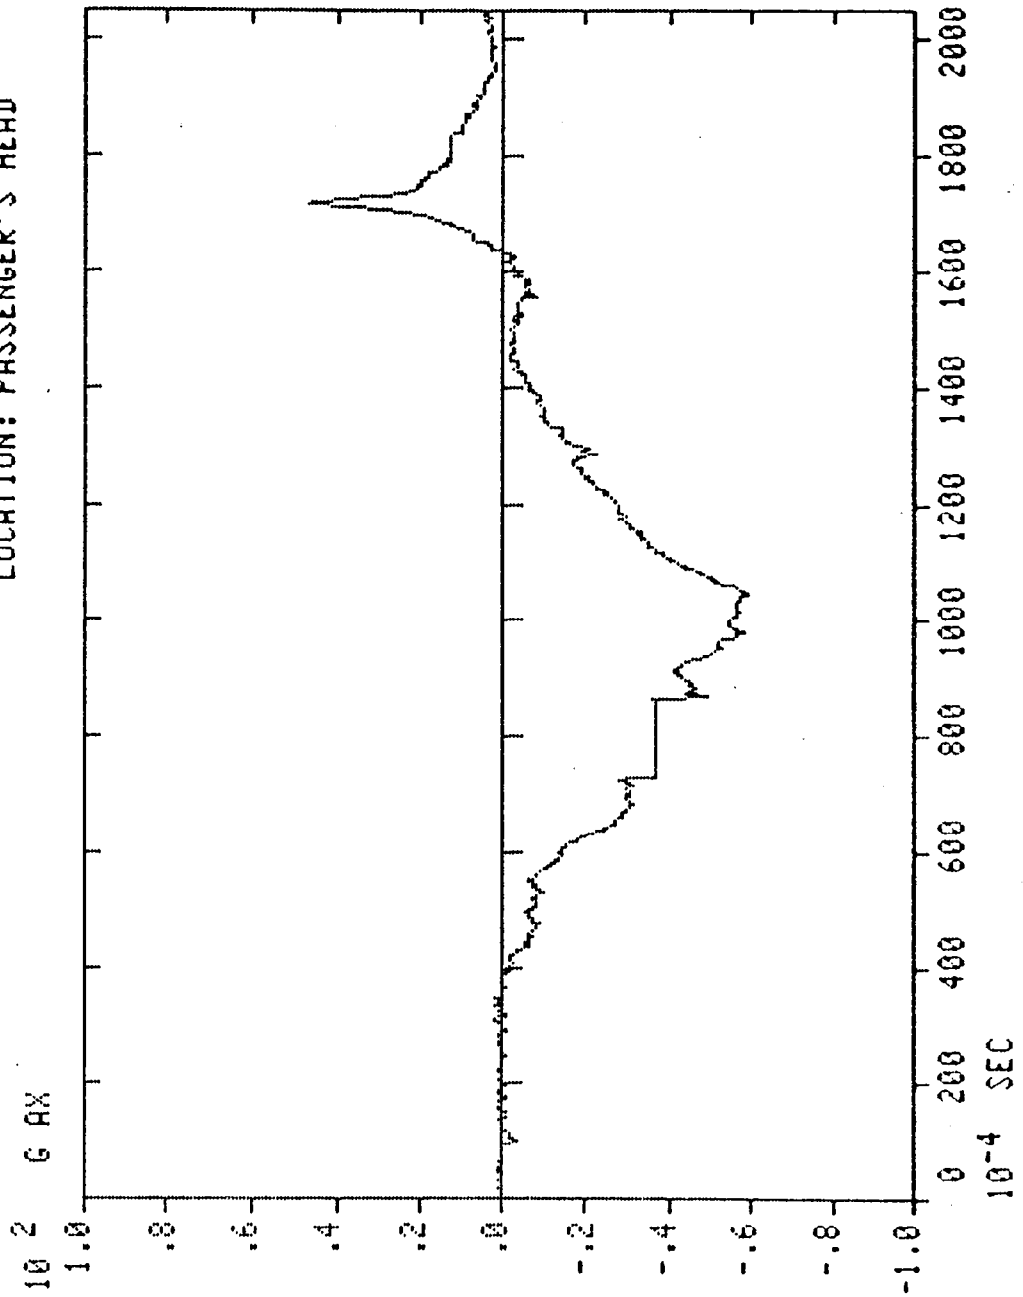
MJO NO.: 671-1489-54  
FILTER: CLASS 1000  
ACCELEROMETER: TAPE 2, CH 1  
DIRECTION: FORWARD  
LOCATION: PASSENGER'S HEAD

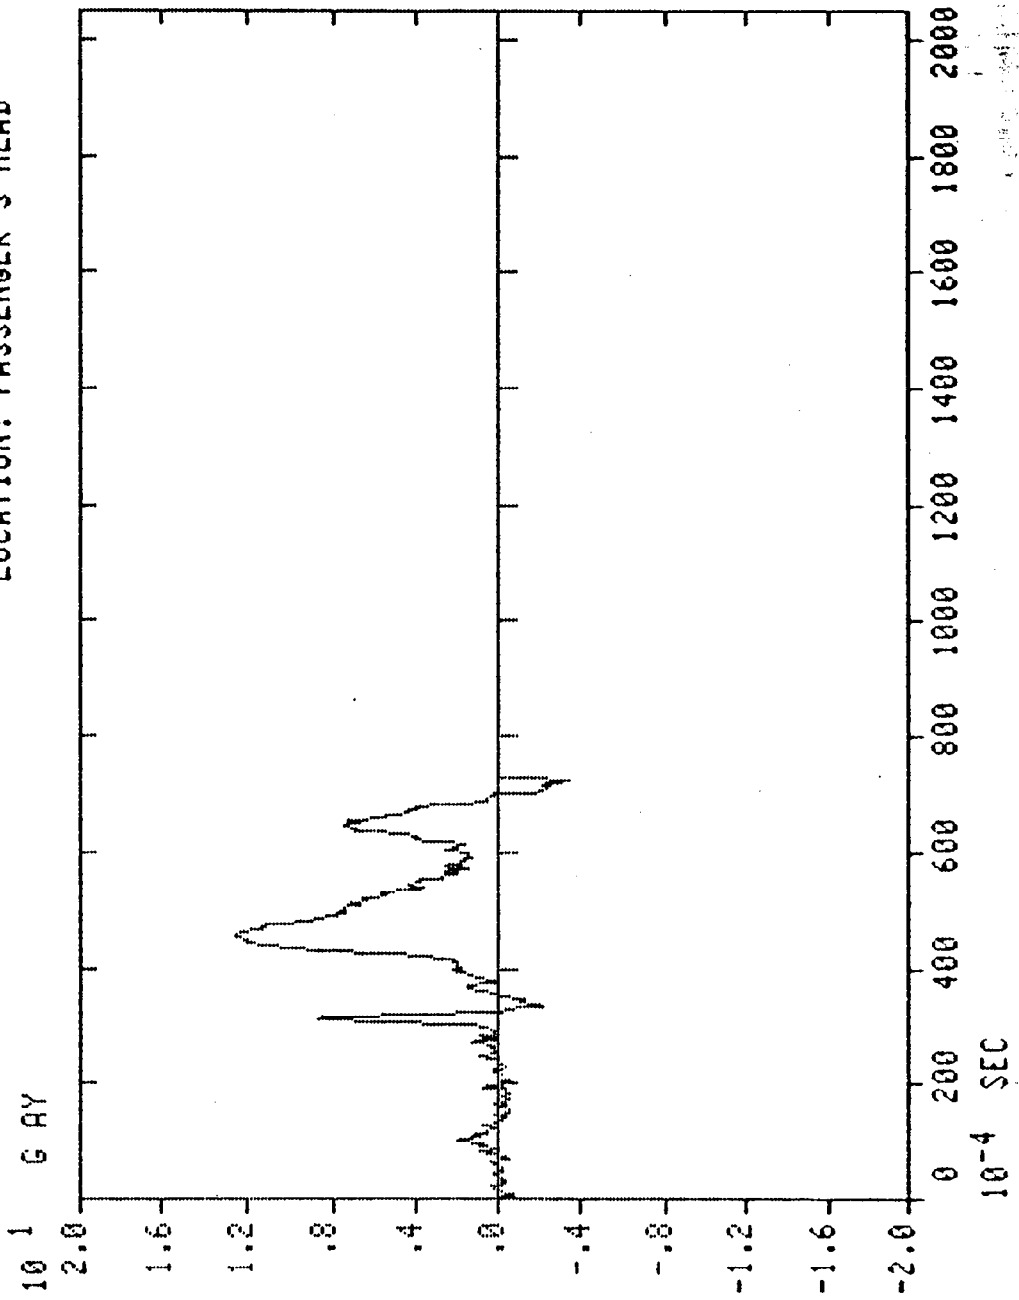
MJO NO.: 671-1489-54  
FILTER: CLASS 1000  
ACCELEROMETER: TAPE 2, CH 2  
DIRECTION: LEFT  
LOCATION: PASSENGER'S HEAD

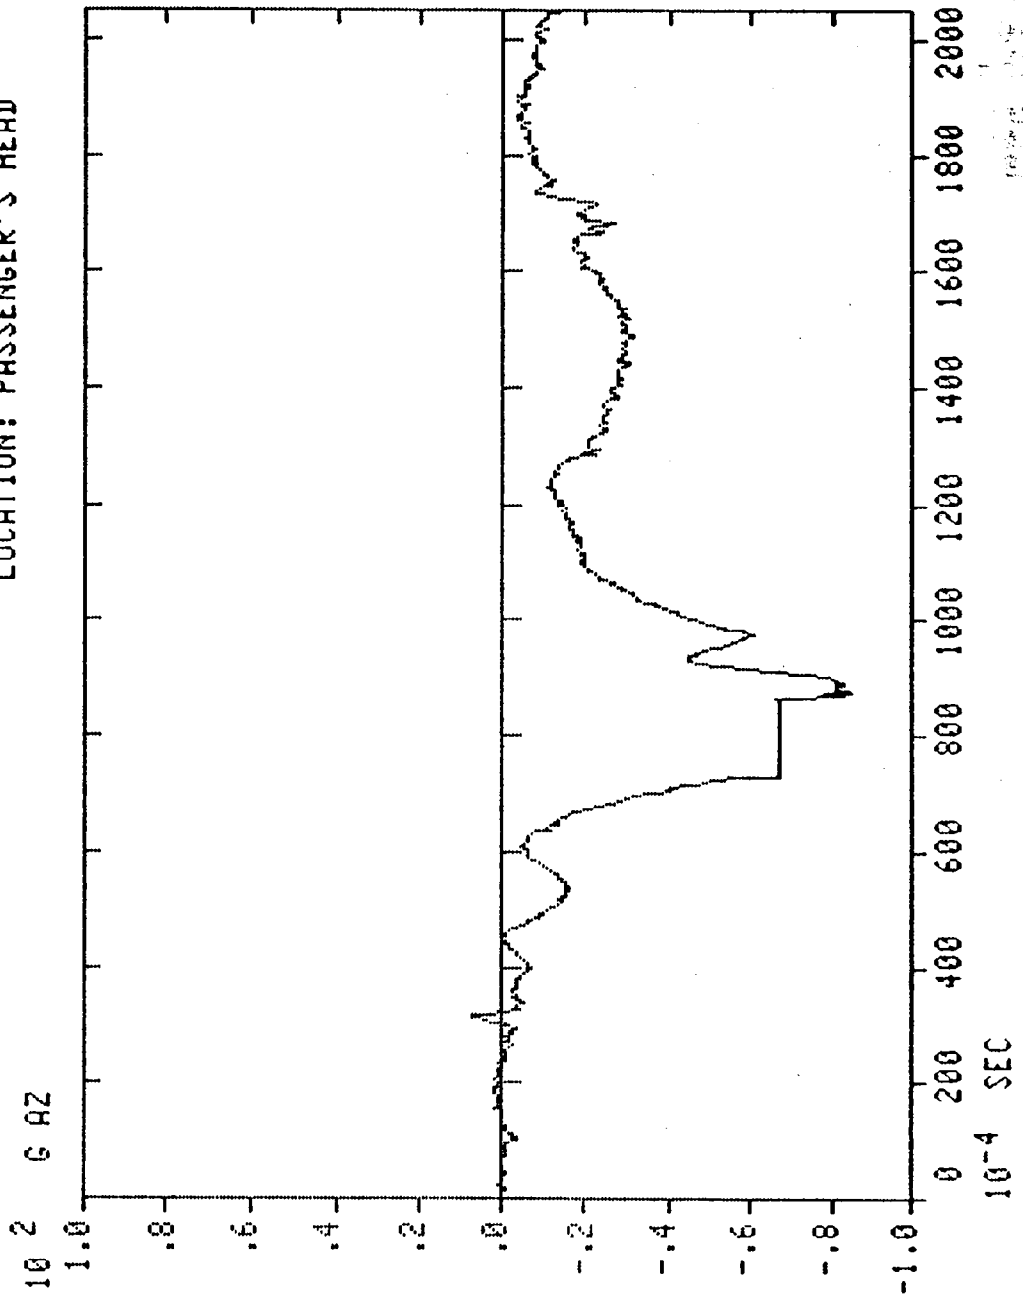
MJO NO.: 671-1489-54  
FILTER: CLASS 1000  
ACCELEROMETER: TAPE 2, CH 3  
DIRECTION: UPWARD  
LOCATION: PASSENGER'S HEAD

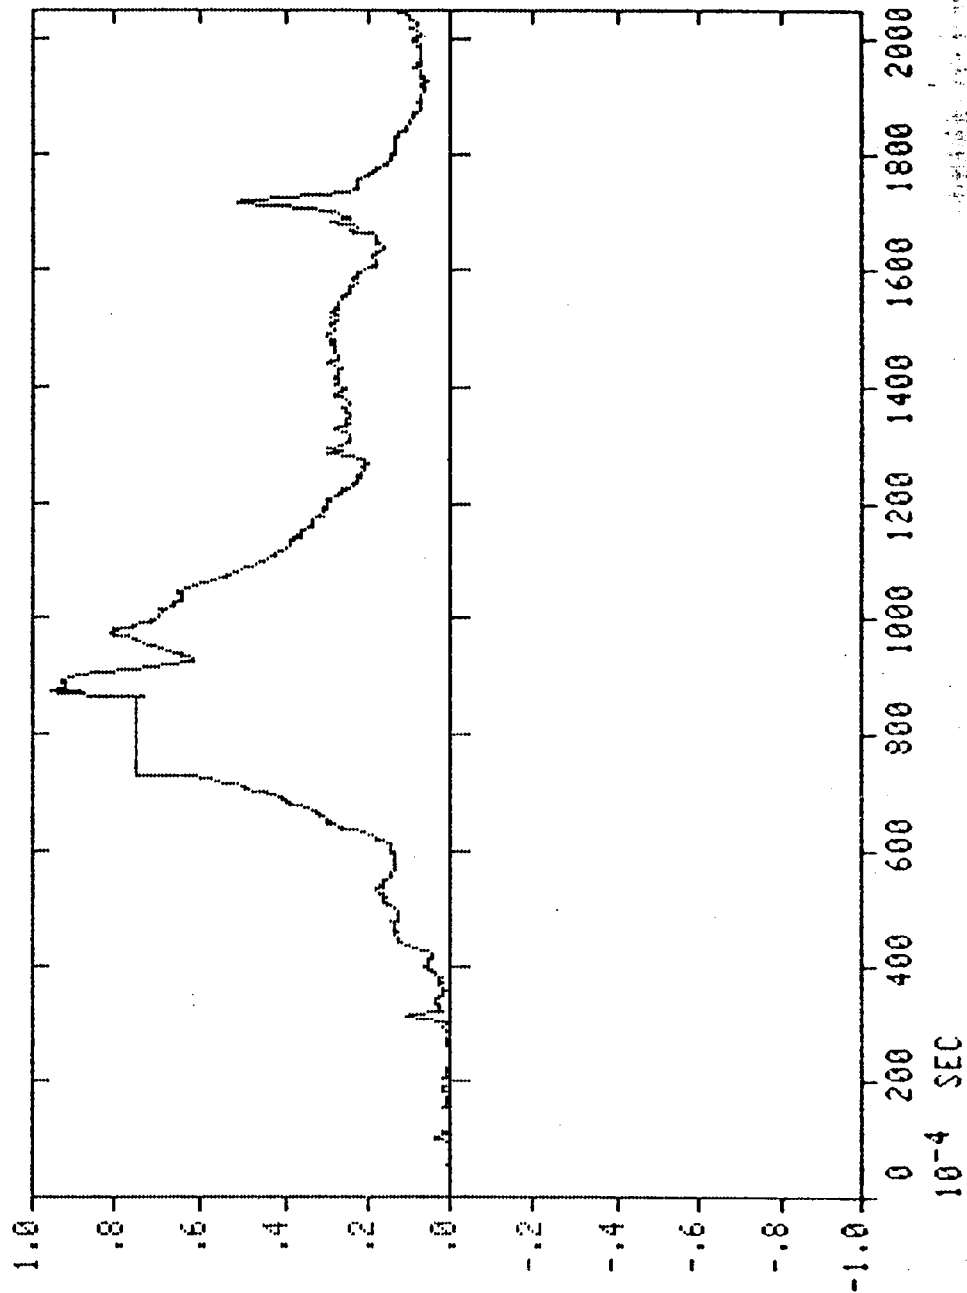
NJO NO.: 671-1489-54  
FILTER: CLASS 1000  
ACCELEROMETER: TAPE 2, CH 1-3  
DIRECTION: RESULTANT OF XYZ  
LOCATION: PASSENGER'S HEAD

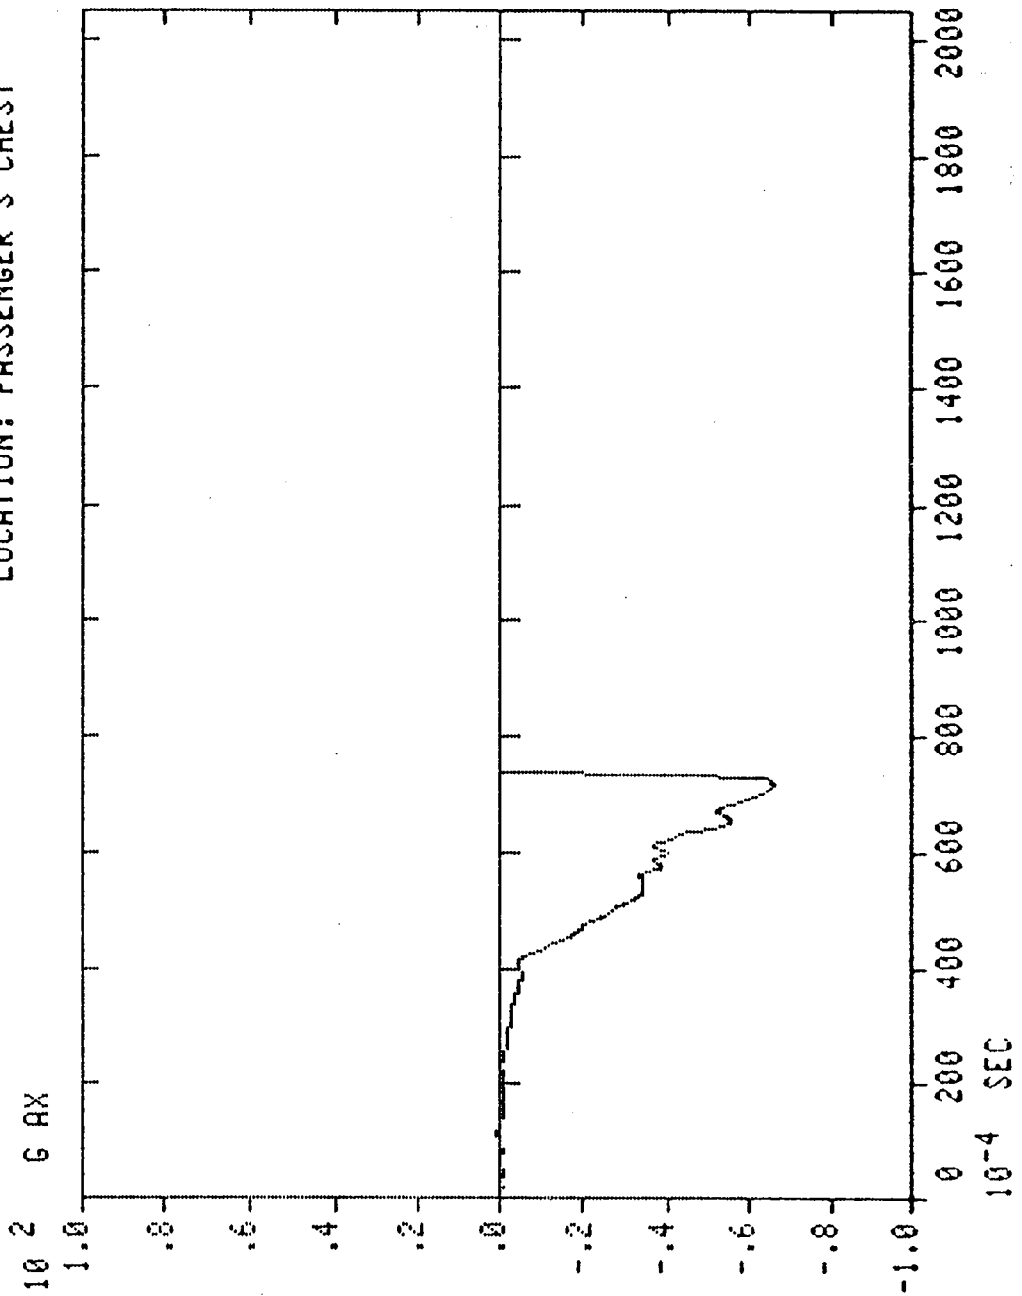
MJO NO.: 671-1489-54  
FILTER: CLASS 180  
ACCELEROMETER: TAPE 2, CH 5  
DIRECTION: FORWARD  
LOCATION: PASSENGER'S CHEST

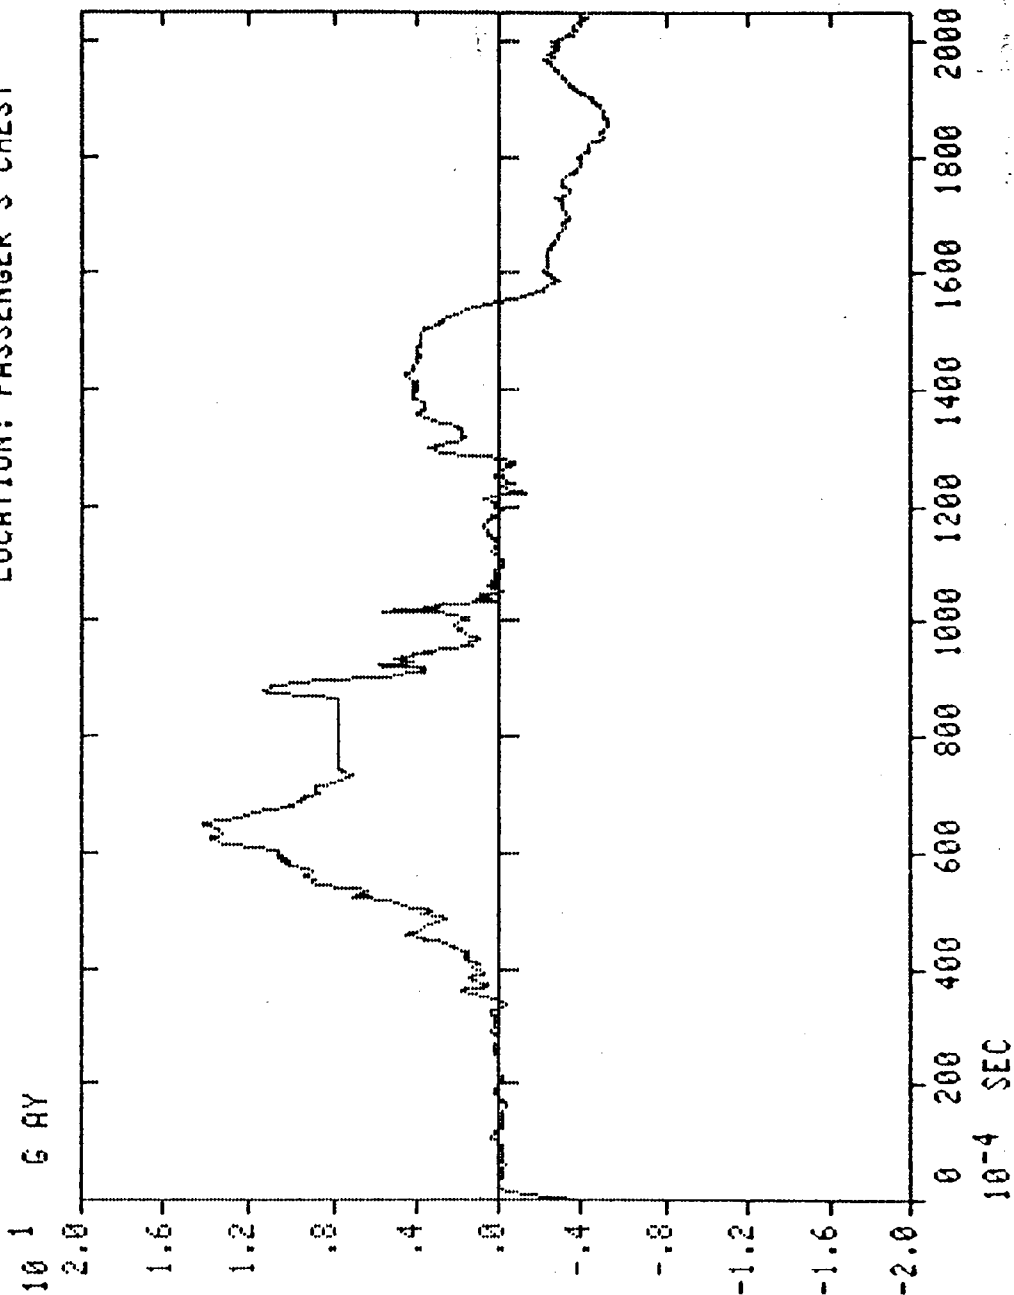
MJO NO.: 671-1489-54  
FILTER: CLASS 180  
ACCELEROMETER: TAPE: 2, CH 6  
DIRECTION: LEFT  
LOCATION: PASSENGER'S CHEST

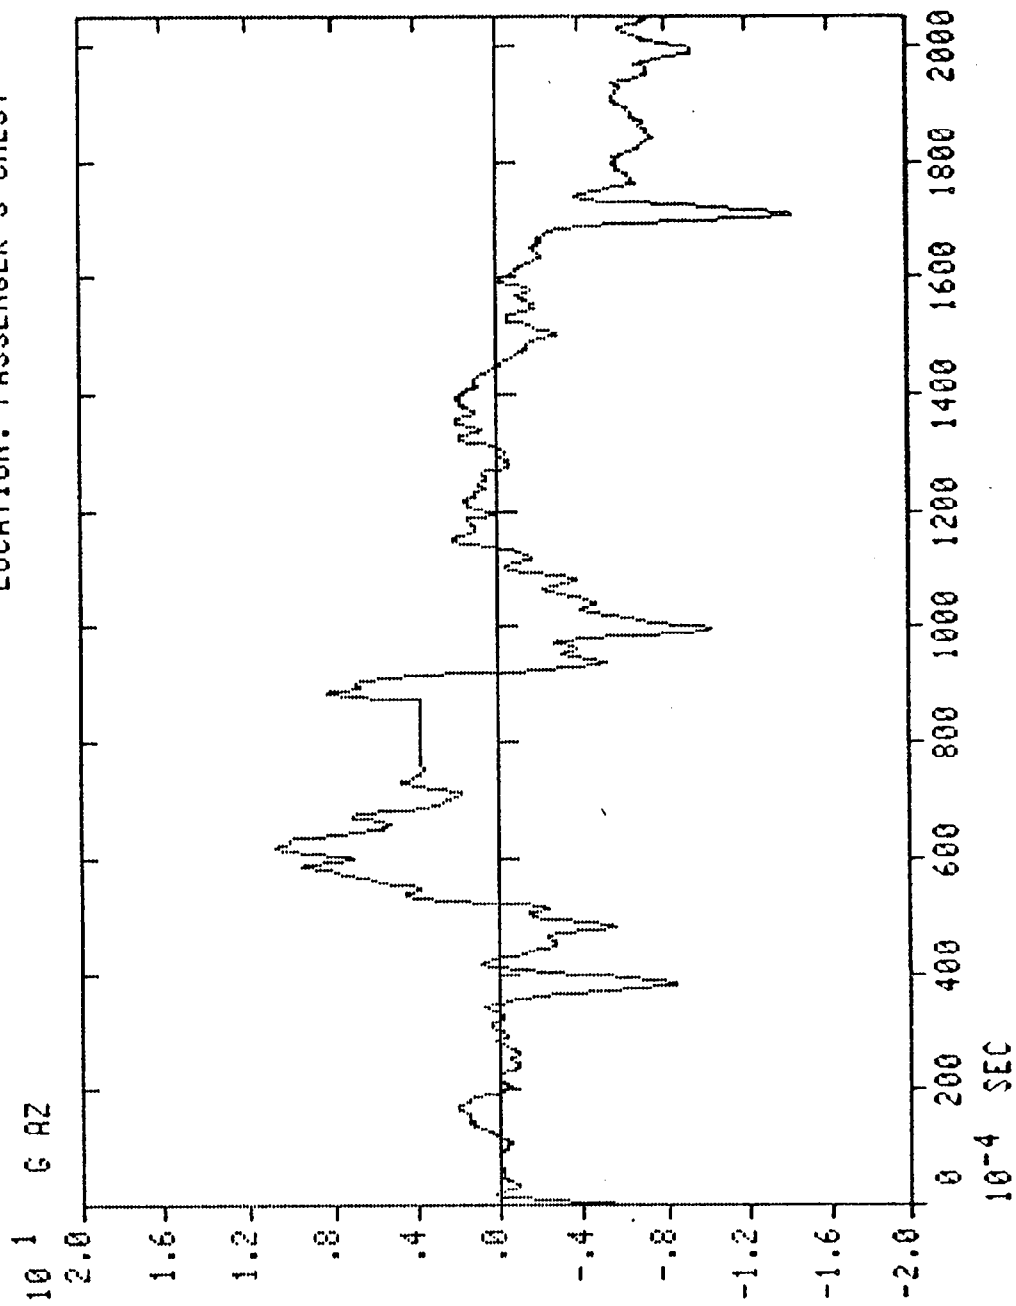
MJO NO. : 671-1489-54  
FILTER: CLASS 180  
ACCELEROMETER: TAPE 2, CH 7  
DIRECTION: UPWARD  
LOCATION: PASSENGER'S CHEST

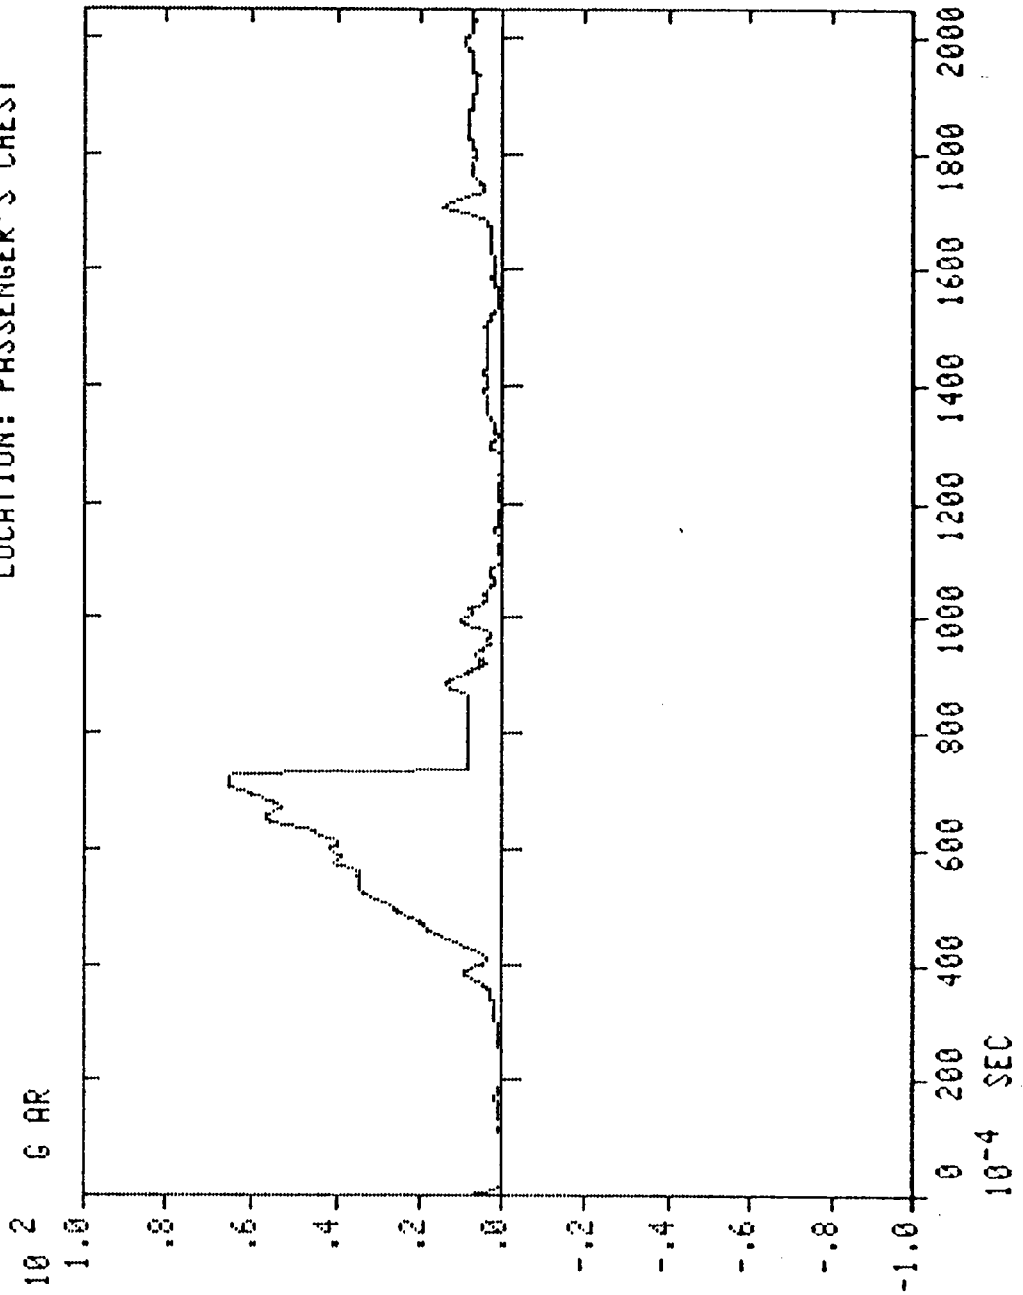
MJO NO.: 671-1489-54  
FILTER: CLASS 1000  
ACCELEROMETER: TAPE 2, CH 5-7  
DIRECTION: RESULTANT OF XYZ  
LOCATION: PASSENGER'S CHEST

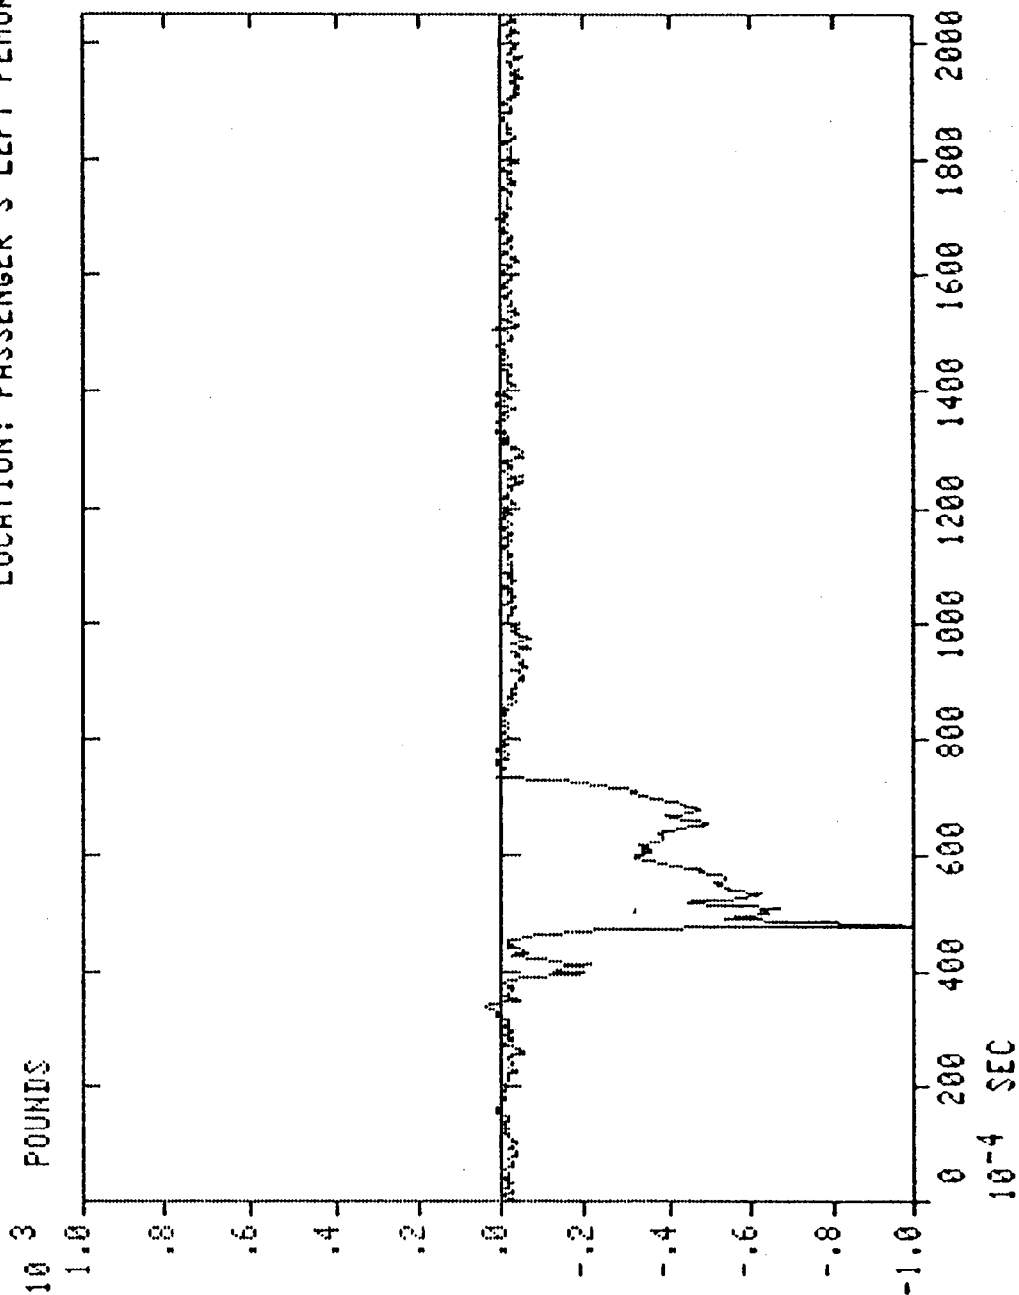
MJO NO.: 671-1489-54  
FILTER: CLASS 600  
LOAD CELL: TAPE 2, CH 8  
DIRECTION: TENSION  
LOCATION: PASSENGER'S LEFT FEMUR

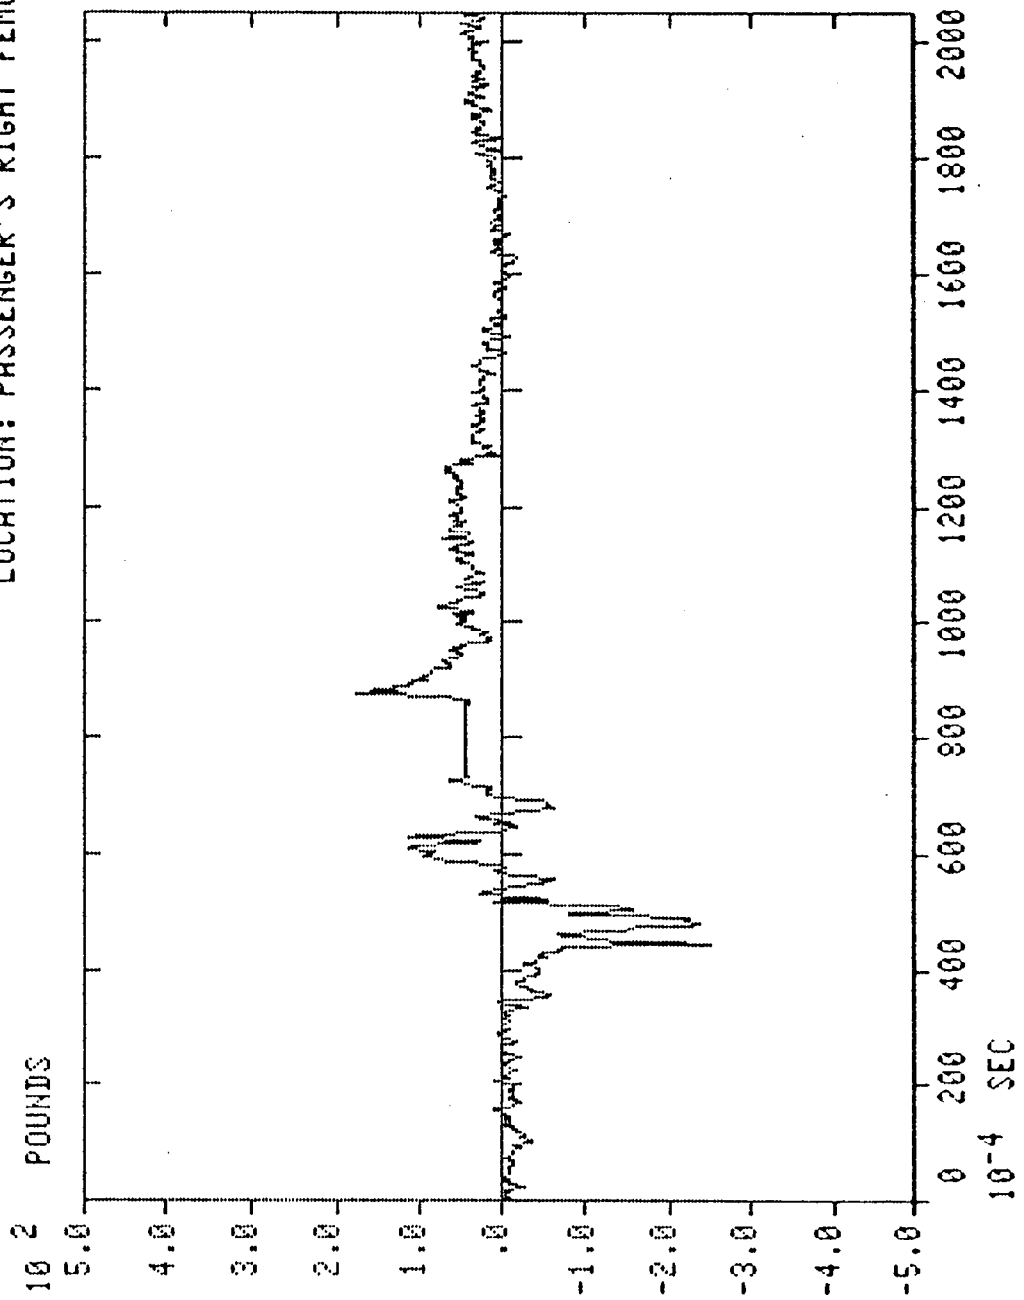
MJO NO.: 671-1489-54  
FILTER: CLASS 600  
LOAD CELL: TAPE 2, CH 4  
DIRECTION: TENSION  
LOCATION: PASSENGER'S RIGHT FEMUR

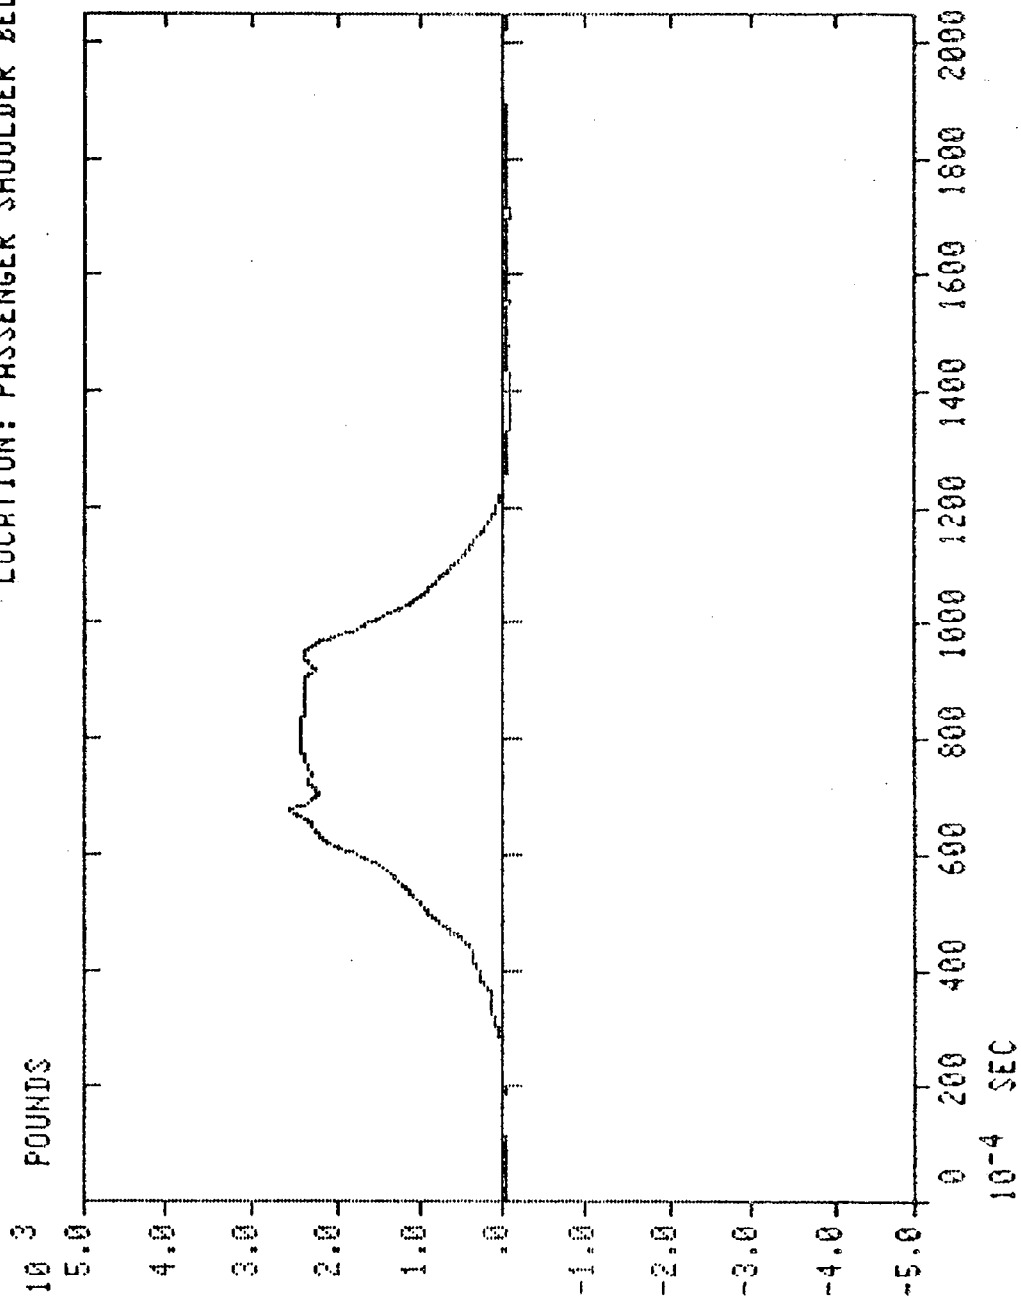
MJO NO.: 671-1489-54  
FILTER: CLASS 60  
LOAD CELL: TAPE 2, CH 9  
DIRECTION: TENSION  
LOCATION: PASSENGER SHOULDER BELT

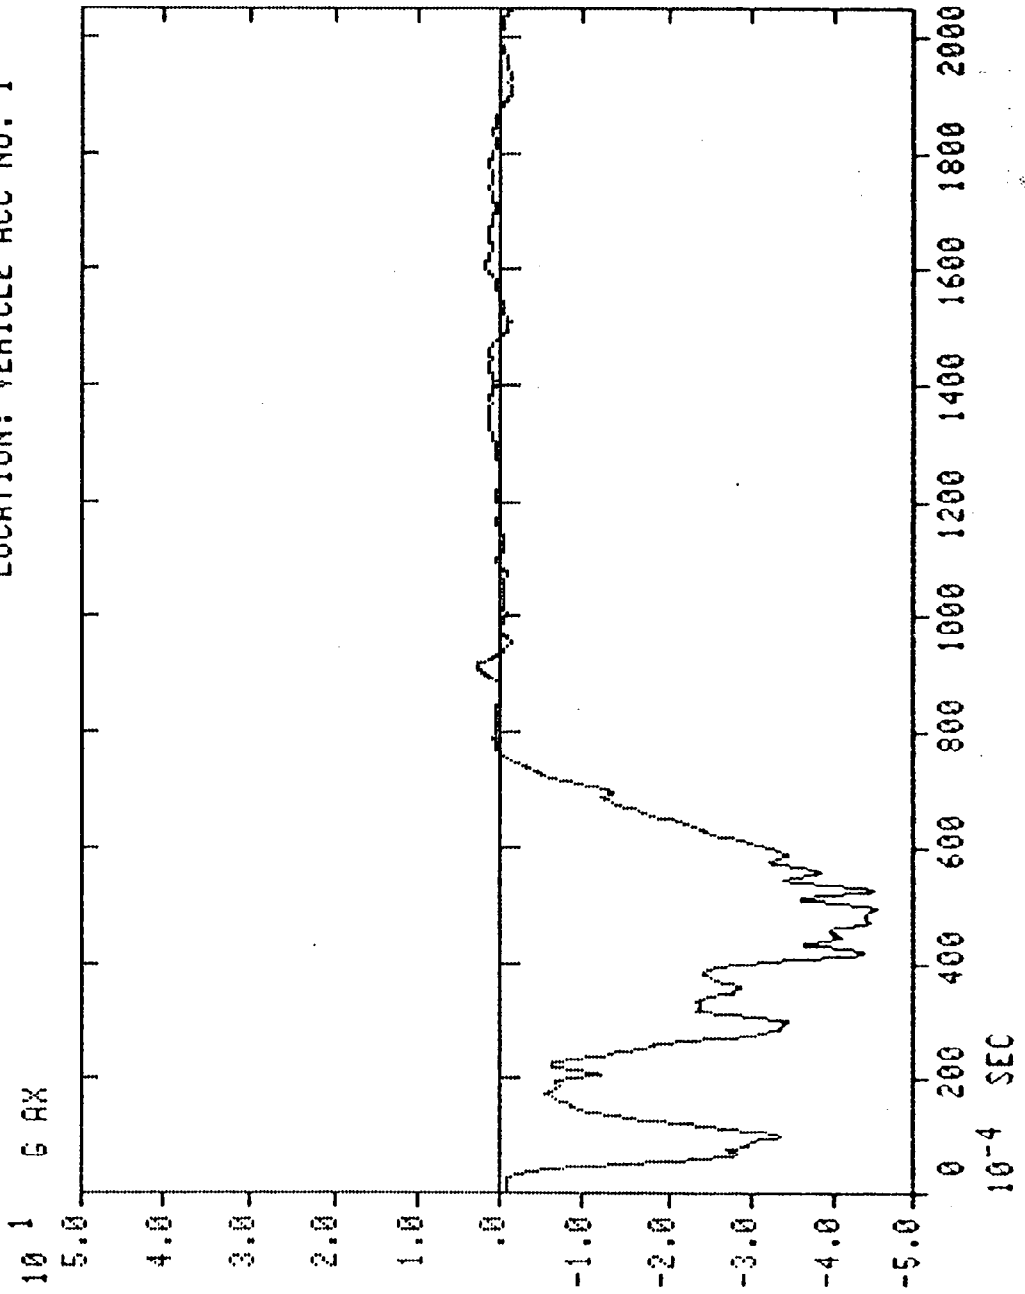
MJO NO.: 671-1489-54  
FILTER: CLASS 60  
ACCELEROMETER: TAPE 1, CH 10  
DIRECTION: FORWARD  
LOCATION: VEHICLE ACC NO. 1

The vehicle accelerations were processed as class 60 data, and presented as computer plots. Additionally, the longitudinal vehicle acceleration was integrated to provide approximate vehicle velocity change and vehicle crush during the impact event.

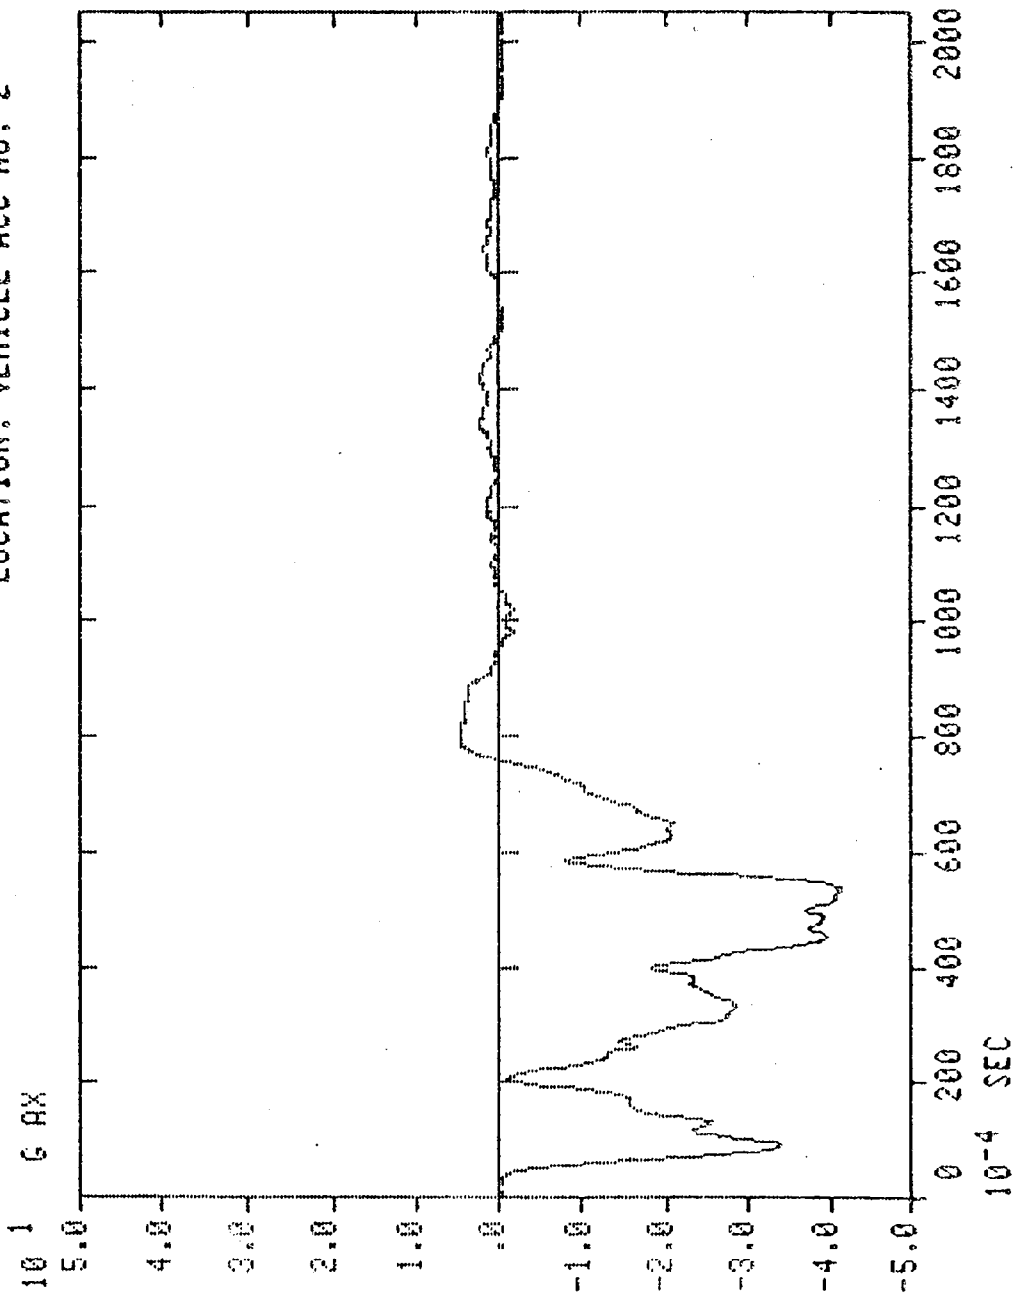
MJO NO.: 671-1489-54  
FILTER: CLASS 60  
ACCELEROMETER: TAPE 1, CH 11  
DIRECTION: FORWARD  
LOCATION: VEHICLE ACC NO. 2
