OCCUPANT RESPONSE  
AND  
VEHICLE ACCELERATION  
IN A  
30 MPH FRONTAL IMPACT TEST

GENERAL MOTORS CORPORATION  
1978 CHEVROLET G20 - SPORT VAN  
NHTSA 781304

FINAL REPORT

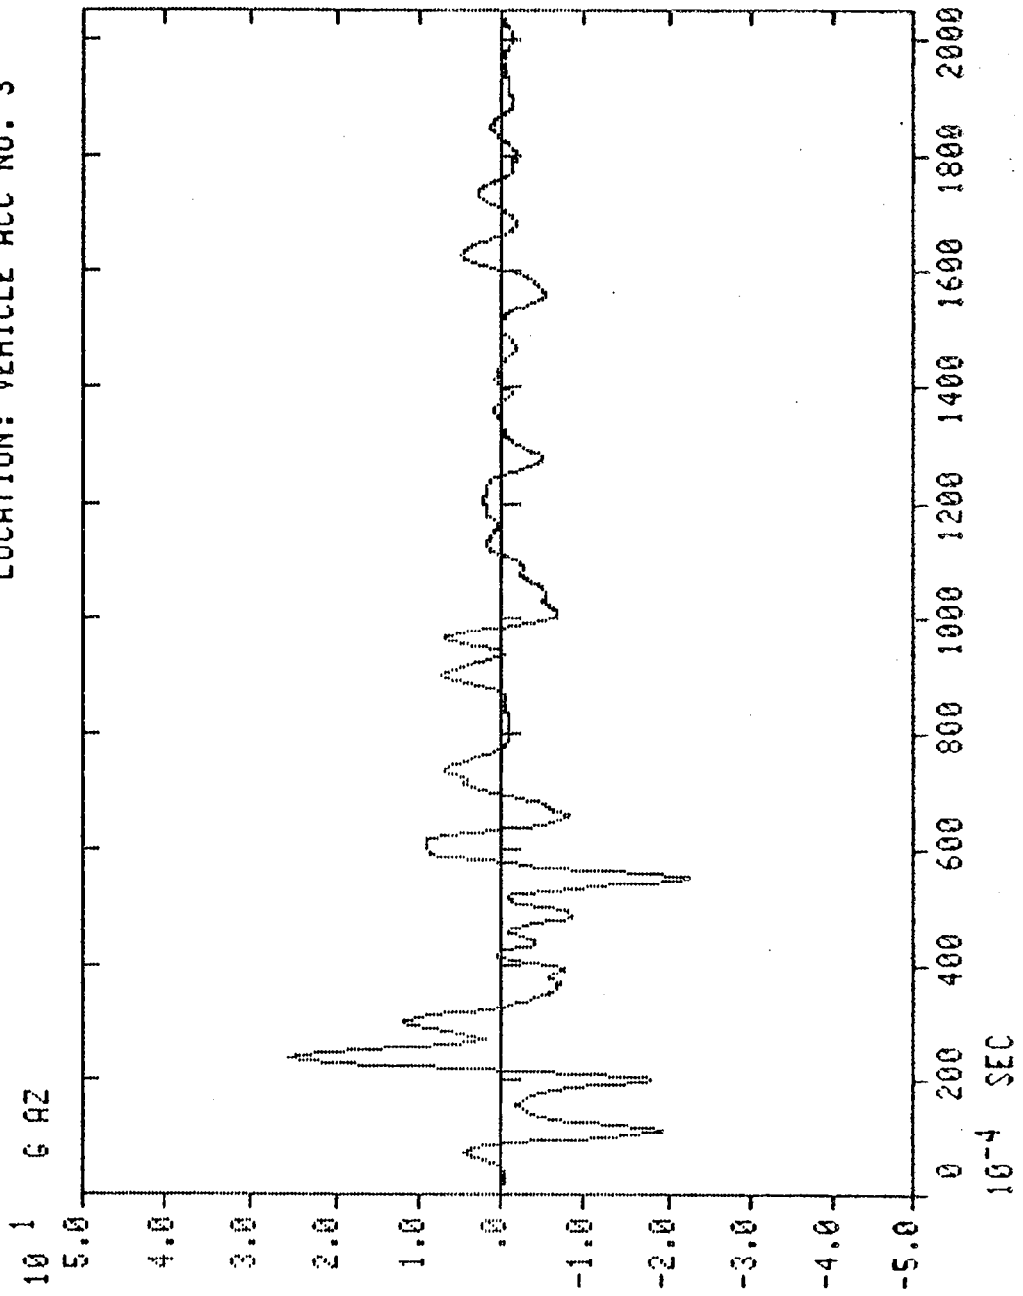
MJO NO.: 671-1489-54  
FILTER: CLASS 60  
ACCELEROMETER: TAPE 1, CH 12  
DIRECTION: UPWARD  
LOCATION: VEHICLE ACC NO. 3

The vehicle accelerations were processed as class 60 data, and presented as computer plots. Additionally, the longitudinal vehicle acceleration was integrated to provide approximate vehicle velocity change and vehicle crush during the impact event.
