OCCUPANT RESPONSE  
AND  
VEHICLE ACCELERATION  
IN A  
30 MPH FRONTAL IMPACT TEST

GENERAL MOTORS CORPORATION  
1978 GMC VANDURA G1500 - VAN  
NHTSA 780624

FINAL REPORT

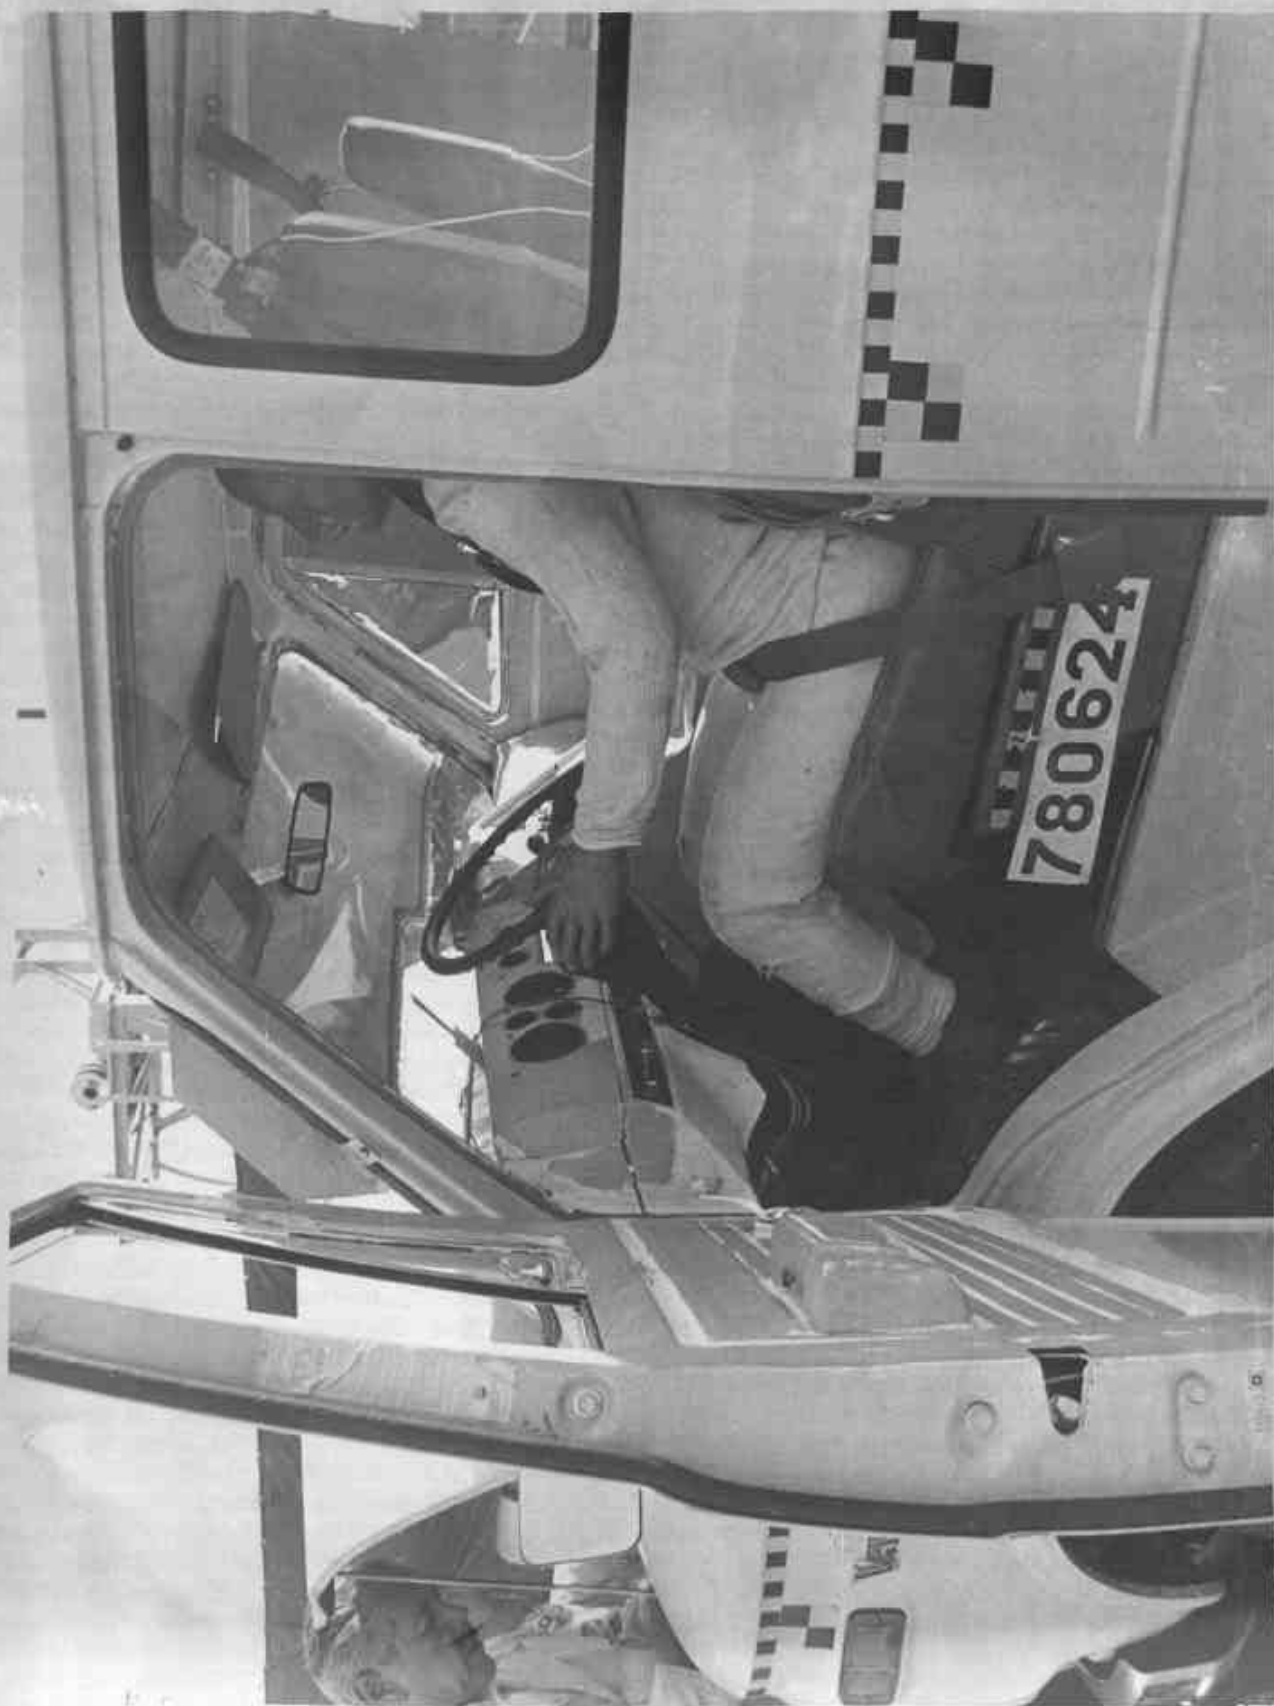
Figure 3-1  
1978 GMC VanDura G1500 - Van  
NHTSA 780624  
Pre-Test, Driver Dummy View

Figure 3-1 through 3-4 are pre-test and post-test views of the occupant compartment, restraint system, and dummies.

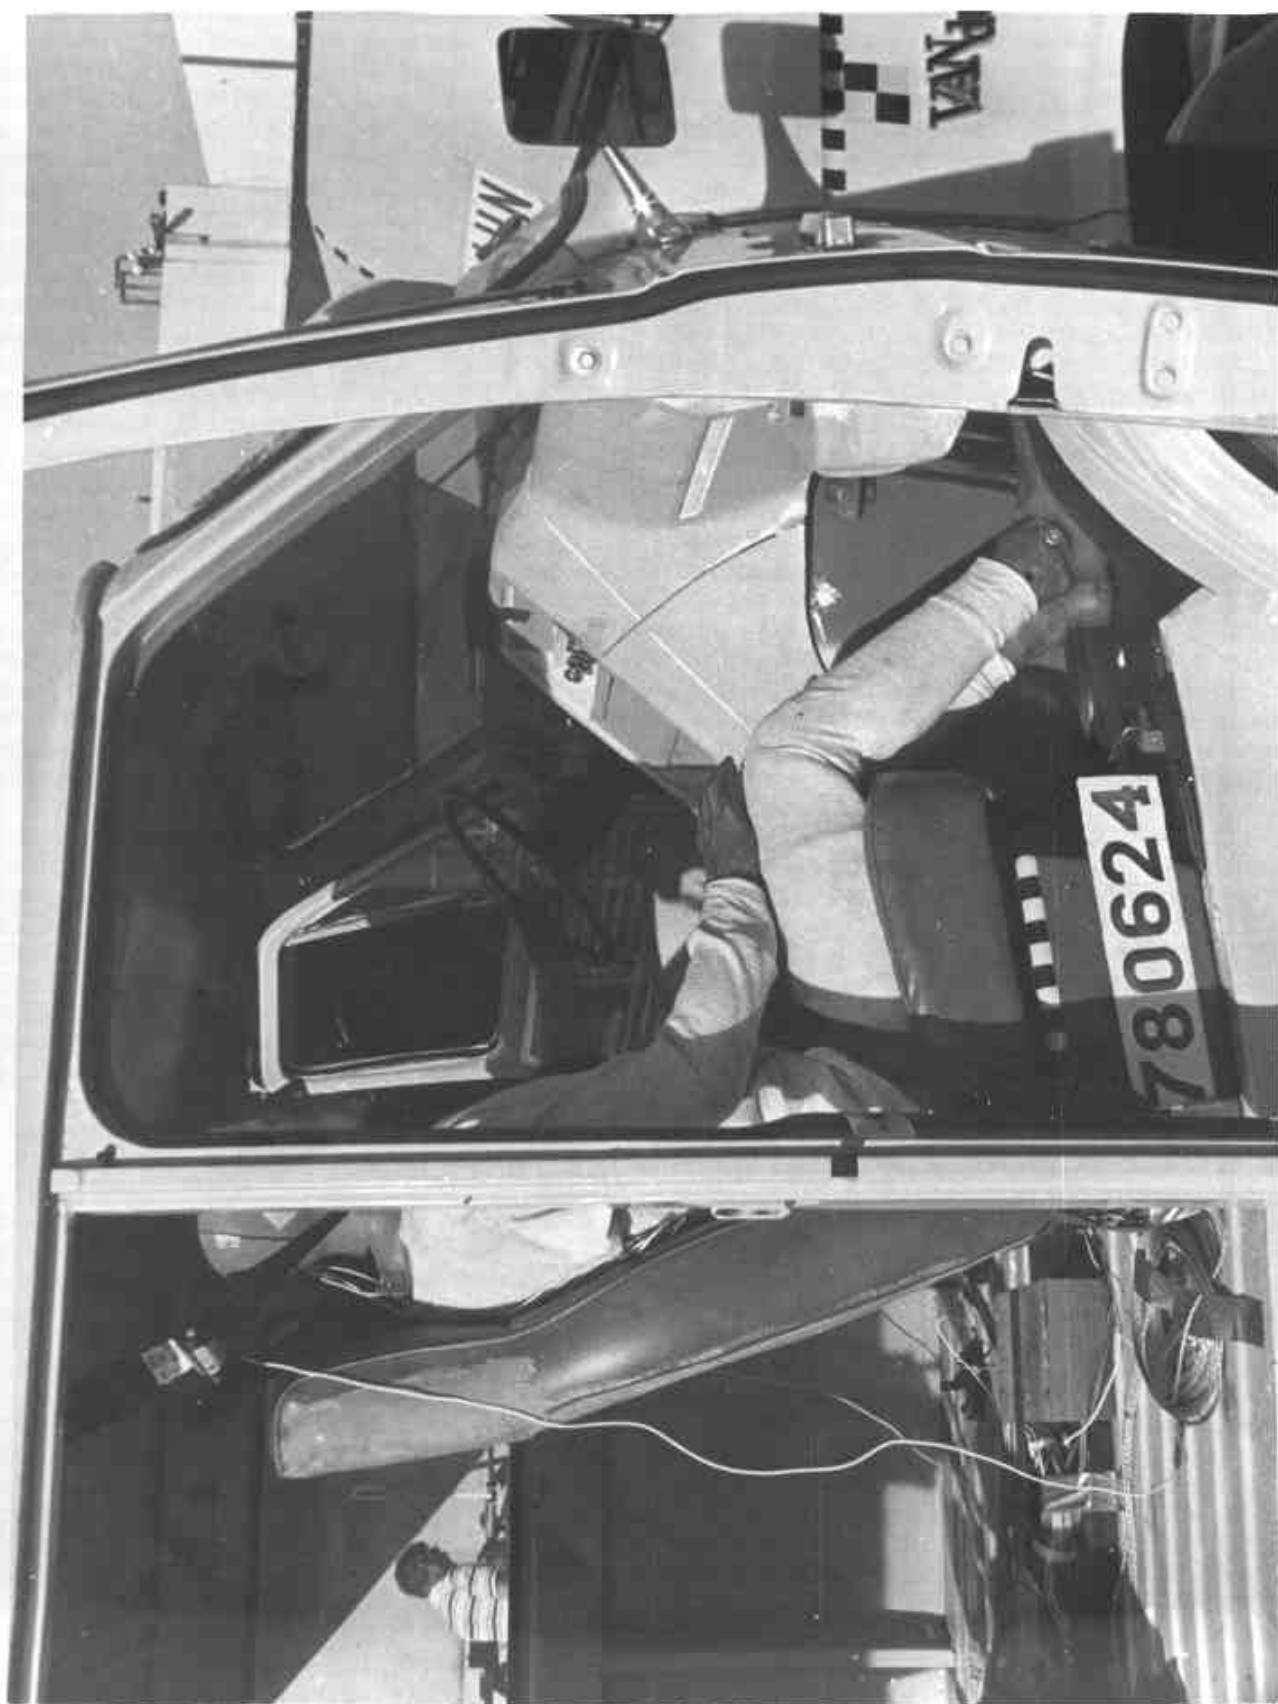
Figure 3-2  
1978 GMC VanDura G1500 - Van  
NHTSA 780624  
Pre-Test, Passenger Dummy View

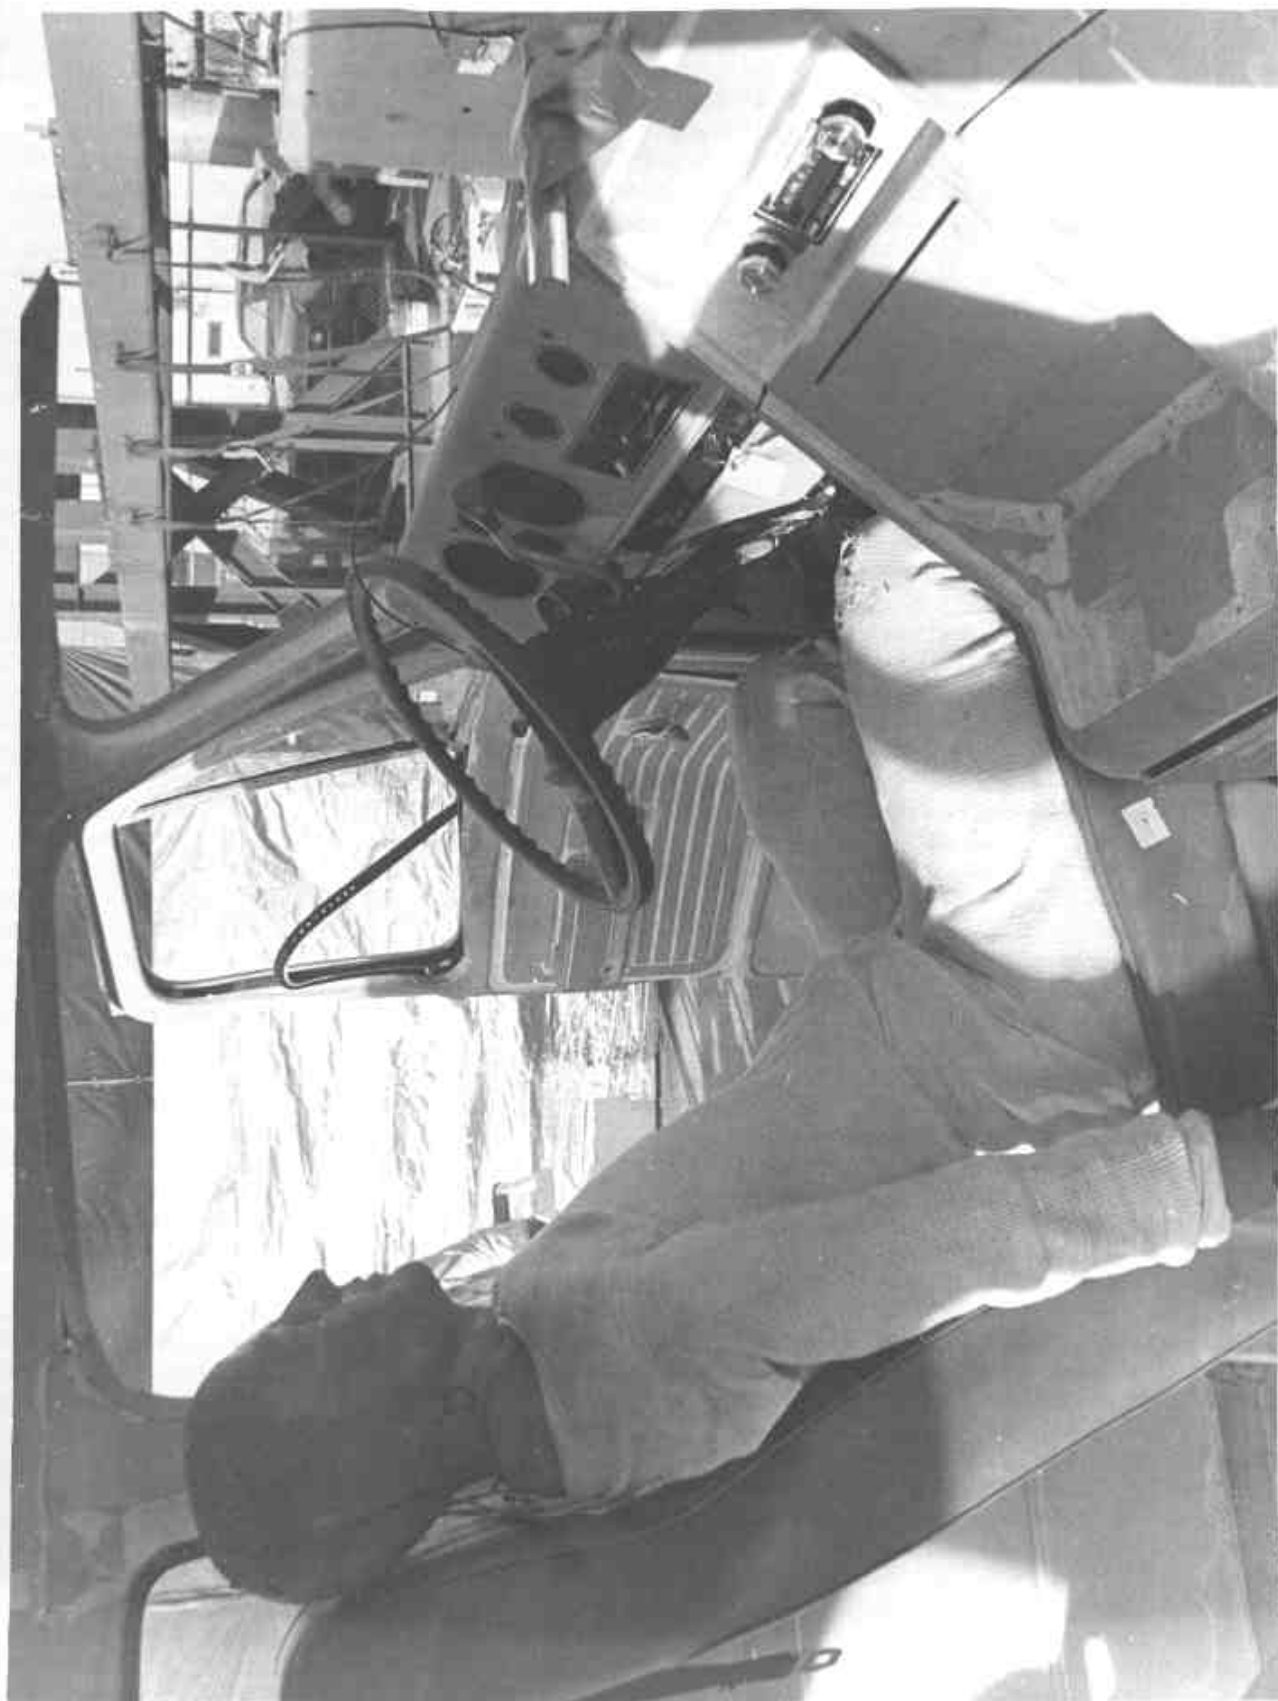
Figure 3-3  
1978 GMC VanDura G1500 - Van  
NHTSA 780624  
Post-Impact, Driver Dummy View

Post-impact inspection of the vehicle revealed almost all crush occurred forward of the front doors. The hood was smashed against the cowl and both front fenders pushed back into the doors. The windshield came completely out of the body opening and the roof buckled over both "B" pillars. The dash was deformed from apparent dummy contact.

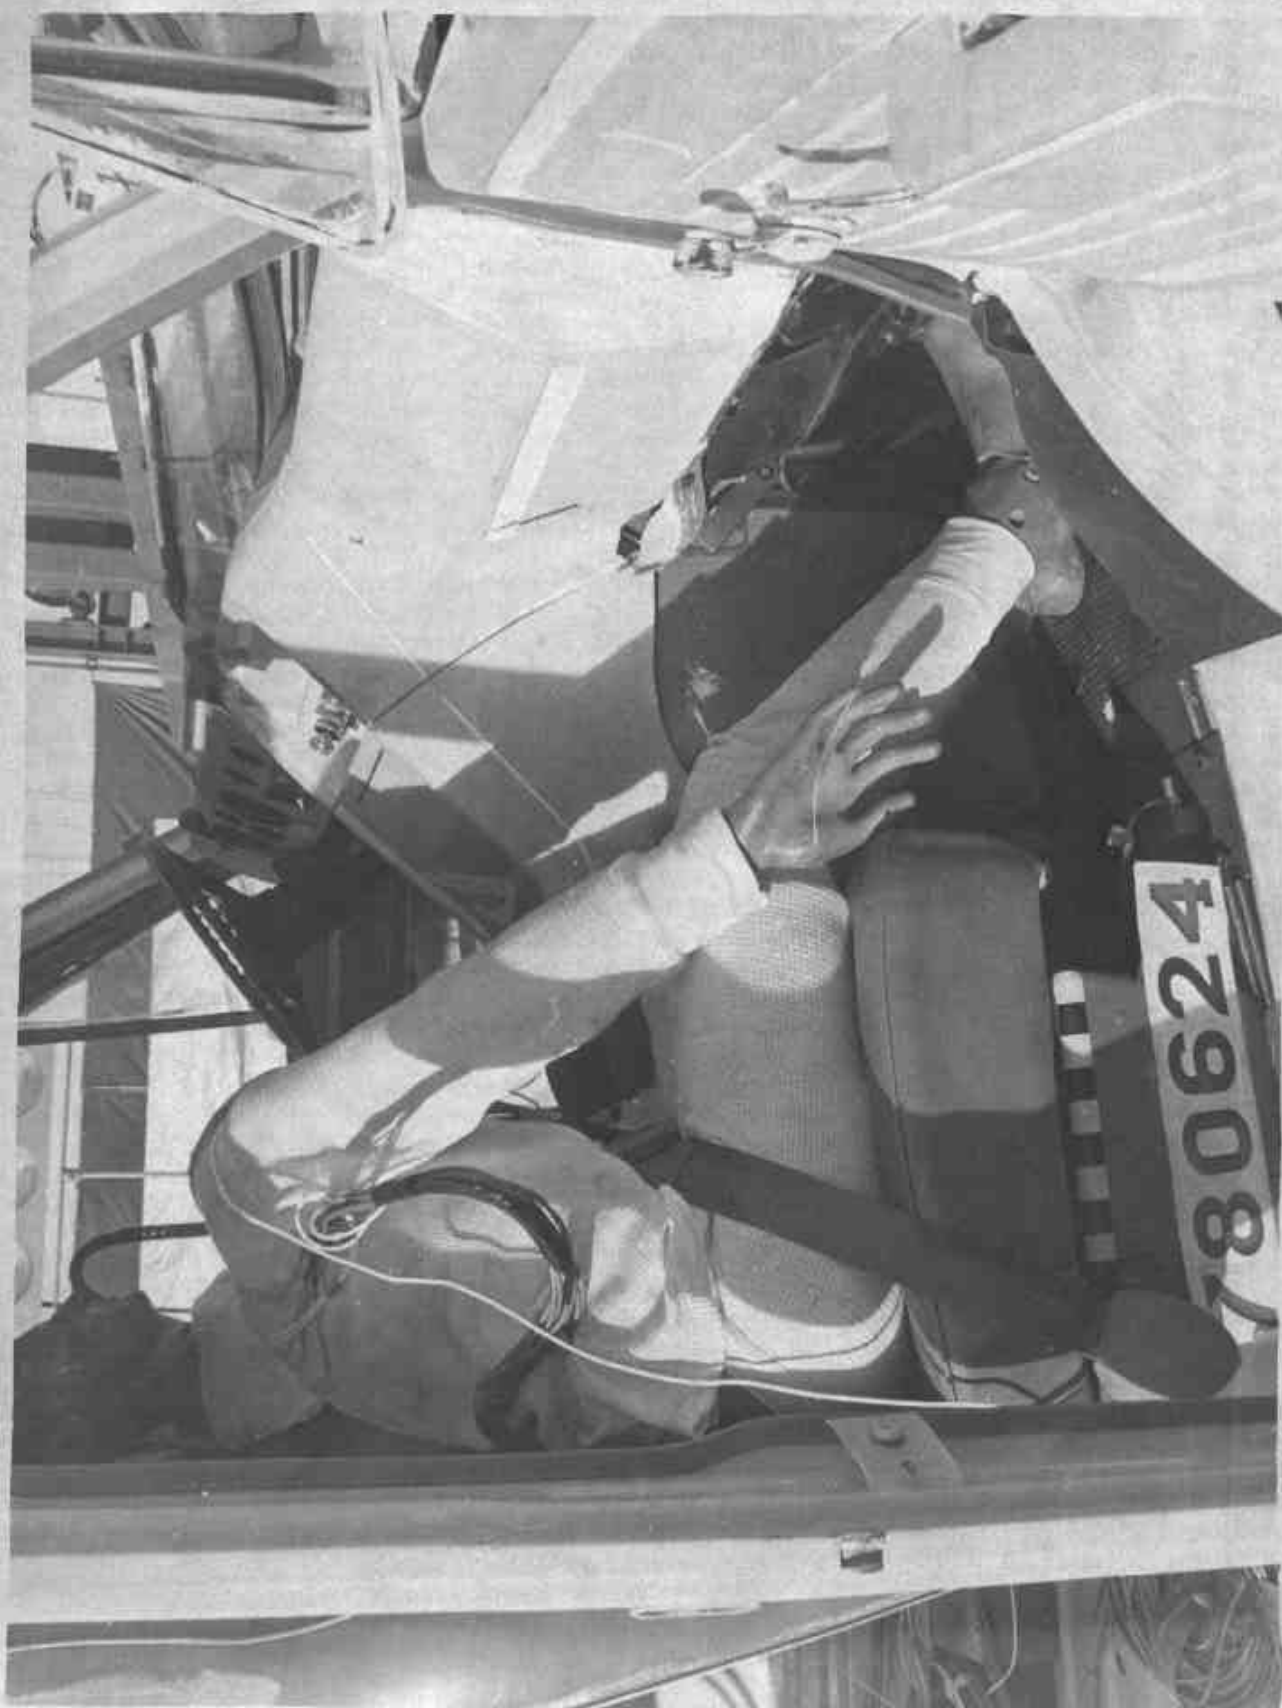
Figure 3-4  
1978 GMC VanDura G1500 - Van  
NHTSA 780624  
Post-Impact, Passenger Dummy View
