DOT 311

OCCUPANT RESPONSE  
AND  
VEHICLE ACCELERATION  
IN A  
30 MPH FRONTAL IMPACT TEST

TOYO KOGYO COMPANY  
1978 FORD COURIER - PICK UP  
NHTSA 780622

FEBRUARY 1979  
CONTRACT NUMBER DOT-HS-6-01477  
FINAL REPORT

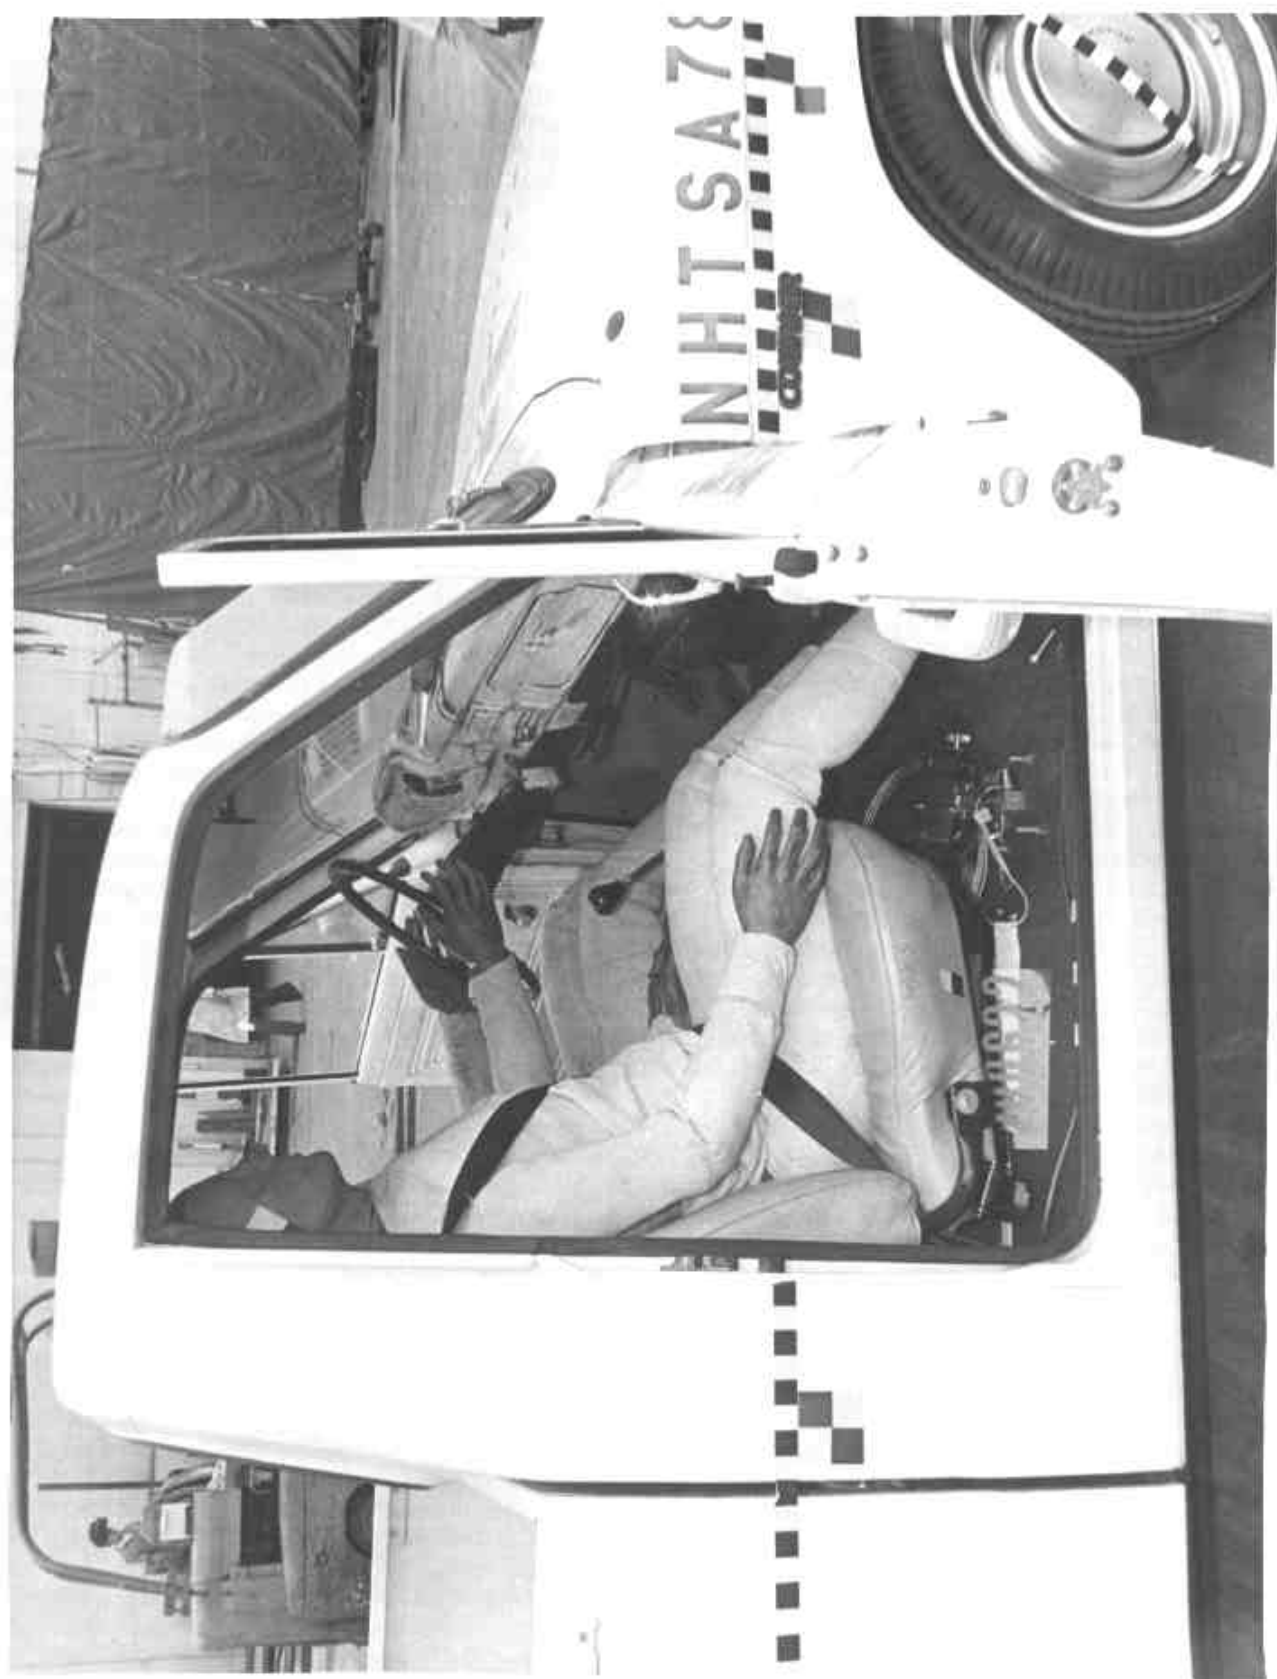
Figure 3-2

Pre-Test, Passenger Dummy View

Figures 3-1 through 3-4 are pre-test and post-test views of the occupant compartment, restraint system, and dummies.
