OCCUPANT RESPONSE  
AND  
VEHICLE ACCELERATION  
IN A  
30 MPH FRONTAL IMPACT TEST

FORD MOTOR COMPANY  
AND  
OLSON BODIES INCORPORATED  
1978 FORD P500 - DELIVERY VAN  
NHTSA 780603

MARCH 1979

FINAL REPORT

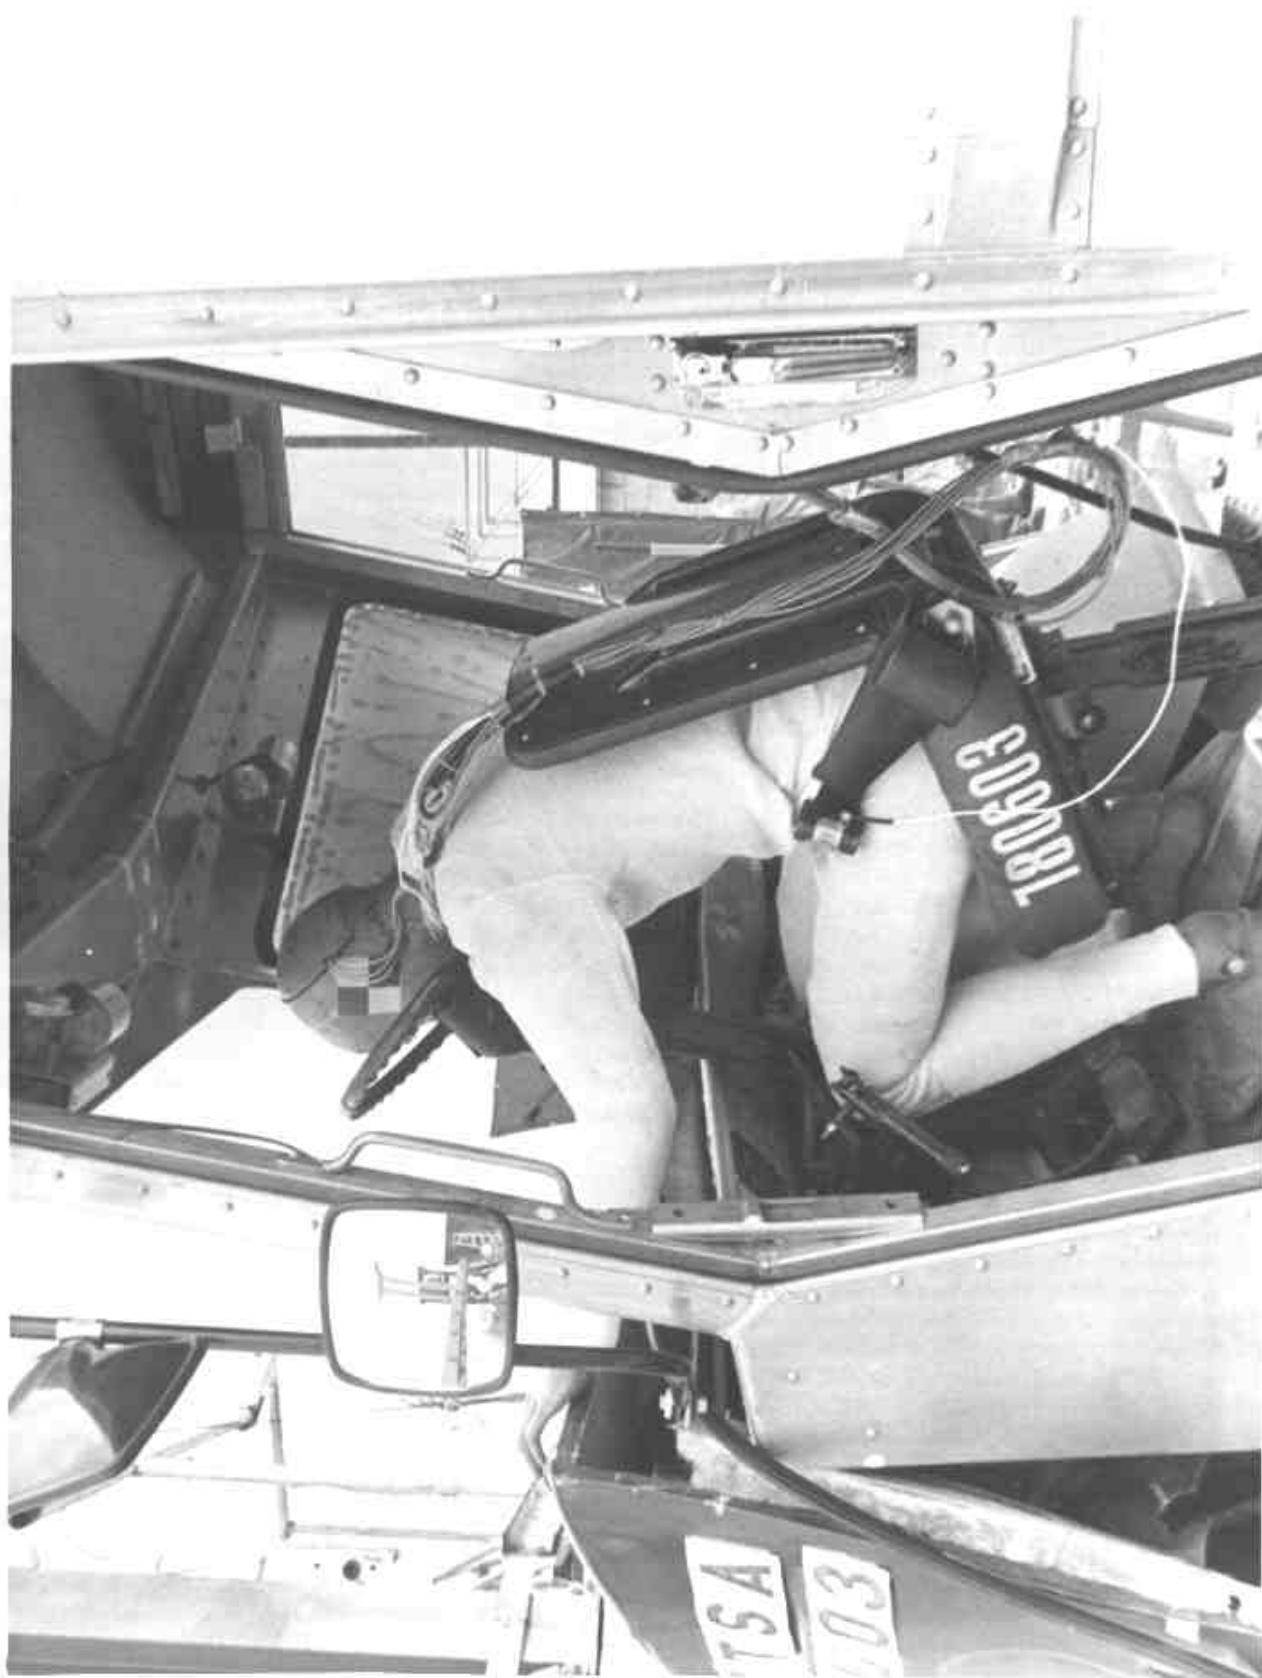
Figure 3-2  
1978 Ford P500 - Delivery Van  
NHTSA 780603  
Post-Impact, Driver Dummy View

The drivers seat pedestal bent forward and the driver dummy impacted the steering wheel column assembly. The steering wheel rim was severely bent in addition to the steering wheel column bent over the dash assembly. The left side windshield assembly came completely out of the body opening from apparent steering wheel and/or driver dummy contact. The floor buckled in various configurations in the occupant compartment as well as in the cargo area.

Figures 3-1 through 3-3 are pre-test and post-test views of the occupant compartment, restraint system, and dummy.

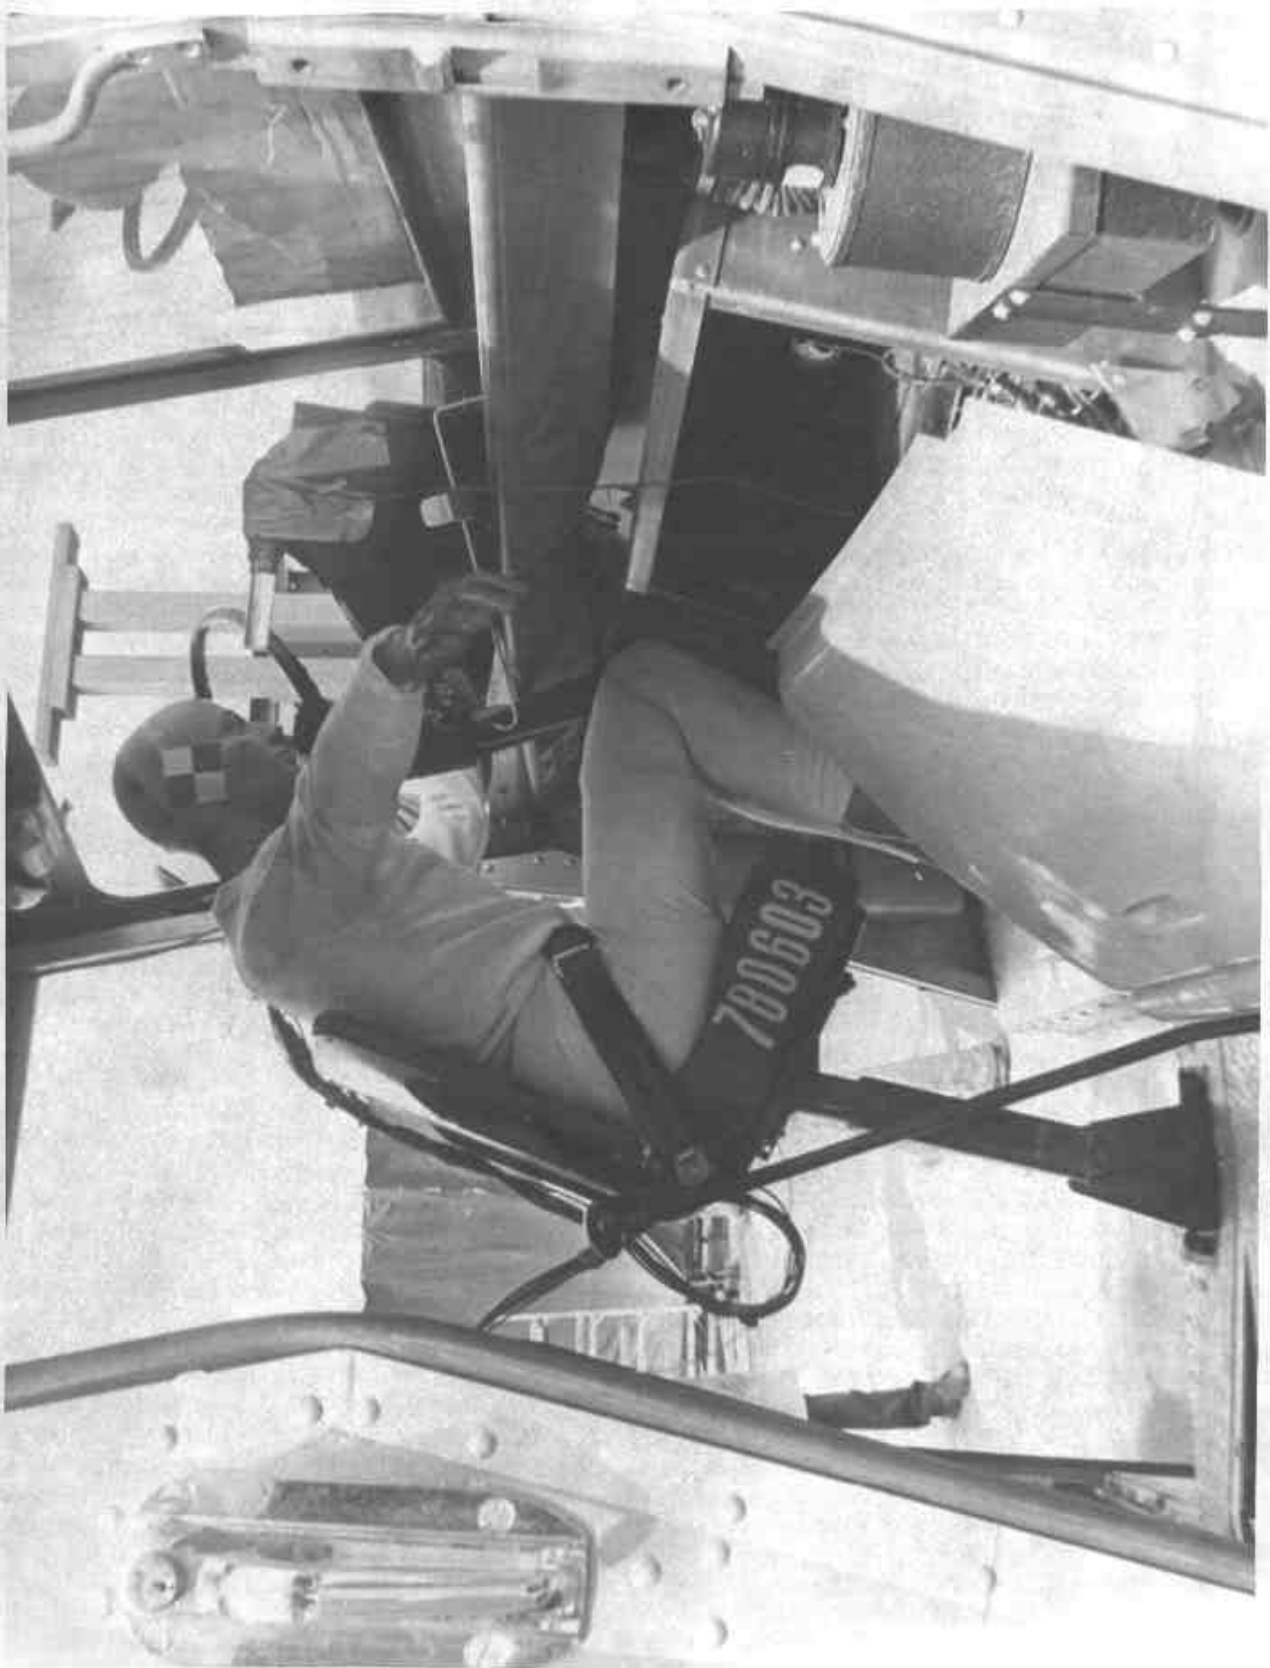
Figure 3-3  
1978 Ford P500 - Delivery Van  
NHTSA 780603  
Post-Impact, Driver Dummy View
