OCCUPANT RESPONSE  
AND  
VEHICLE ACCELERATION  
IN A  
30 MPH FRONTAL IMPACT TEST

GENERAL MOTORS CORPORATION  
AND  
SATELLITE TRUCK BODY COMPANY  
1978 GMC G35 - MAGNAVAN  
NHTSA 780615

FINAL REPORT

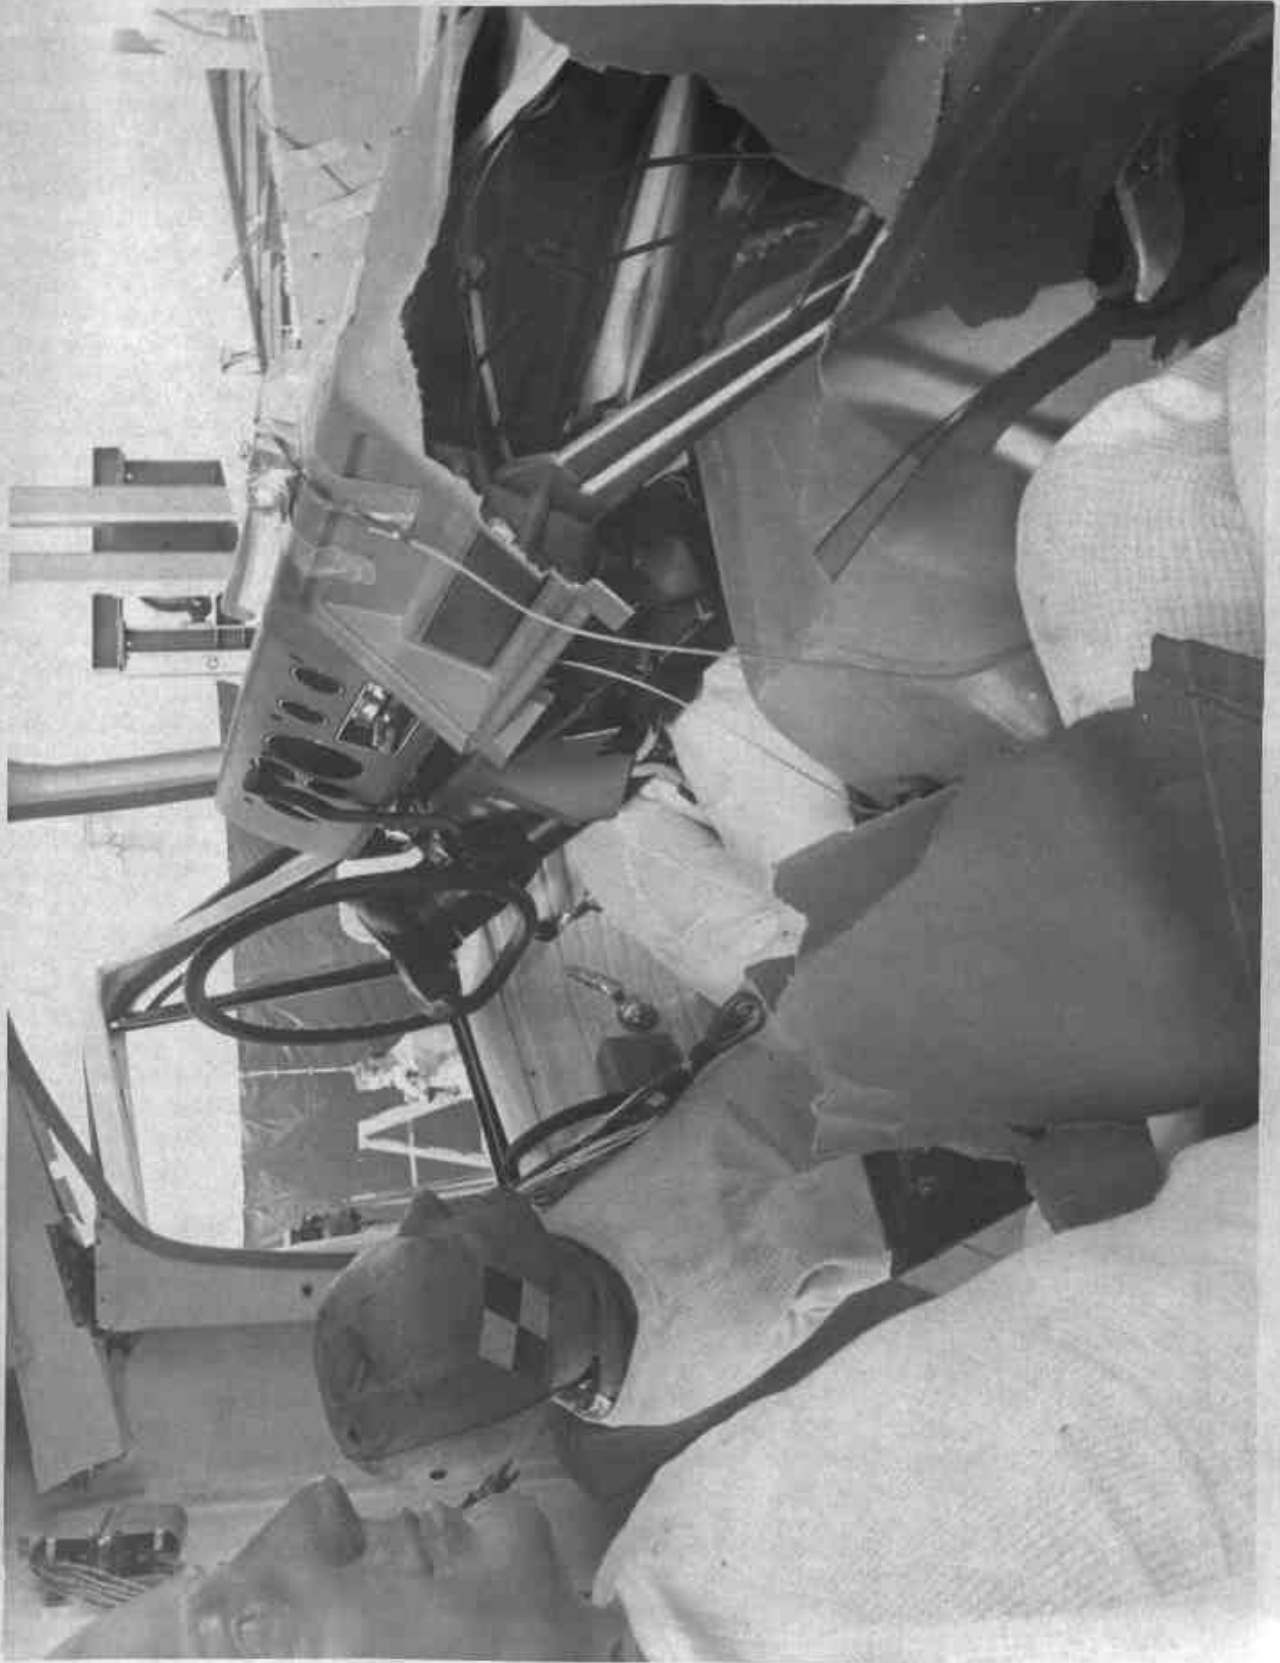
Figure 3-4

Post-Impact, Passenger Dummy View

Post-impact inspection of the vehicle revealed almost all crush occurred forward of the cargo box. Both front doors bowed out and were jammed. The left and right frame rails buckled in the vicinity of the "A" posts and the roof buckled over both "B" posts. The windshield assembly came completely out of the body opening during the impact event. The cowl and roof assemblies were severely deformed which apparently aided the windshield retention loss. The driver dummy impacted the steering wheel assembly and the steering wheel rim was severely bent. The passenger dummy impacted the dash assembly and penetrated thru to the cowl assembly.

Figures 3-1 through 3-4 are pre-test and post-test views of the occupant compartment, restraint system, and dummies.
