OCCUPANT RESPONSE  
AND  
VEHICLE ACCELERATION  
IN A  
30 MPH FRONTAL IMPACT TEST

CHRYSLER CANADA LTD.  
1978 DODGE MAGNUM XE - 2 DOOR HARDTOP  
NHTSA 780308

CONTRACT NUMBER DOT-HS-6-01477

FINAL REPORT

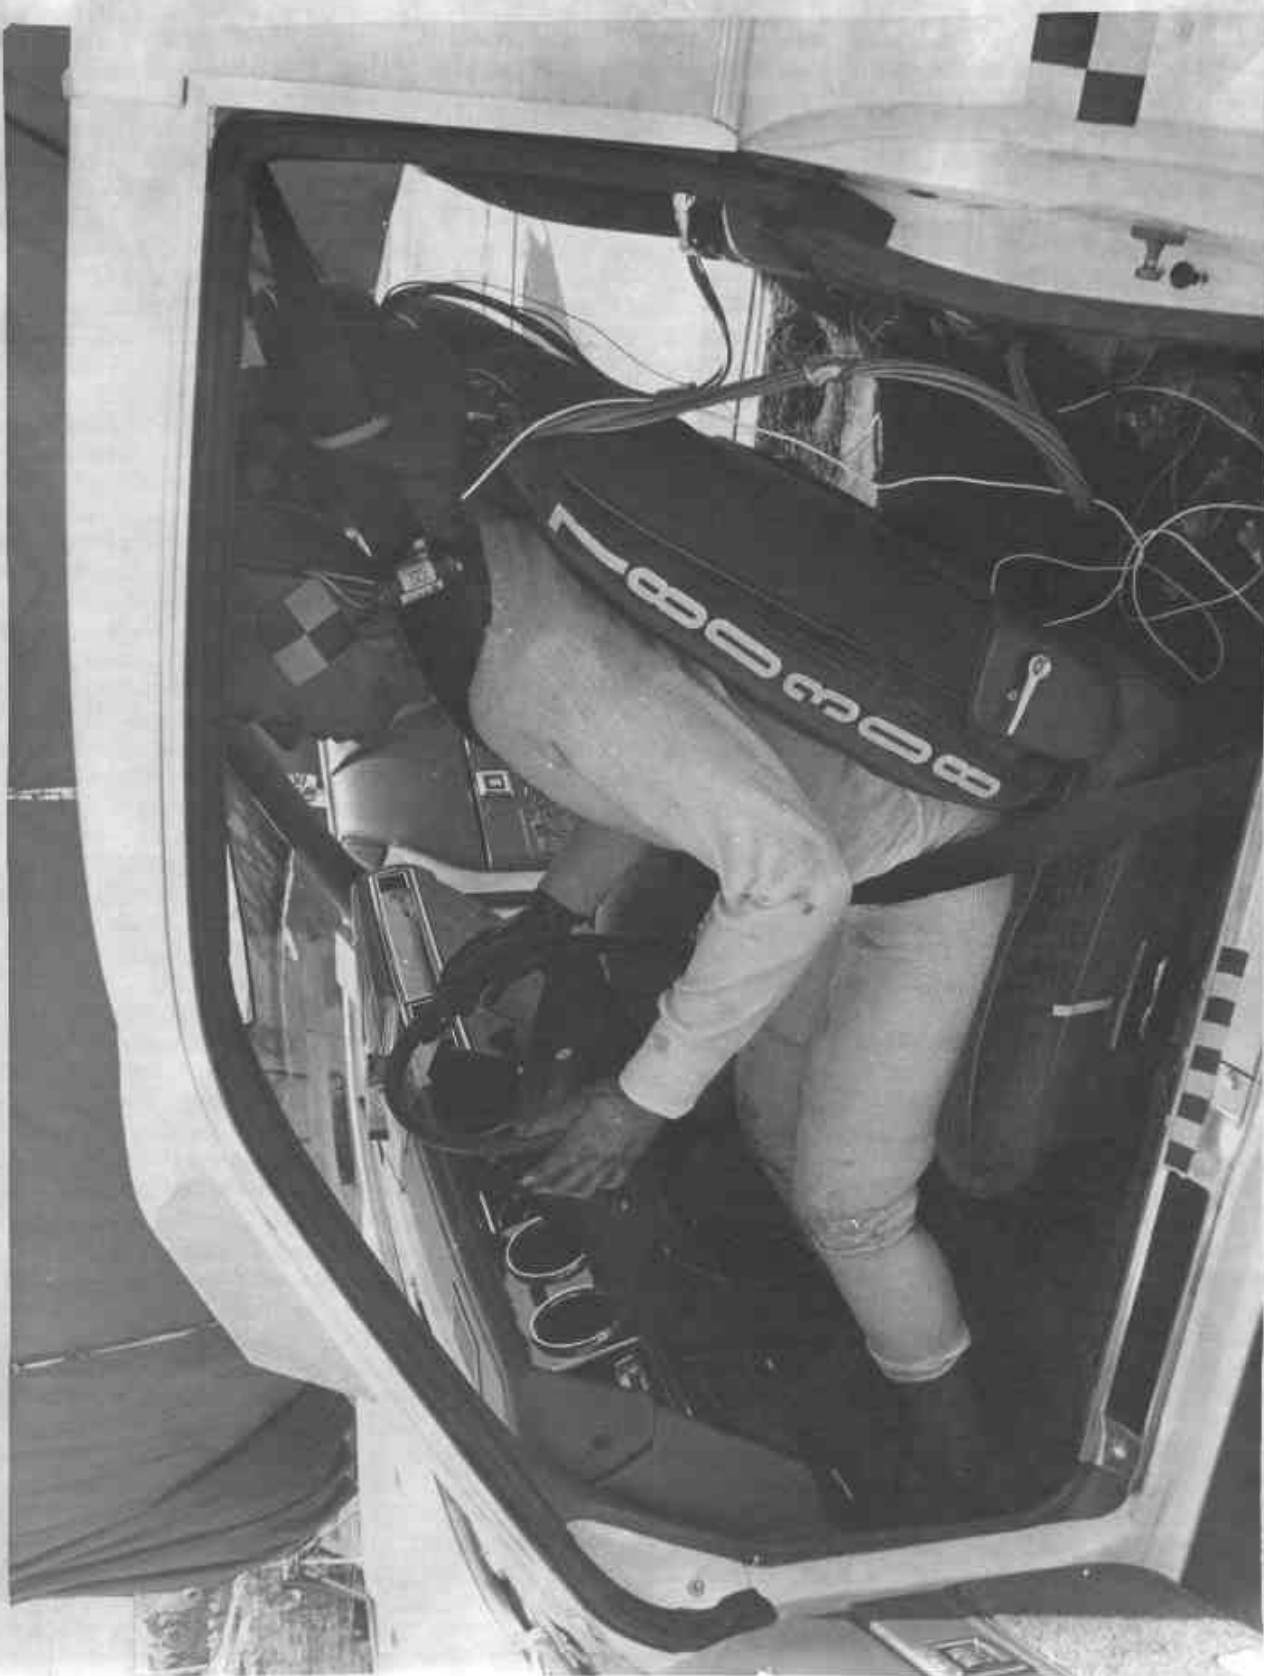
Figure 3-1  
1978 Dodge Magnum XE - 2 Door Hardtop  
NHTSA 780308  
Pre-Test, Driver Dummy View

Figures 3-1 through 3-4 are pre-test and post-test views of the occupant compartment, restraint system, and dummies.

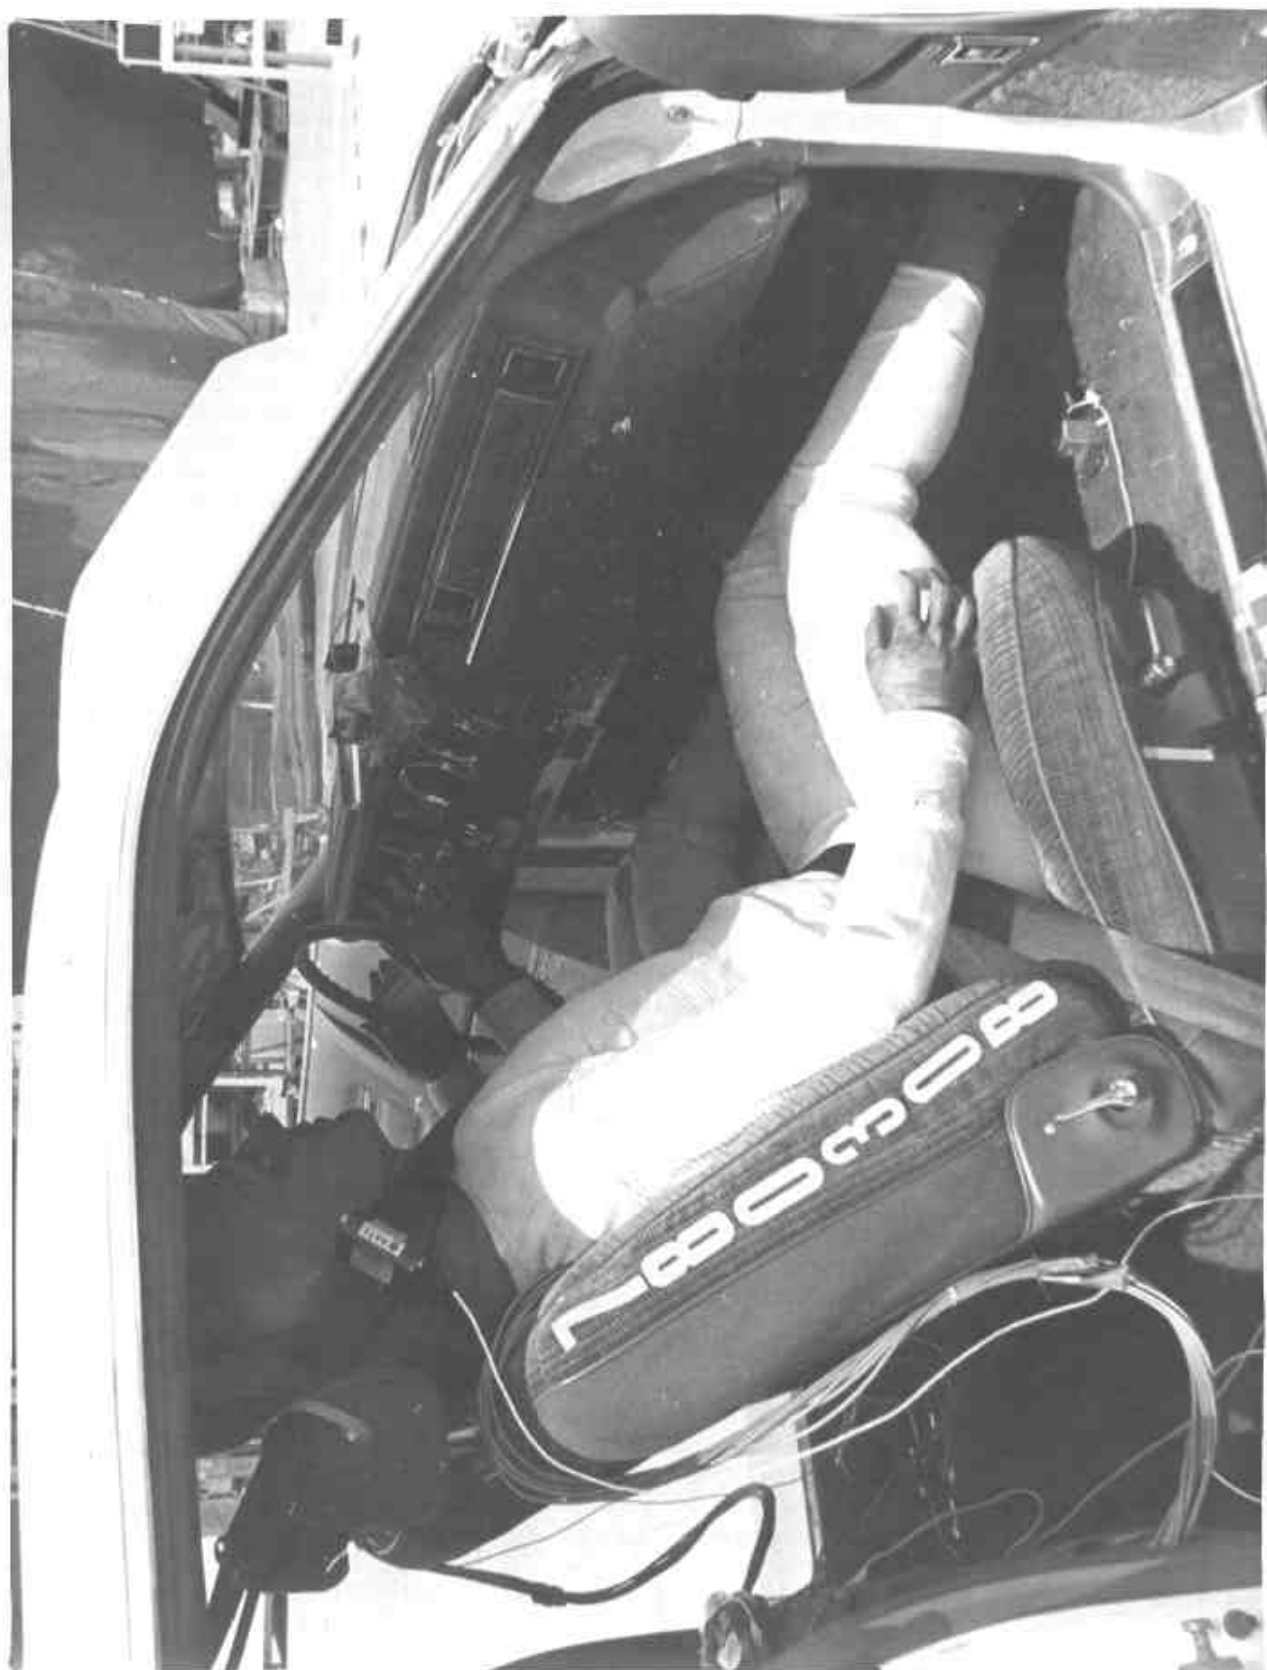
Figure 3-2  
1978 Dodge Magnum XE - 2 Door Hardtop  
NHTSA 780308  
Pre-Test, Passenger Dummy View

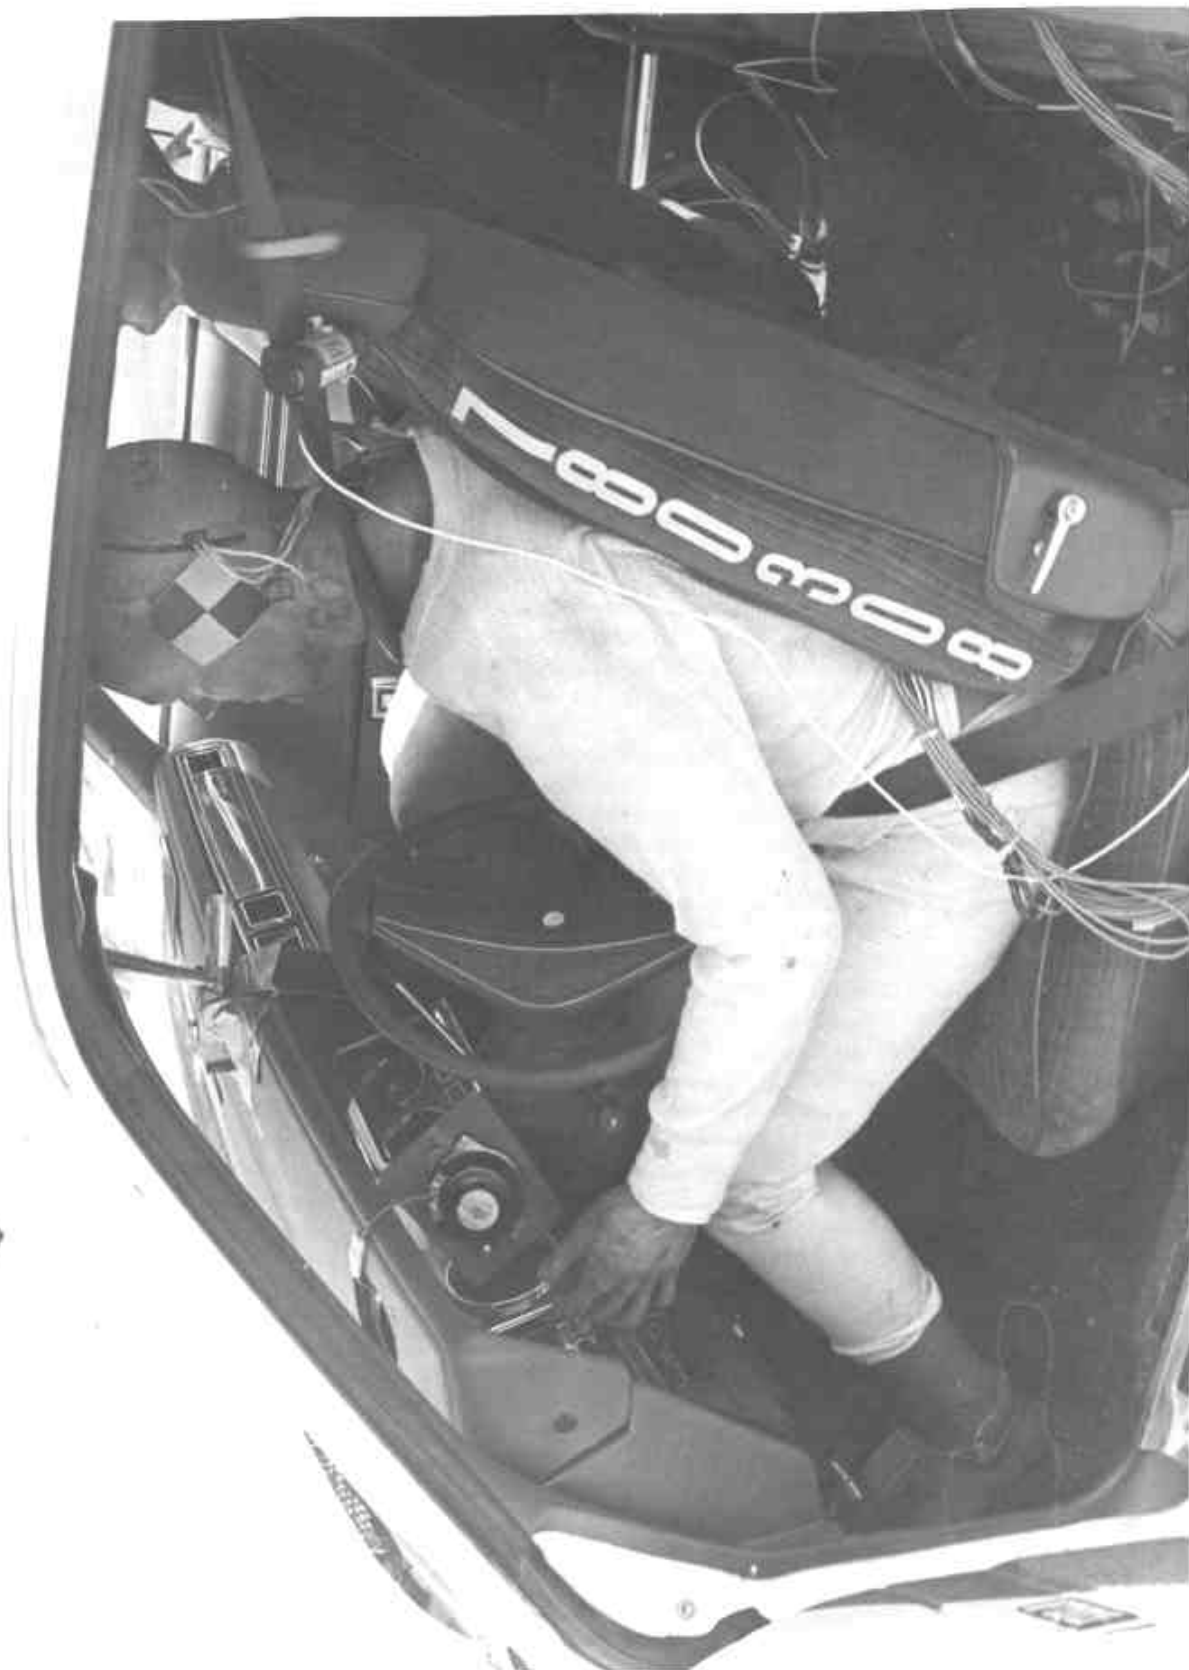
Figure 3-3  
1978 Dodge Magnum XE - 2 Door Hardtop  
NHTSA 780308  
Post-Impact, Driver Dummy View

Post-impact inspection of the vehicle revealed almost all crush occurred forward of the front doors. The hood buckled up in the middle and both front fenders pushed back and jammed the doors. The left and right frame rails buckled in the vicinity of the cowl and the roof buckled over both "B" posts. The windshield had numerous cracks that developed from apparent hood hinge impact into the lower (below dash line) windshield corners. The driver dummy impacted the steering wheel assembly and the steering wheel rim was severely bent. The passenger seat adjuster broke and the passenger dummy impacted the dash assembly with his legs.

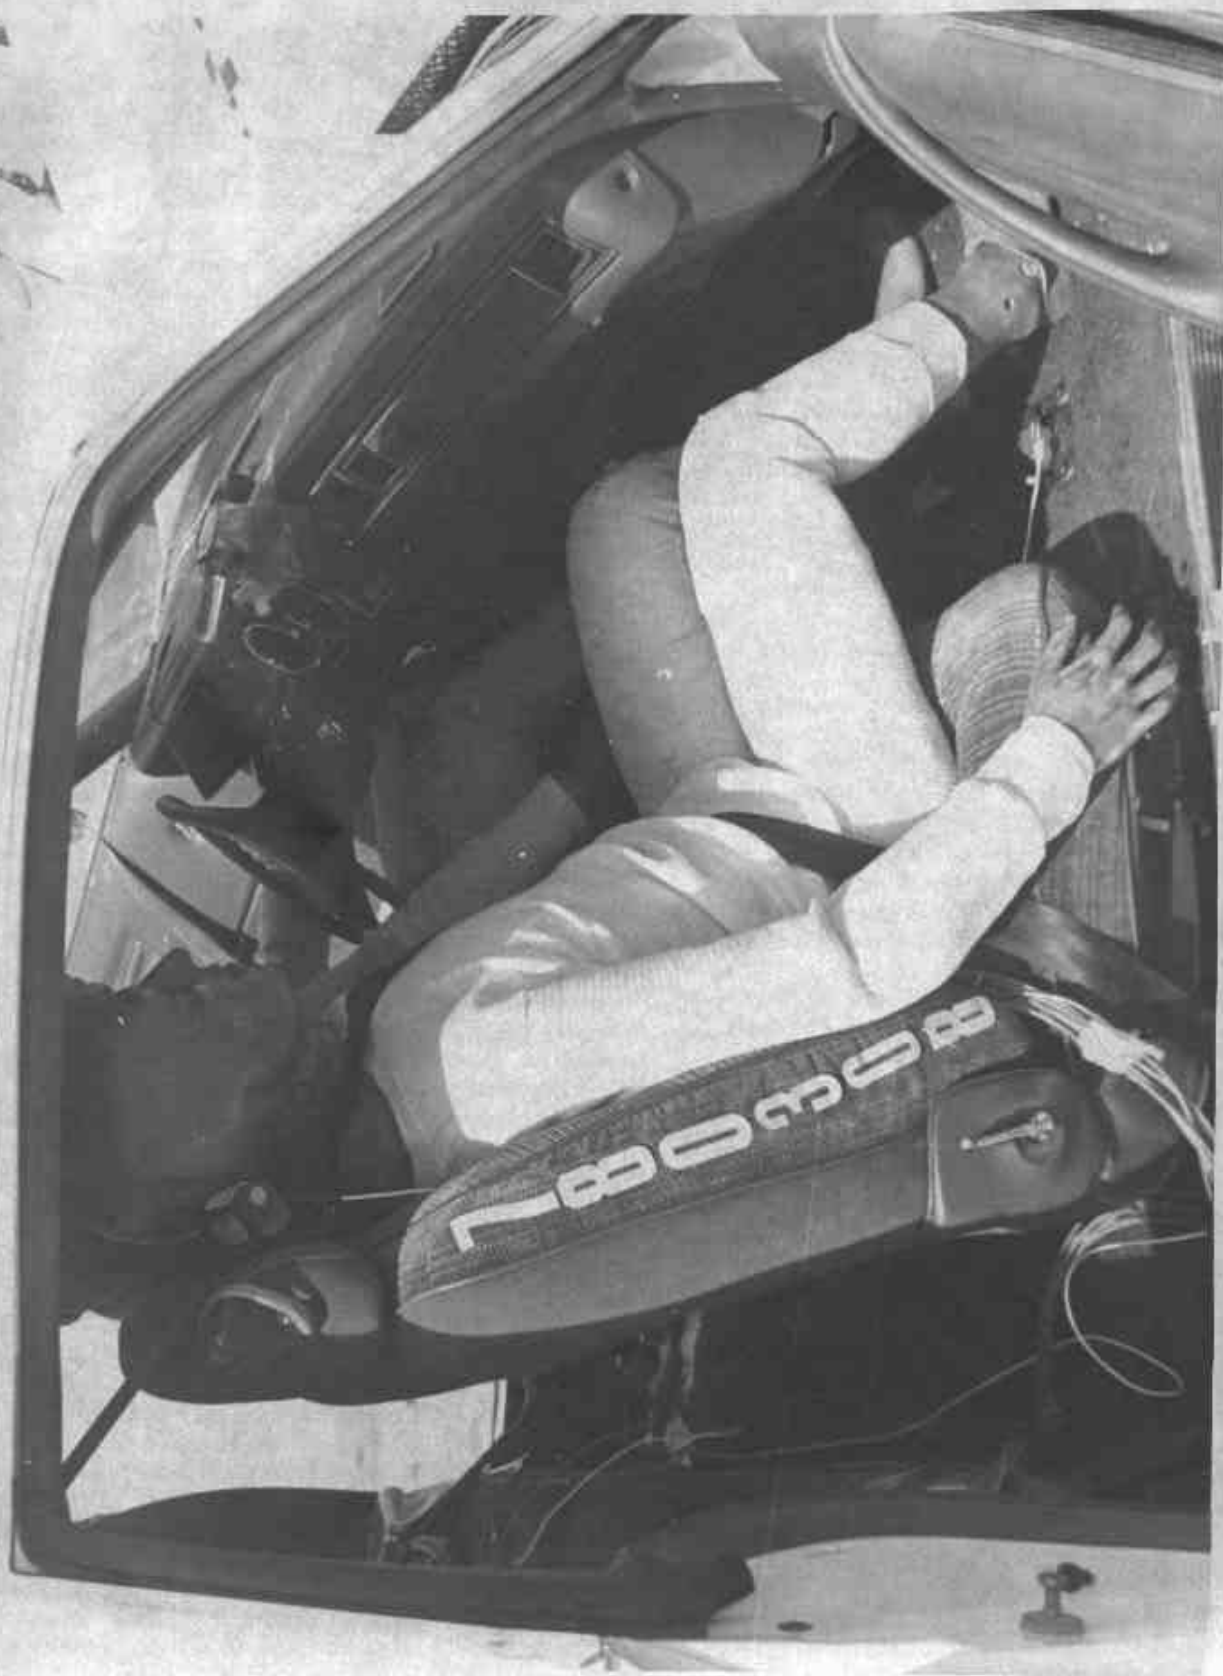
Figure 3-4

Post-Impact, Passenger Dummy View
