OCCUPANT RESPONSE  
AND  
VEHICLE ACCELERATION  
IN A  
30 MPH FRONTAL IMPACT TEST

CHRYSLER CORPORATION  
1978 CHRYSLER LE BARON - 4 DOOR SEDAN  
NHTSA 780306

FINAL REPORT

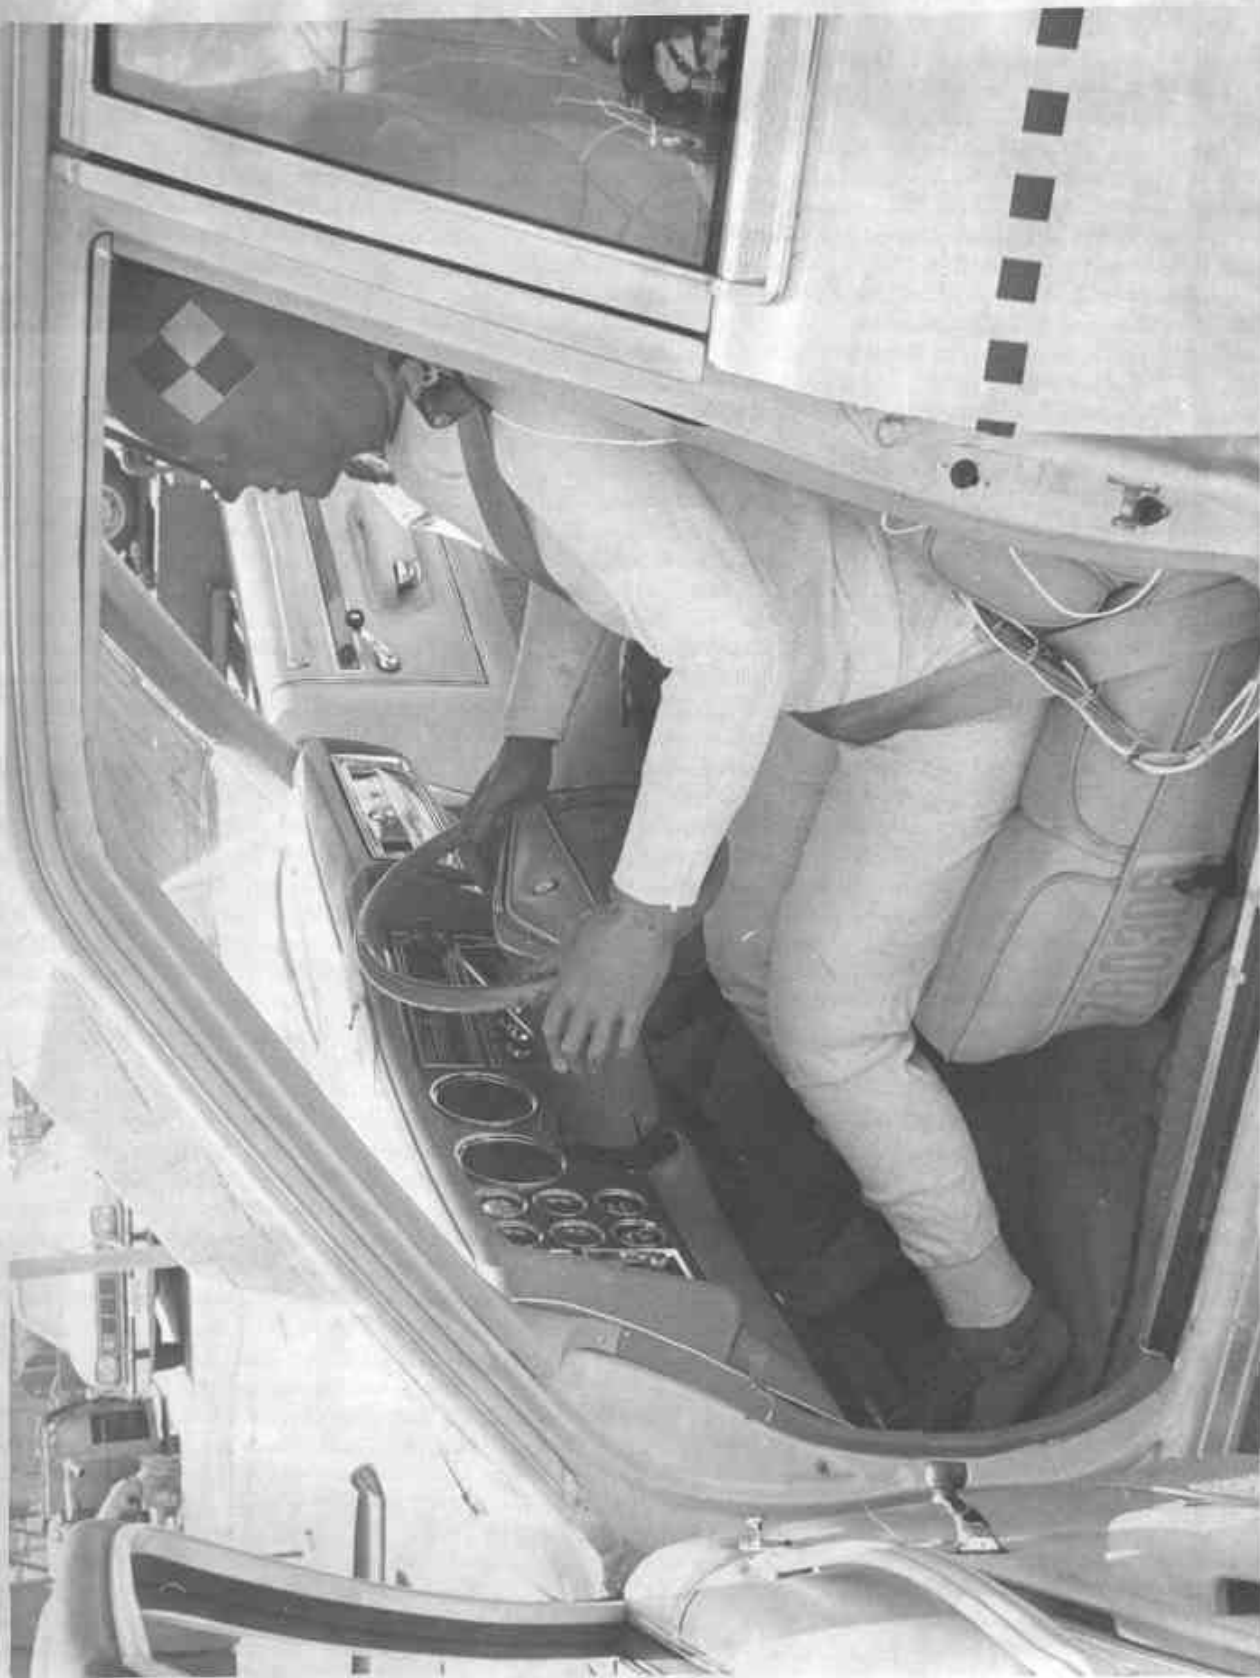
Figure 3-1  
1978 Chrysler Le Baron - 4 Door Sedan  
NHTSA 780306  
Pre-Test, Driver Dummy View

Figure 3-1 through 3-4 are pre-test and post-test views of the occupant compartment, restraint system, and dummies.

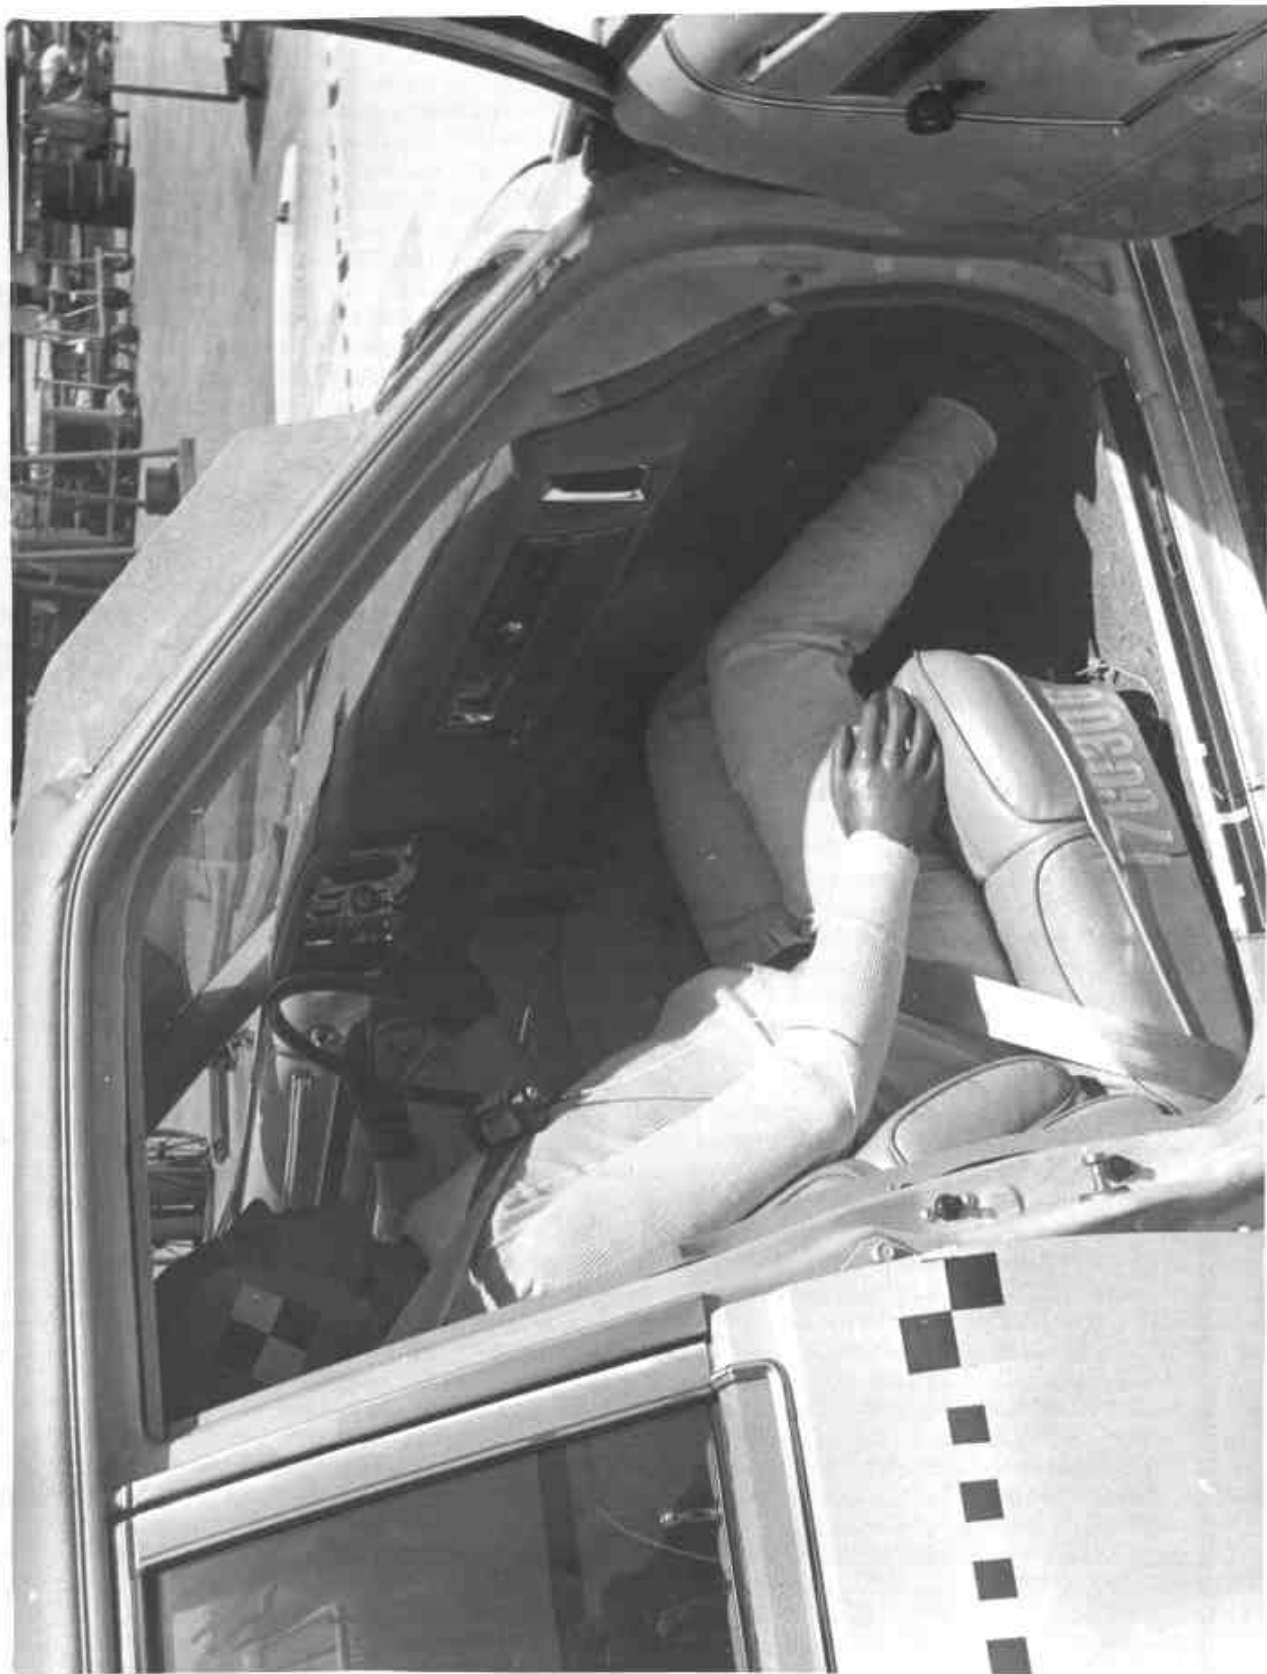
Figure 3-2  
1978 Chrysler Le Baron - 4 Door Sedan  
NHTSA 780306  
Pre-Test, Passenger Dummy View

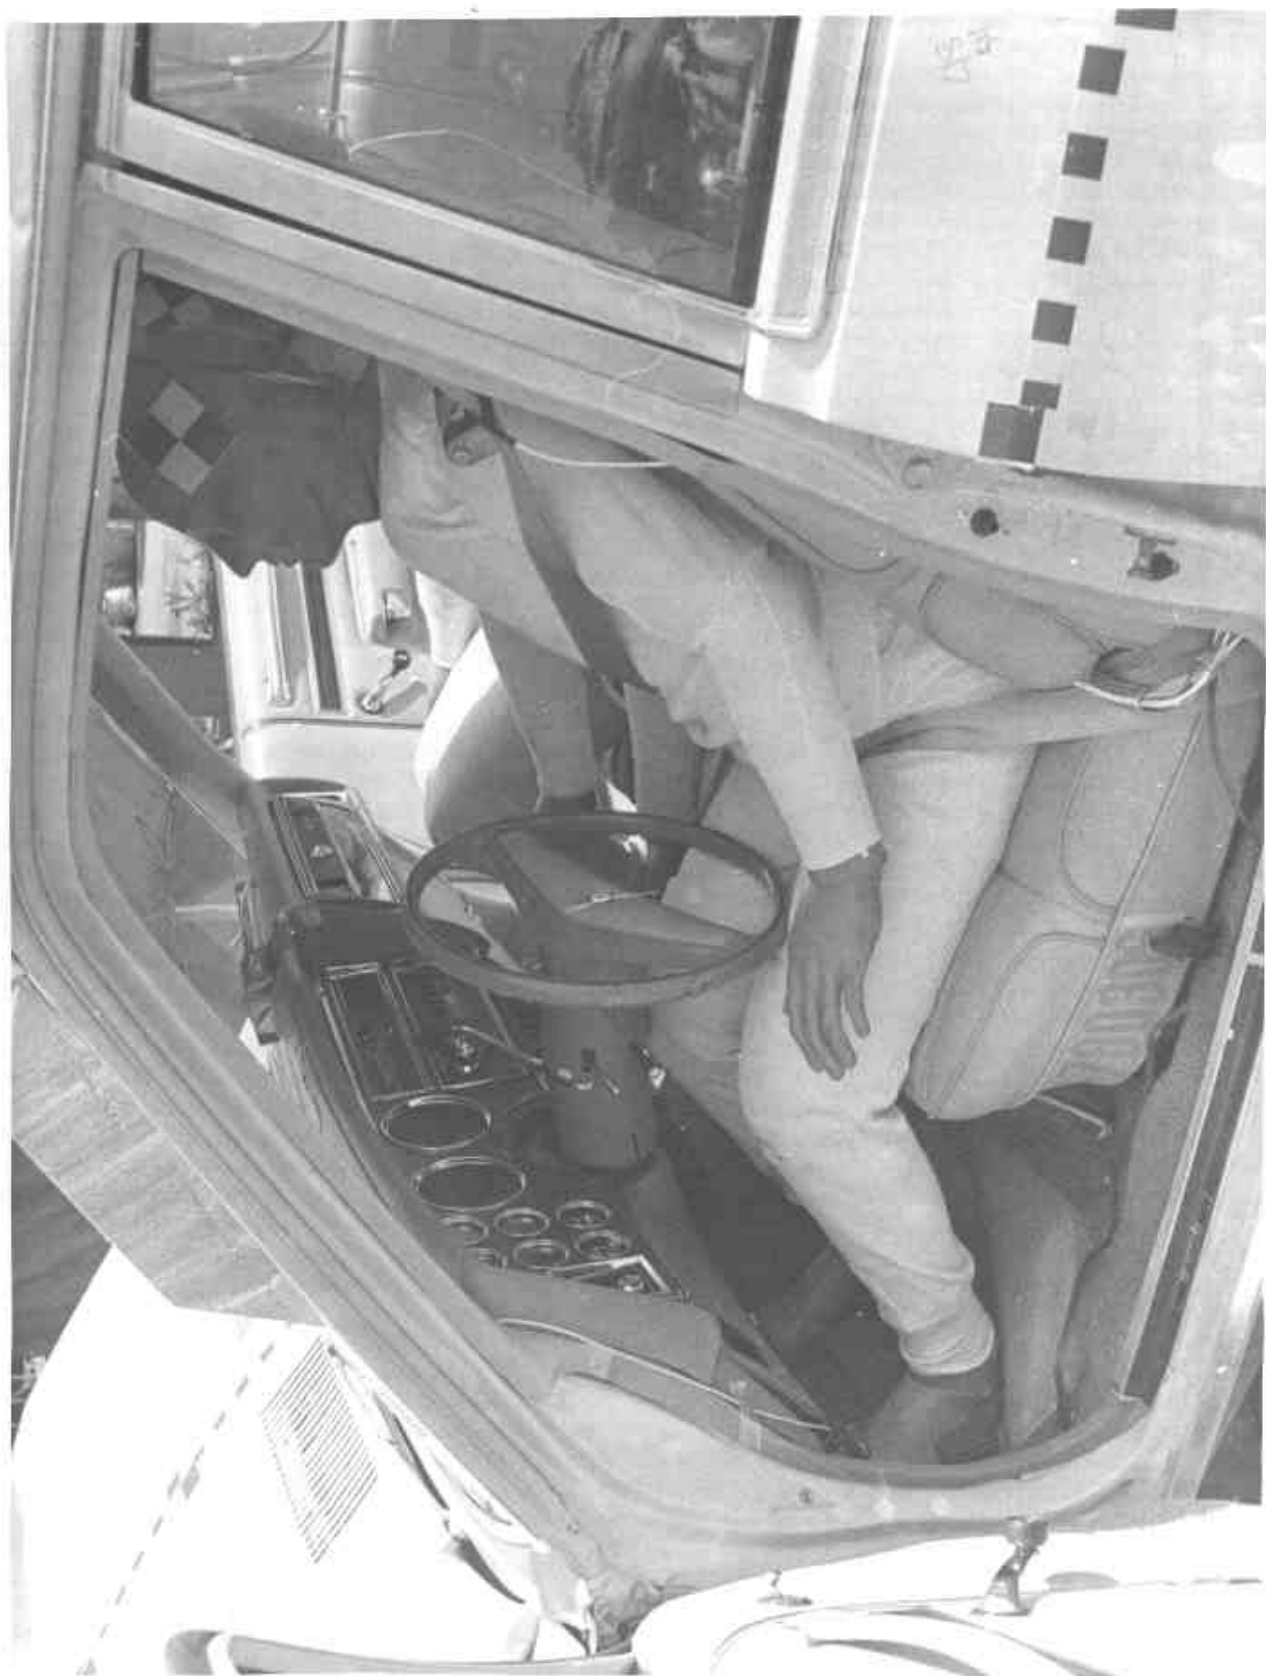
Figure 3-3  
1978 Chrysler Le Baron - 4 Door Sedan  
NHTSA 780306  
Post-Impact, Driver Dummy View

Post-impact inspection of the vehicle revealed almost all crush occurred forward of the front doors. The hood buckled up in the middle and both front fenders pushed back into the front doors. The left and right frame rails buckled in the vicinity of the "A" post and the roof buckled over the left "B" post. The rear axel housing buckled more predominately on the right side. The windshield was un-broken. The driver and passenger dummies impacted the lower dash assembly.

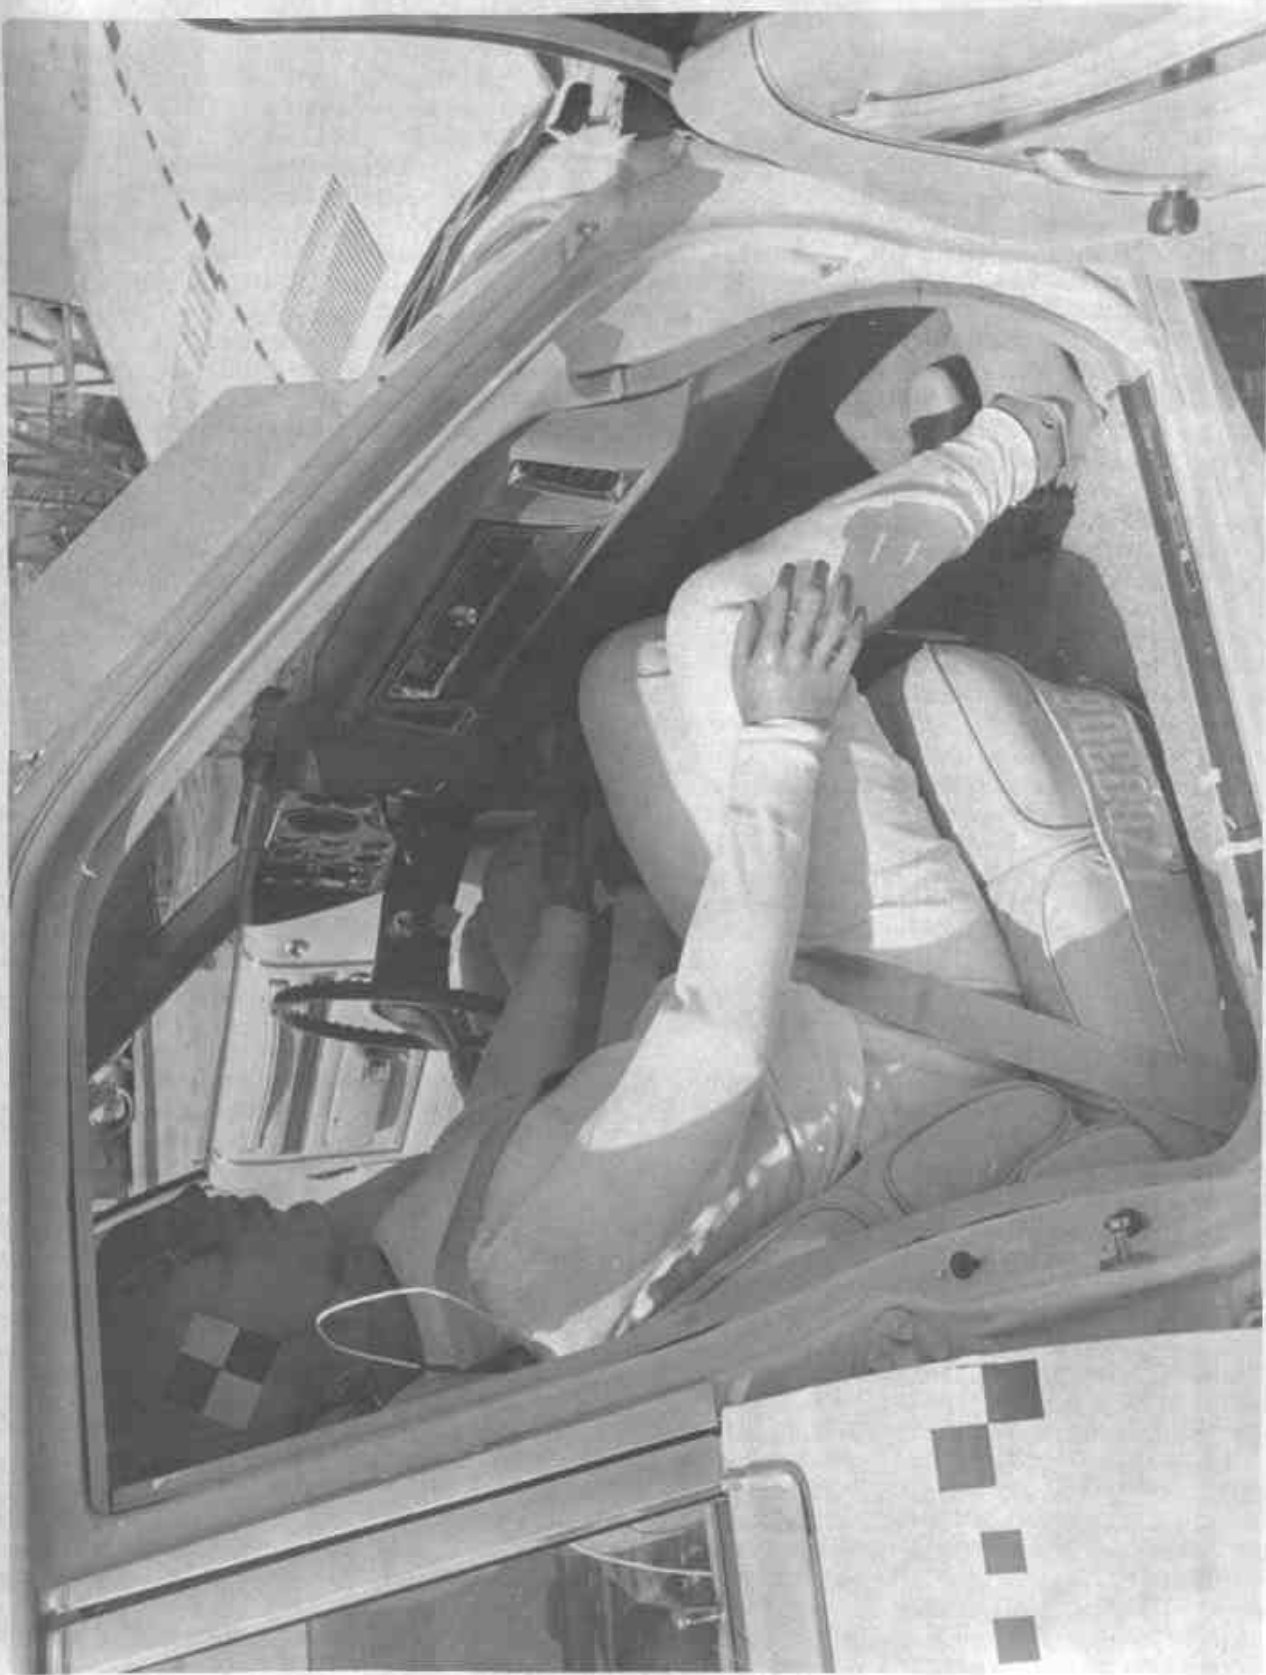
Figure 3-4  
1978 Chrysler Le Baron - 4 Door Sedan  
NHTSA 780306  
Post-Impact, Passenger Dummy View
