OCCUPANT RESPONSE  
AND  
VEHICLE ACCELERATION  
IN A  
30 MPH FRONTAL IMPACT TEST

AMERICAN MOTORS CORPORATION  
1978 AMC CONCORD - 2 DOOR HATCHBACK  
NHTSA 780402

FINAL REPORT

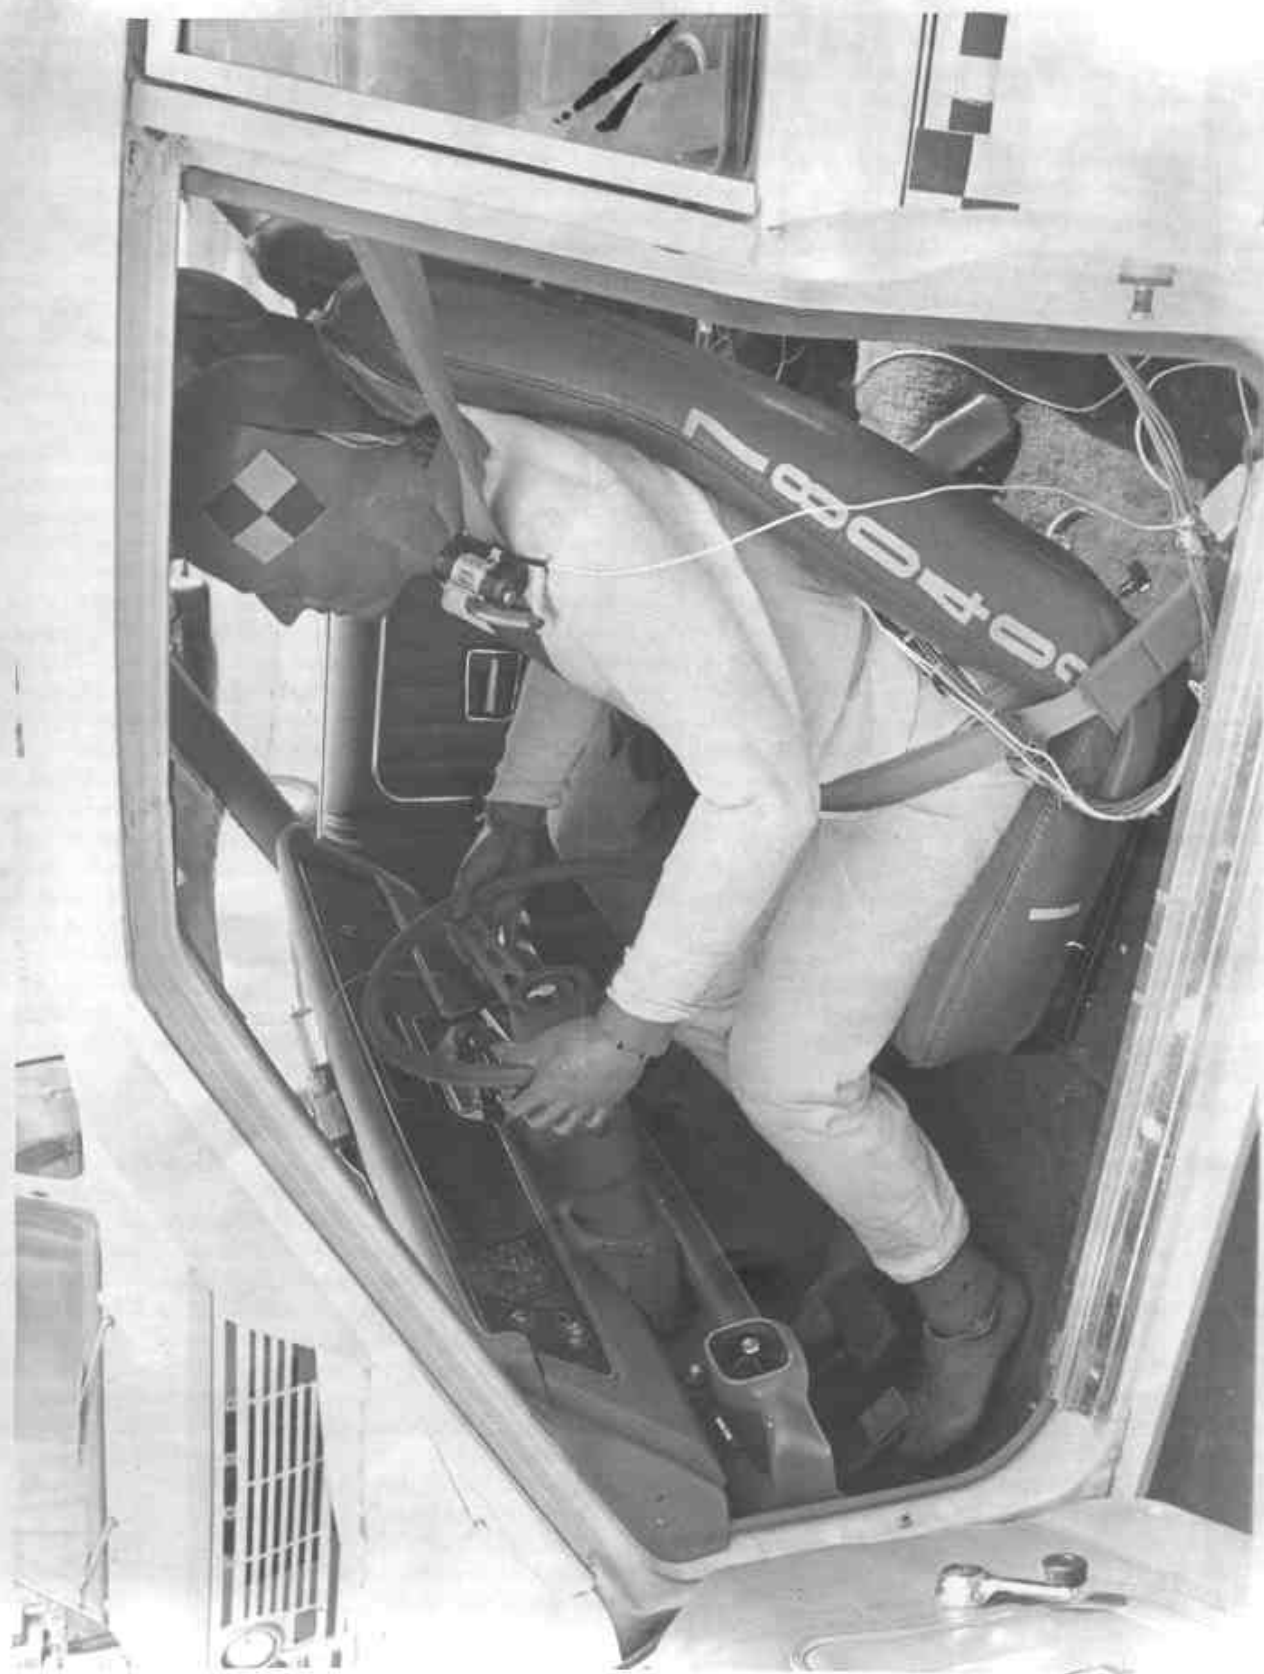
Figure 3-1  
1978 AMC Concord - 2 Door Hatchback  
NHTSA 780402  
Pre-Test, Driver Dummy View

Figures 3-1 through 3-4 are pre-test and post-test views of the occupant compartment, restraint system, and dummies.

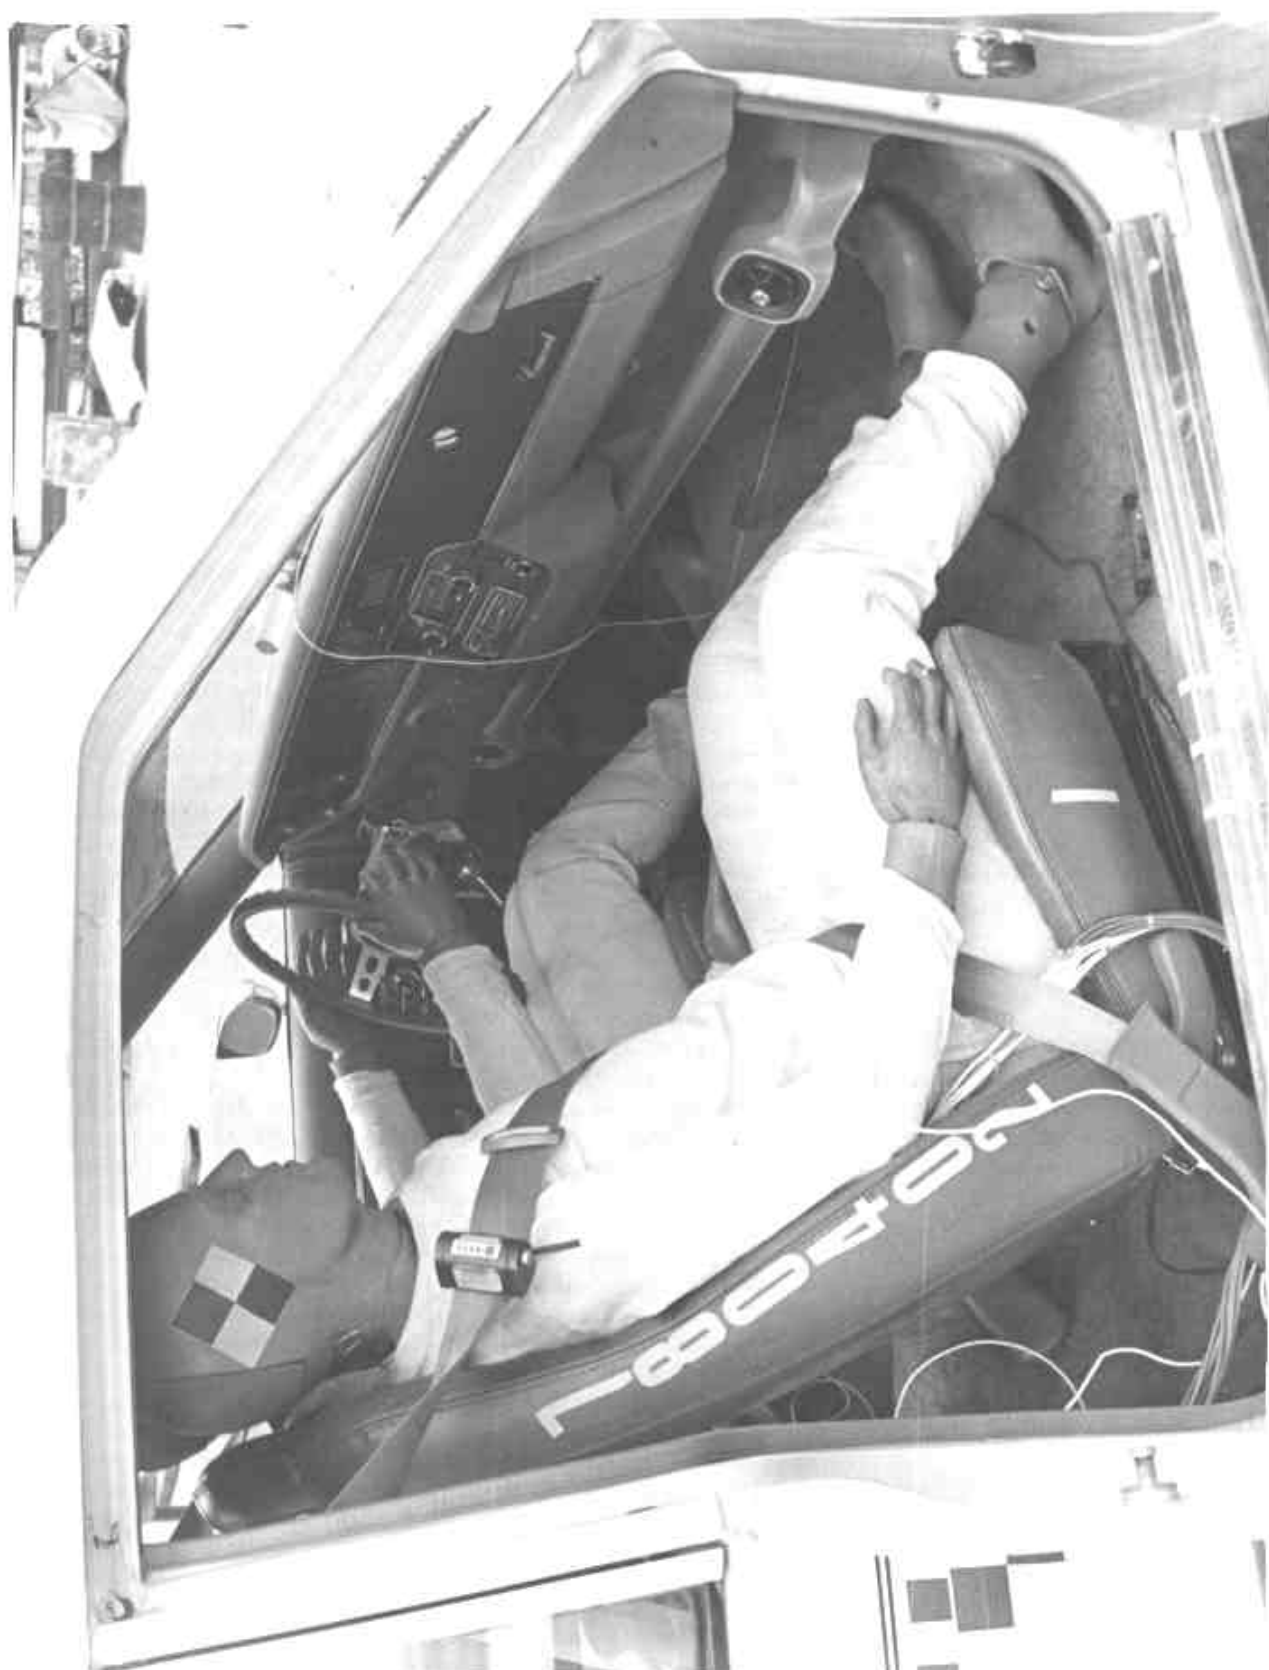
Figure 3-2  
1978 AMC Concord - 2 Door Hatchback  
NHTSA 780402  
Pre-Test, Passenger Dummy View

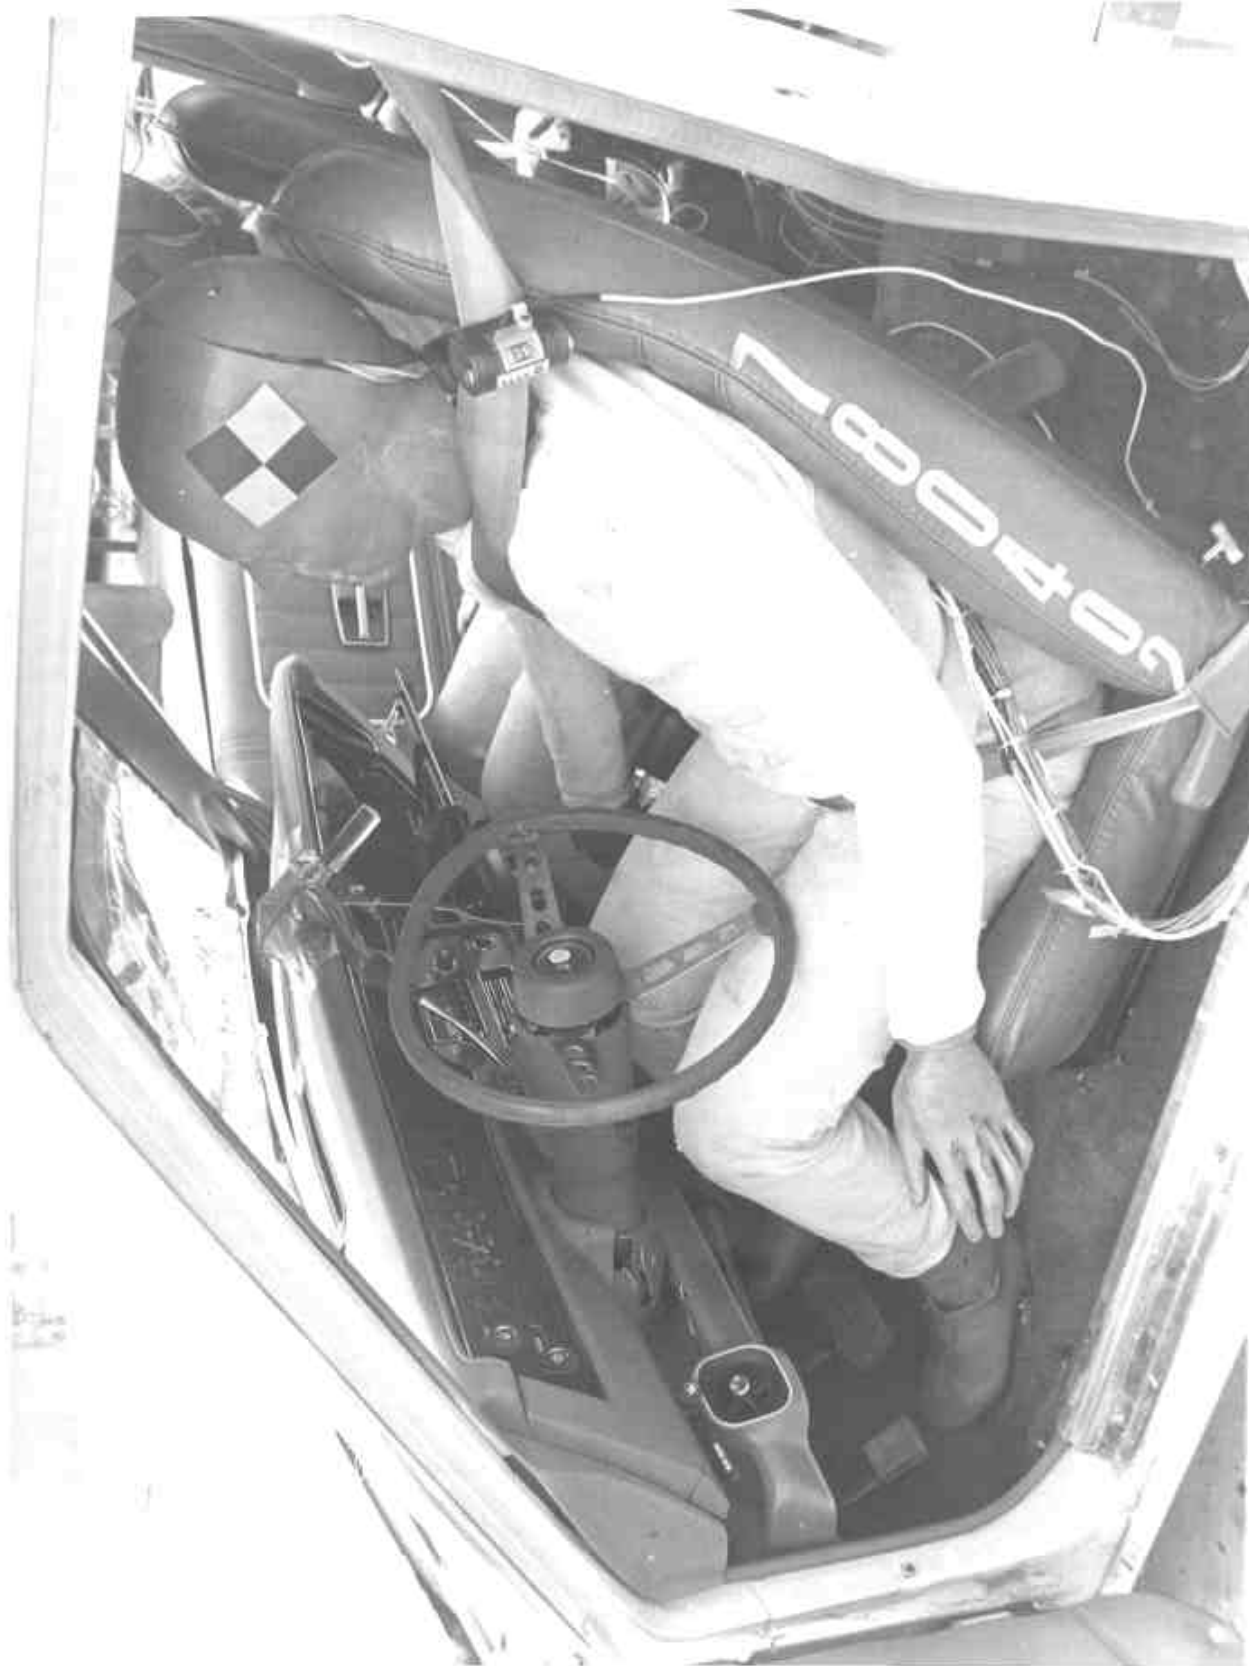
Figure 3-3

Post-Impact, Driver Dummy View

Post-impact inspection of the vehicle revealed almost all crush occurred forward of the front doors. The hood buckled up in the middle and both front fenders pushed back into the doors. The right frame rail buckled in the vicinity of the cowl and the roof pushed upward and both "B" post upper welds were broken. The windshield had numerous cracks and partial retention loss at the lower right corner from apparent heavy cowl deformation. The dash assembly tore loose on the right side and the right "A" post weld was broken. The driver dummy impacted the steering wheel assembly (wheel bent severely) and the lower dash assembly. The passenger dummy also impacted the lower dash assembly.

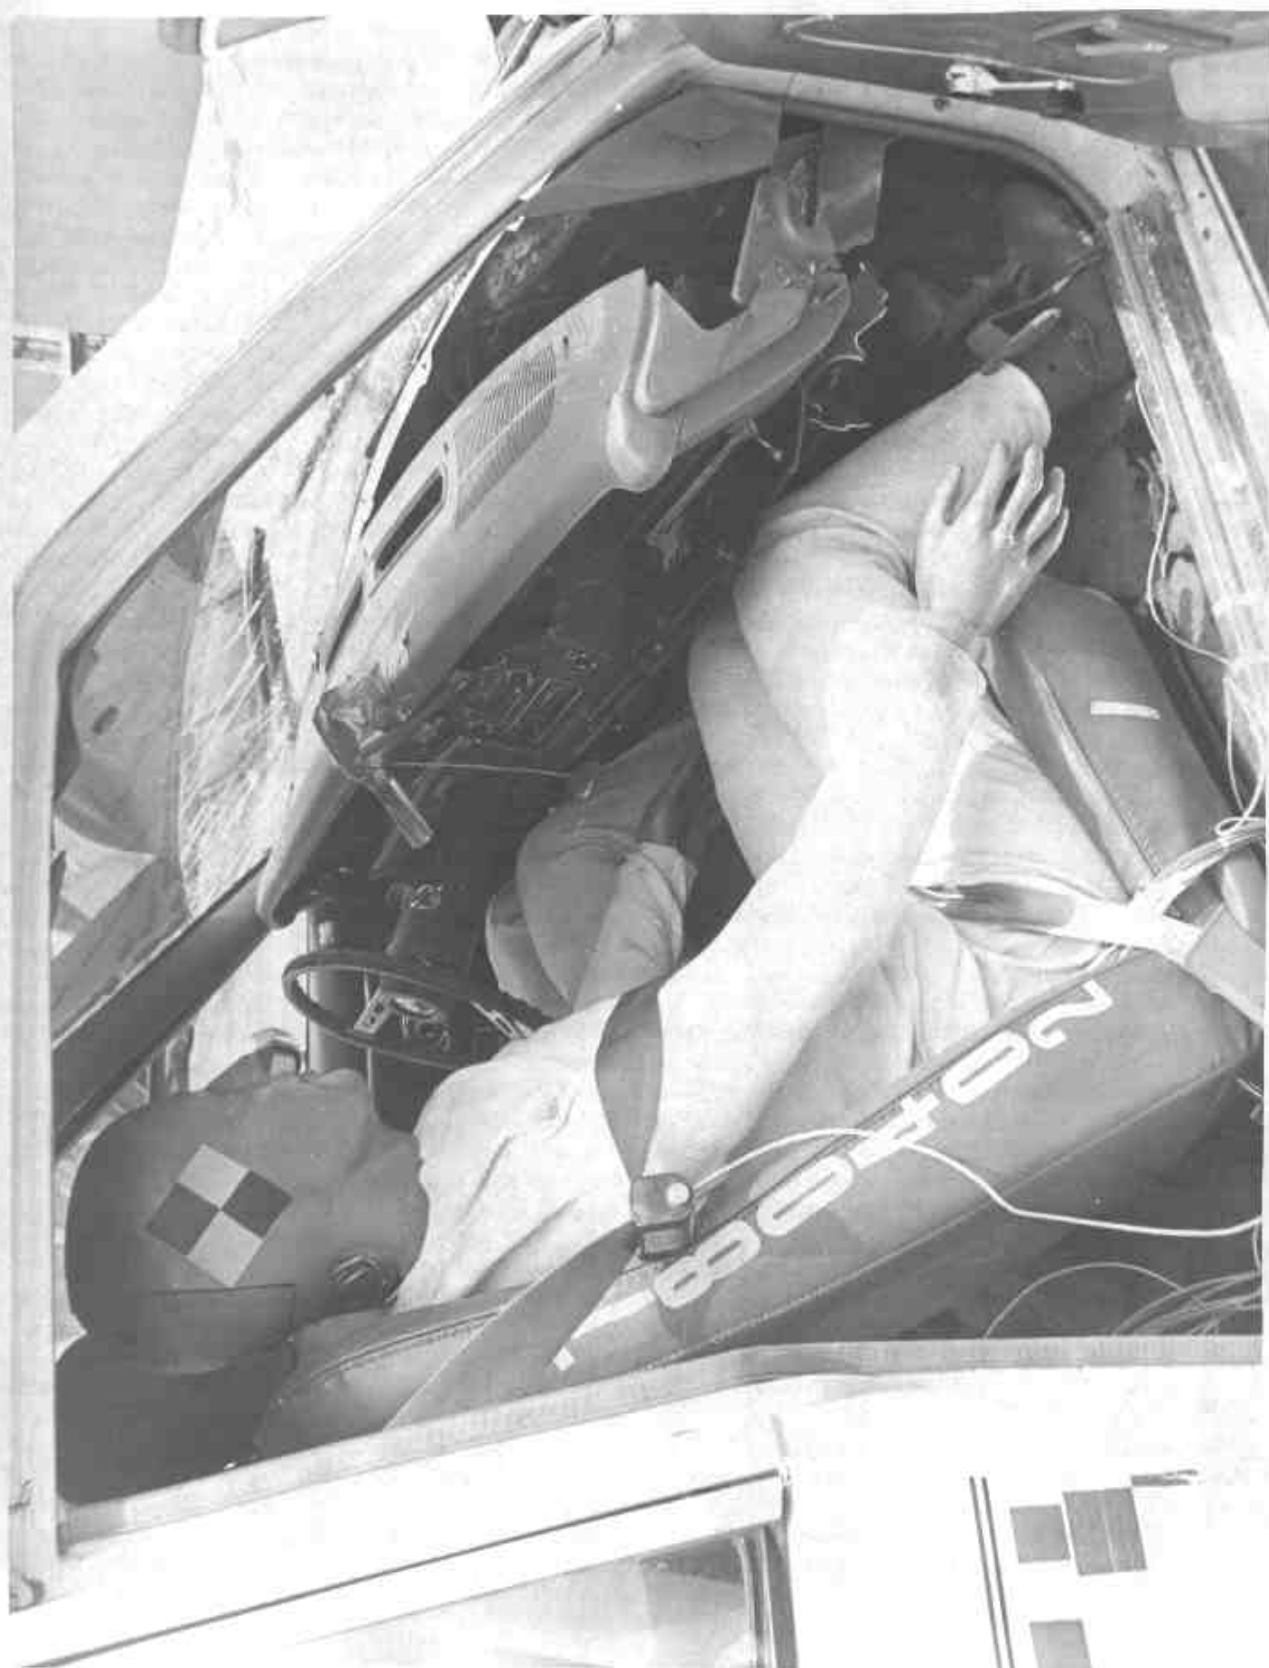
Figure 3-4  
1978 AMC Concord - 2 Door Hatchback  
NHTSA 780402  
Post-Impact, Passenger Dummy View
