OCCUPANT RESPONSE  
AND  
VEHICLE ACCELERATION  
IN A  
30 MPH LEFT OBLIQUE IMPACT TEST

FIAT S.p.A.  
1978 FIAT 131-S MIRAFIORI - 2 DOOR  
NHTSA 780507

FINAL REPORT

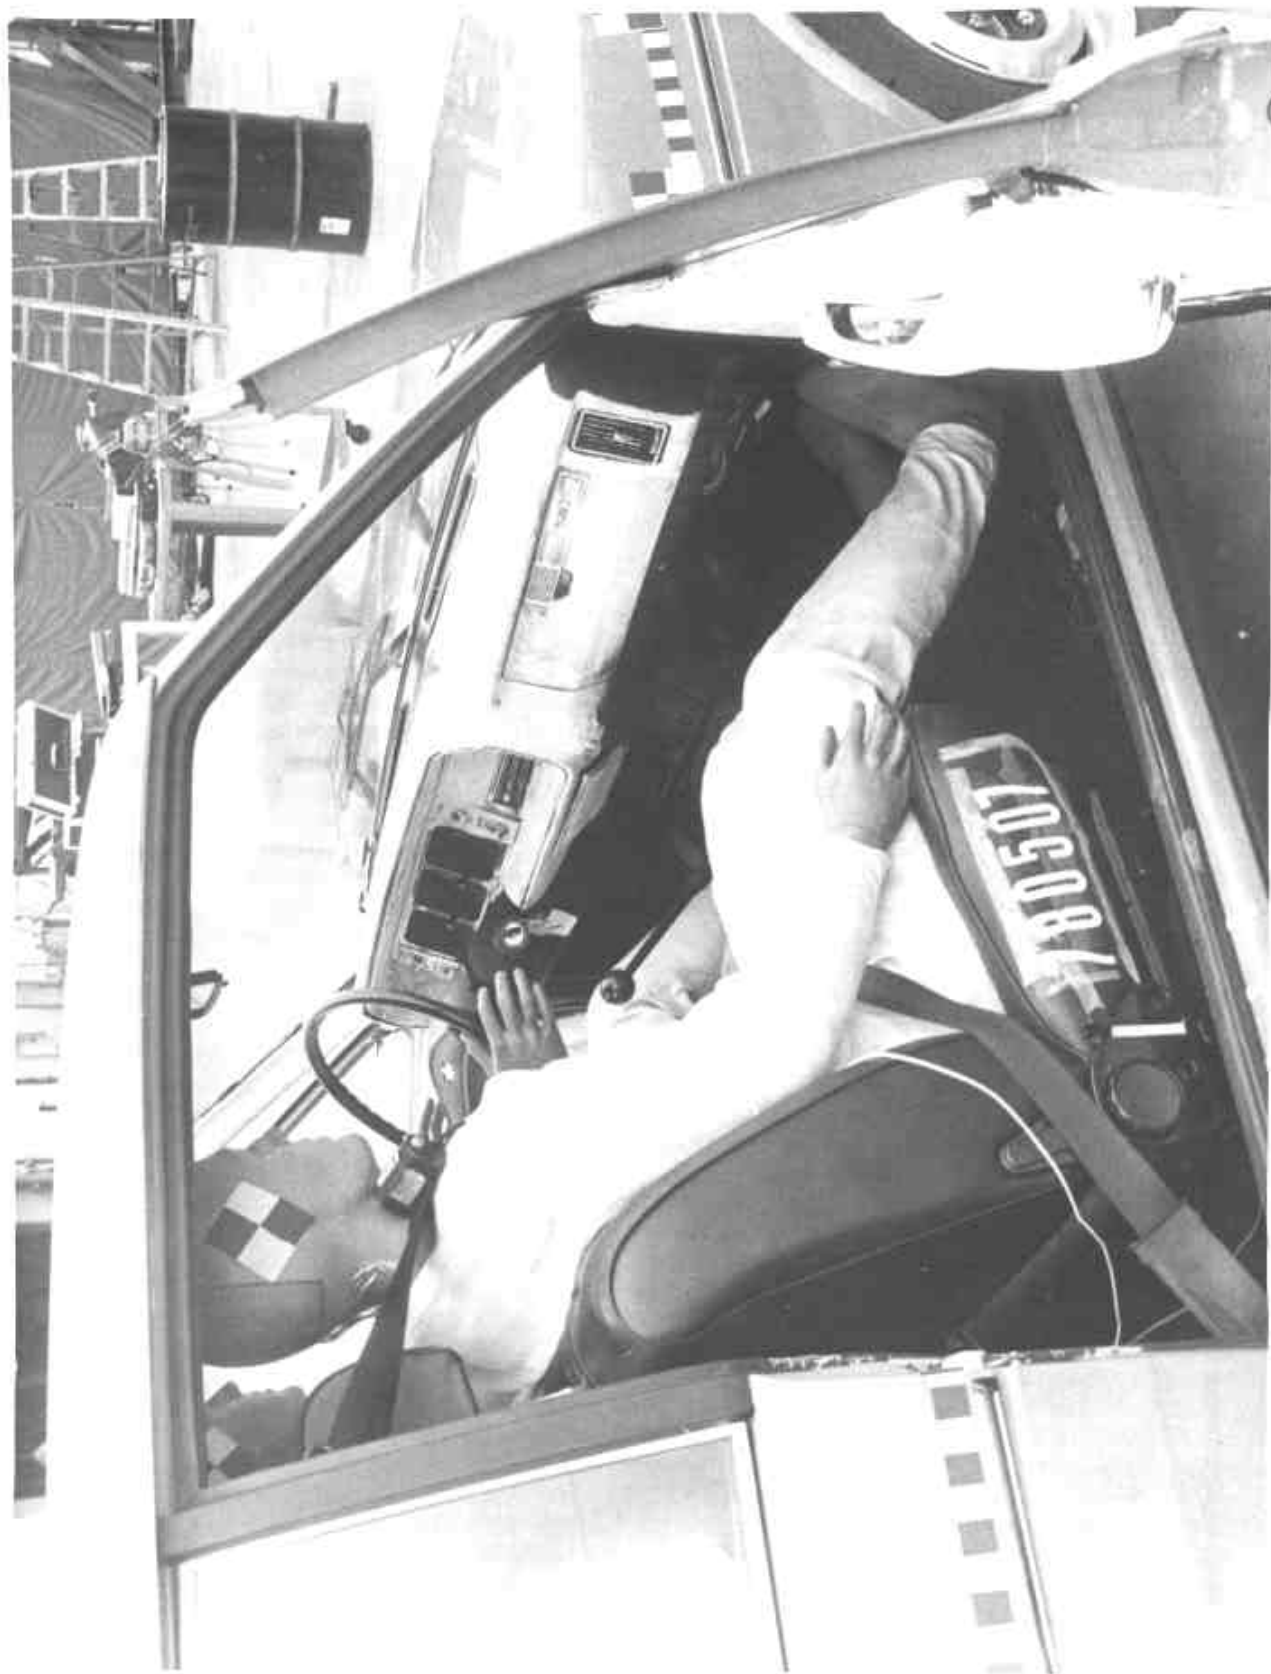
Figure 3-2

Pre-Test, Passenger Dummy View

Figures 3-1 through 3-4 are pre-test and post-test views of the occupant compartment, restraint system, and dummies.

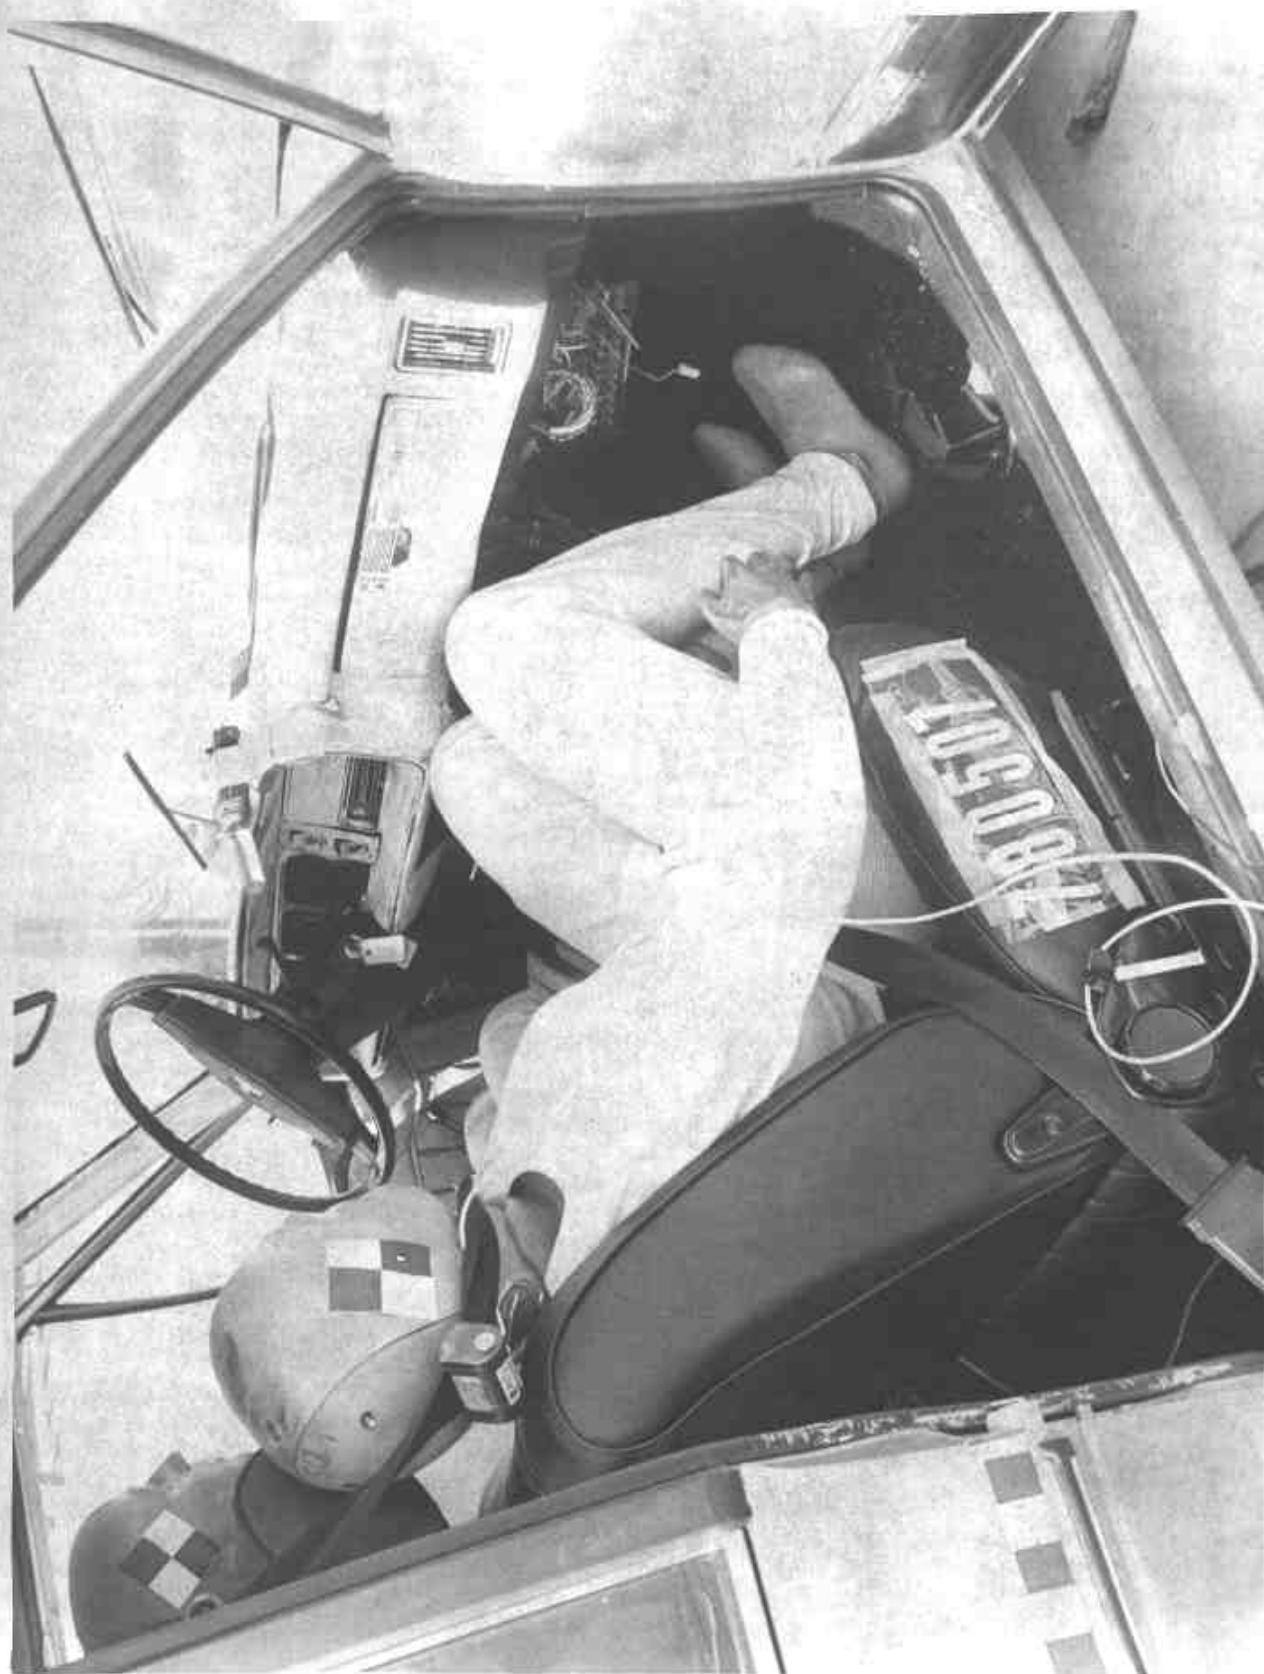
Figure 3-4

Post-Impact, Passenger Dummy View

Post-impact inspection of the vehicle revealed almost all crush occurred forward of the left door. The hood buckled up in the middle and the left front fender pushed back into the door. The left front tire was flat and the left frame rail buckled in the vicinity of the "A" post. The windshield was cracked from cowl deformation and the roof buckled over the left door. The driver dummy impacted the steering wheel assembly (severely bent) and the lower dash assembly. The passenger dummy also impacted the lower dash assembly.
