OCCUPANT RESPONSE
AND
VEHICLE ACCELERATION
IN A
30 MPH LEFT OBLIQUE IMPACT TEST

GENERAL MOTORS CORPORATION
1978 OLDSMOBILE OMEGA BROUGHAM - 2 DOOR COUPE
NHTSA 780108

FINAL REPORT

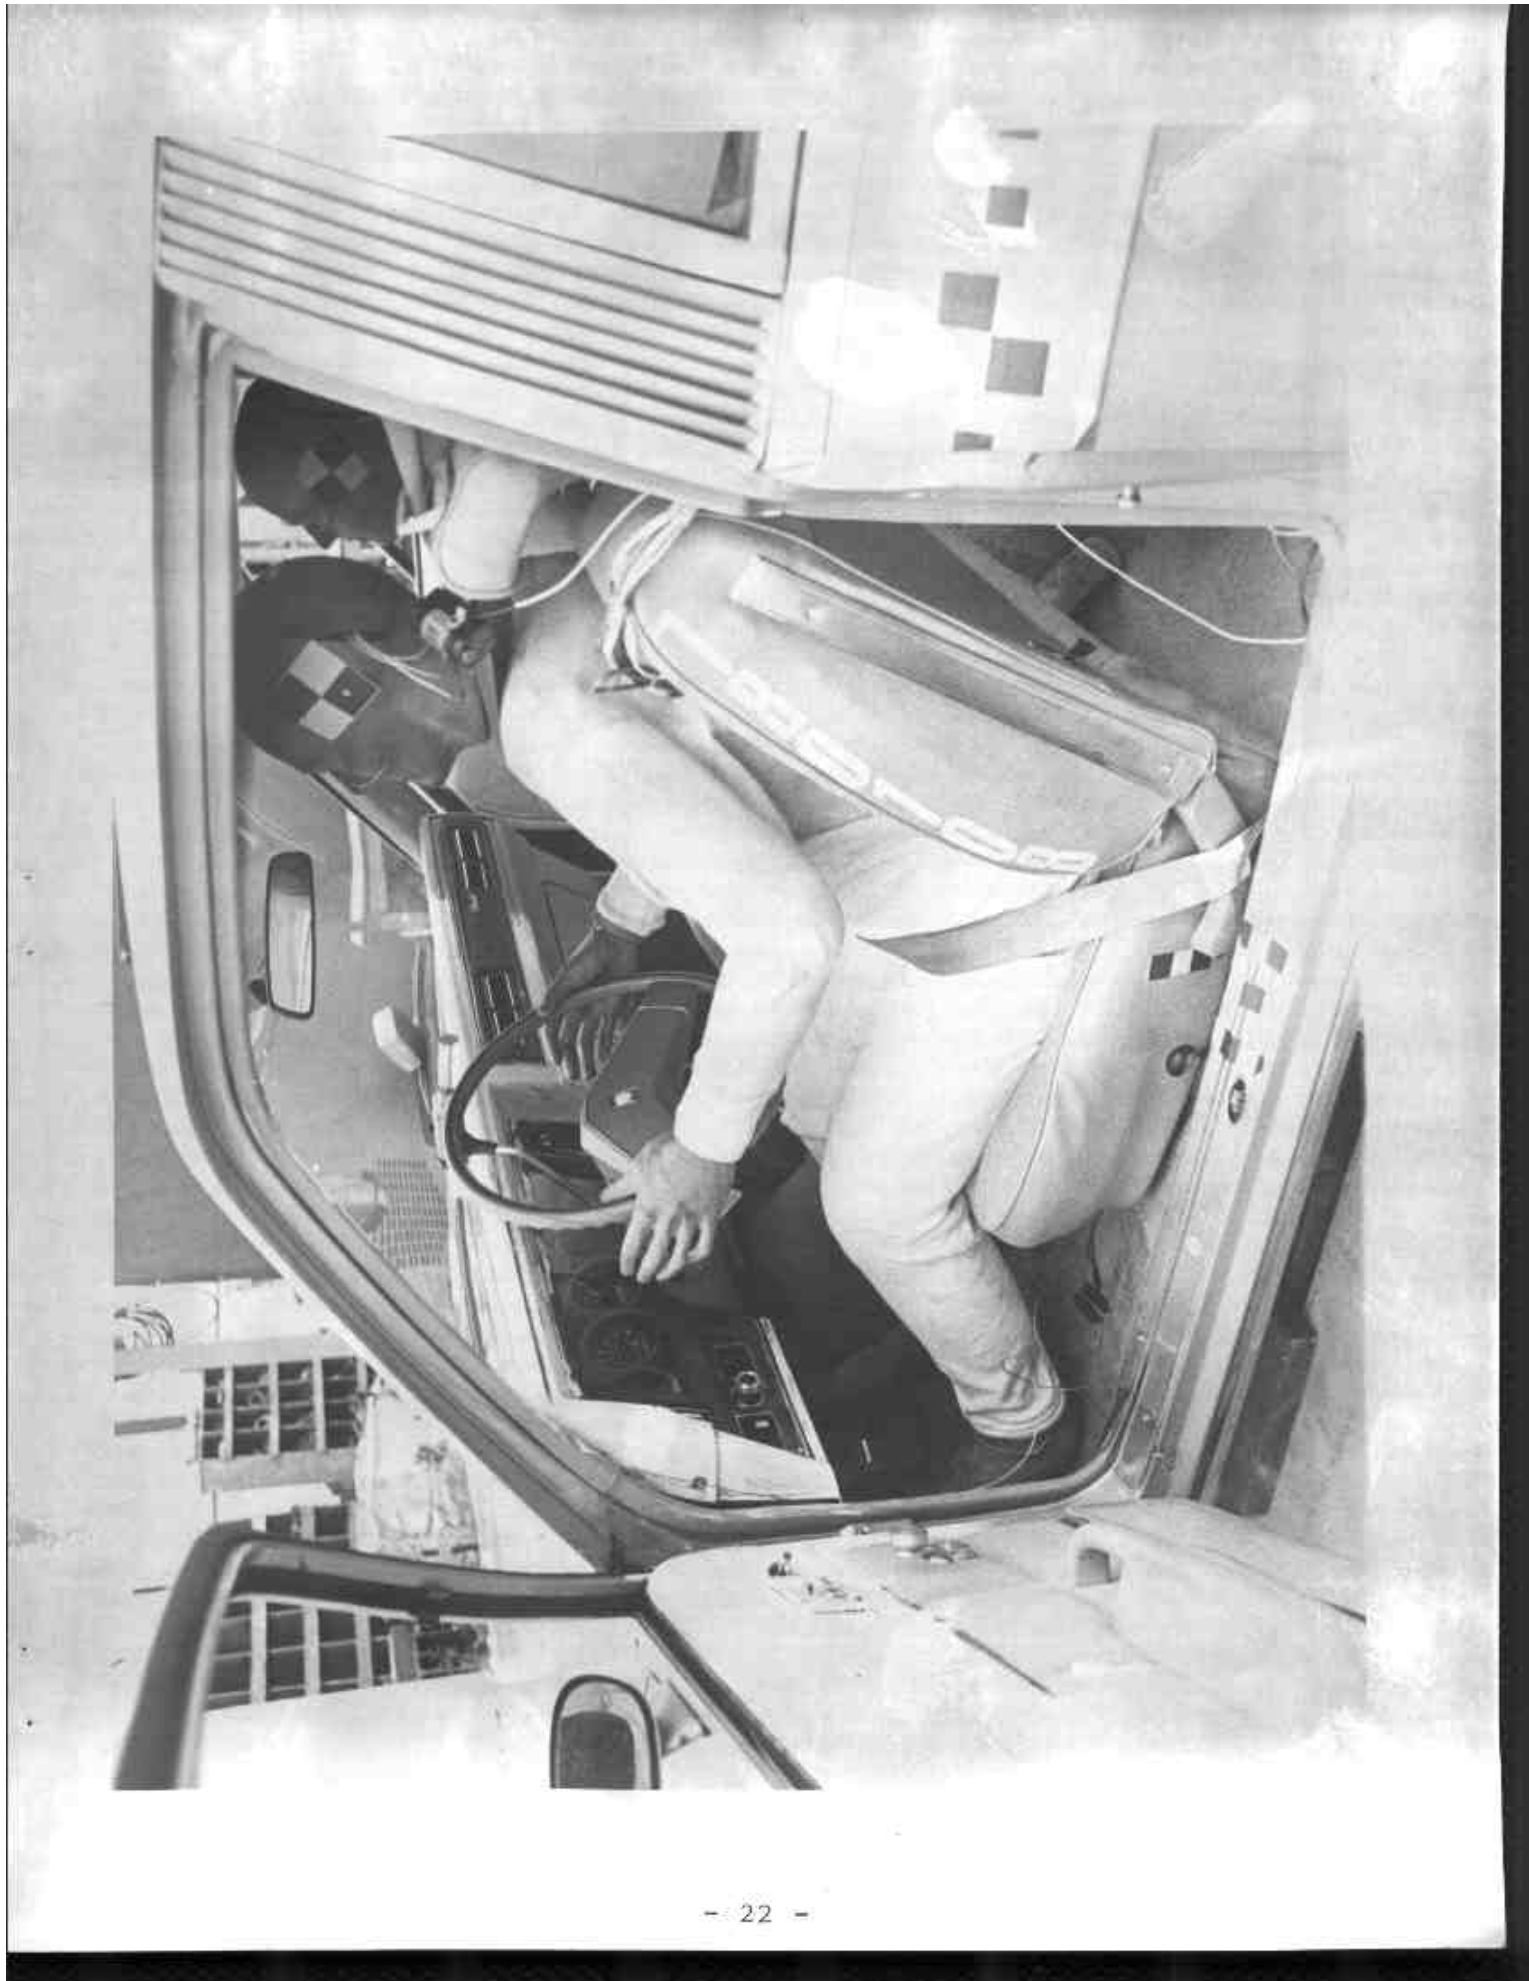
Figure 3-1

Pre-Test, Driver Dummy View

Figures 3-1 through 3-4 are pre-test and post-test views of the occupant compartment, restraint system, and dummies.

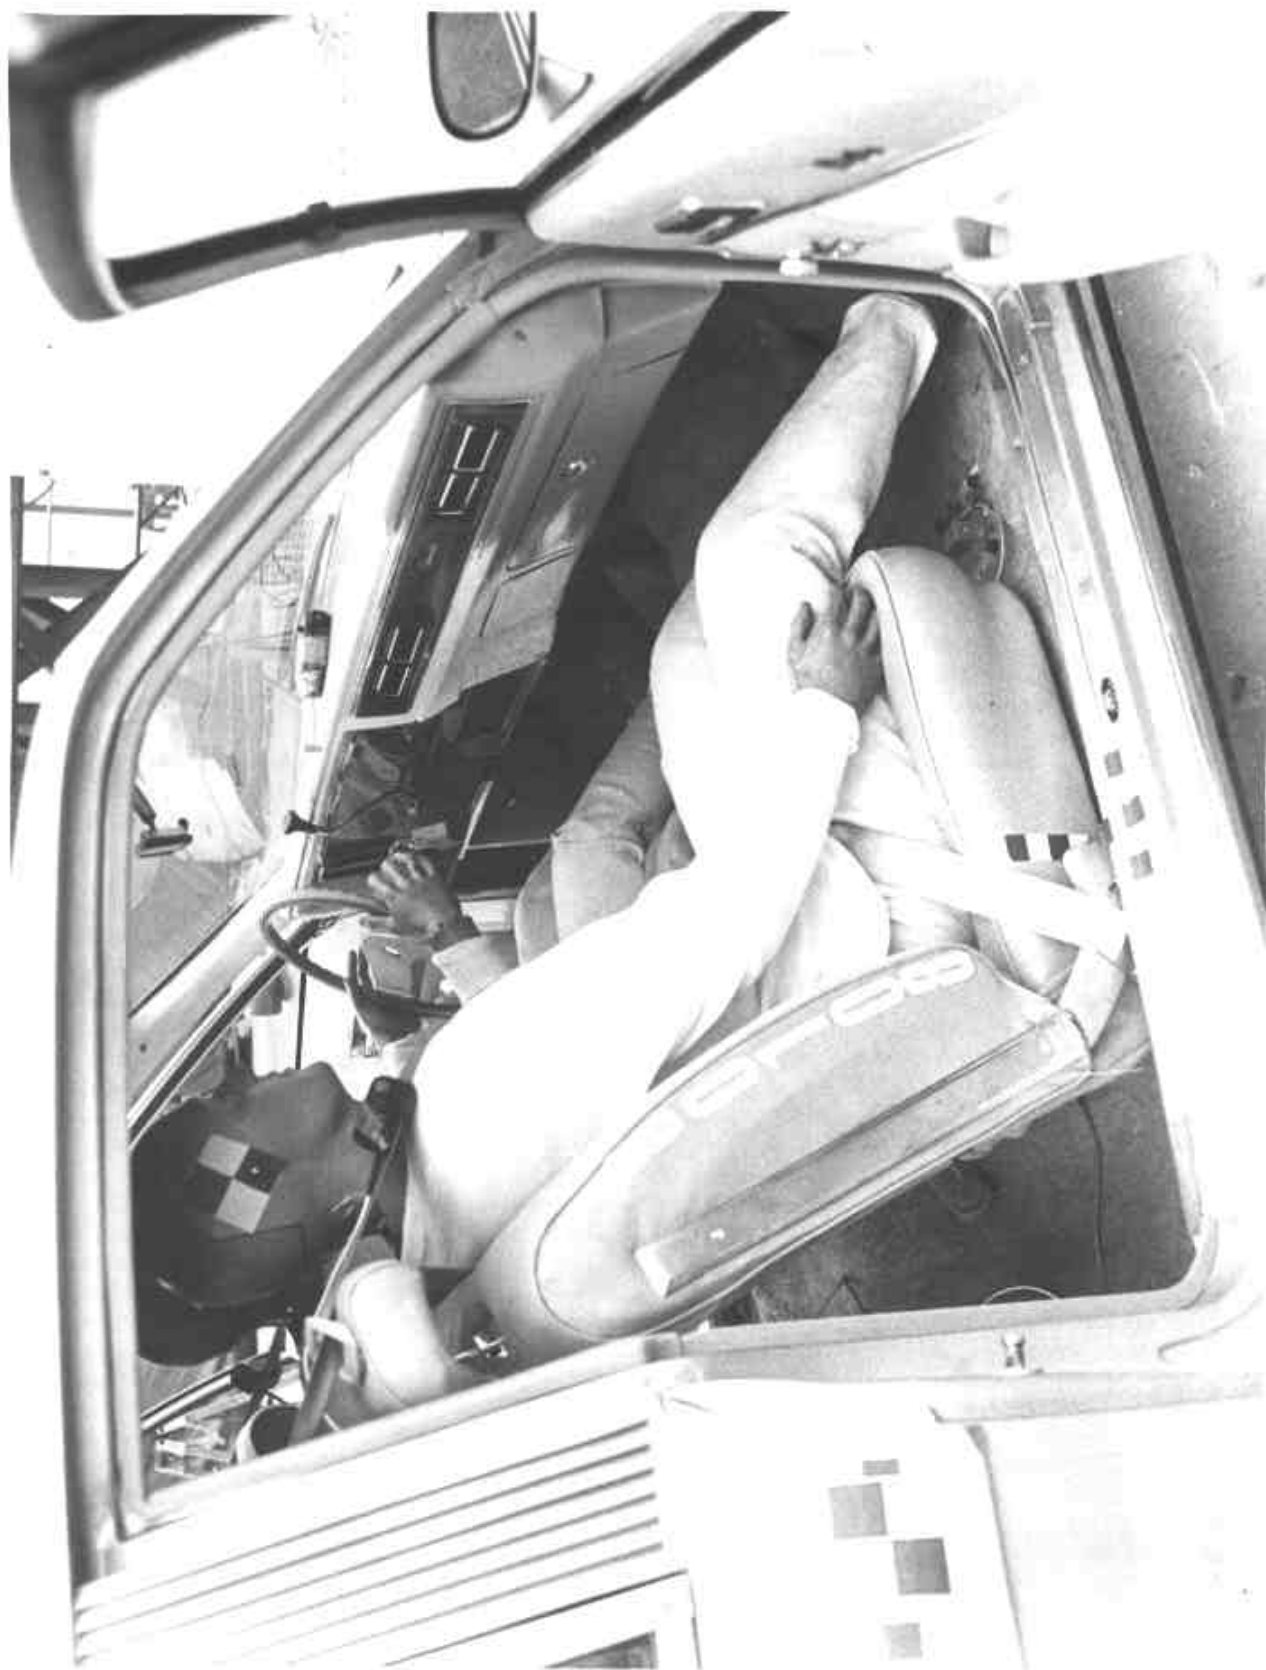
Figure 3-2
1978 Oldsmobile Omega Brougham - 2 Door Coupe
NHTSA 780108
Pre-Test, Passenger Dummy View

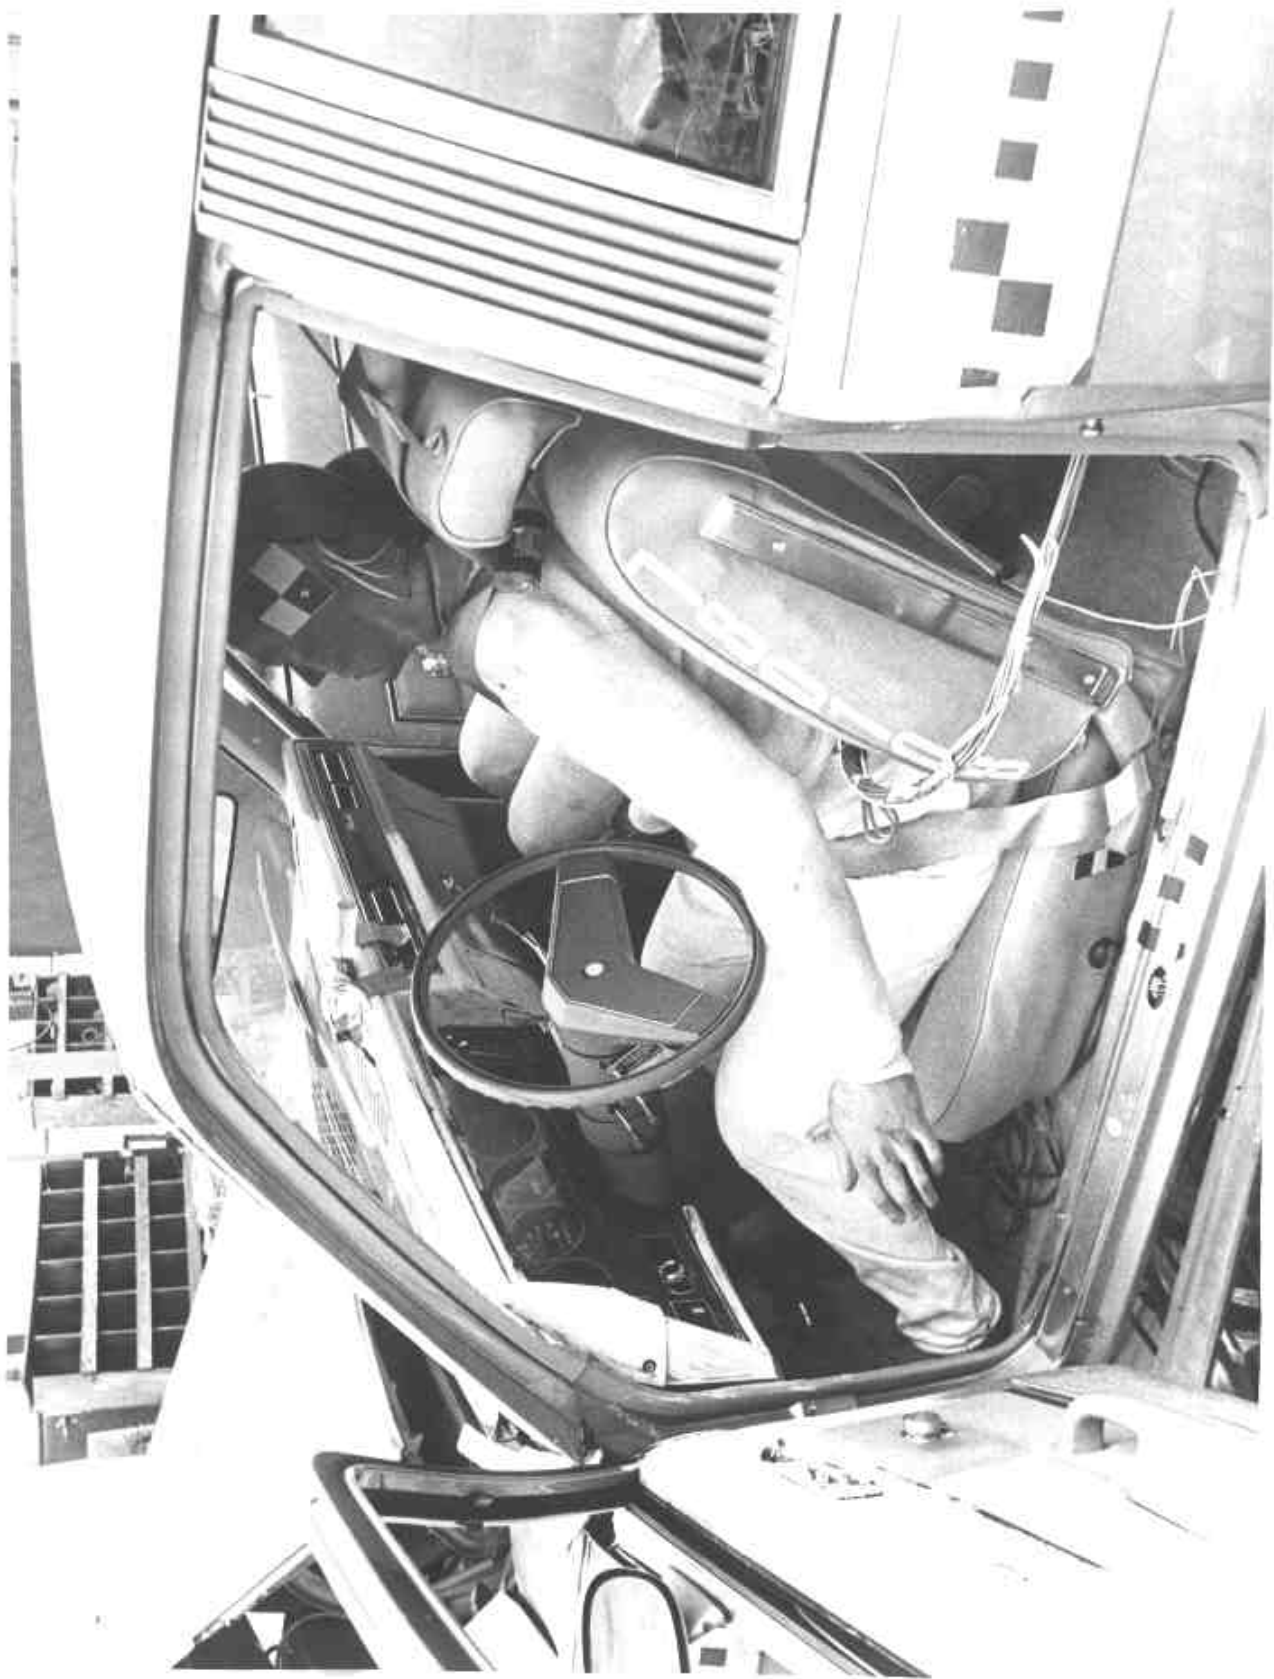
Figure 3-3

Post-Impact, Driver Dummy View

Post-impact inspection of the vehicle revealed almost all crush occurred forward of the left door. The hood buckled up in the middle and both front fenders pushed back into the doors. The windshield was cracked from cowl deformation and the left frame rail buckled in the vicinity of the "A" post. The roof buckled over the left "B" post. The driver dummy impacted the steering wheel assembly and the lower dash assembly. The passenger dummy also impacted the lower dash assembly.

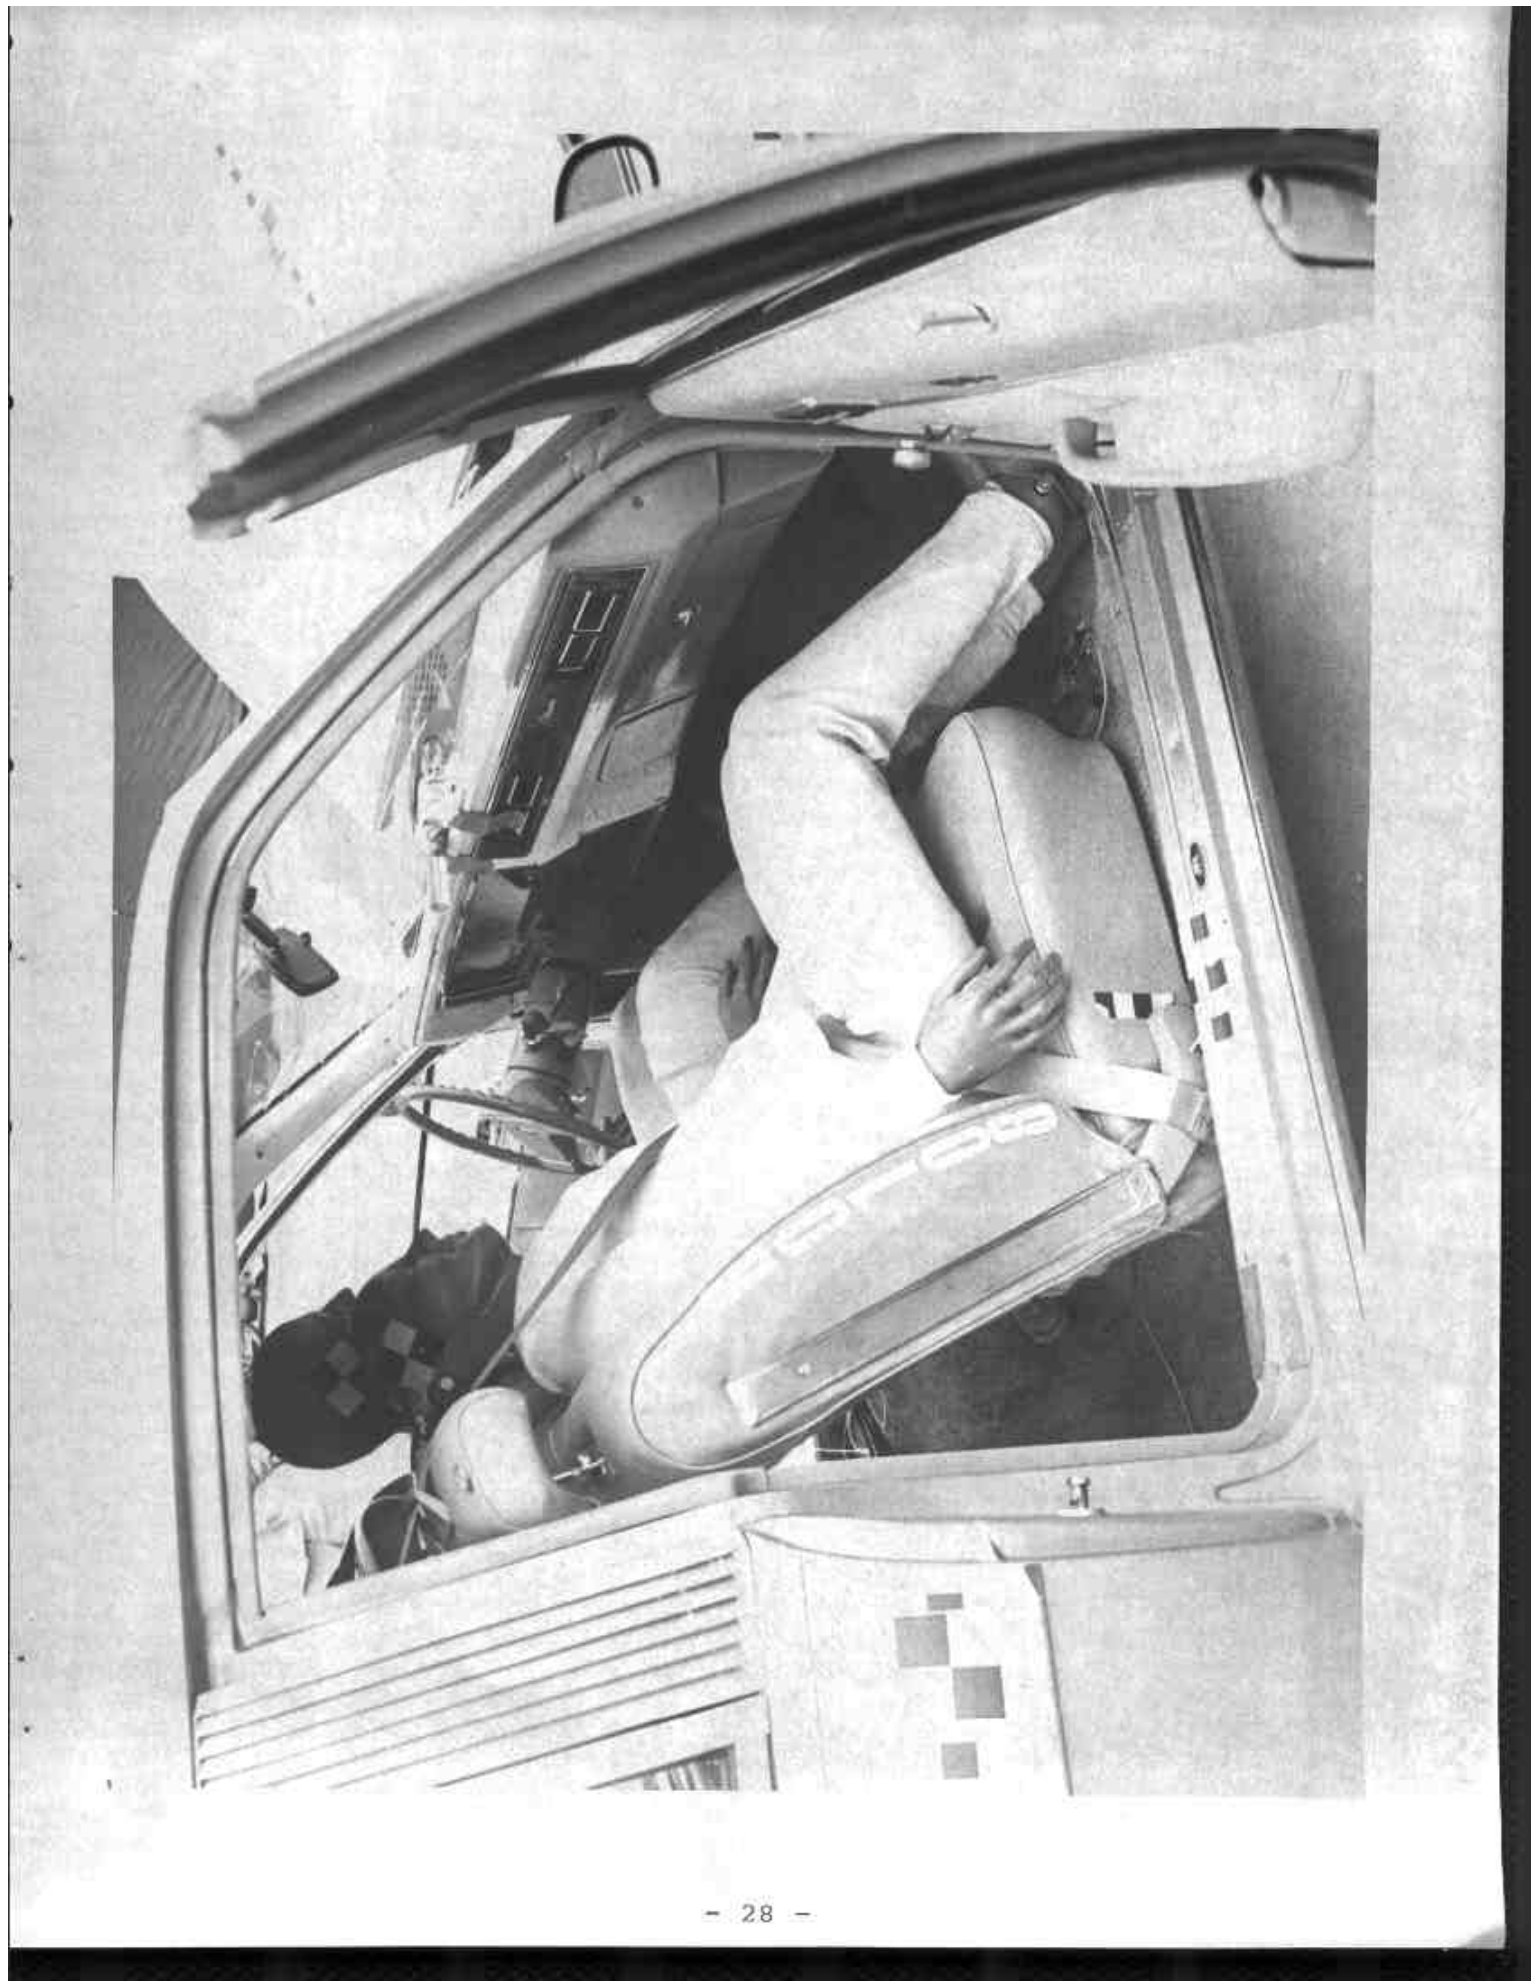
Figure 3-4

Post-Impact, Passenger Dummy View
