Dynamic Science Report No. 301-DYS-81-010

NEW VEHICLE ASSESSMENT AND  
STANDARDS ENFORCEMENT INDICANT TESTING

FMVSS 301-75

VOLKSWAGENWERK A.G., W. GERMANY  
1981 VOLKSWAGEN JETTA 4-DOOR SEDAN

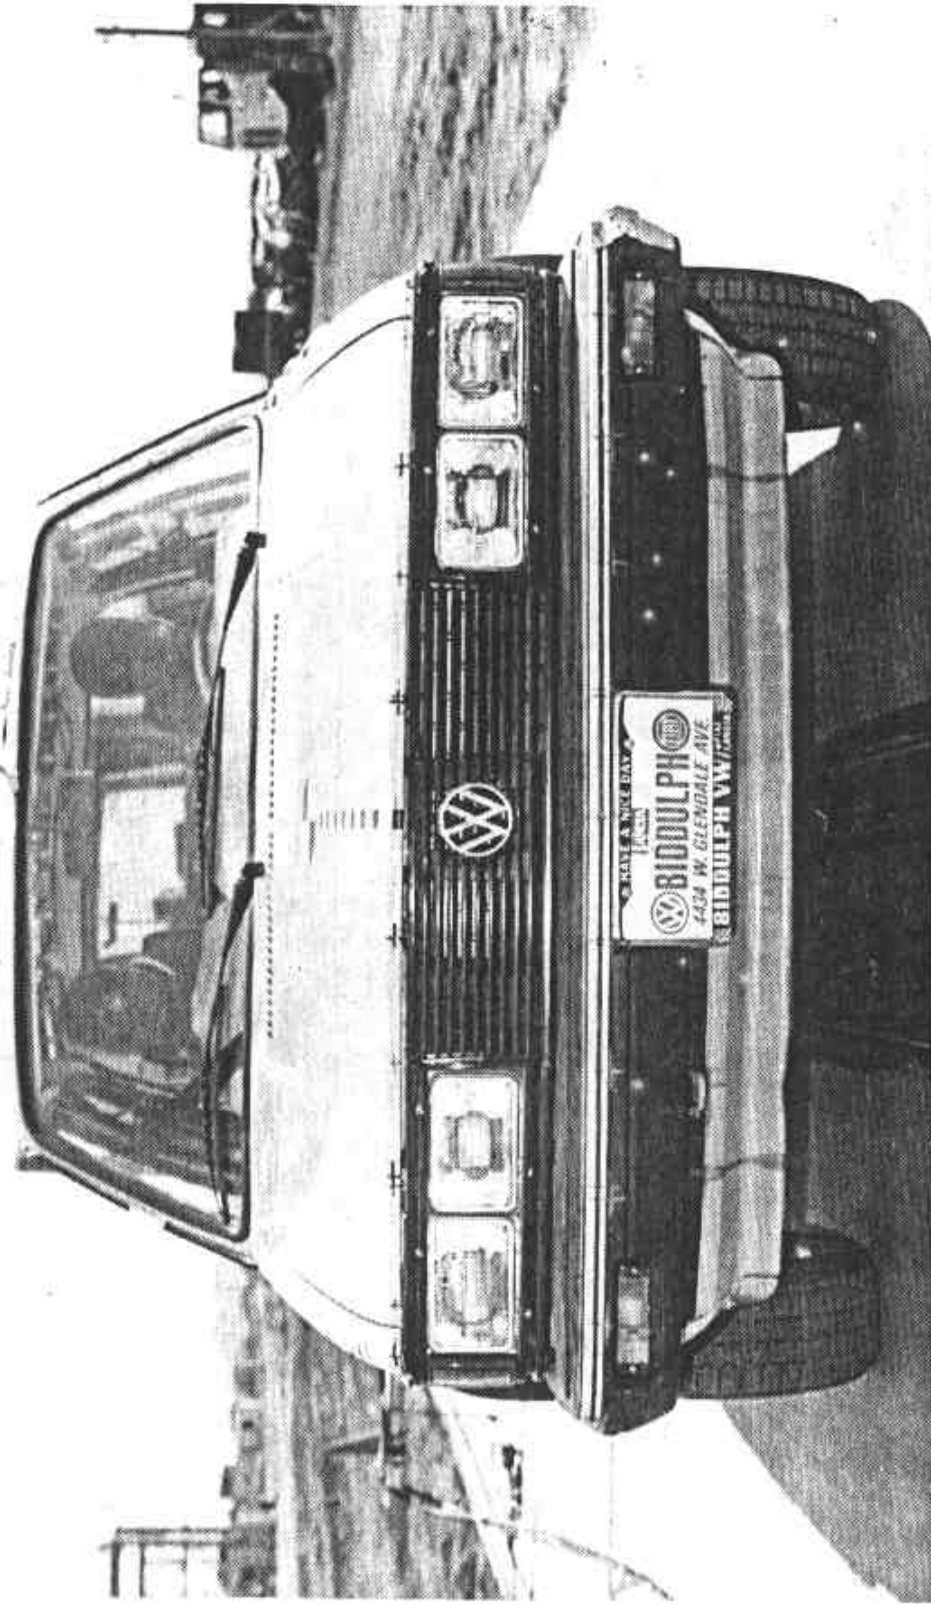
FIGURE A-1. PRE-TEST FRONT VIEW - 1981 VW JETTA - NHTSA 810521.

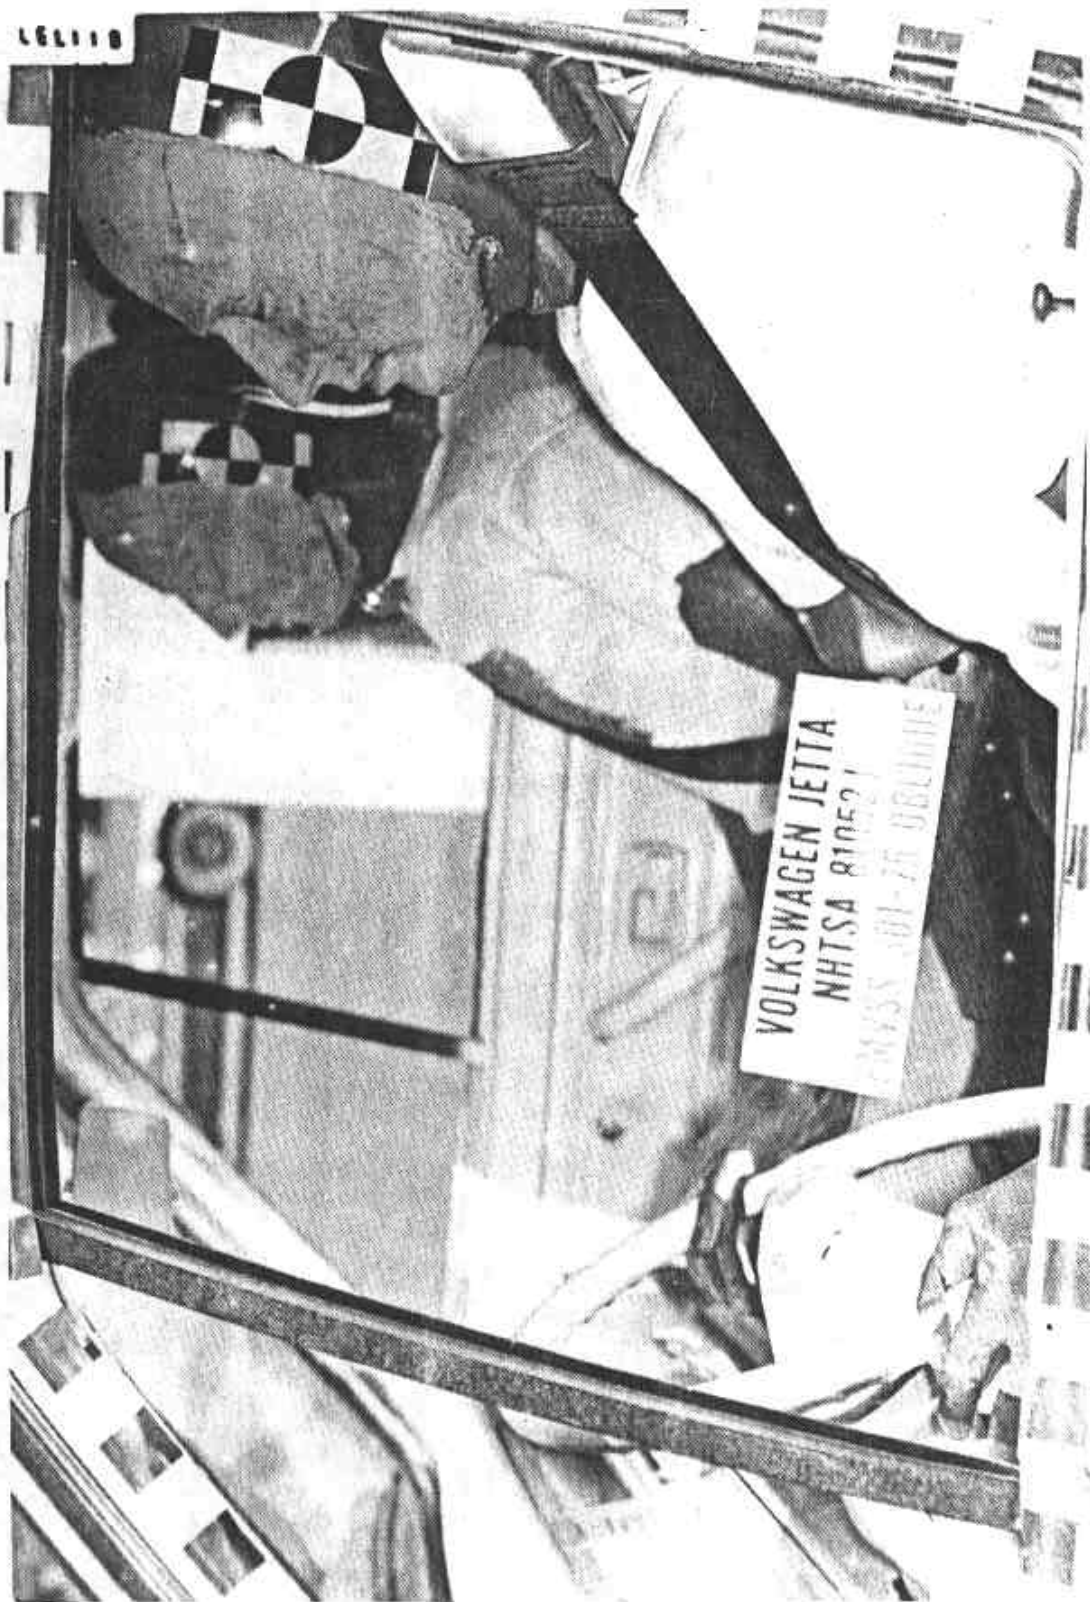
FIGURE A-8. PRE-TEST DRIVER DUMMY POSITION - 1981 VW JETTA - NHTSA 810521.

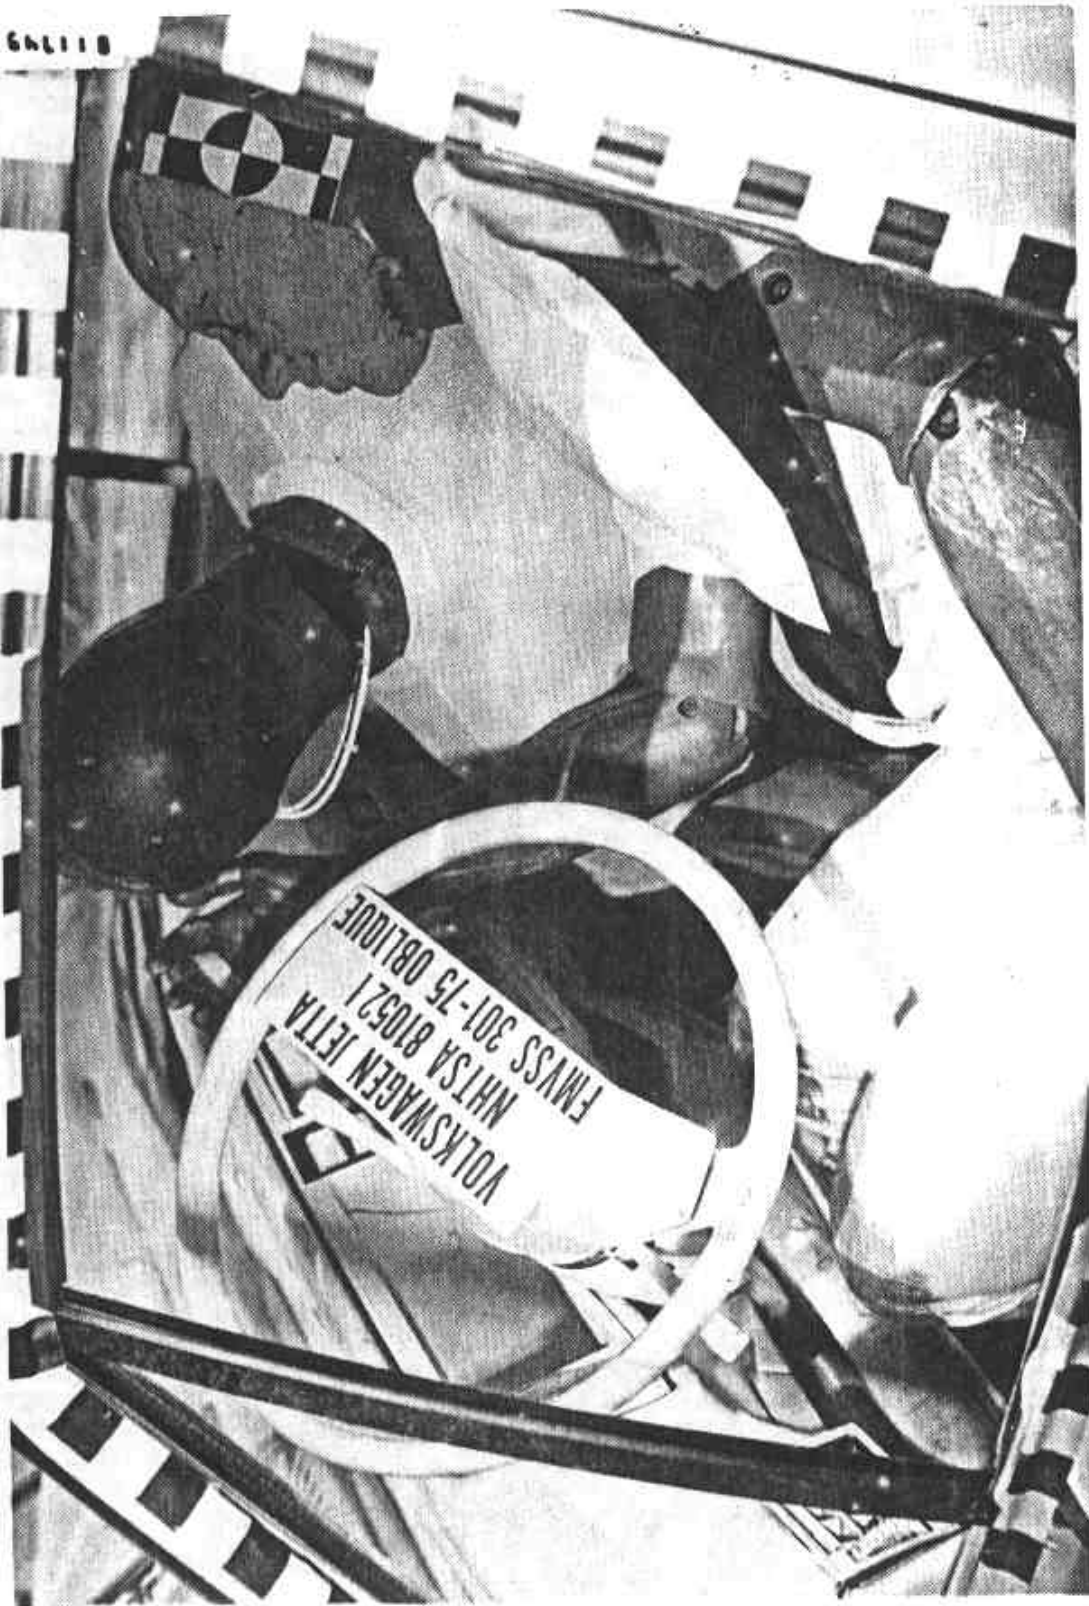
FIGURE A-9. POST-TEST DRIVER DUMMY POSITION - 1981 JETTA - NHTSA 810521.

| | <u>Driver</u> | <u>Passenger</u> |
|---|---|---|
| Head | <u>Top left side hit</u><br><u>light and side header</u><br><u>above LF door, steering wheel hub</u> | <u>Upper right corner of instrument panel cowl;</u><br><u>right A-pillar</u> |

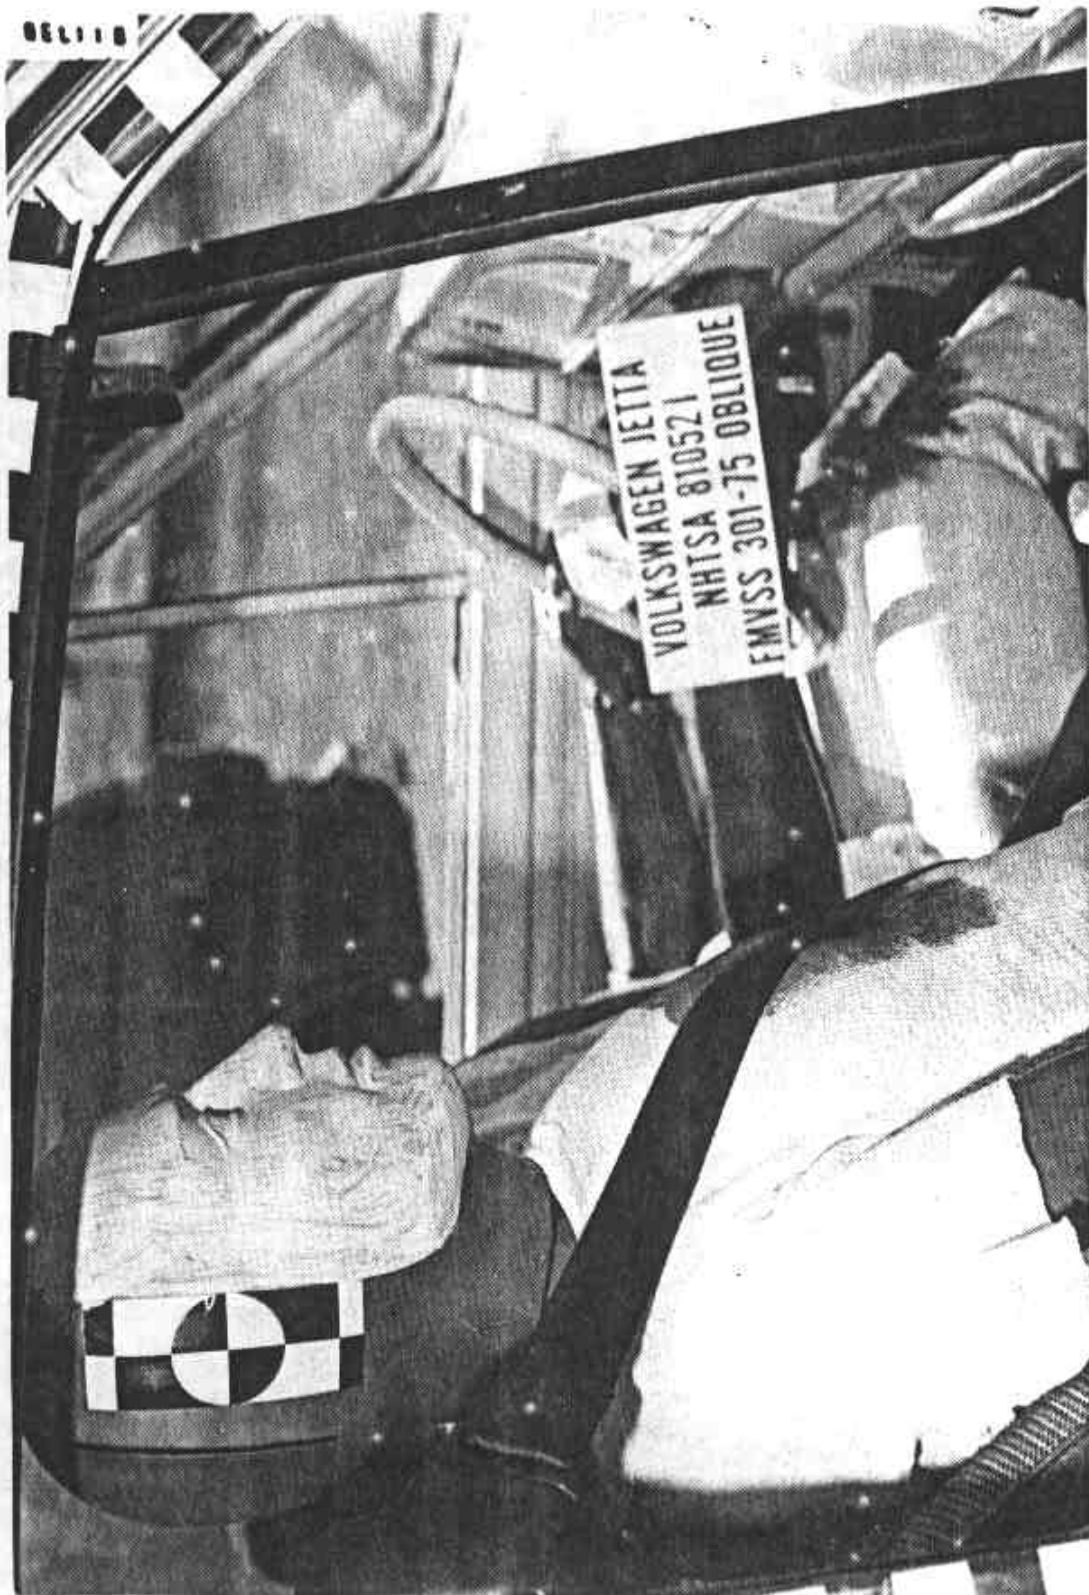
FIGURE A-10. PRE-TEST PASSENGER DUMMY POSITION - 1981 VW JETTA - NHTSA 810521.

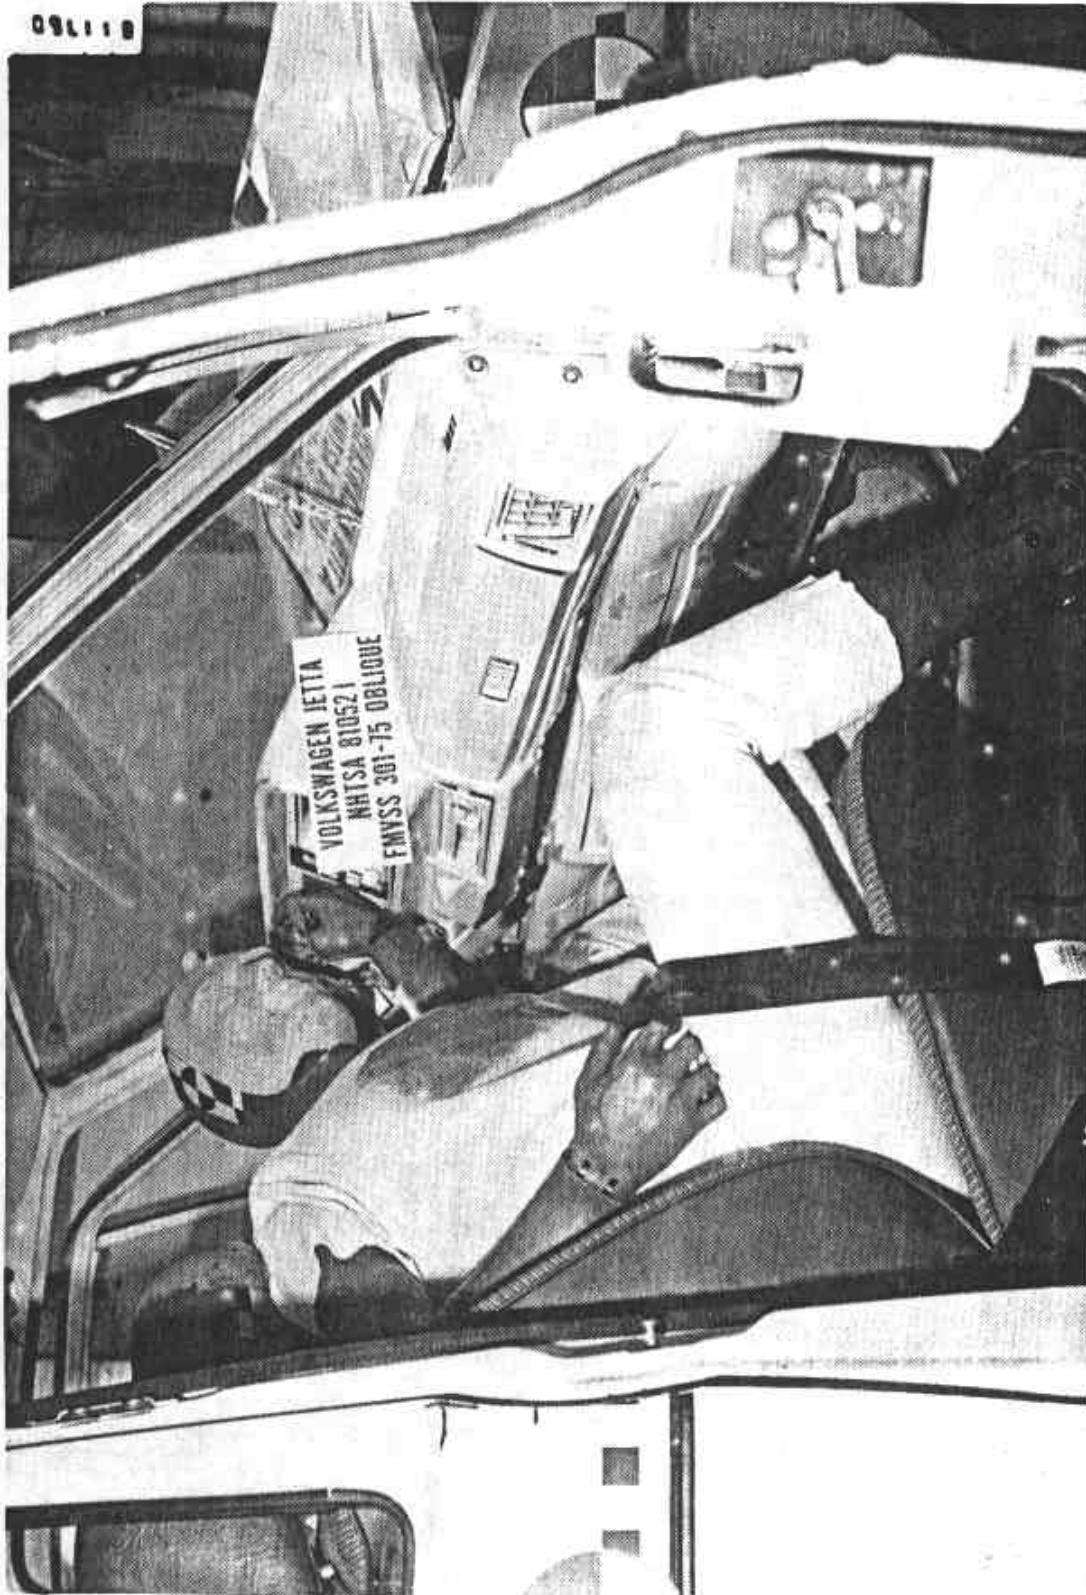
FIGURE A-11. POST-TEST PASSENGER DUMMY POSITION - 1981 VW JETTA - NHTSA 810521.

PASSENGER - After impact, dummy began to rotate forward and lean to left, and right knee loaded into dash. Left knee apparently slid under dash. Torso began clockwise rotation when right shoulder was arrested by torso belt. Top left of head struck upper right corner of instrument panel cowl. Head rebounded off dash and dummy rotated clockwise till nearly sideways in seat and leaning rearward. As car pitched up on rear wheels, dummy was thrown forward (relative to car) and head contacted right A pillar. When car fell back down, dummy was thrown back toward driver side and toward front of car. Dummy settled into seat and back toward rear of car, coming to rest with a clockwise rotation and rearward lean, resting against the driver dummy.
