## **EVALUATION OF AGGRESSIVENESS TEST TECHNIQUES**

CALSPAN REPORT NO. 6706-V-1

| TYPE OF TEST: | SYMMETRIC FRONTAL CAR-TO-BARRIER IMPACT<br>1980 Oldsmobile Cutlass Surpeme<br>DEFORMABLE MOVING BARRIER |

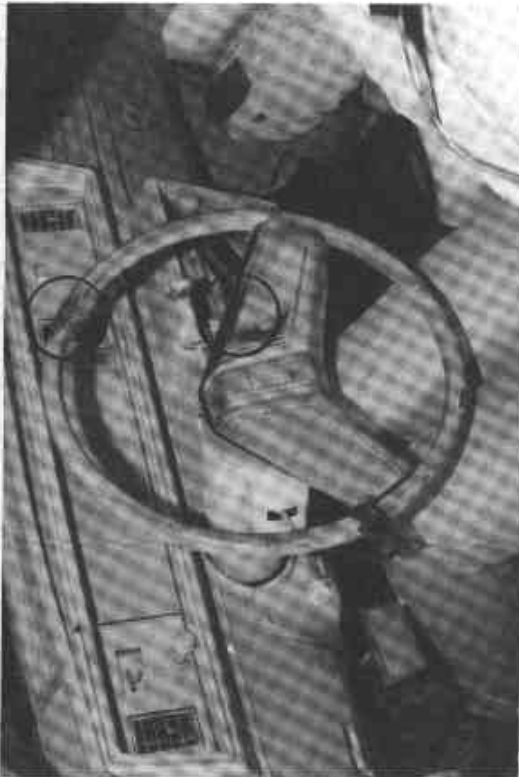
FIGURE A-14 VEHICLE NO. 1 - VIEW OF DRIVER  
HEAD CONTACT WITH STEERING WHEEL

The driver ATD head contacted the upper rim and the hub of the steering wheel (Figure A-14) and this ATD failed to comply with FMVSS 208 - Head Injury Criteria. The right-front passenger complied with all FMVSS 208 - Injury Criteria. Occupant results are summarized in Table 10 and the data traces, along with vehicle data traces, are presented in Appendix B.

- Both front doors were operable after impact
- Windshield has stress cracks (Figure A-14)
- Roof buckled at "B" pillar
- No fuel leakage
- No loss of windshield retention
