June 1981  
Test Report

## Heavy Truck Pilot Crash Test

### Frontal Impact

Roy S. Rice  
Norris E. Shoemaker

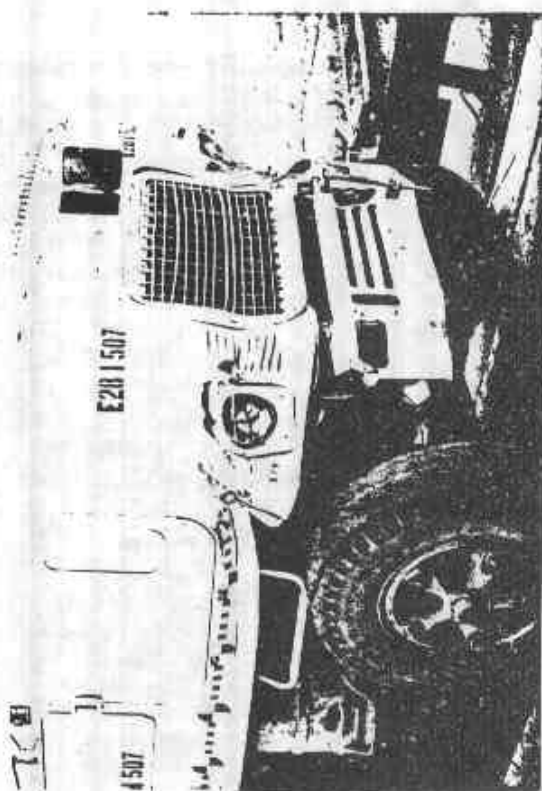
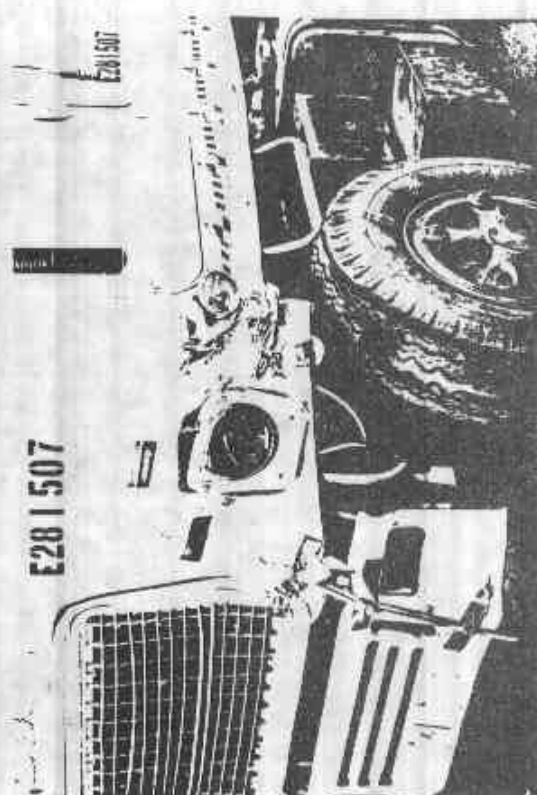
FIGURE A-6 POST-TEST VIEWS OF VEHICLE FRONT DAMAGE

Vehicle damage was limited to minor sheet metal distortion at the front end of the tractor. This was because the deceleration loads were taken out through the vehicle's two longitudinal frame rails, the ends of which are located at the front-most position of the vehicle. These frame rails are the main load-bearing members of the vehicle's structure. The vehicle's front bumper attaches directly to the ends of the frame rails. There was no deformation or buckling of these frame rails. The unbelted driver seat occupant contacted the steering wheel at both head and chest areas but contact forces were low due to the low deceleration loads experienced during the test. The restrained co-driver seat occupant did not make contact with any internal surface. After the crash, the vehicle was driveable under its own power following removal of a minor interference between the clutch pedal arm and the distorted sheet metal.
