NEW VEHICLE ASSESSMENT  
AND  
STANDARDS ENFORCEMENT INDICANT TESTING

FMVSS NOS. 212, 219, AND 301-75

FORD MOTOR COMPANY OF CANADA LTD.  
1982 FORD EXP - 3 DOOR SPORTY COUPE  
NHTSA 820201

FINAL REPORT

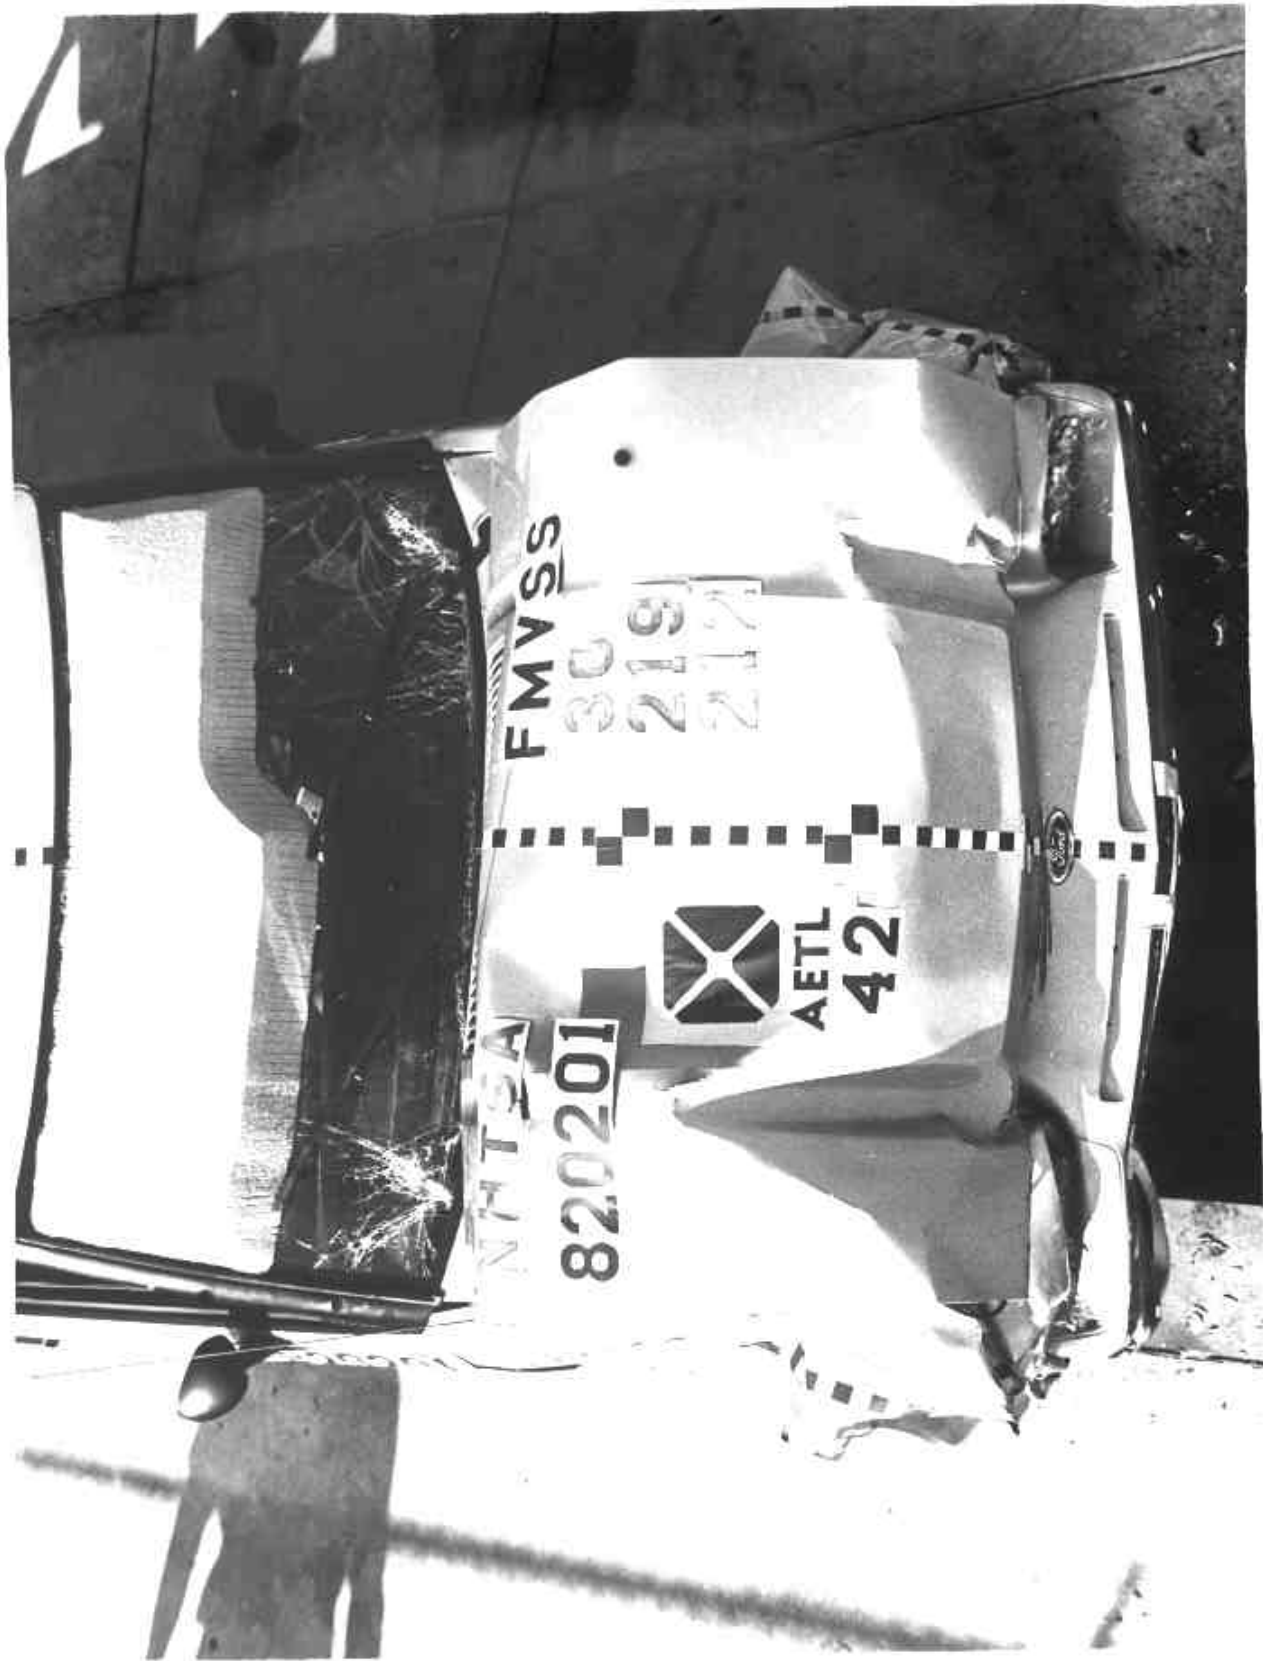
Figure 3-6  
1982 Ford EXP - 3 Door Sporty Coupe  
NHTSA 820201  
Post-Impact, Windshield View

The windshield assembly revealed no apparent retention loss during the impact event. The windshield had numerous cracks developed by the apparent cowl/body deformation. A black trim moulding encompasses the windshield glass, retained in the body opening with body clips. Apparent adhesive is used between the body opening and the windshield glass.

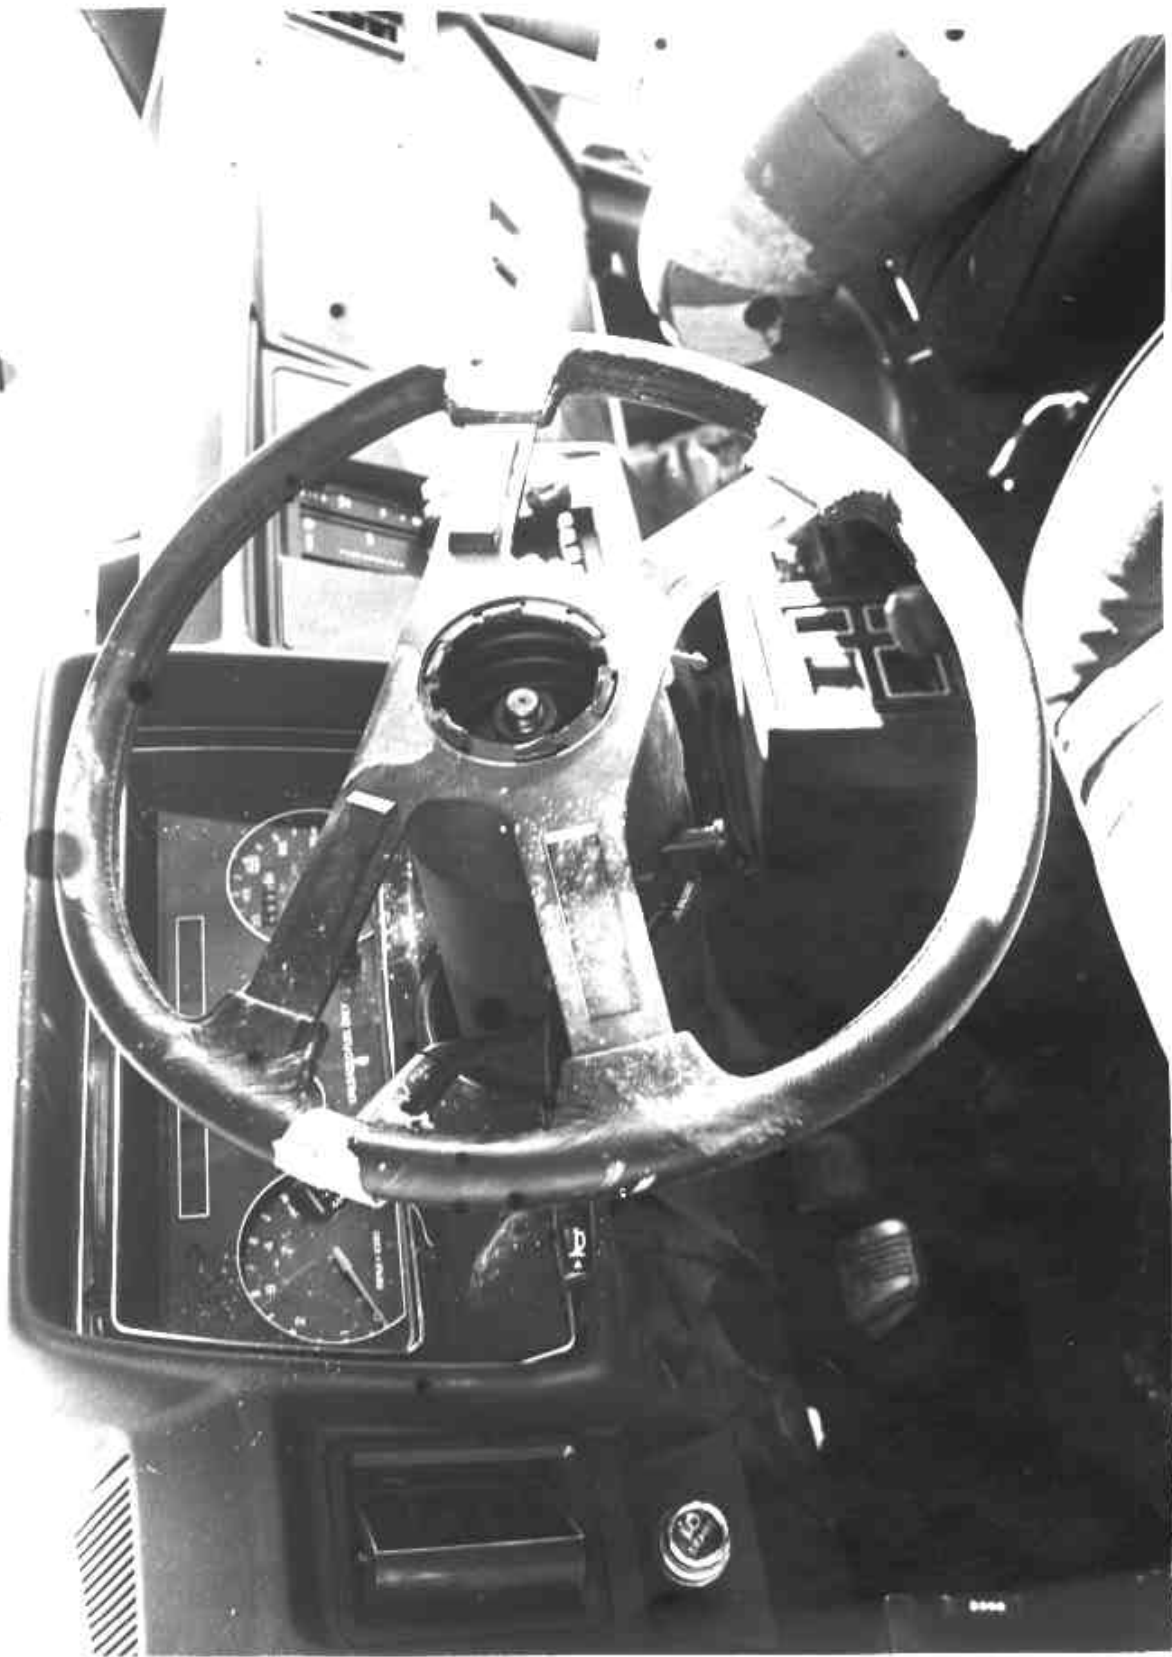
Post-Impact, Driver Dummy Contact Area

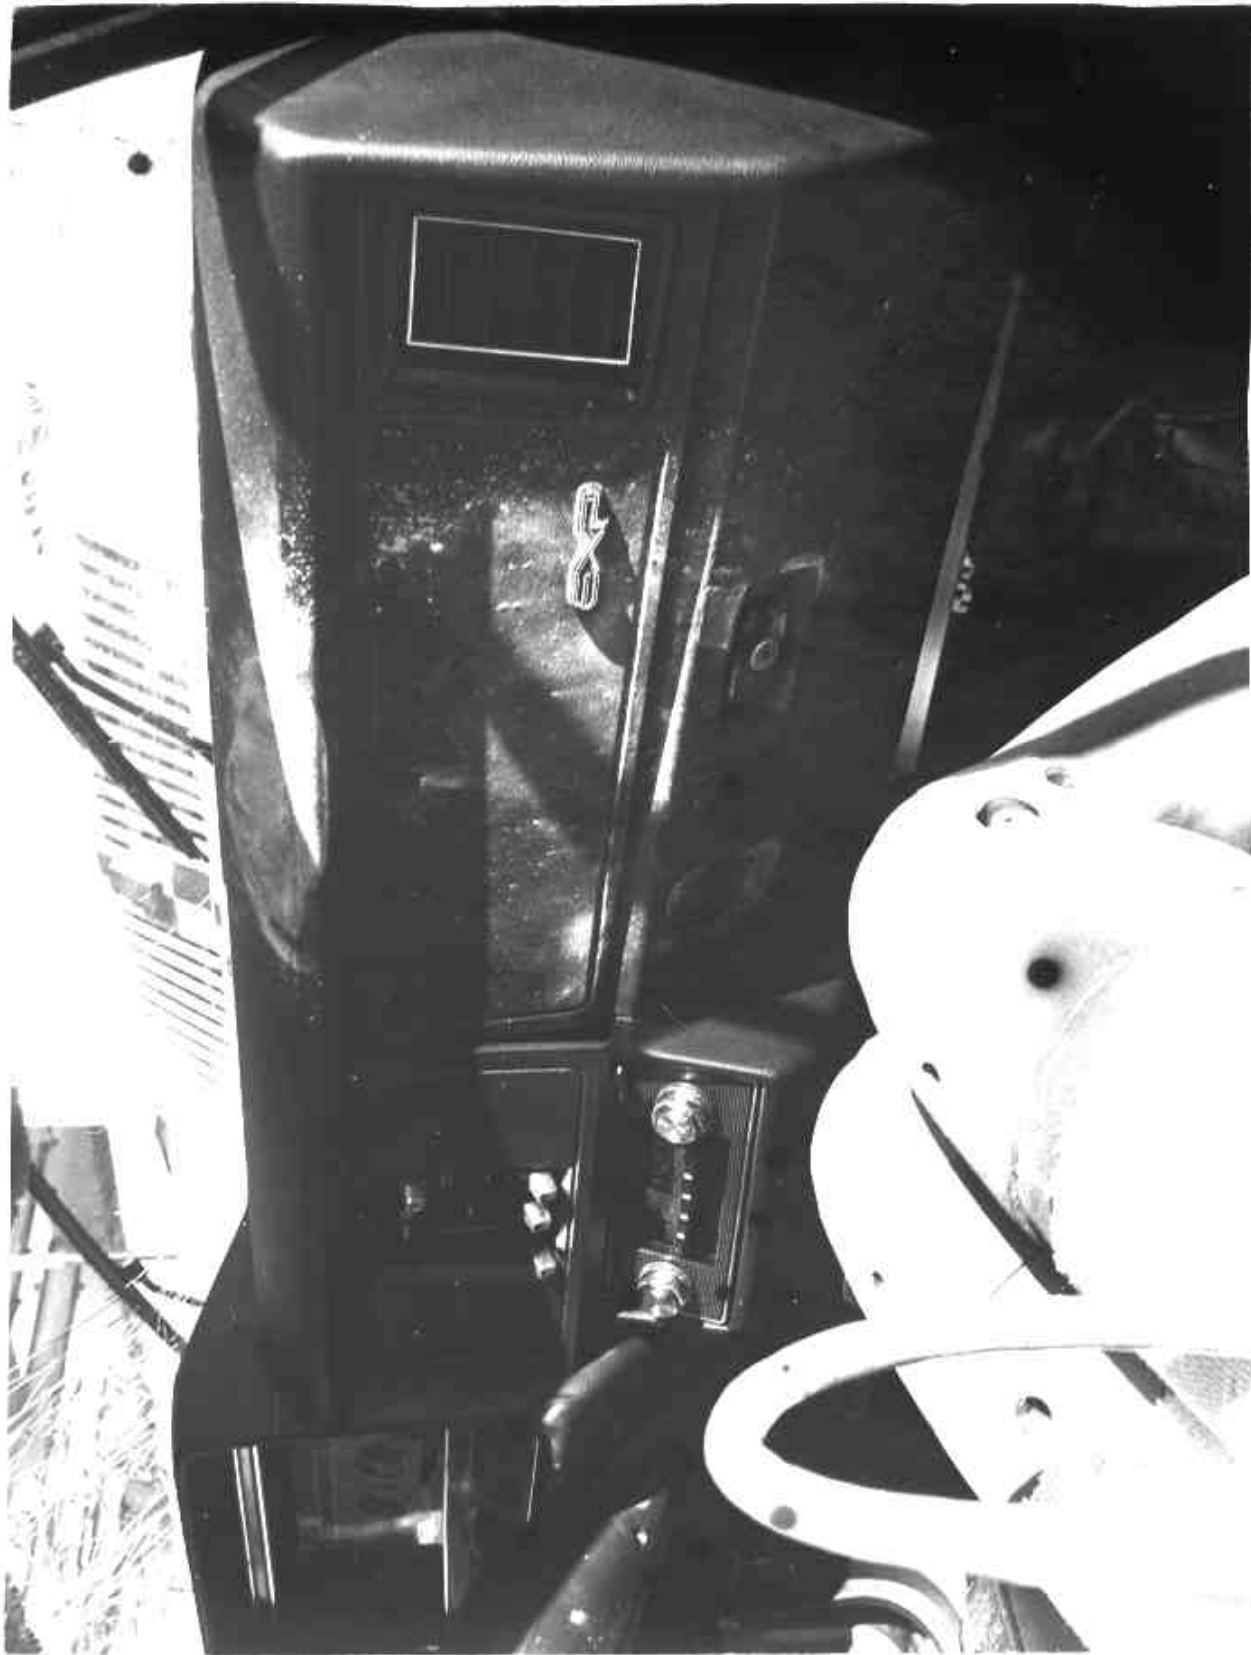
Post-Impact, Passenger Dummy Contact Area
