REPORT NO. 6851-V-3

NEW CAR ASSESSMENT AND STANDARDS
ENFORCEMENT INDICANT TESTING
FMVSS NOS. 212, 219 and 301-75

AMERICAN MOTOR CORPORATION
1981 SPIRIT 2-DOOR LIFTBACK

NHTSA 703-2-523

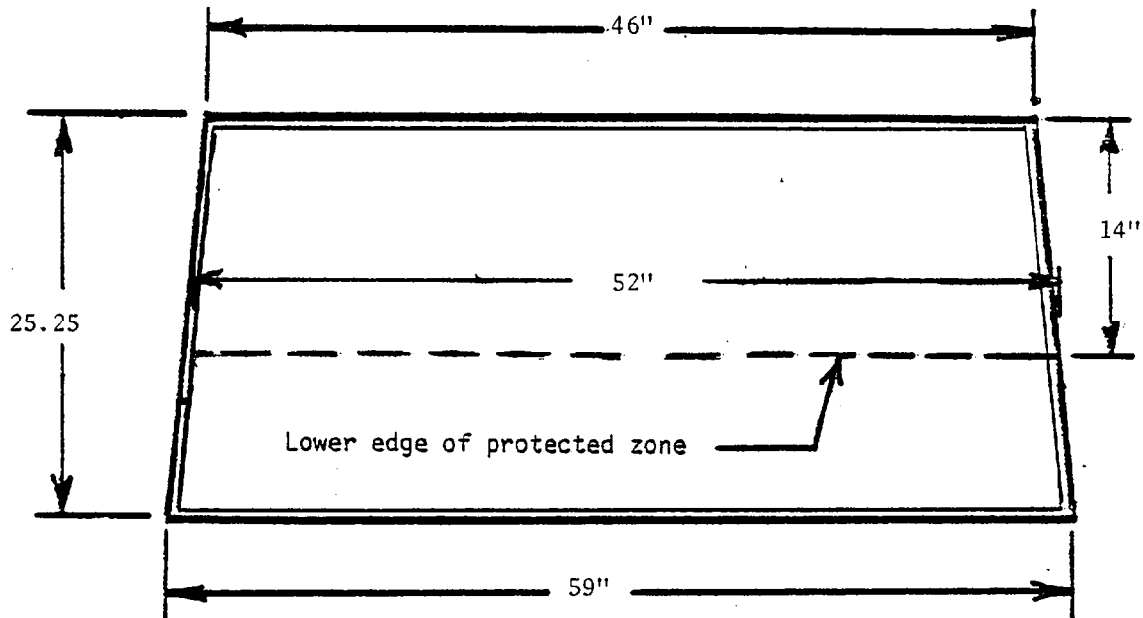
Figure 3-1 WINDSHIELD ZONE INTRUSION, FMVSS 219 - DATA SHEET

With the zero coordinate for the X-Y grid located at the lower right corner (passenger side) of the windshield, record the following positions:

- (1) The area that the "Protected Zone" template was penetrated more than .25 inches by a vehicle component other than one which is normally in contact with the windshield.

NONE

- (2) The area beneath the "Protected Zone" that the inner surface of the windshield was penetrated by a vehicle component.

- (3) Record any windshield retention clips or brackets used to insure that the windshield would not disengage from the body.

The windshield was severely cracked after impact, but very little windshield retention loss occurred. There was no windshield zone intrusion.

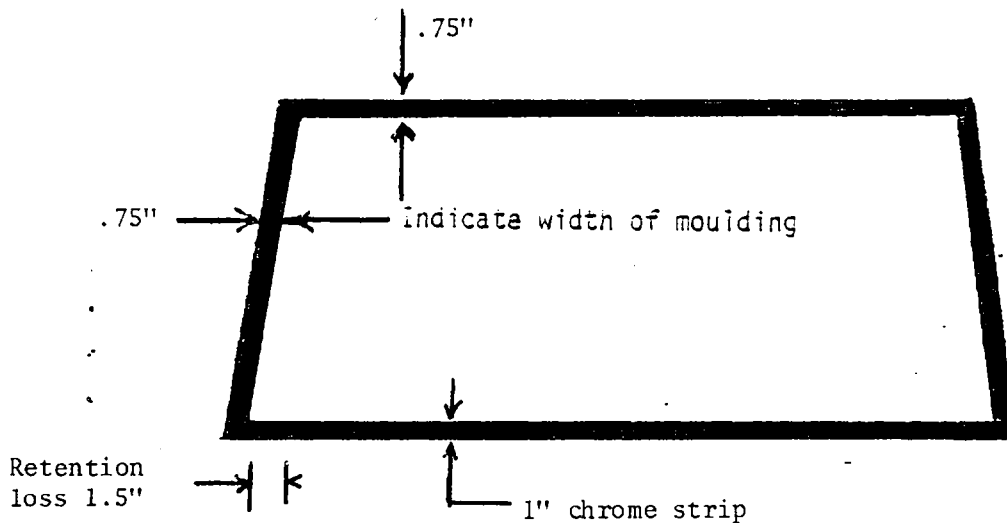
Figure 3-3 SUMMARY OF FMVSS 212 DATA

Windshield is bonded in place and has a .75 inch chrome strip along the top and sides, and a 1 inch chrome strip on the bottom.

Windshield Periphery		Retention %
	Pre-Test	Post-Test	
Right Side	77.75	77.75	100%
Left Side	77.75	76.25	98%
TOTAL	155.5	154.0	99%

The standard requires that Post-Test be a minimum of 75 percent of the Pre-Test total periphery measurement for vehicle not equipped with occupant passive restraints and 50 percent for each side of the windshield for vehicles which are equipped with occupant passive restraints.

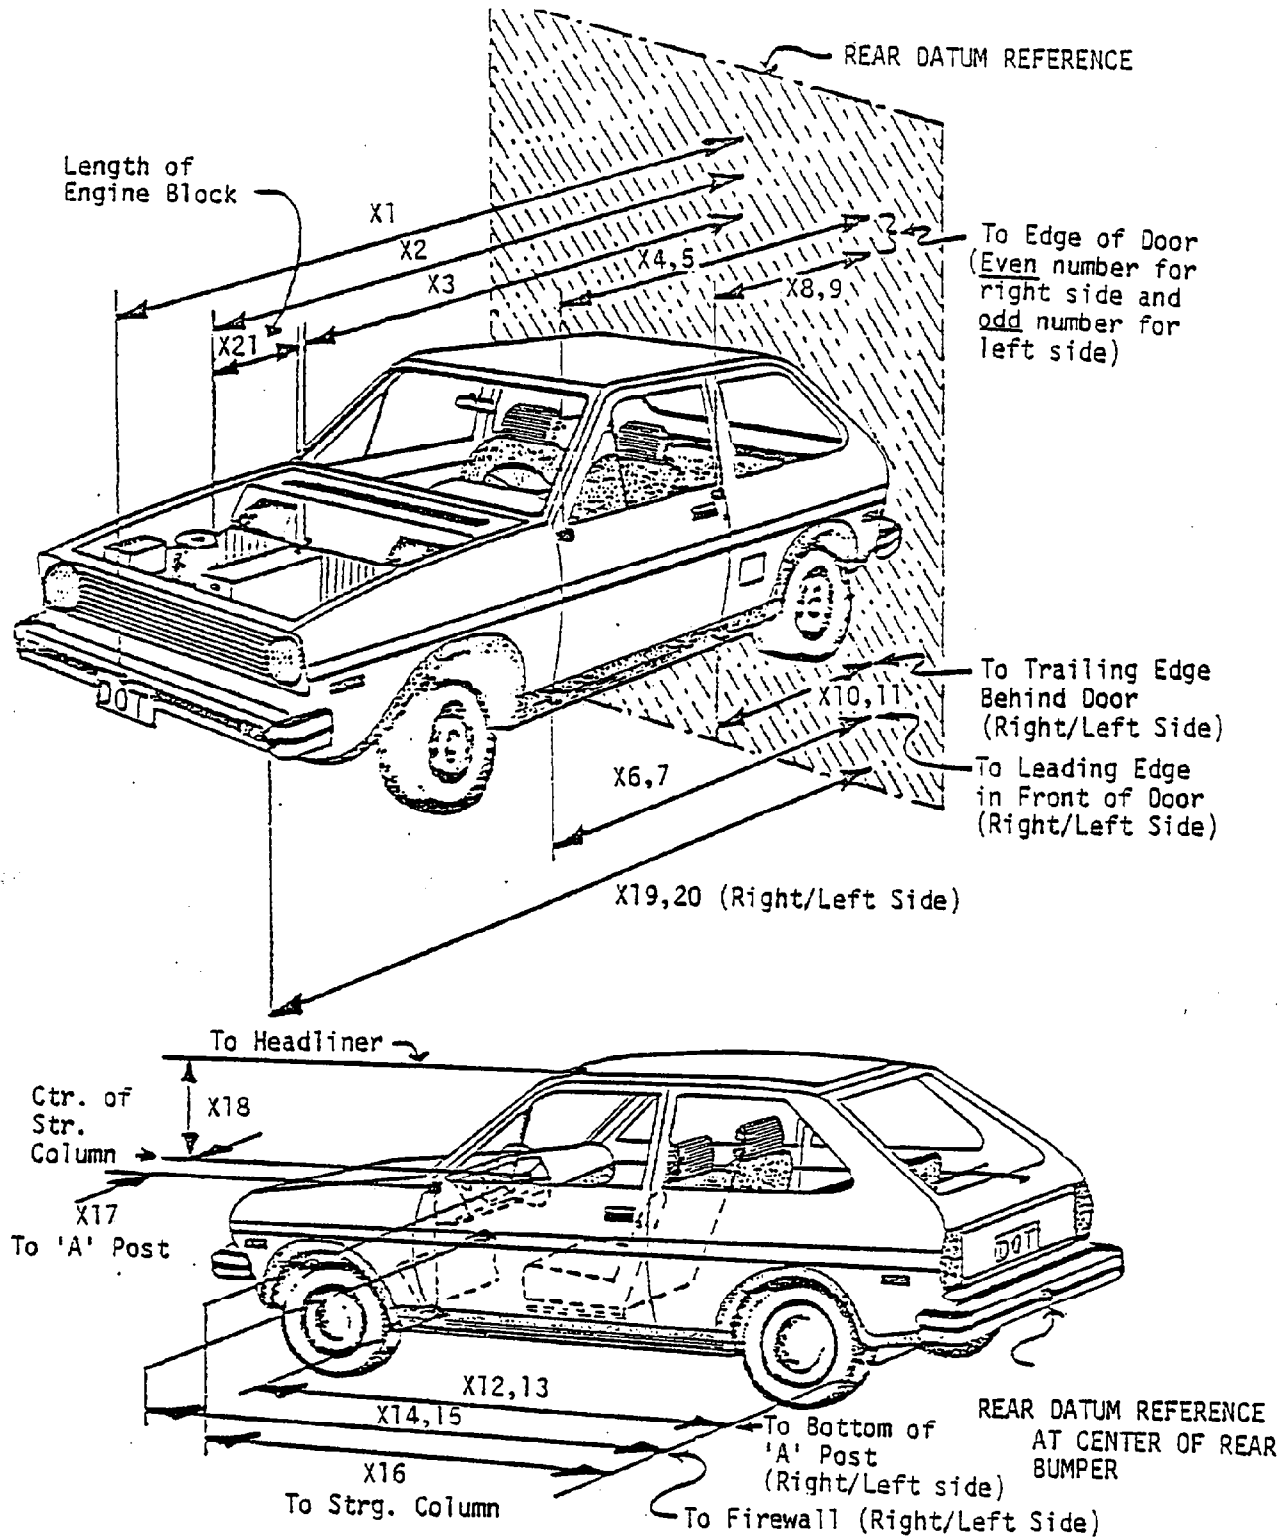
Figure 4-1 PRE-TEST AND POST-TEST MEASUREMENT POINTS

All Dimensions in Inches		
No.		Pre-Test	Post-Test	Difference
X1	Total Length of Vehicle at Centerline	167.6	145.0	22.6
X2	Rear Surface of Vehicle to Front of Engine	141.2	136.3	4.9
X3	Rear Surface of Vehicle to Firewall	118.3	114.7	3.6
X4	Rear Surface of Vehicle to Upper Leading Edge of Right Door	111.2	110.8	.4
X5	Rear Surface of Vehicle to Upper Leading Edge of Left Door	111.1	110.5	.6
X6	Rear Surface of Vehicle to Lower Leading Edge of Right Door	110.5	110.0	.5
X7	Rear Surface of Vehicle to Lower Leading Edge of Left Door	110.4	109.8	.6
X8	Rear Surface of Vehicle to Upper Trailing Edge of Right Door	60.4	60.2	.2
X9	Rear Surface of Vehicle to Upper Trailing Edge of Left Door	60.3	60.0	.3
X10	Rear Surface of Vehicle to Lower Trailing Edge of Right Door	60.5	60.1	.4
X11	Rear Surface of Vehicle to Lower Trailing Edge of Left Door	60.5	60.0	.5
X12	Rear Surface of Vehicle to Bottom of "A" Post of Right Side	107.9	107.5	.4

X13	Rear Surface of Vehicle to Bottom of "A" Post of Left Side	107.9	107.4	.5
X14	Rear Surface of Vehicle to Firewall, Right Side	118.3	114.4	3.9
X15	Rear Surface of Vehicle to Firewall, Left Side	118.3	114.2	4.1
X16	Rear Surface of Vehicle to Steering Column	91.0	89.4	1.6
X17	Center of Steering Column to "A" Post	15.0	14.2	.8
X18	Center of Steering Column to Headliner	16.4	18.1	-1.7
X19	Rear Surface of Vehicle to Right Side of Front Bumper	166.0	143.5	22.5
X20	Rear Surface of Vehicle to Left Side of Front Bumper	166.0	143.7	22.3
X21	Length of Engine Block	22.0	22.0	0.0

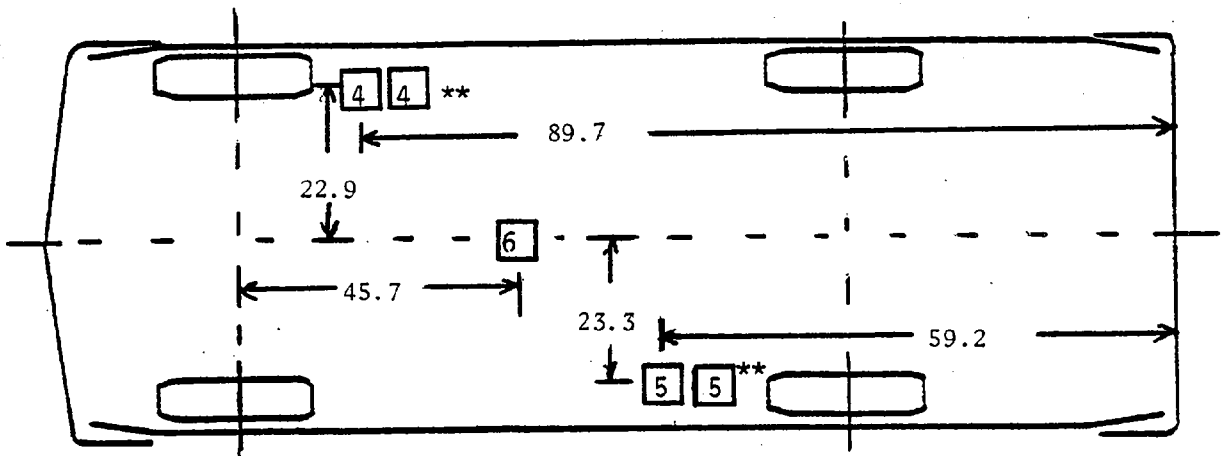
FIGURE 4-2 VEHICLE ACCELEROMETER LOCATIONS

ACCELEROMETER NUMBER *		ACCELEROMETER LOCATION	DIRECTION		
			X	Y	Z
4		Front Seat Crossmember	X		X
4	**	Redundant Front Seat Crossmember	X		
5		Rear Seat Crossmember	X		X
5	**	Redundant Rear Seat Crossmember	X		
6		Center of Gravity	X	X	X

* The accelerometer pack number can be correlated with the vehicle response data traces found in Appendix B.

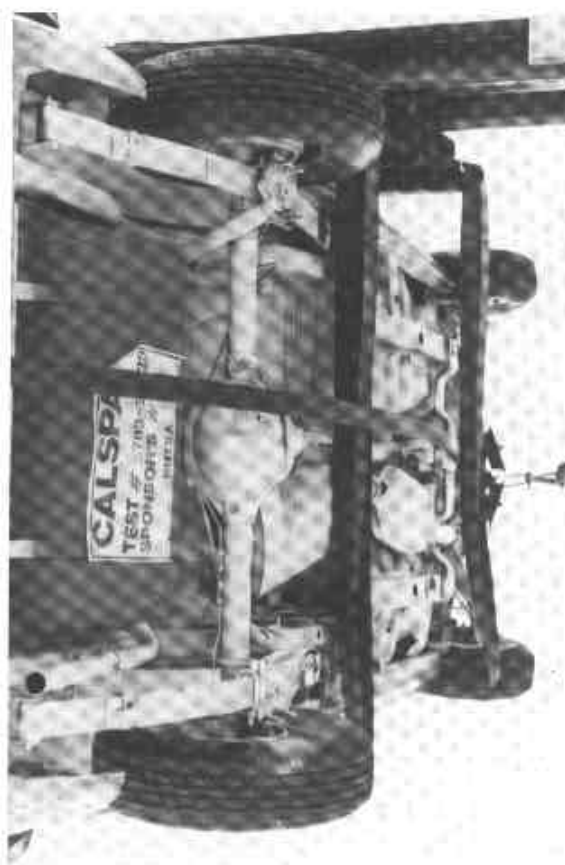
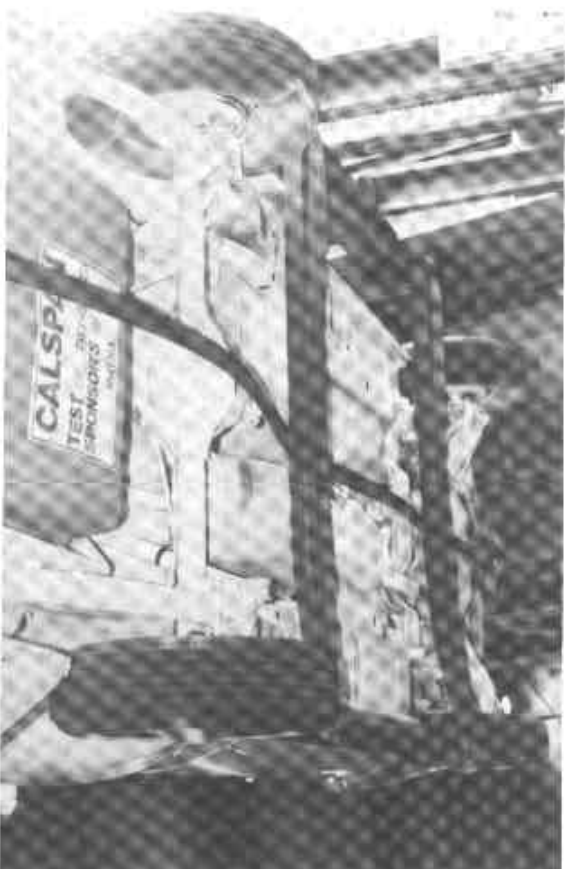
Figure A-6 Pre- and Post-Test Front and Rear Underbody Views

No fuel leakage occurred during or after impact or during the rollover cycle.

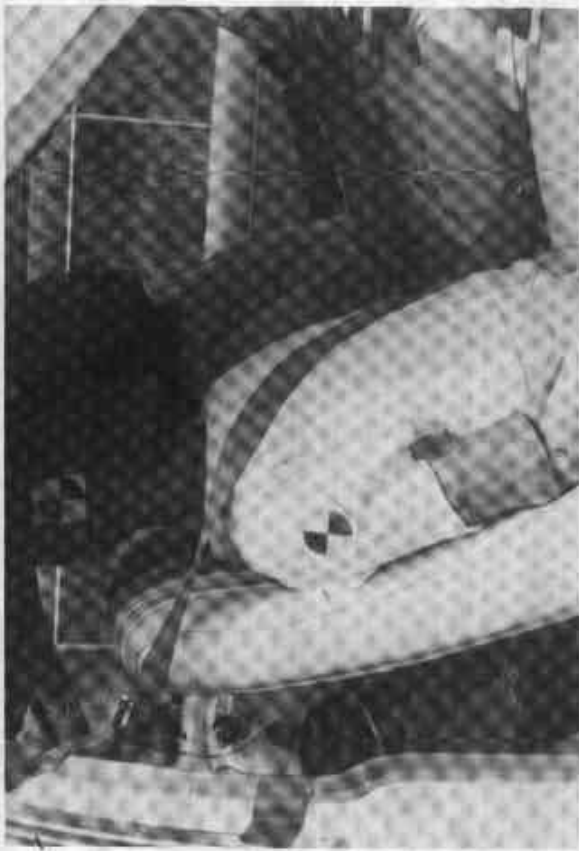
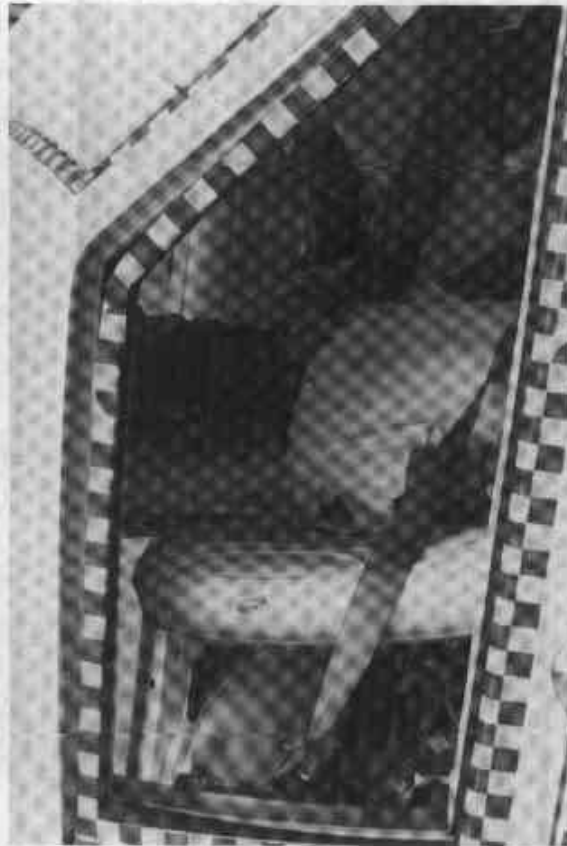
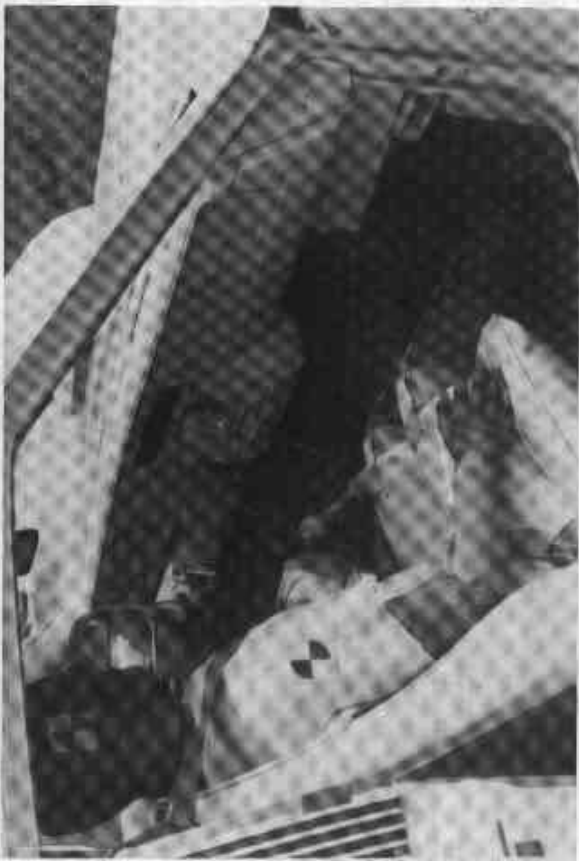
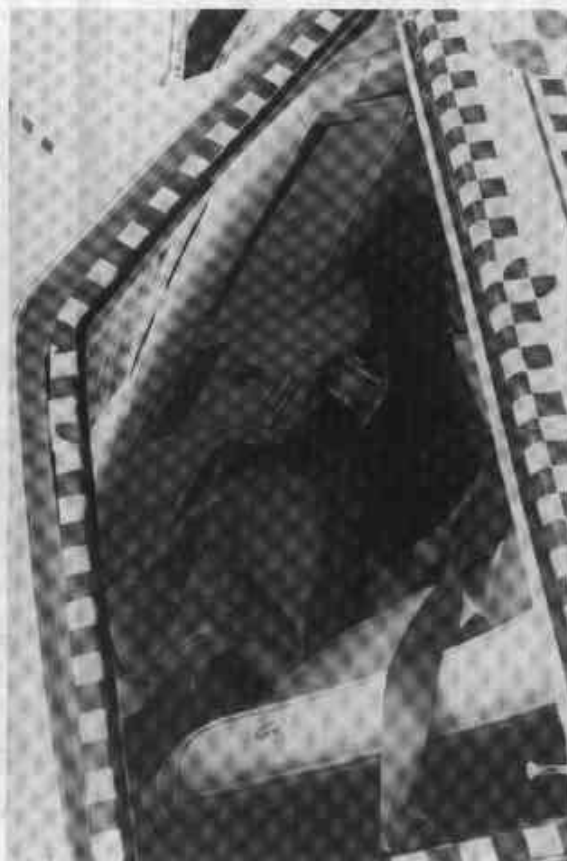
Figure A-9 Pre- and Post-Test Right Front Passenger Views

The passenger occupant kinematics were also very good with the occupant moving straight forward and rolling slightly outboard on rebound. No contacts were evident in the film or the data, and no chalk marks from the head were observed on the vehicle interior. The passenger occupant complied with all FMVSS Injury Criteria with an HIC number of 652, a maximum chest resultant acceleration over a 3 msec. interval of 33 and femur loads of 560 and 280 lbs. The passenger side retractor spool-off as read from the high-speed film was 2 3/4 inches.

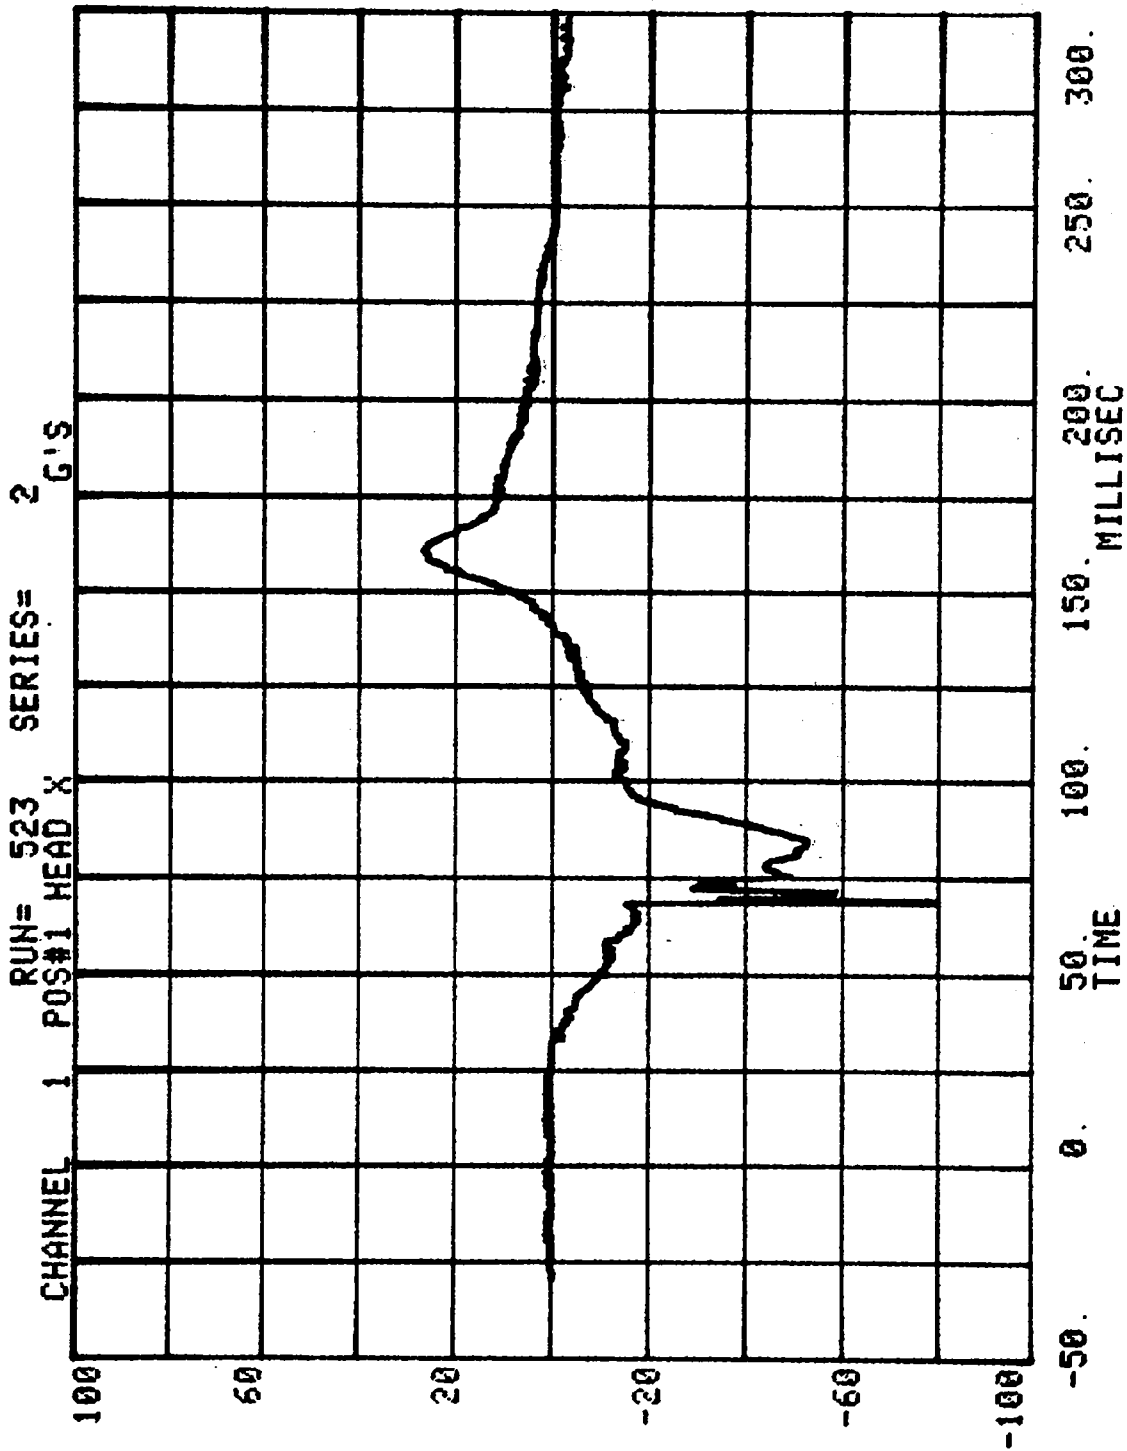
POS#1 HEAD RESULTANT

HIC= 702.4 FROM T1= .06180 TO T2= .09270
AVERAGE ACCELERATION BETWEEN T1 AND T2= 55.3G'S
EVENT TIME= 300.0 MSEC
SEVERITY INDEX= 929.5

The driver occupant kinematics are very good with the driver moving straight forward and the belt remaining in good position on the occupant shoulder. The driver head struck the upper wheel rim, but this did not appear to be a severe impact. The steering column moves rearward only slightly before impact. The driver occupant complied with all FMVSS 208 Injury Criteria with an HIC number of 702, a maximum chest resultant over a 3 msec. interval of 43 g's, and a right femur load of 1300. The driver left femur data was lost due to a cut signal wire, however, as evident by the chalk marks and interior dash panel damage, the left femur load was well within the limits of FMVSS 208 Injury Criteria. The driver side retractor spool-off as read from the high-speed film was 3 inches.

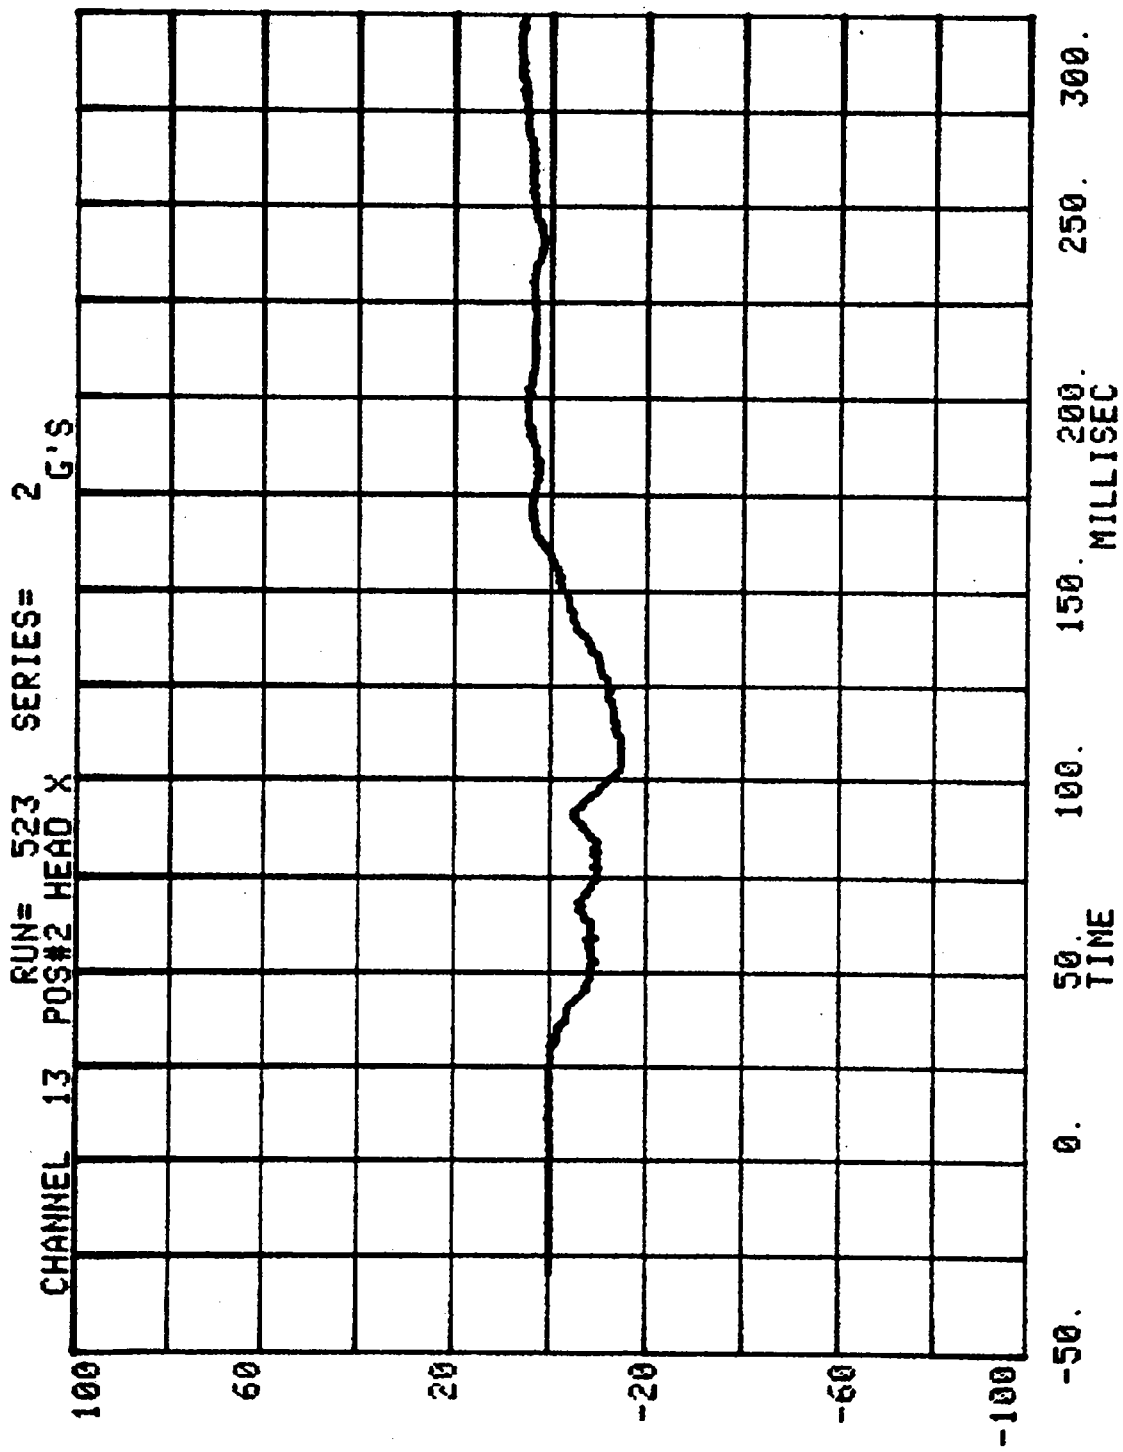
POS#2 HEAD RESULTANT

HIC= 652.3 FROM T1= .05370 TO T2= .12840
AVERAGE ACCELERATION BETWEEN T1 AND T2= 37.7G'S
EVENT TIME= 300.0 MSEC
SEVERITY INDEX= 876.6
