# ARVIN/CALSPAN

## EVALUATION OF AGGRESSIVENESS TEST TECHNIQUES

CALSPAN REPORT NO. 6892-V-1

TEST: TEST NO. 752-1-527  
TYPE OF TEST: SYMMETRIC FRONTAL CAR-TO-BARRIER IMPACT  
1981 VOLVO DL  
DEFORMABLE MOVING BARRIER  
TEST DATE: 10/5/81  
CONTRACT NO.: DTNH22-81-C-87088  
TASK ORDER NO.: 2

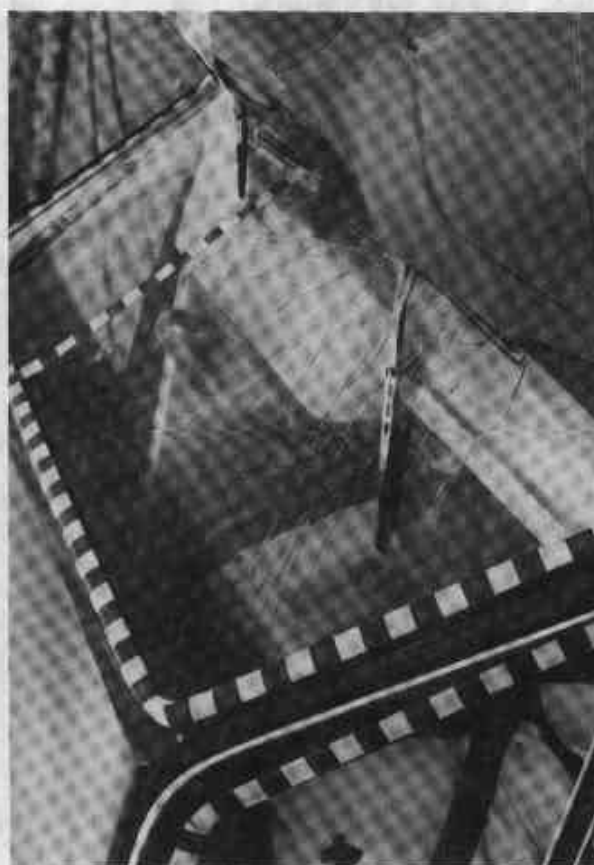
FIGURE A-9 VEHICLE NO. 1 - PRE- AND POST-TEST VIEWS OF REAR UNDERBODY

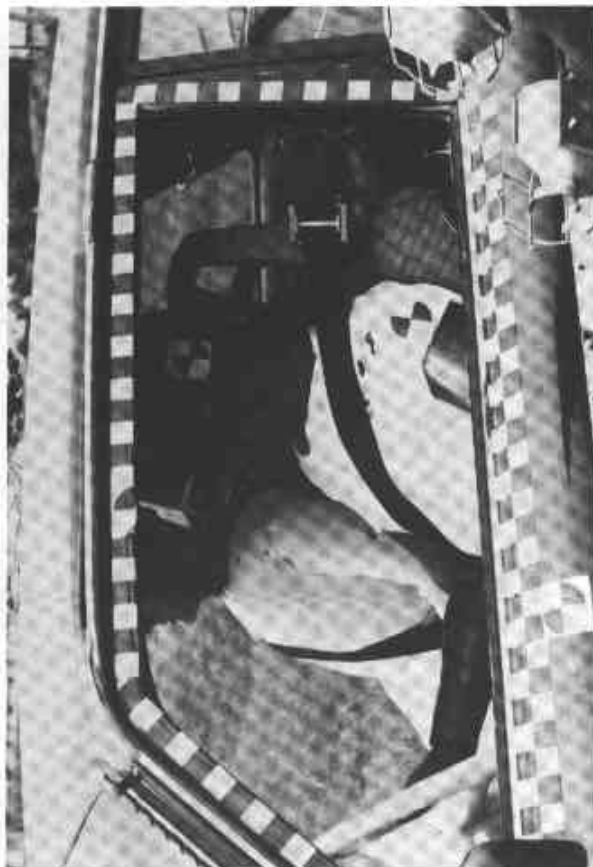
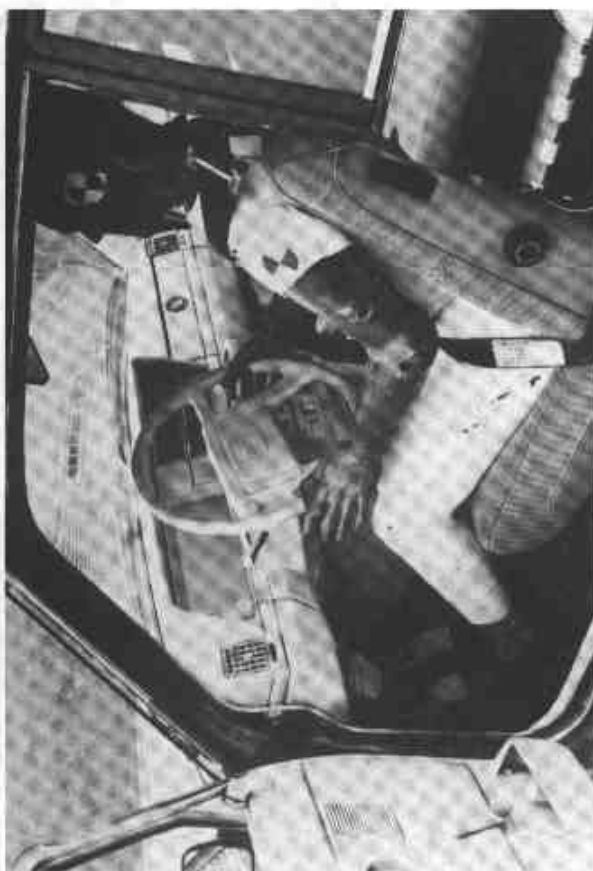
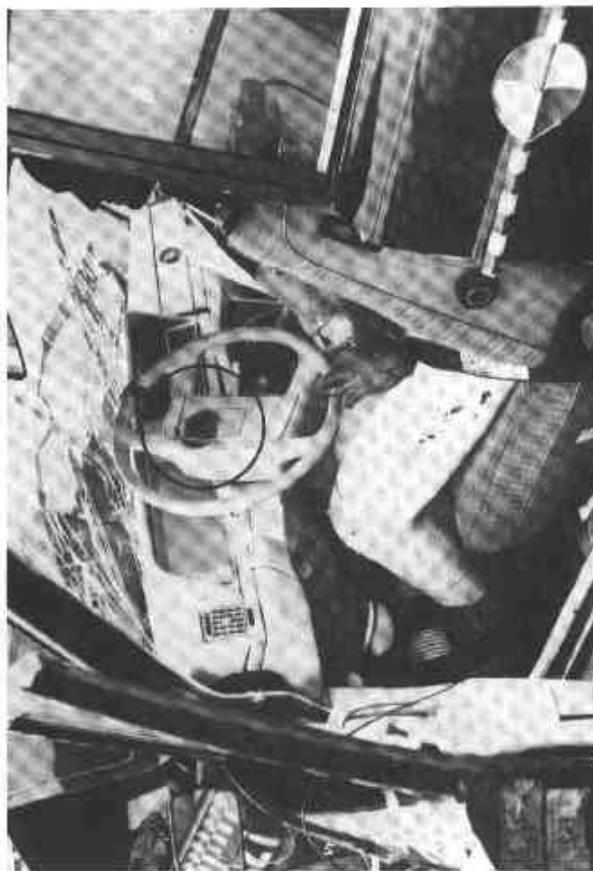
FIGURE A-11 VEHICLE NO. 1 - PRE- AND POST-TEST VIEWS OF DRIVER POSITIONS
