EVALUATION OF AGGRESSIVENESS  
TEST TECHNIQUES

Calspan Report No. 6892-V-3

TEST: 752-3-531  
TYPE OF TEST: Symmetrical Frontal Car-to-Barrier Impact  
1981 Volkswagen Rabbit  
Deformable Moving Barrier  
TEST DATE: 10/22/81  
CONTRACT NO.: DTNH22-81-C-87088  
TASK ORDER NO.: 2

| 4. Title and Subtitle<br>Evaluation of Aggressiveness Test Techniques/Deformable Barrier Baseline Test - Frontal Impact 65.6 mph Closing Speed | | | | 5. Report Date<br>December, 1981 | |

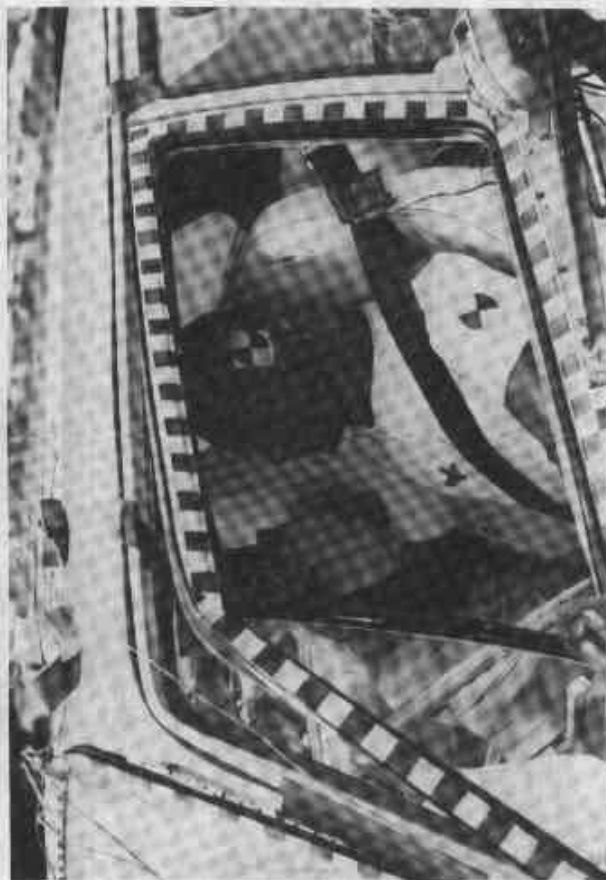
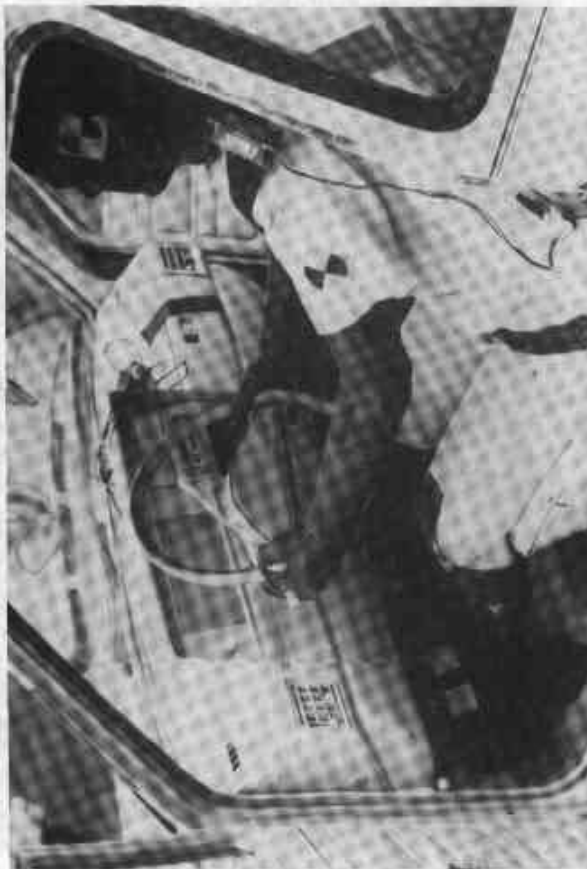
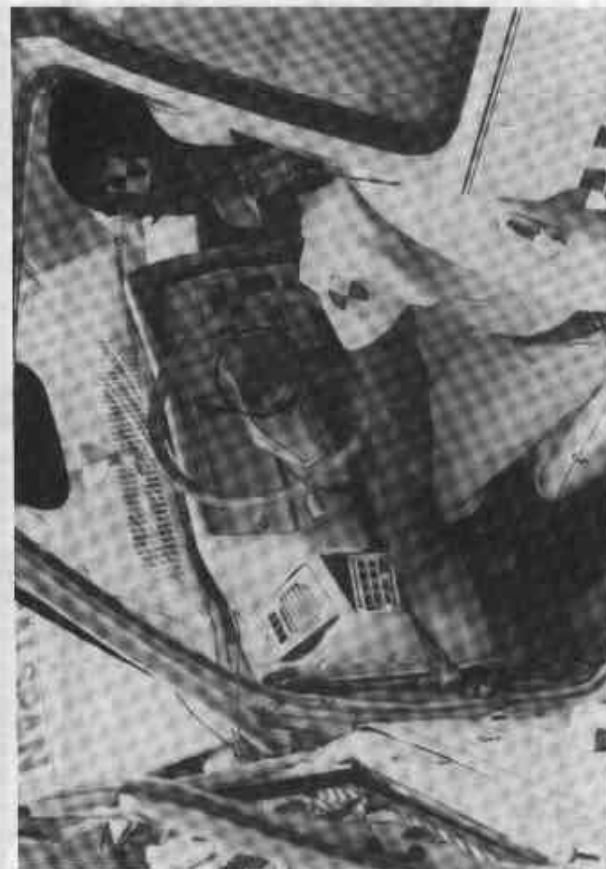
Figure A-9 Vehicle No. 1 - Pre- and Post-Test Views of Driver Position

The driver failed to comply with FMVSS 208 Injury Criteria Requirements for the head. The driver's head struck the center of the steering wheel hub (Fig. A-9) as evident by the chalk mark and the high-speed film. Head contact with the steering wheel occurred at 80 millisec. after impact with a HIC value of 2246, calculated between .0813 and .0840 millisec. The right front passenger complied with FMVSS 208 Injury Criteria Values for the head, chest, and femurs. Occupant results are summarized in Table 11, and the data traces along with the vehicle data traces are presented in Appendix B.

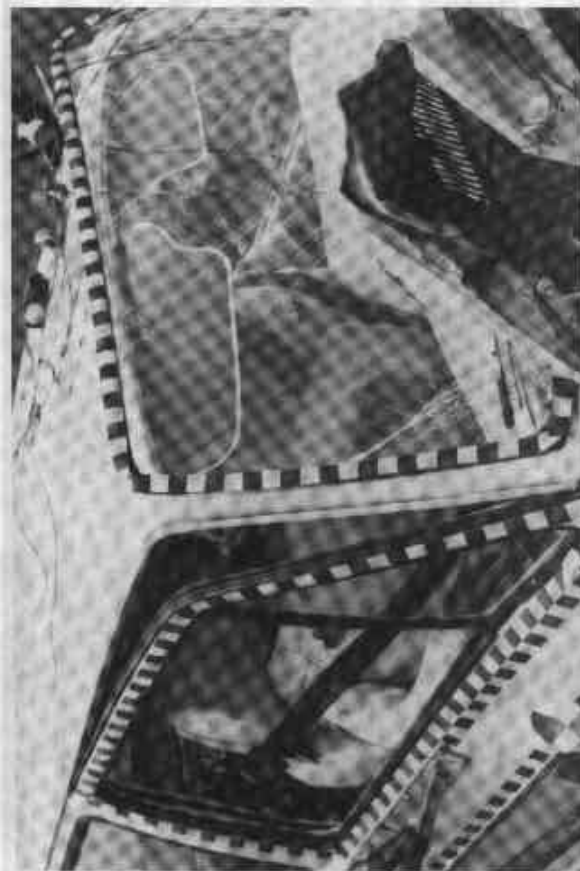
Figure A-12 Vehicle No. 1 - Post-Test View of Windshield and Door Separation

**GLAZING** Windshield has stress crack and the windshield along with the rubber retention molding separated from the vehicle (Fig. A-12)

The windshield has stress cracks, and windshield retention loss was greater than 75 percent. The rubber molding securing the windshield to the vehicle, separated along the entire top and sides (Fig. 12).

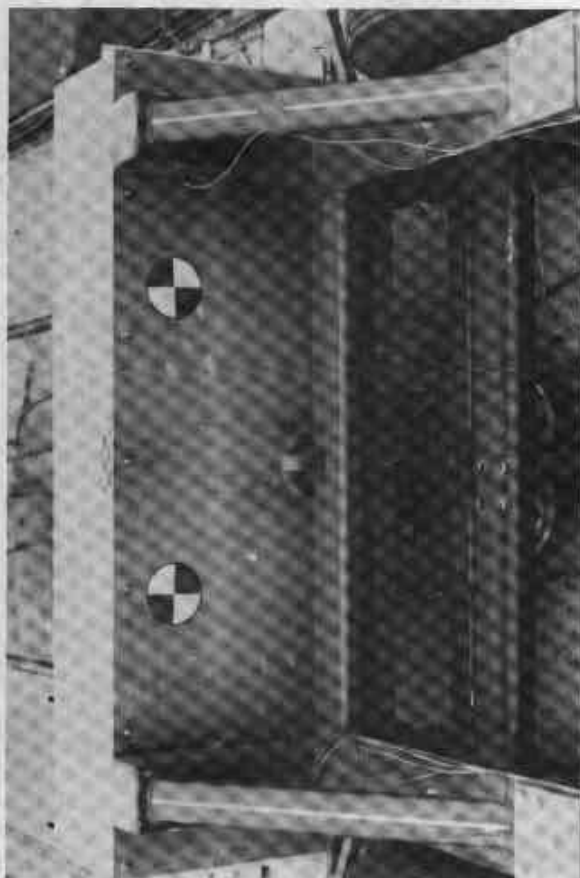
Figure A-14 Vehicle No. 2 - View of Moving Barrier Load Cells

Maximum crush of the honeycomb on the face of the moving barrier was 14.5 inches. The total maximum force as measured by the 5 load cells was 88,500 pounds at 37 millisec. after impact. Complete pre- and post-test measurements of the barrier face honeycomb are presented in Table 7 , and data traces are found in Appendix B.
