## *IMPROVED LIGHTWEIGHT SUBCOMPACT SIDE STRUCTURE TEST REPORT*

Calspan Report No. 6225-V-6

TEST: TEST NO. 5  
TYPE OF TEST: CAR-TO-CAR FRONT TO SIDE OBLIQUE  
TEST DATE: 17 MAY 1978

The test objective was to obtain performance data on the low weight (10 lb) modification that was done to the side structure on a 1978 VW Rabbit by the Budd Company. The test, a 30 mph car-to-car front-to-side oblique impact, involved a 1978 Chevrolet Impala striking the side of the VW Rabbit. This test program is part of the National Highway Traffic Safety Administration (NHTSA) Contract DOT-HS-7-01588 to improve subcompact side structures.

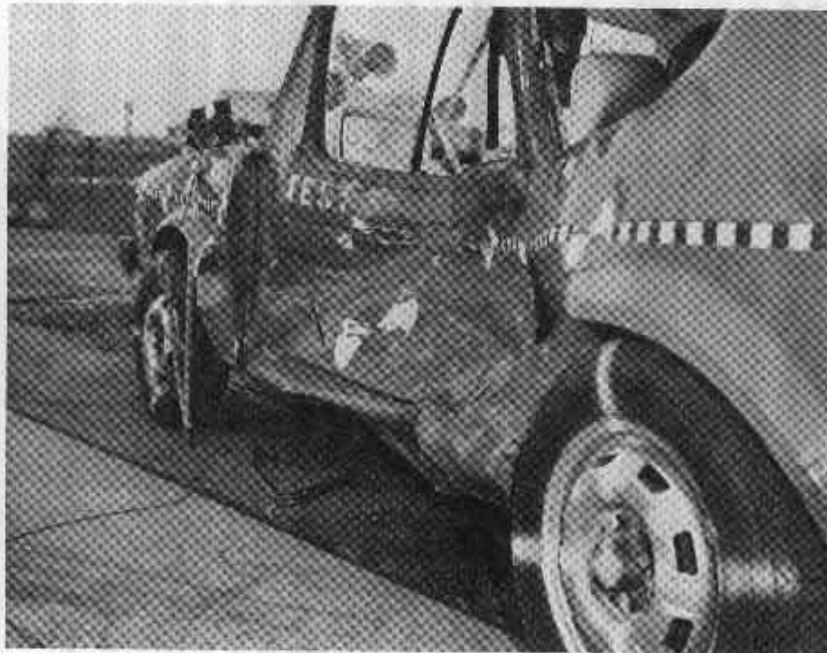
Figure 6 IMPACT AND POST IMPACT OF V.W. RABBIT

CRASH EVENT

SIDE DAMAGE ON V.W. RABBIT

| <u>Figure No.</u> | | <u>Page No.</u> |
|---|---|---|
| 6 | IMPACT AND POST IMPACT OF V.W. RABBIT | 10 |

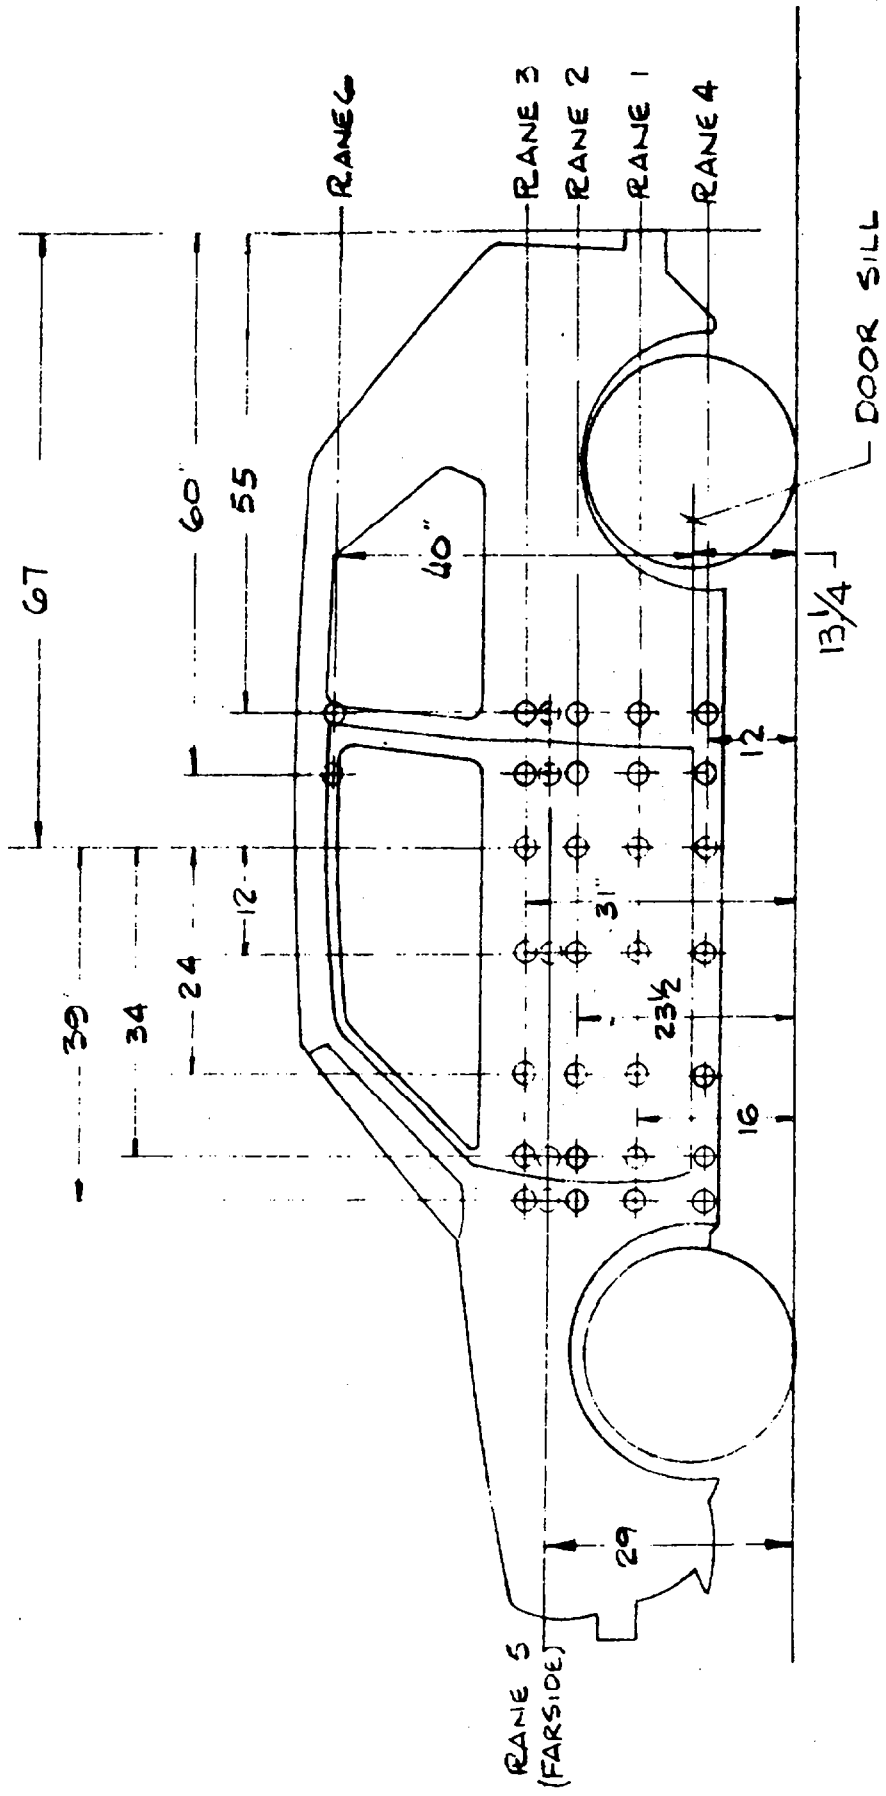
Figure 9 SIDE INTRUSION MEASUREMENTS (SEE TABLE NO. 2)

1976 V.W. RABBIT PRE-TEST LOCATION MEASUREMENTS

DIMENSIONS LISTED BELOW ARE FROM POINTS SHOWN ON FIGURE 9 TO REFERENCE PLANES LOCATED PARALLEL TO AND OUTBOARD FROM OF VEHICLE (L. SIDE 42.6 - R. SIDE 38.2)

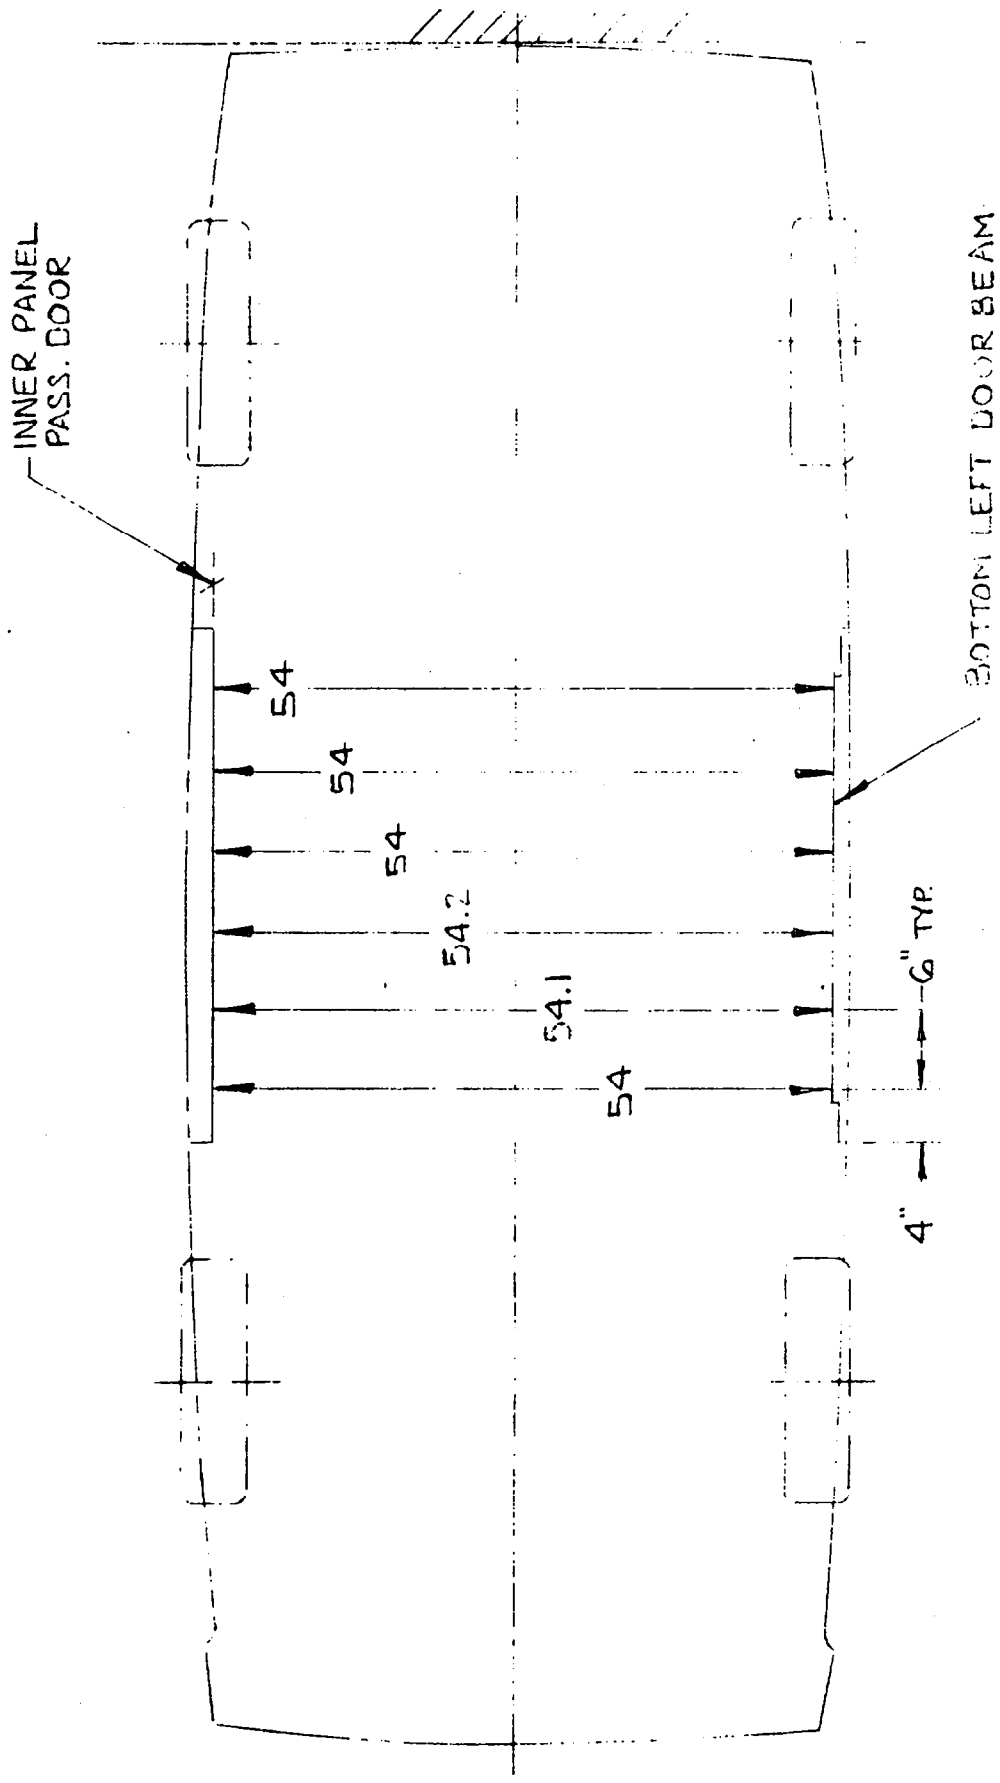
Figure 10-1 PRE-TEST DOOR BEAM INTRUSION MEASUREMENTS

1976 V.W. RABBIT  
 SCALE .06" = 1"

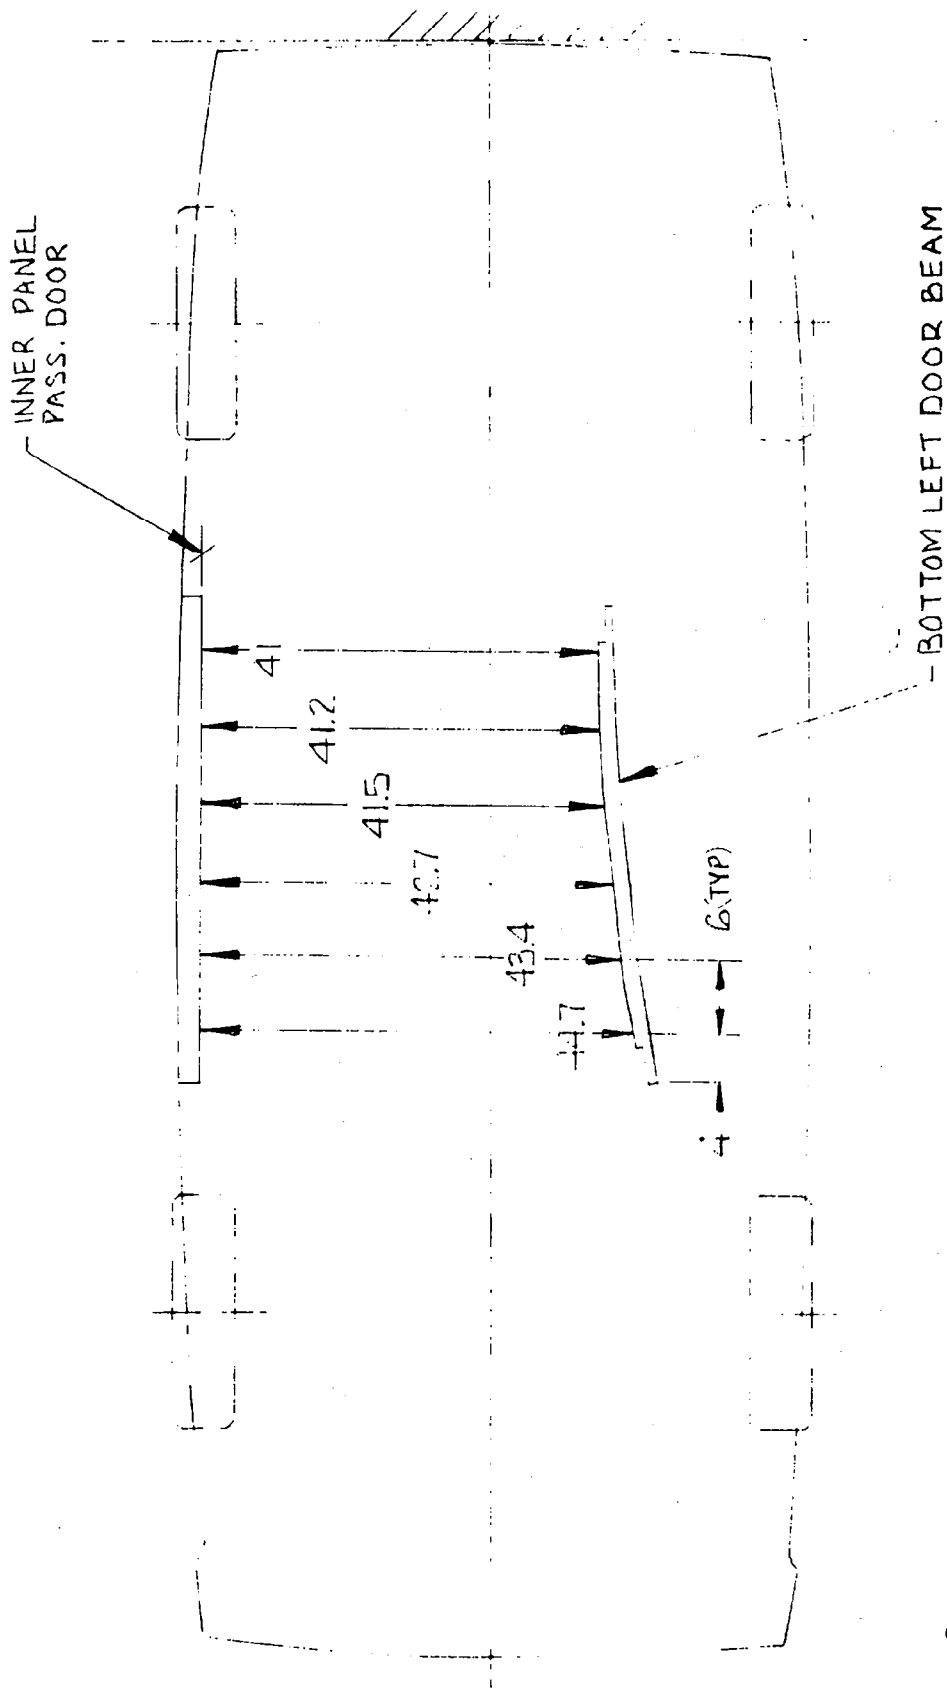
Figure 10-2. POST-TEST DOOR BEAM INTRUSION MEASUREMENTS

1976 V.W. RABBIT

SCALE .06" = 1"

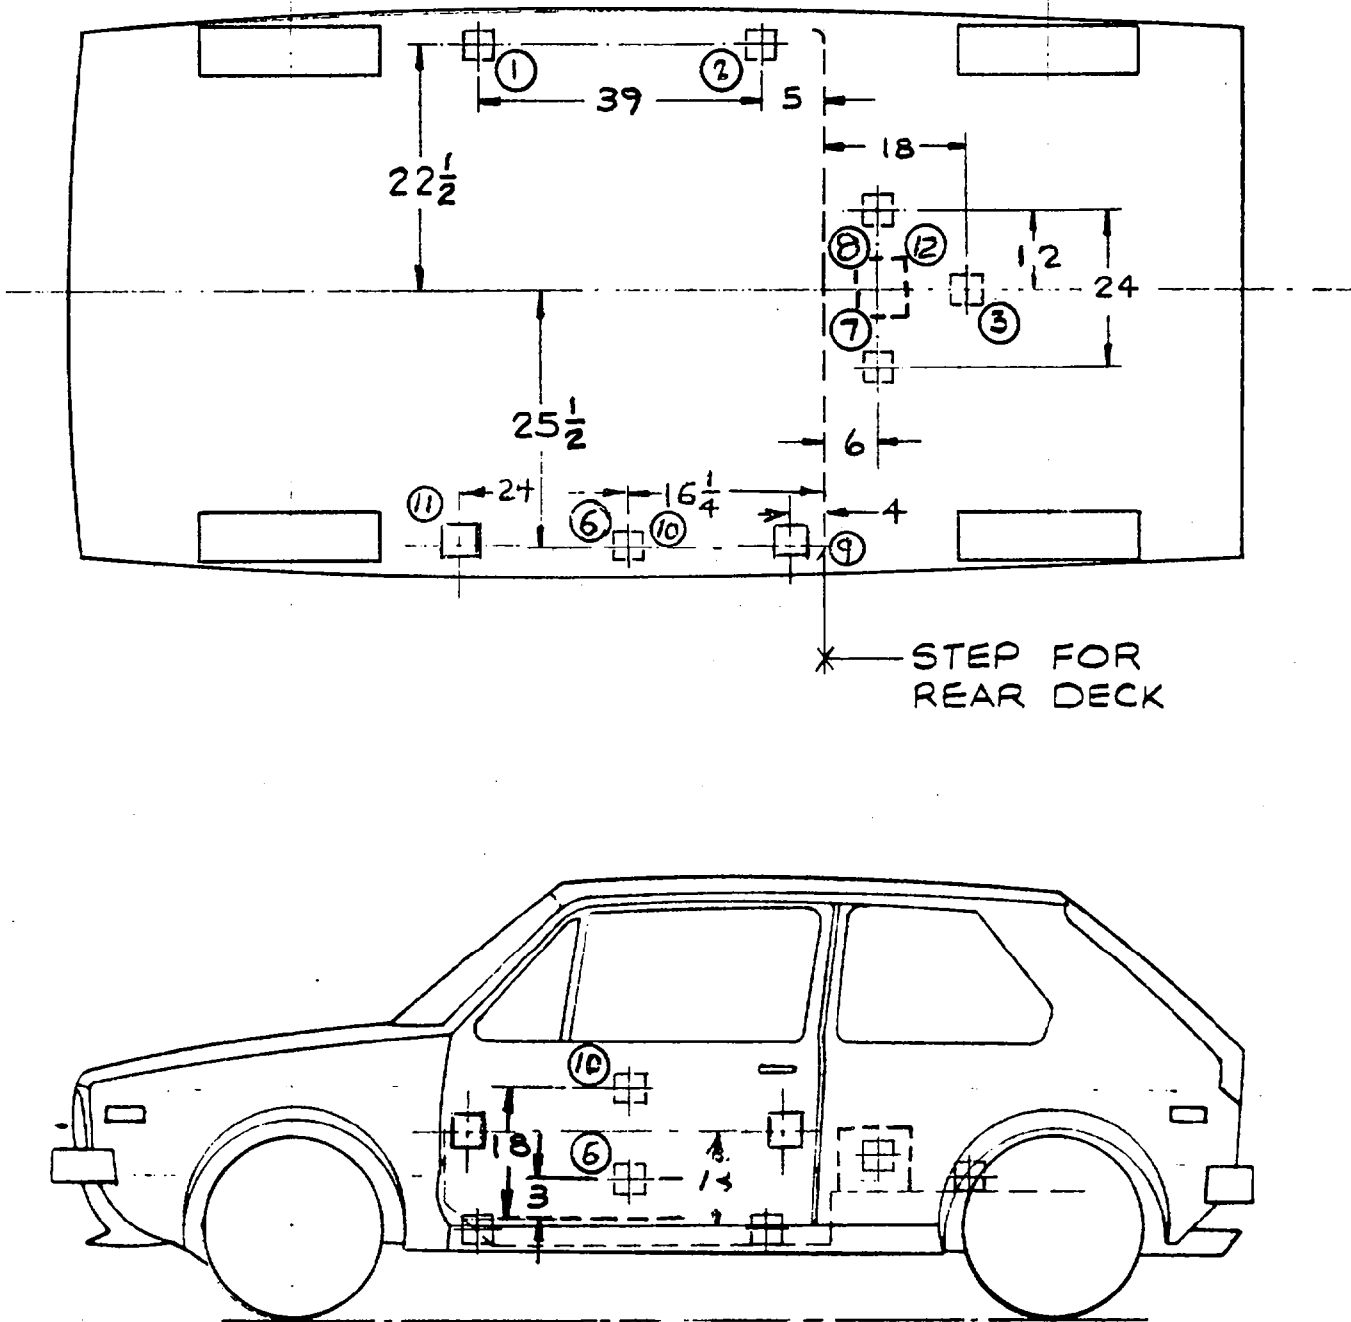
Figure 13 VEHICLE ACCELEROMETER LOCATIONS

Car 2 - Target Vehicle - 1976 Volkswagen Rabbit

\* See Accelerometer Layout Diagram Figure 13

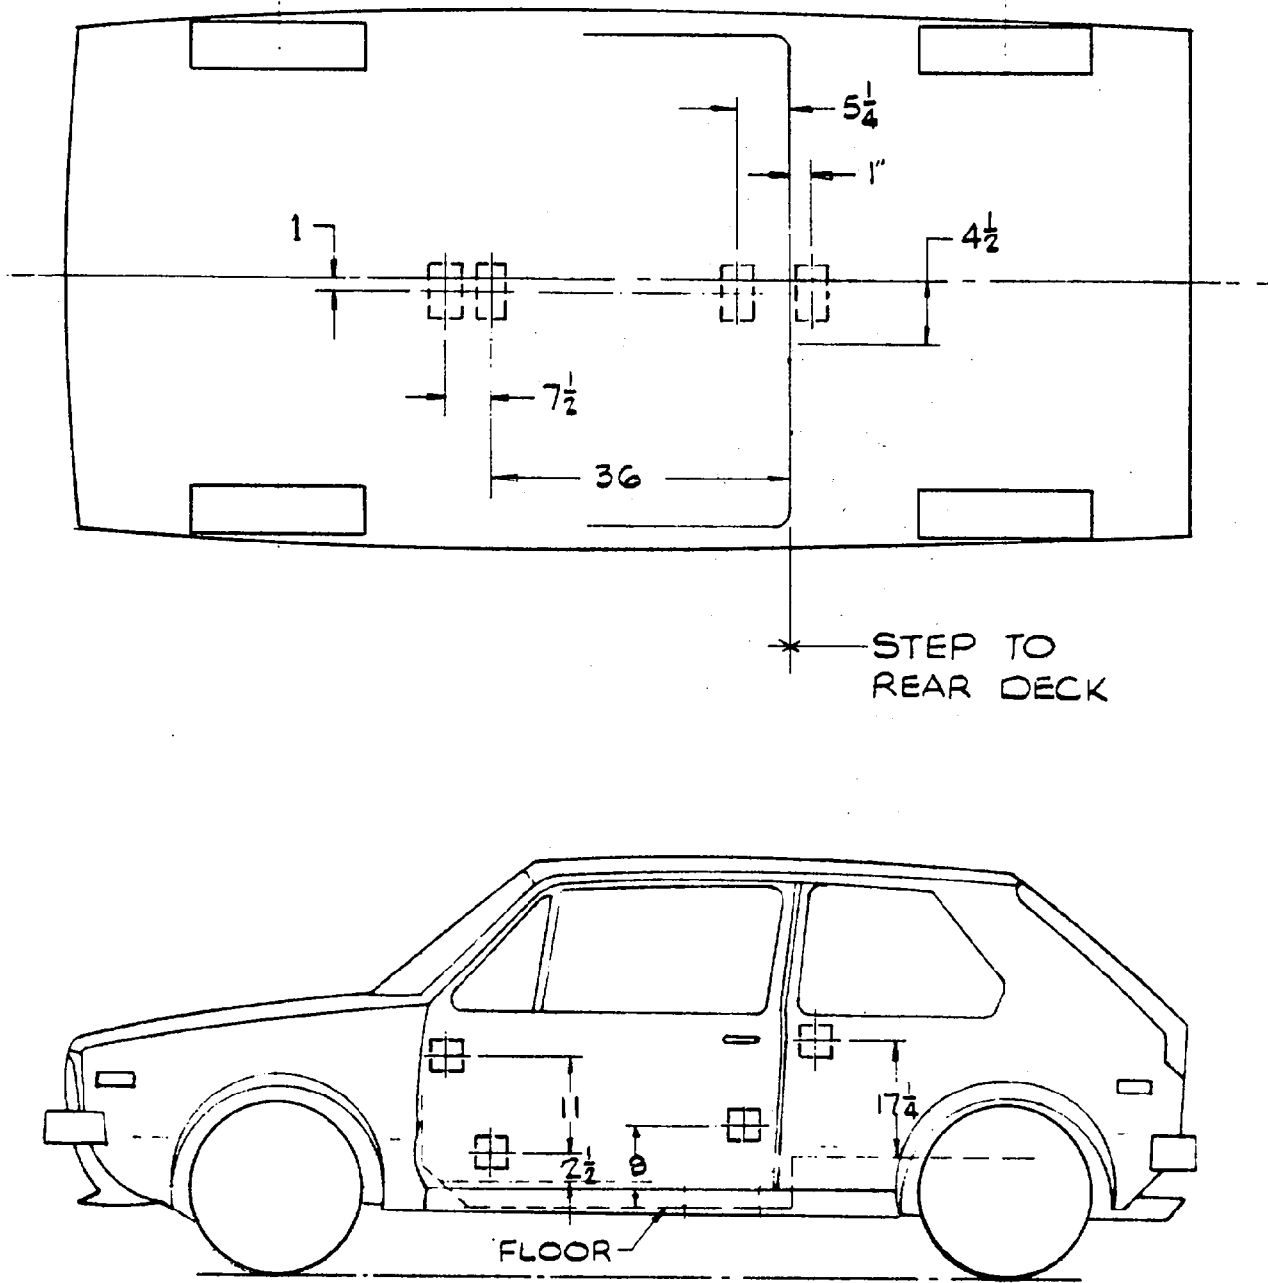
Figure 14 VEHICLE POTENTIOMETER LOCATIONS

Car 2 - Target Vehicle - 1976 Volkswagen Rabbit

| TRANSDUCER DESCRIPTION OR ACCELEROMETER LOCATION * | DIRECTION OF PARAMETER BEING MEASURED | LOCATION ON VEHICLE | DESCRIPTION LISTED ON DATA PLOTS |
|--|---|---|---|
| 13 - 16 | Side Intrusion | Side Intrusion (Driver Side) | Side Intrusion |
