TEST  
REPORT

CONTRACT NAME: EVALUATION OF VEHICLE SIDE  
STRUCTURES UNDER VARYING  
IMPACT CONDITIONS

TEST DESCRIPTION: CITATION INTO "BUDD" MODIFIED  
VW RABBIT (37.5 MPH CLOSING  
VELOCITY)

MINICARS TEST NUMBER: 2265

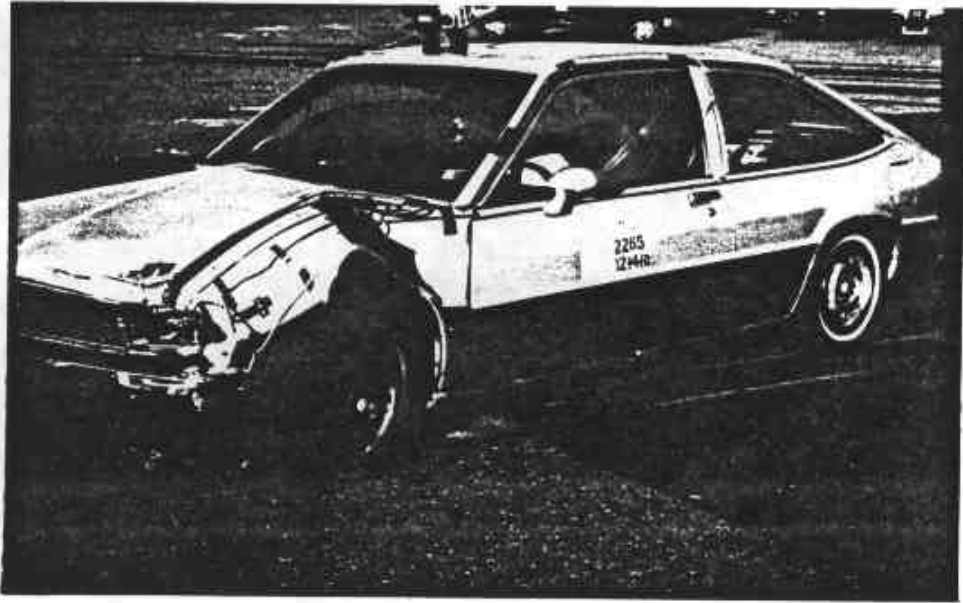
FIGURE 13. IMPACTING VEHICLE DAMAGE

| | <u>Actual</u> | <u>Intended</u> |
|---|---|---|
| Static (frontal) | 8.75 | |
