Dynamic Science Report No. 301-DYS-79-018

NEW VEHICLE ASSESSMENT AND  
STANDARDS ENFORCEMENT INDICANT  
TESTING

FMVSS 301-75

CHRYSLER CORPORATION  
1979 CHRYSLER CORDOBA 2-DOOR SEDAN  
NHTSA NO. 790314

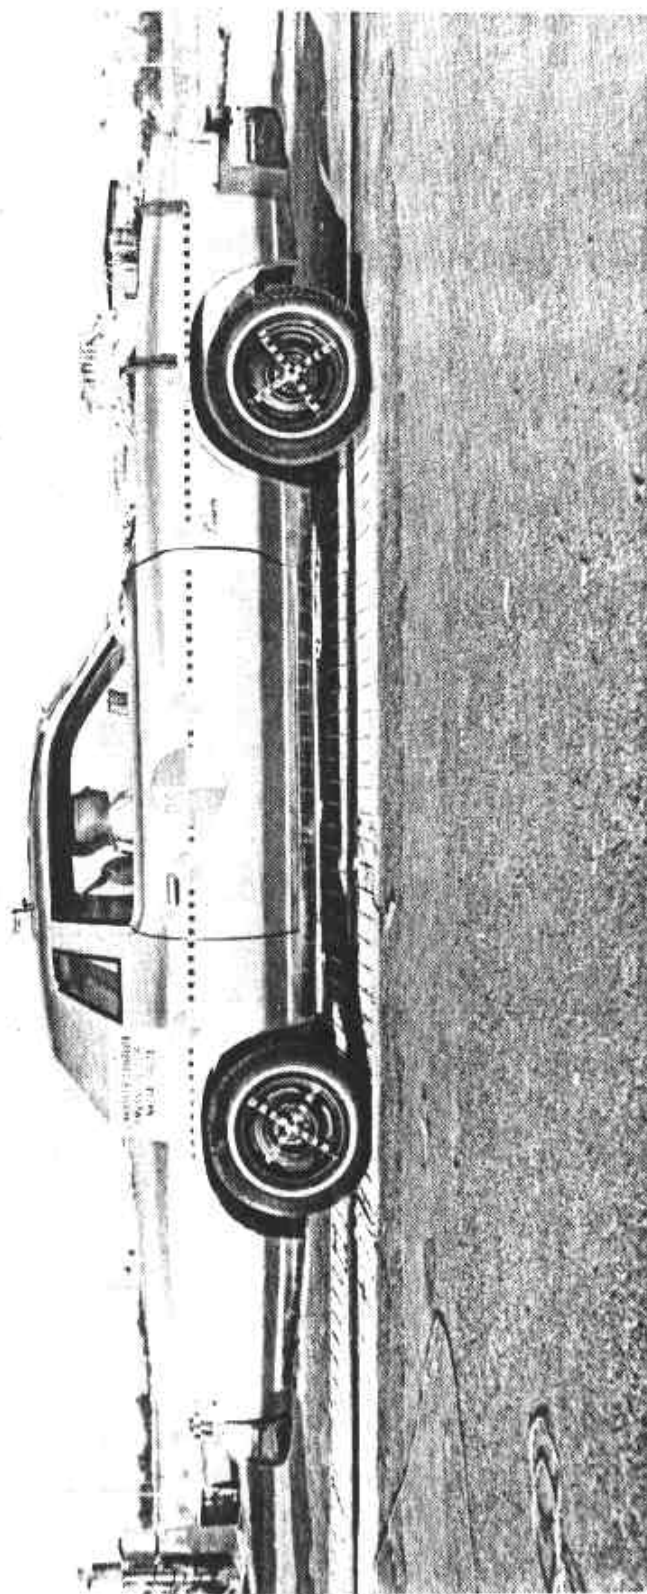
Figure 2-3. Pre-test Right Side View.

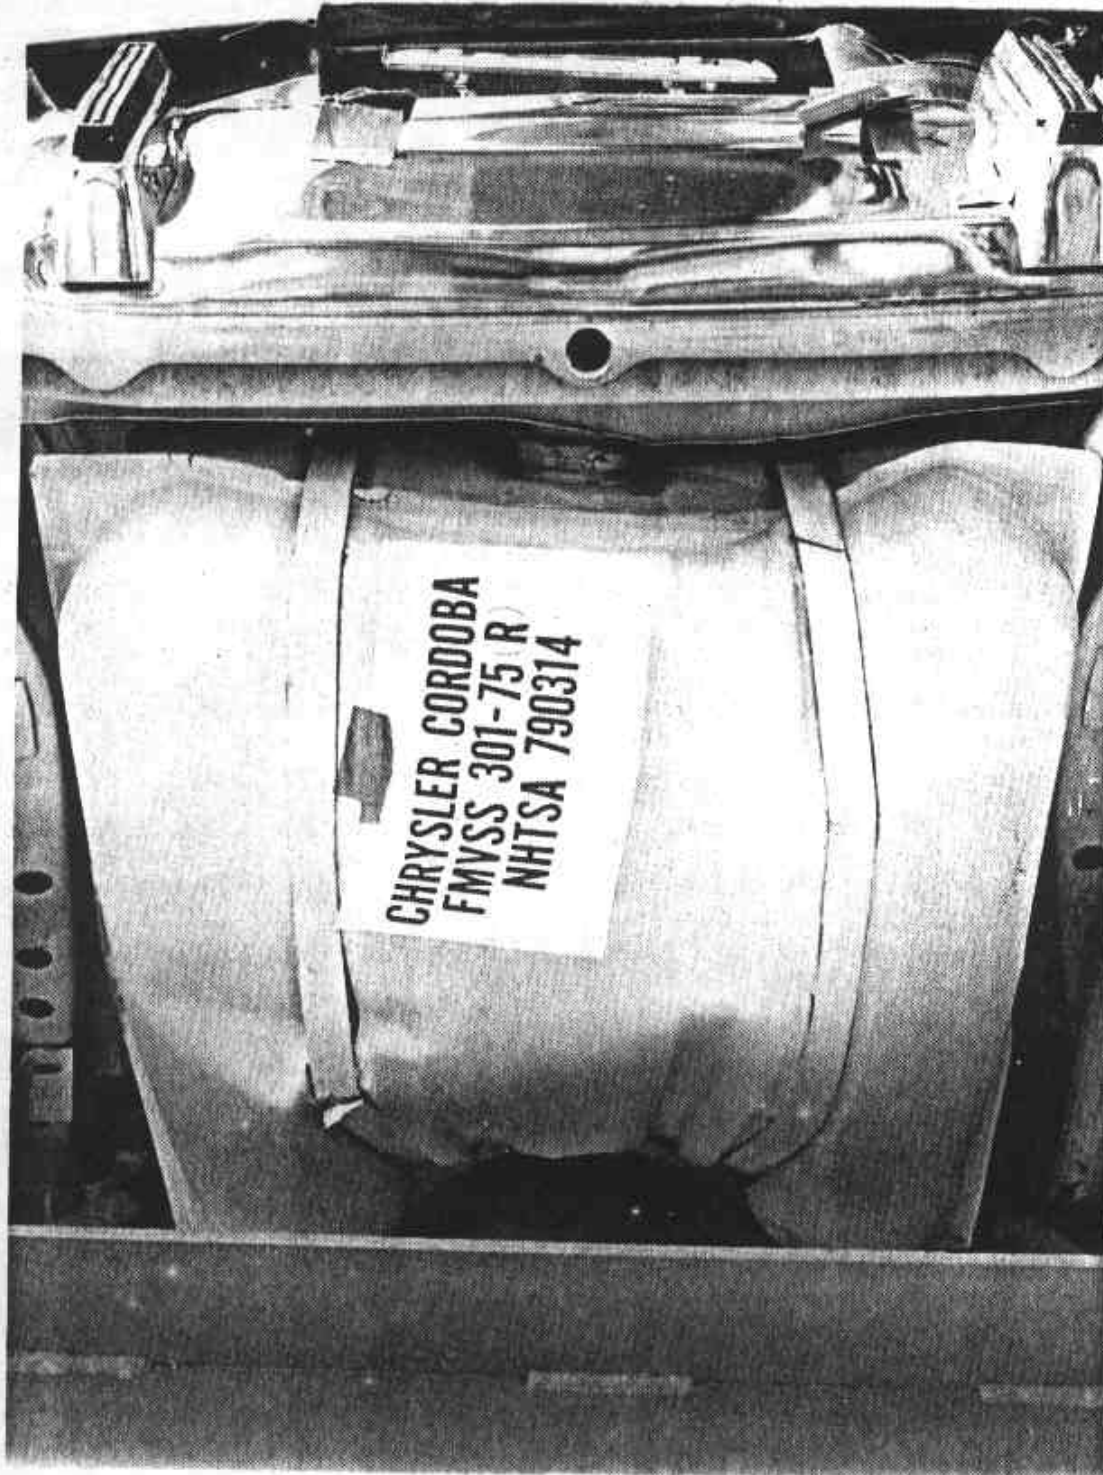
Figure 3-2. Post-test Fuel Tank.

Details of Leakage: None

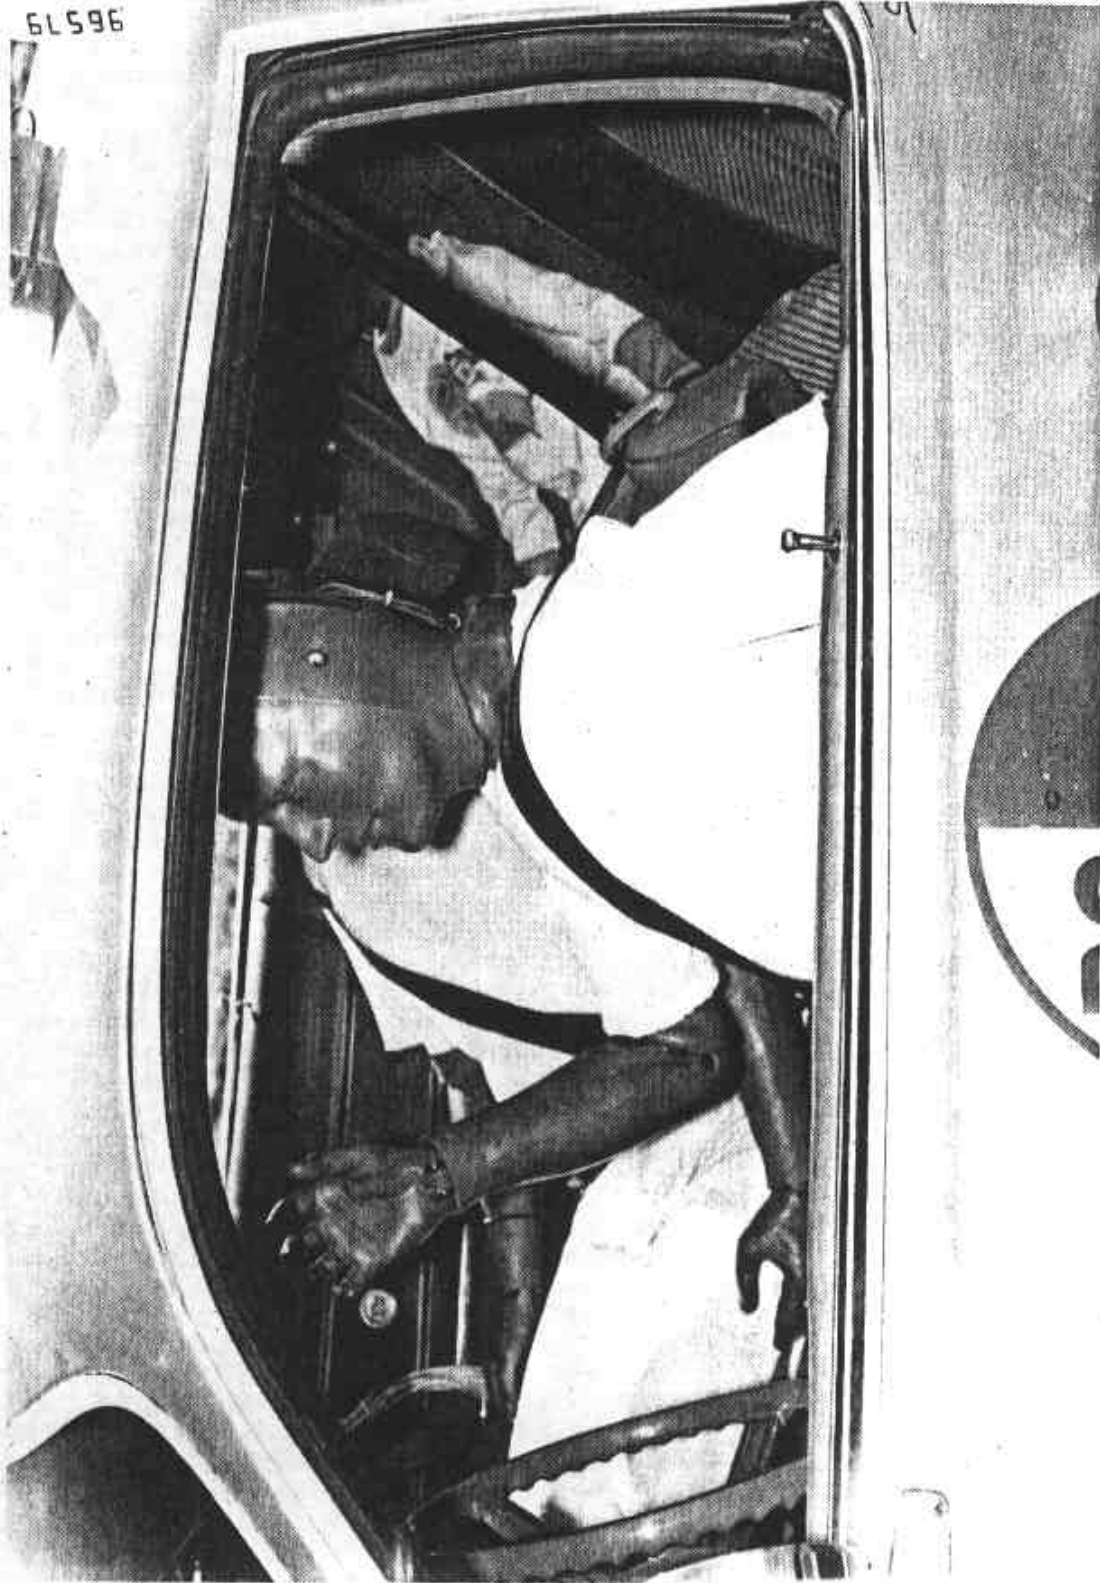
Figure 4-3. Post-test Driver Dummy Position.

DRIVER - At impact, moved smoothly backward and struck rear seatback with top of front seatback, then torso flexed forward past pre-test seating position. Torso came to rest in pre-test position; only lumbar portion of back was in contact with seatback.

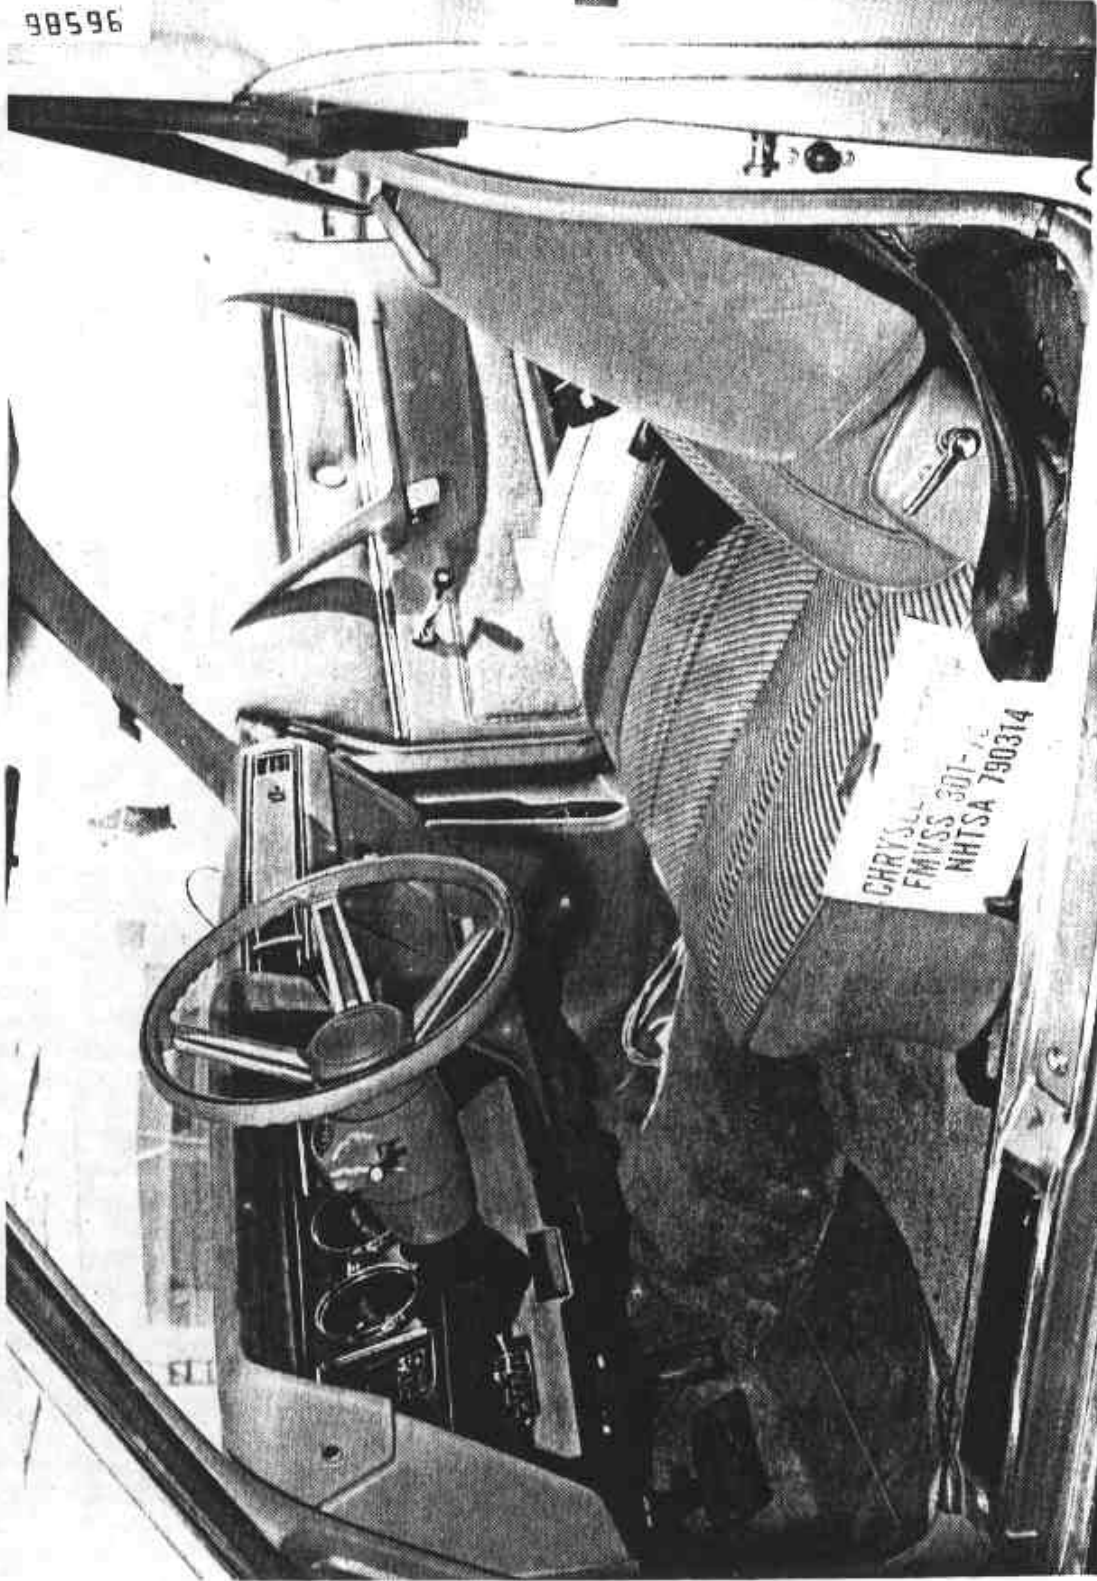
Figure 4-4. Post-test Driver Location With Dummy Removed.

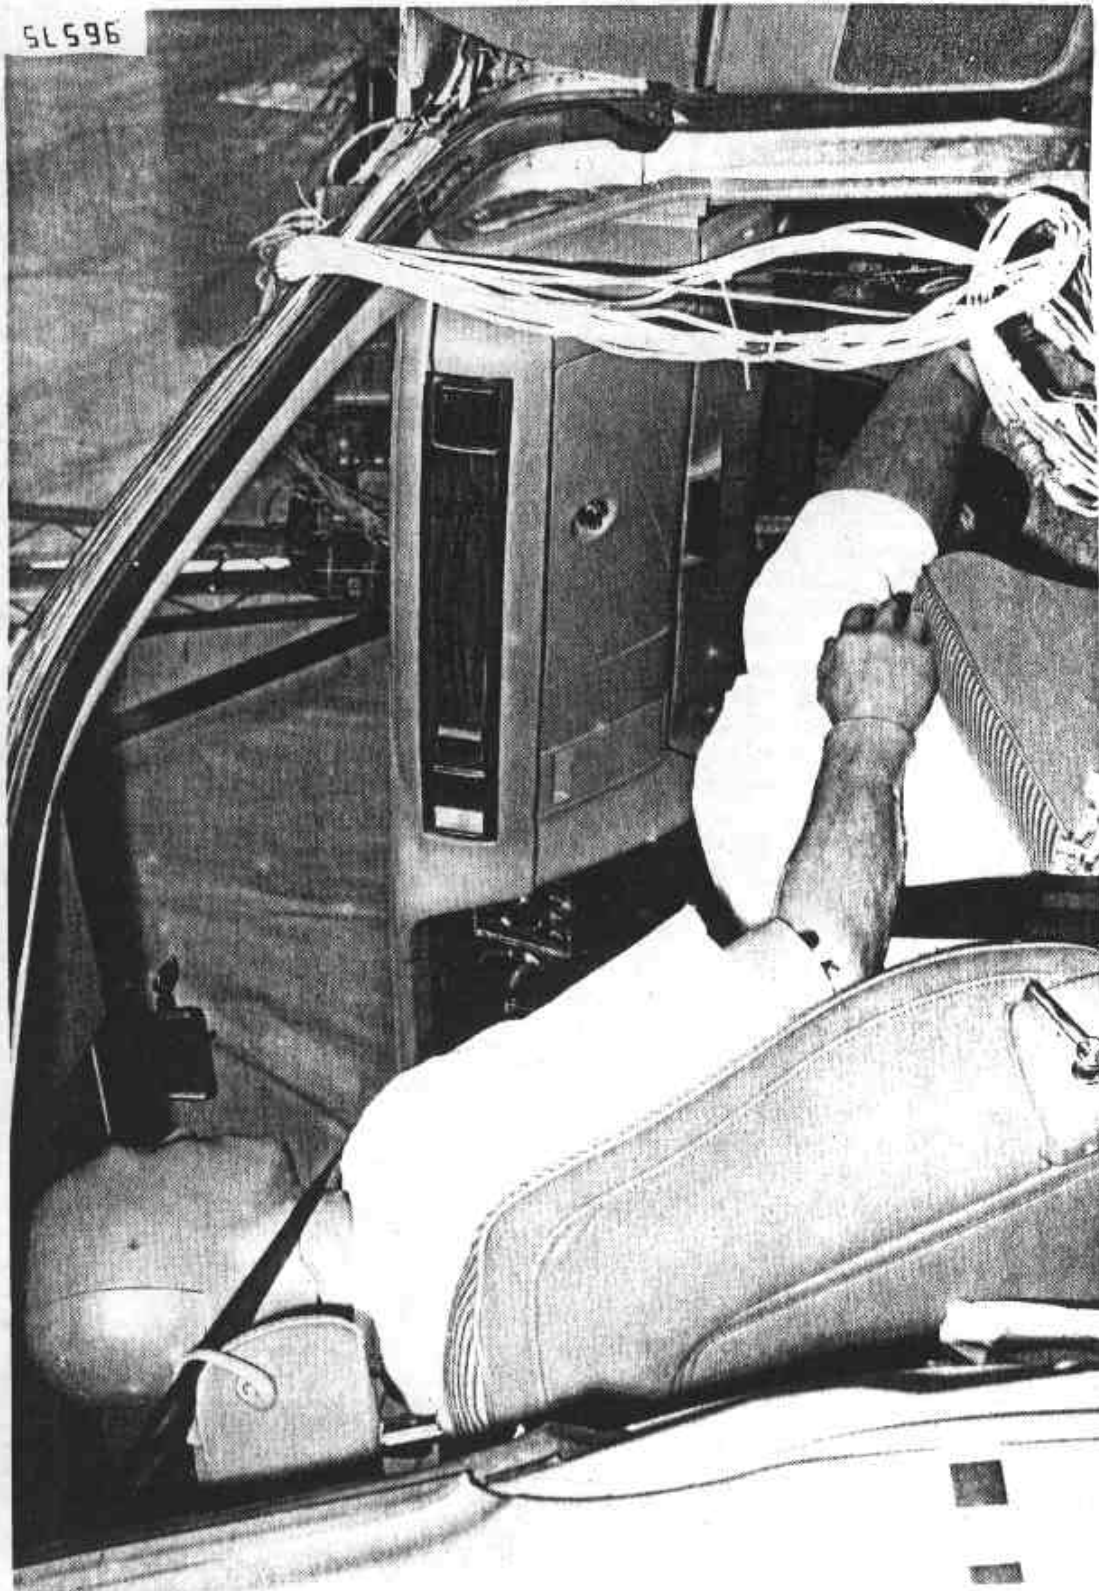
Figure 4-5. Pre-test Passenger Location.

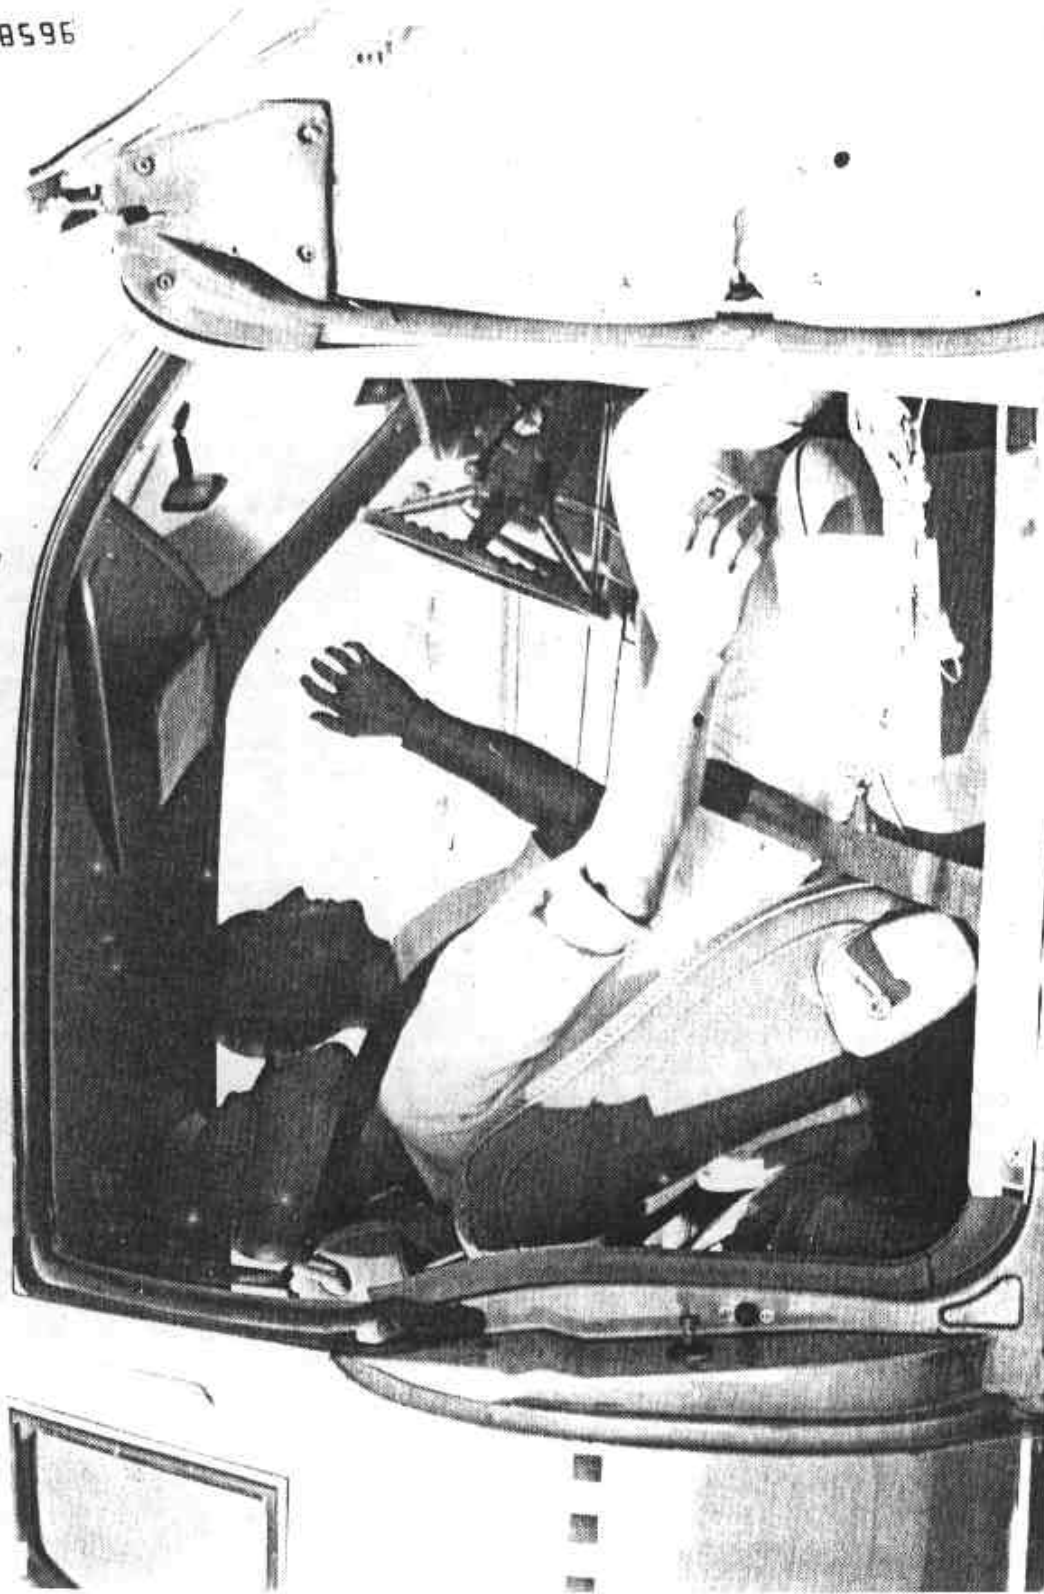
Figure 4-7. Post-test Passenger Position.

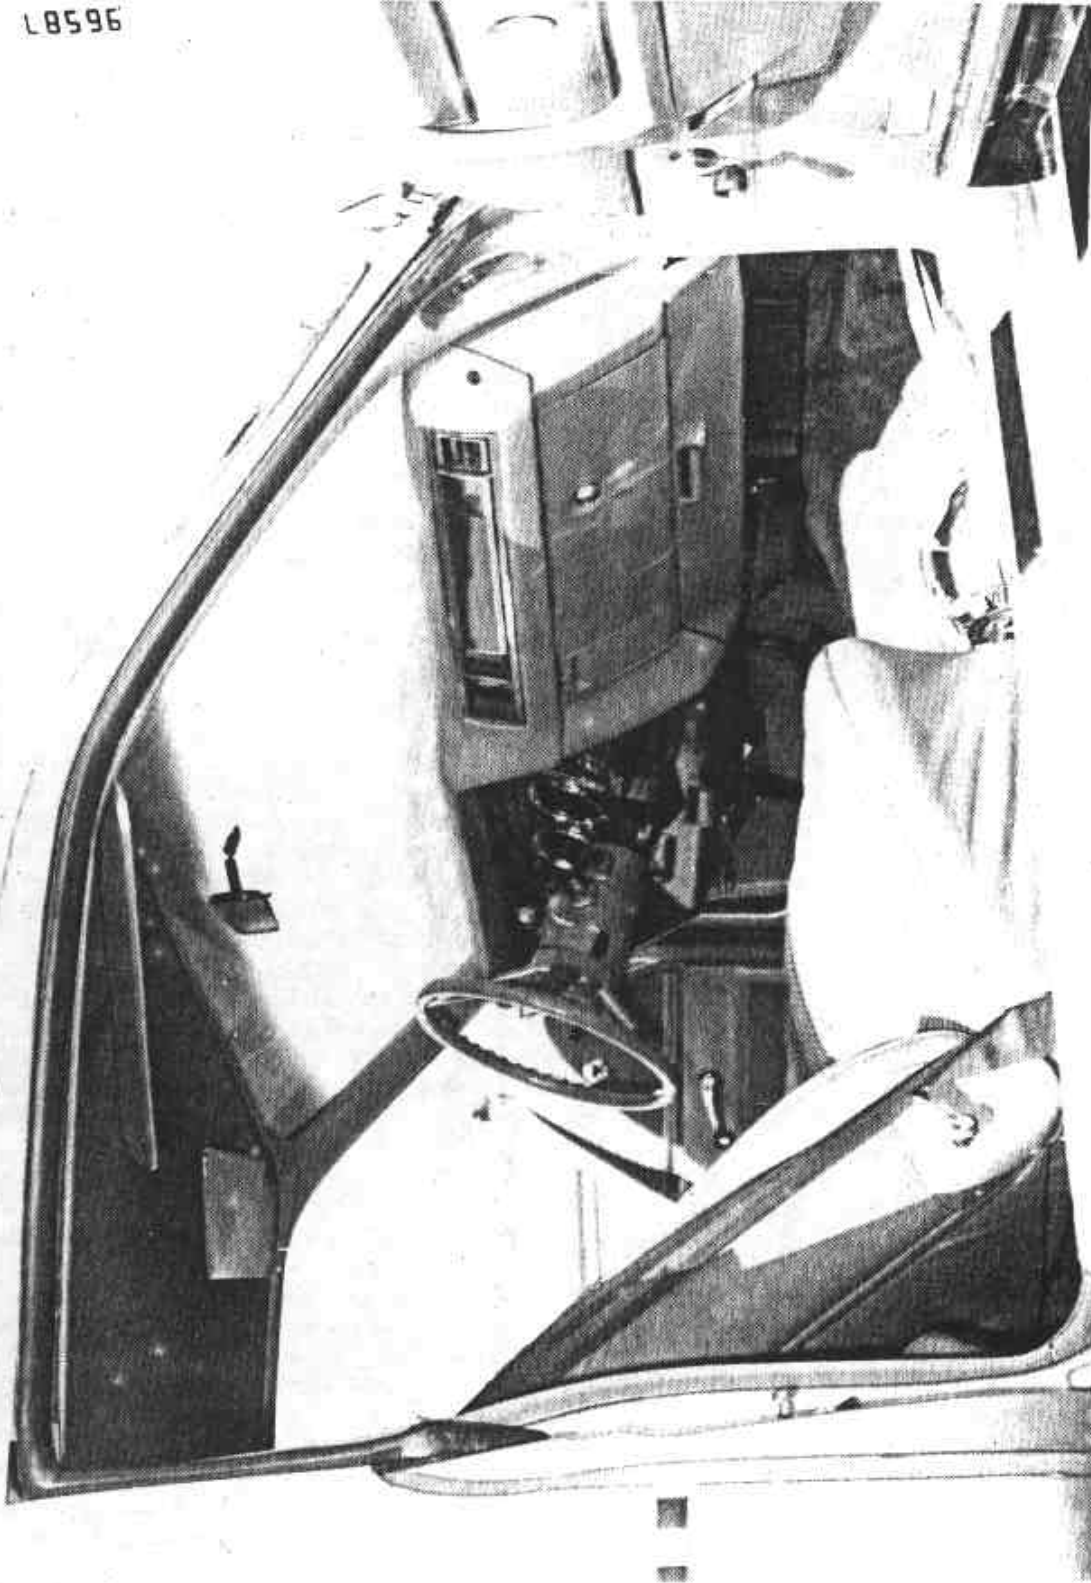
Figure 4-8. Post-test Passenger Position With Dummy Removed.
