NEW VEHICLE ASSESSMENT AND  
STANDARDS ENFORCEMENT INDICANT  
TESTING

FMVSS 212, 219, AND 301-75

CHRYSLER CORPORATION  
1980 CHRYSLER LEBARON  
NHTSA NO. 800311

FINAL REPORT

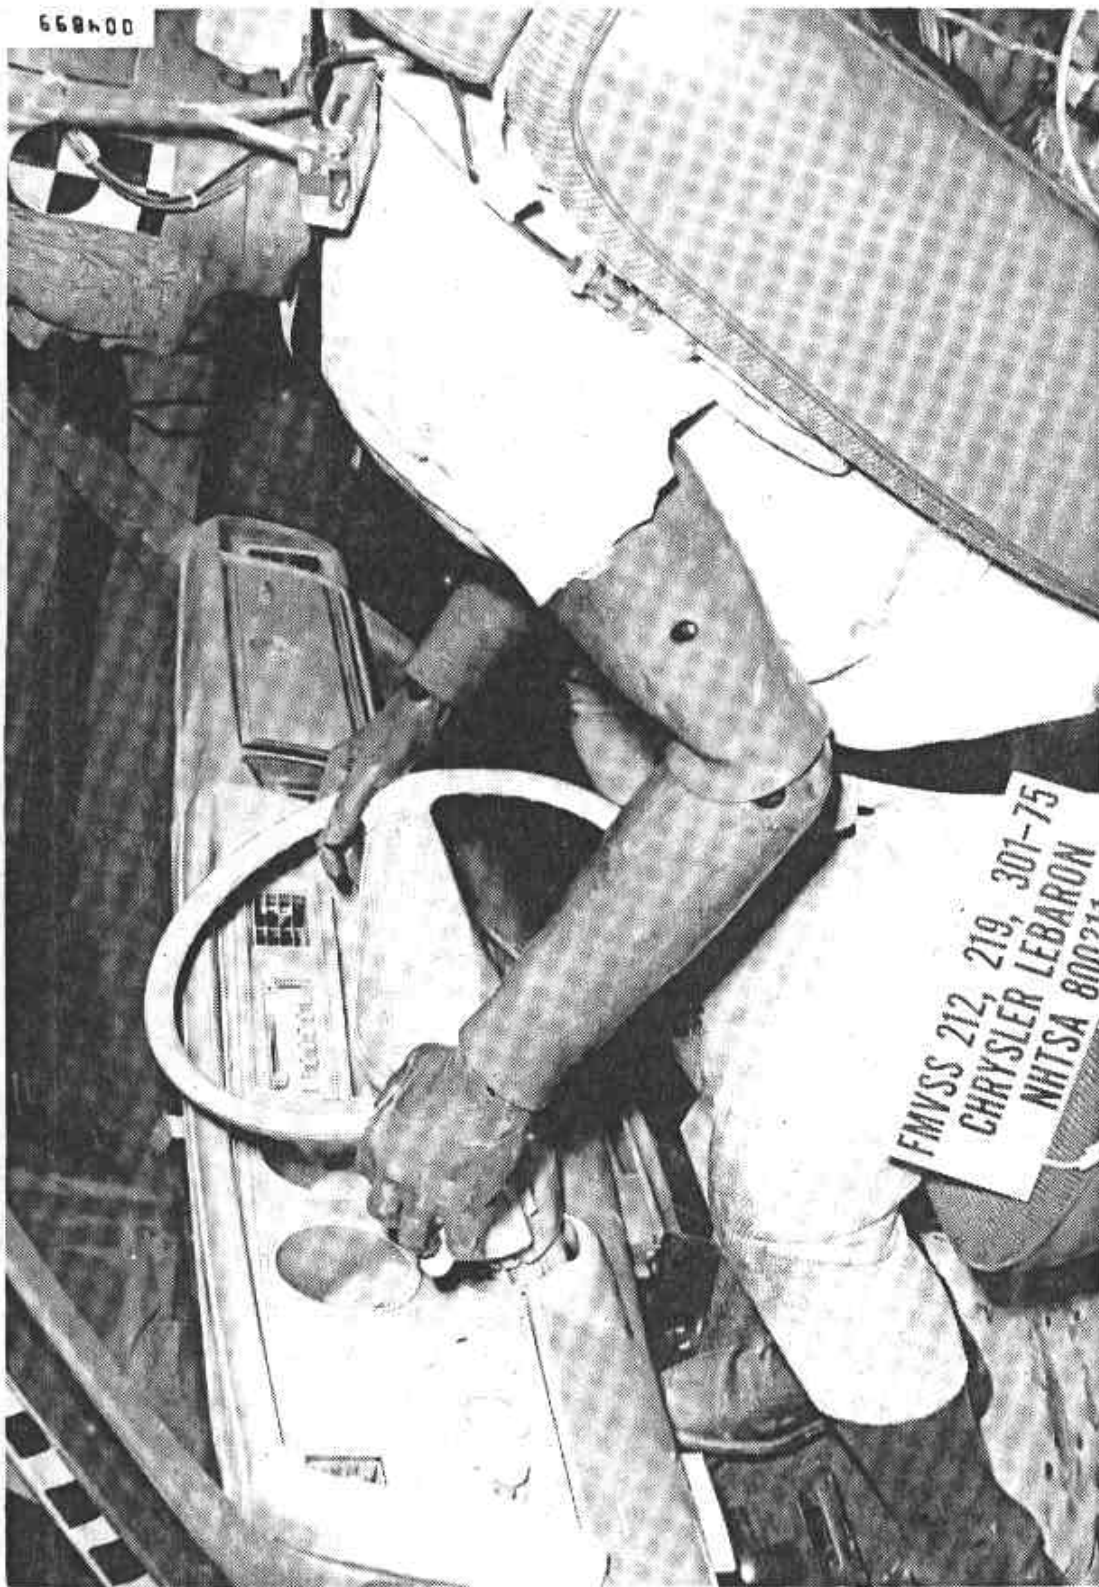
Figure A-6. Pre-test Driver Dummy Position - 1980 Chrysler LeBaron - NHTSA 800311.

All front seat dummies are positioned according to the procedure "OSE RECOMMENDED PROCEDURE FOR POSITIONING PART 572 DUMMIES IN TEST VEHICLE."

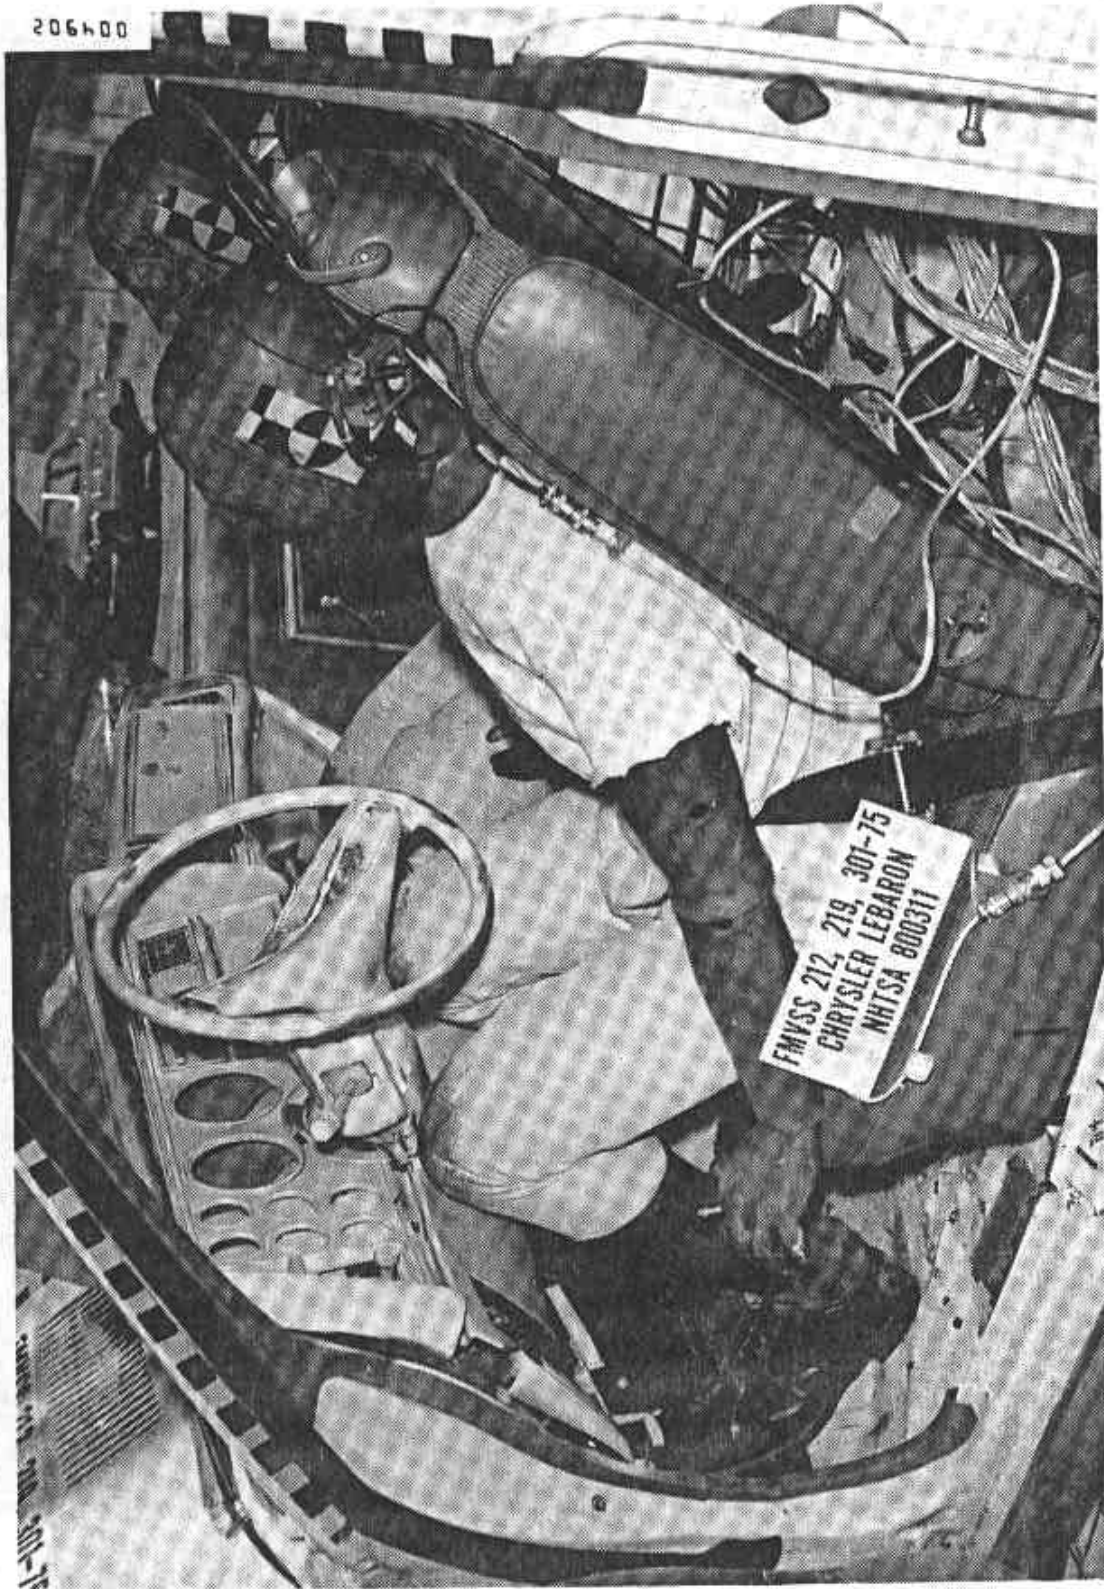
Figure A-7. Post-test Driver Dummy Position - 1980 Chrysler LeBaron - NHTSA 800311.

| | <u>Driver</u> | <u>Passenger</u> |
|---|---|---|
| Head | <u>Steering Wheel hub, rim</u> | <u>None</u> |
| Chest | <u>Steering Wheel hub, rim</u> | <u>None</u> |

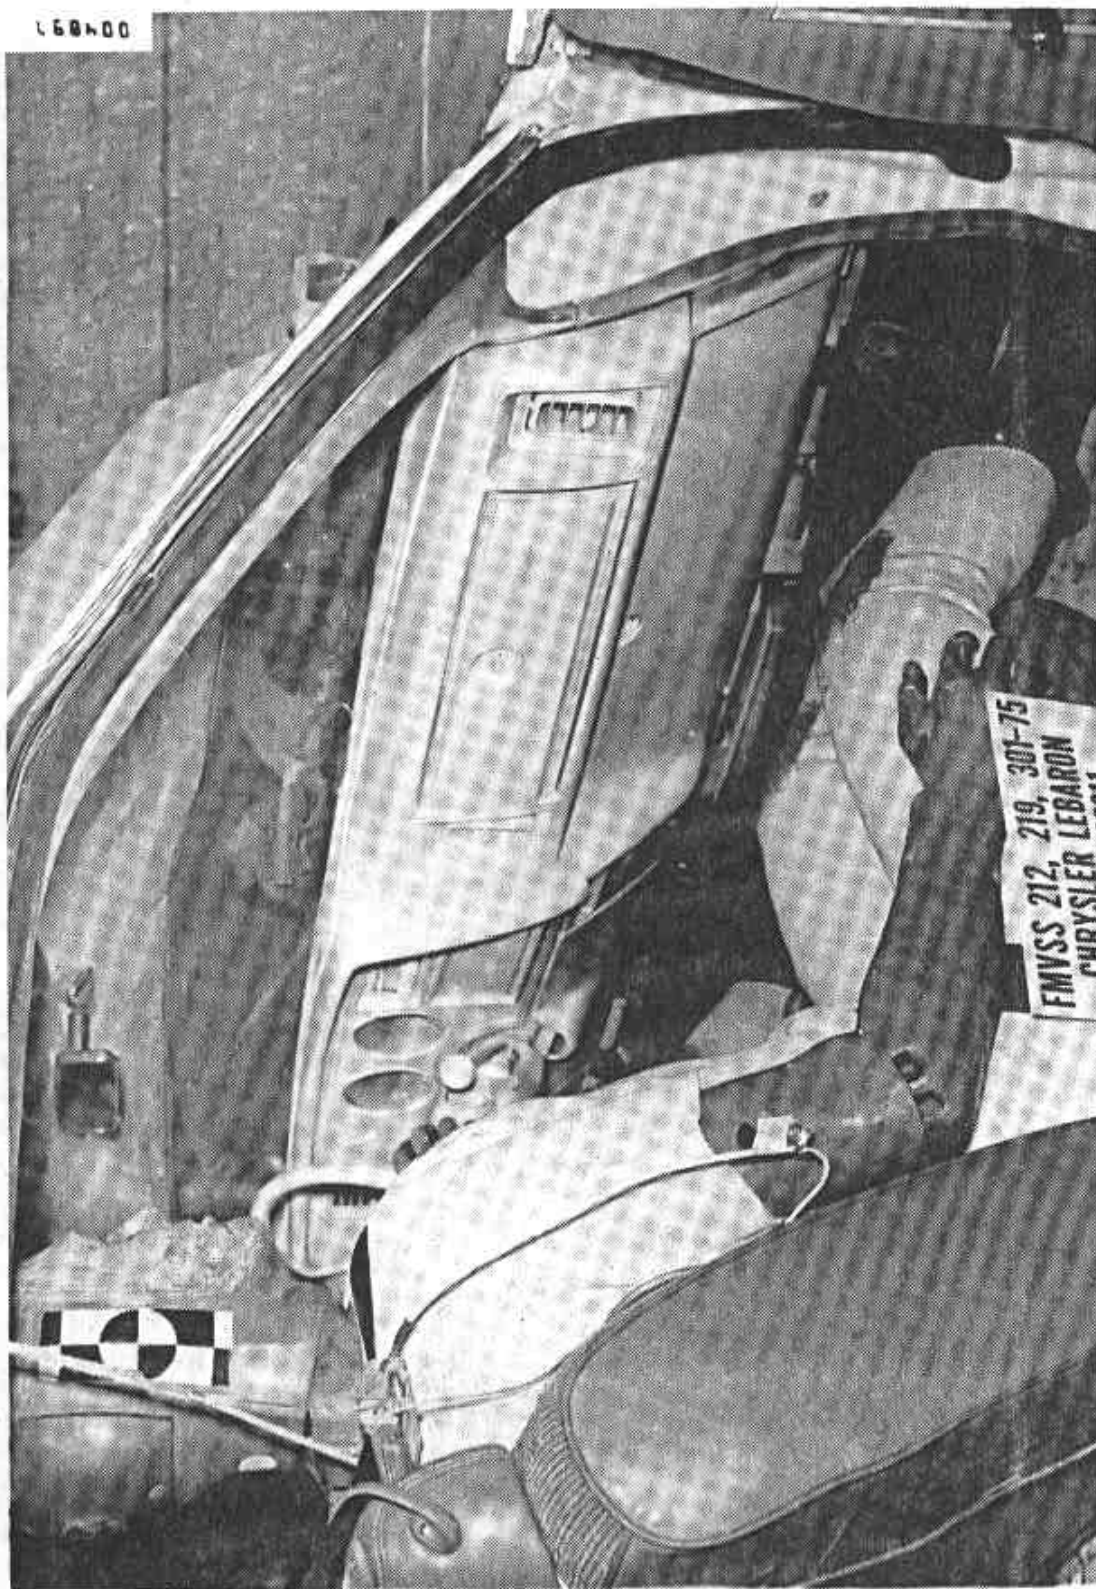
Figure A-8. Pre-test Passenger Position - 1980 Chrysler LeBaron - NHTSA 800311.
