LABORATORY PROCEDURES TO DETERMINE THE  
BREAKAWAY BEHAVIOR OF LUMINAIRE SUPPORTS  
IN MINI-SIZED VEHICLE COLLISIONS

FHWA CONTRACT NO.  
DTFH61-81-C-00036

HIGH SPEED OFFCENTER FRONTAL IMPACT OF A  
MINICOMPACT SEDAN AND A VALIDATED  
SURROGATE BREAKAWAY LUMINAIRE SUPPORT  
TEST RESULTS REPORT  
TEST NUMBER 1469-2A82

12 March 1982

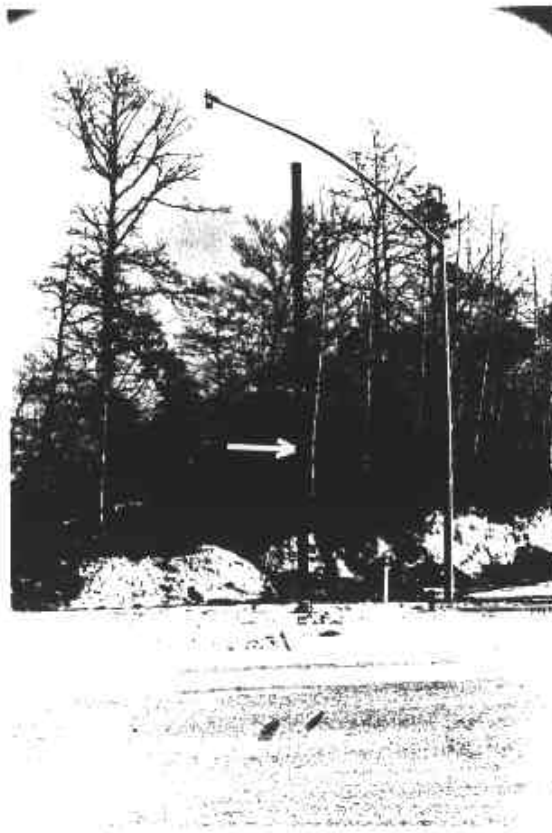
Figure 1. Pre-Crash Photograph of Surrogate  
Breakaway Luminaire Support

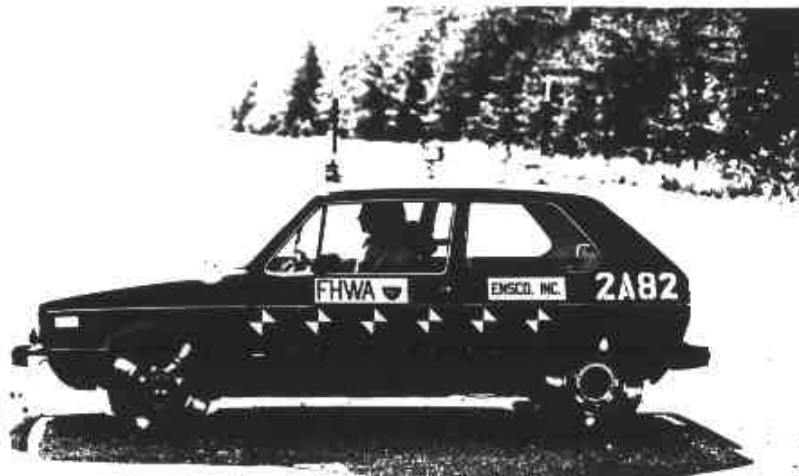
Figure 2. Pre-Test Photograph of Test Vehicle,  
Left Side View

The vehicle was equipped with a triaxial accelerometer package mounted on the lateral centerline of the vehicle at the longitudinal location of the center of gravity. The vehicle was also equipped with a contact switch mounted on the front bumper to permit vehicle and occupant data to be measured relative to the time of impact. The test vehicle is shown in Figures 2 through 5.

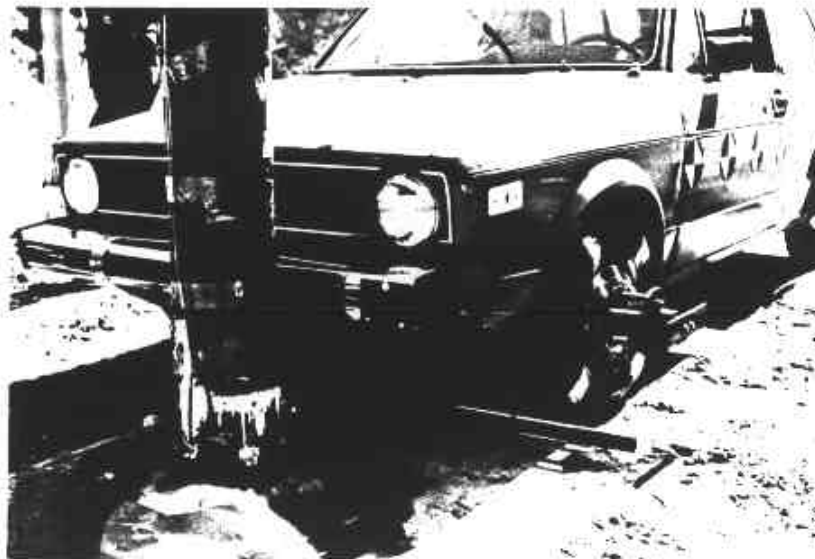
Figure 4. Pre-Test Photograph of Test Vehicle Shown in Contact with Surrogate Luminaire Support, Left Front Angle View

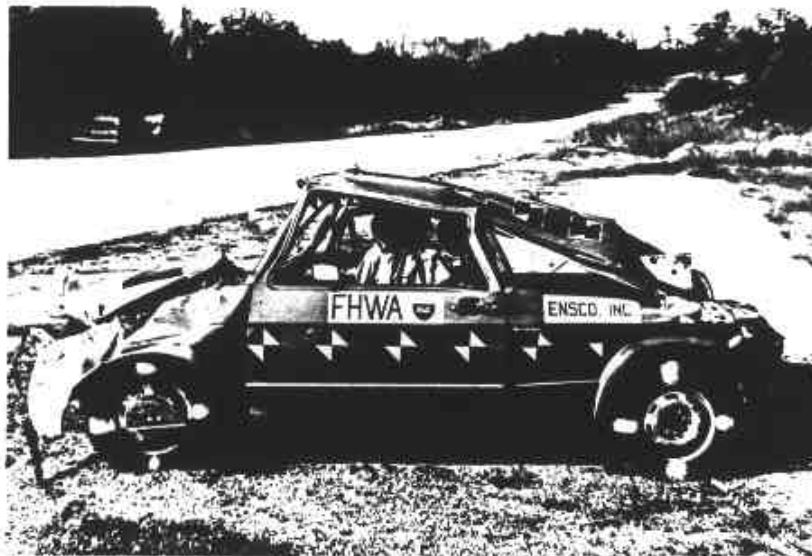
Figure 7. Post-Test Photograph of Test Vehicle,  
Left Side View

The impact conditions were 61.6 mph (27.5 m/s) at the planned impact point of 14.25 inches (0.36 m) to the left of the lateral centerline of the vehicle. The residual crush of the vehicle at the impact point was  $18\frac{1}{2}$  inches (.47 m). The dynamic crush as measured from the film data was  $24\frac{1}{2}$  inches (.62 m). Photographs of the vehicle crush resulting from the collision with the luminaire support and subsequent rollover of the vehicle are shown in Figures 6 through 10.

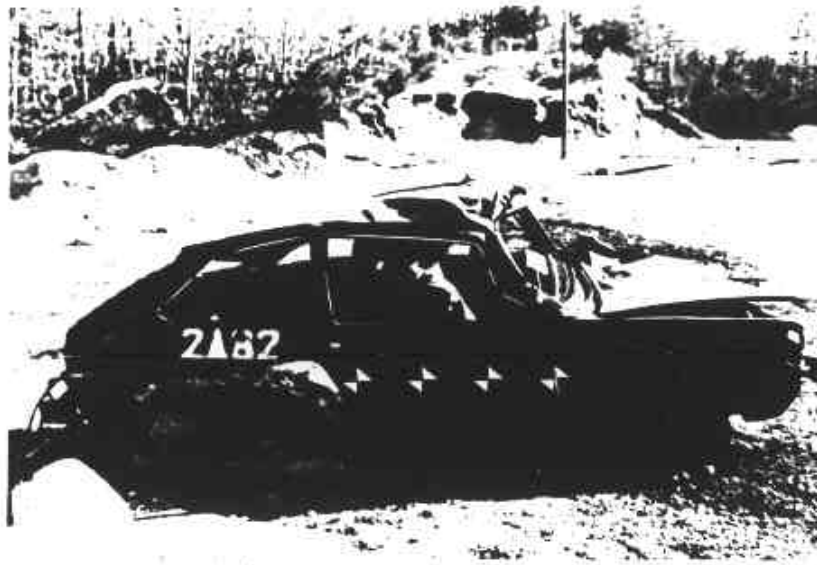
Figure 8. Post-Test Photograph of Test Vehicle,  
Right Side View

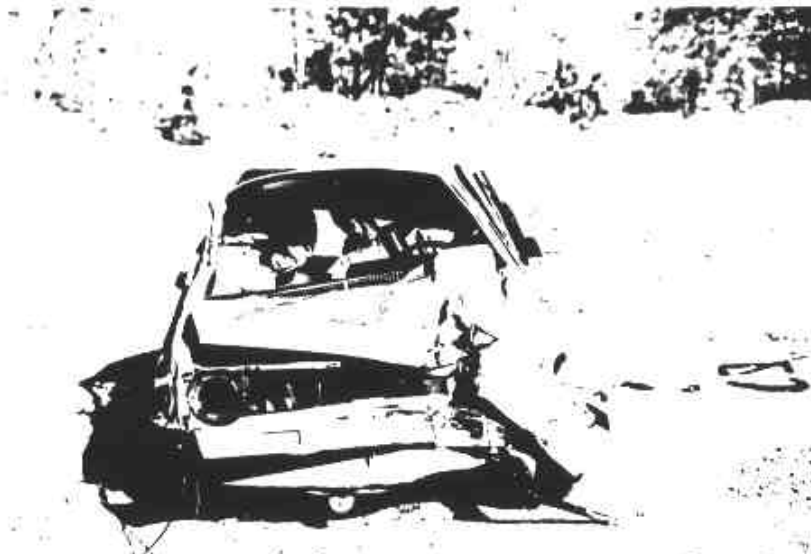
Figure 9. Post-Test Photograph of Test Vehicle,  
Front View

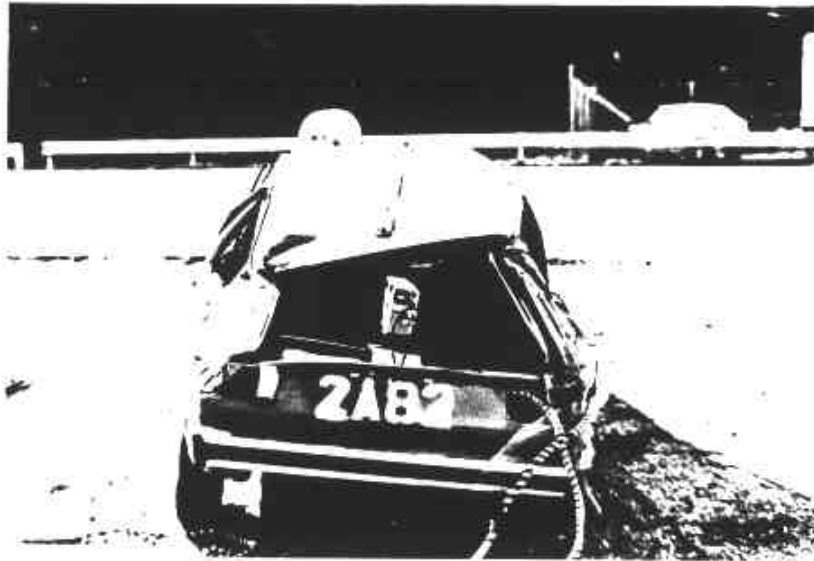
Figure 10. Post-Test Photograph of Test Vehicle,  
Rear View

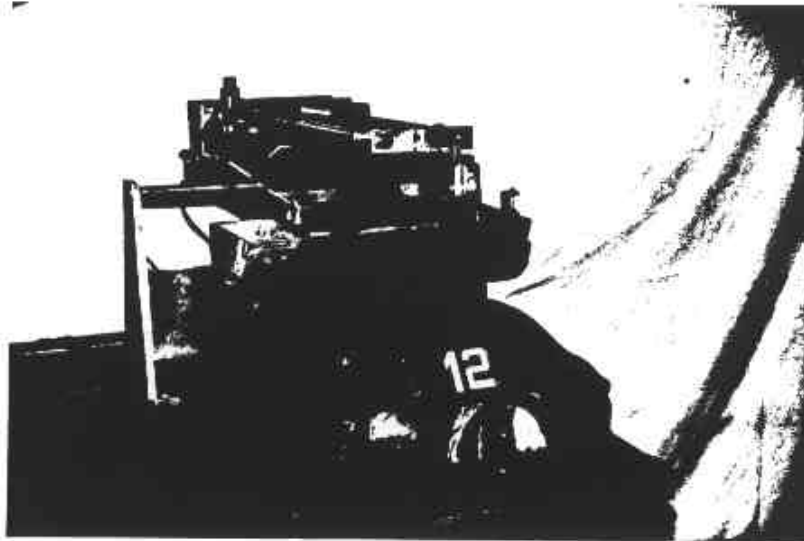
Figure B-11. Abdominal Compression Test Setup with Torso  
in Place for Testing for Part 572.B  
Anthropomorphic Test Dummy Serial Number 186
