LABORATORY PROCEDURES TO DETERMINE THE  
BREAKAWAY BEHAVIOR OF LUMINAIRE SUPPORTS  
IN MINI-SIZED VEHICLE COLLISIONS

LOW SPEED OFF CENTER FRONTAL  
IMPACT OF A MINICOMPACT SEDAN  
AND A VALIDATED SURROGATE  
BREAKAWAY LUMINAIRE SUPPORT

TEST RESULTS REPORT

TEST NUMBER 1469-3A82

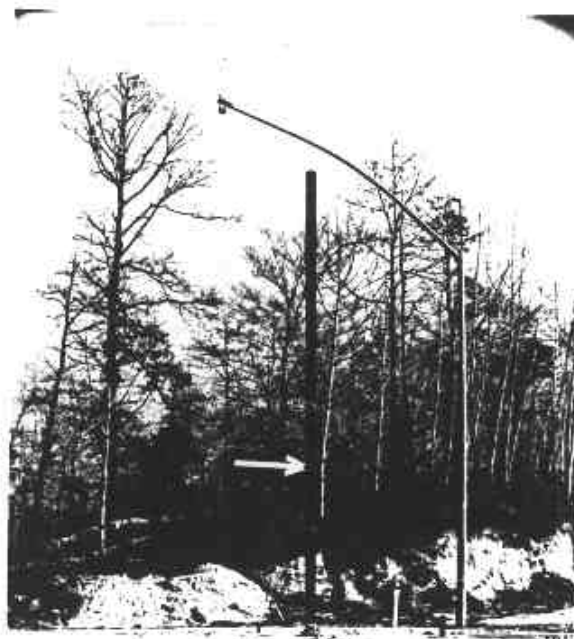
Figure 1. Pre-Crash Photograph of Surrogate Breakaway Luminaire Support

The physical properties of the surrogate breakaway luminaire support are contained in Table 2. The surrogate breakaway luminaire support incorporated a triangular 3-bolt slip base which was designed using the California state plan for a Type 31 support.<sup>13</sup> The luminaire support was installed using the guidelines provided by the California DOT.<sup>13</sup> The slip base was positioned so impact would occur against the lead bolt, which is equivalent to a 30° impact angle with respect to the mast arm.<sup>9</sup> The luminaire support did not have a mast arm attached during this test. The slip base was clamped together with three strain gaged bolts which were tightened to 14,000 pounds (62,300 N) each just prior to the test. The surrogate breakaway luminaire support is shown in Figure 1.

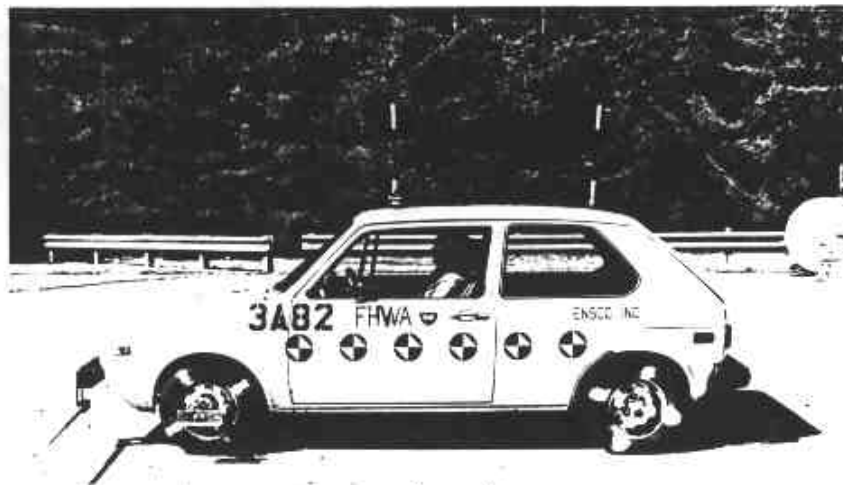
Figure 2. Pretest Photograph of Test Vehicle,  
Left Side View

The vehicle was equipped with a triaxial accelerometer package mounted on the lateral centerline of the vehicle at the longitudinal location of the center of gravity. The vehicle was also equipped with a contact switch mounted on the front bumper to permit vehicle and occupant data to be measured relative to the time of impact. The test vehicle is shown in Figures 2 through 5.

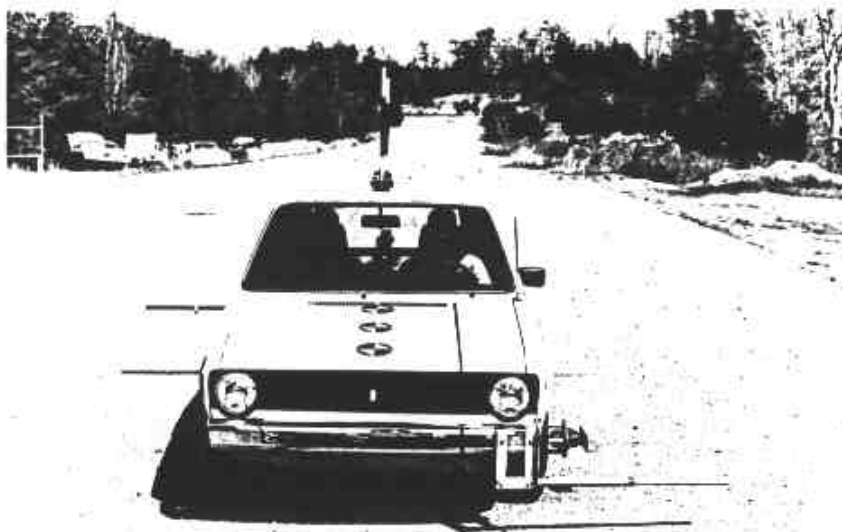
Figure 3. Pretest Photograph of Test Vehicle,  
Front View

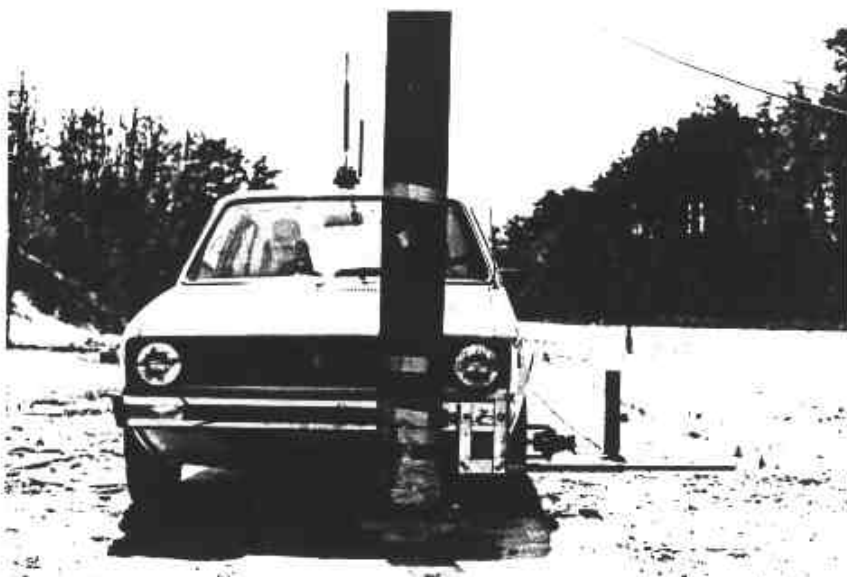
Figure 5. Pretest Photograph of Test Vehicle  
Shown in Contact with Surrogate  
Luminaire Support, Front View

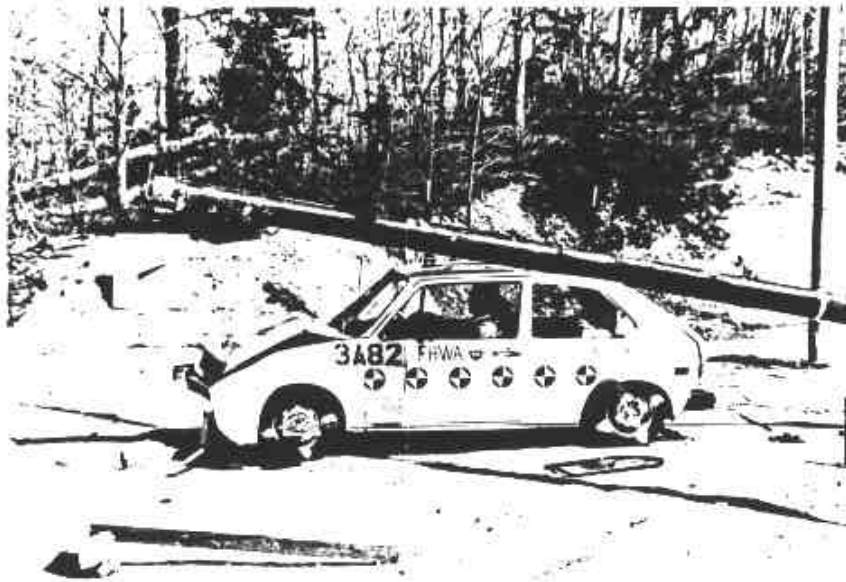
Figure 6. Post-Test Photograph of Test Vehicle,  
Left Side View

The impact conditions were 19.0 mph (8.49 m/s) at a point on the front bumper 12.25 inches (.31 m) to the left of the lateral center line of the vehicle. The residual crush of the vehicle at the impact point was 15.1 inches (.38 m). The dynamic crush as measured from the high speed film data with parallax correction was 19.25 inches (.49m). Photographs of the vehicle and luminaire support after the collision event are shown in Figures 6 through 9.

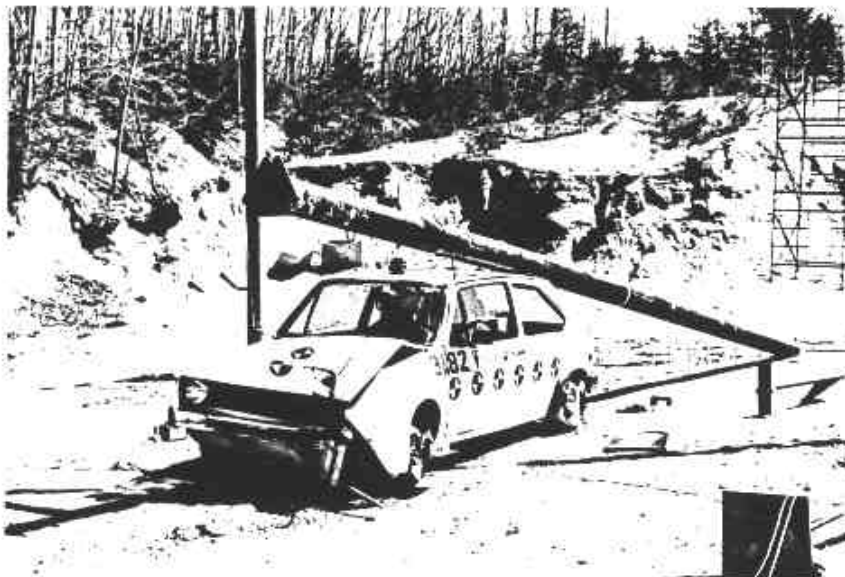
Figure 7. Post-Test Photograph of Test Vehicle,  
Right Angle View

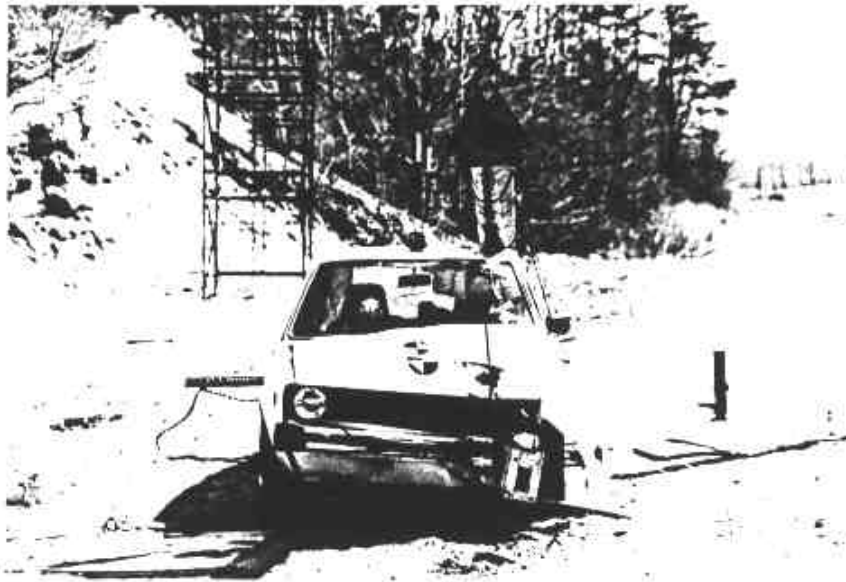
Figure 8. Post-Test Photograph of Test Vehicle,  
Front View

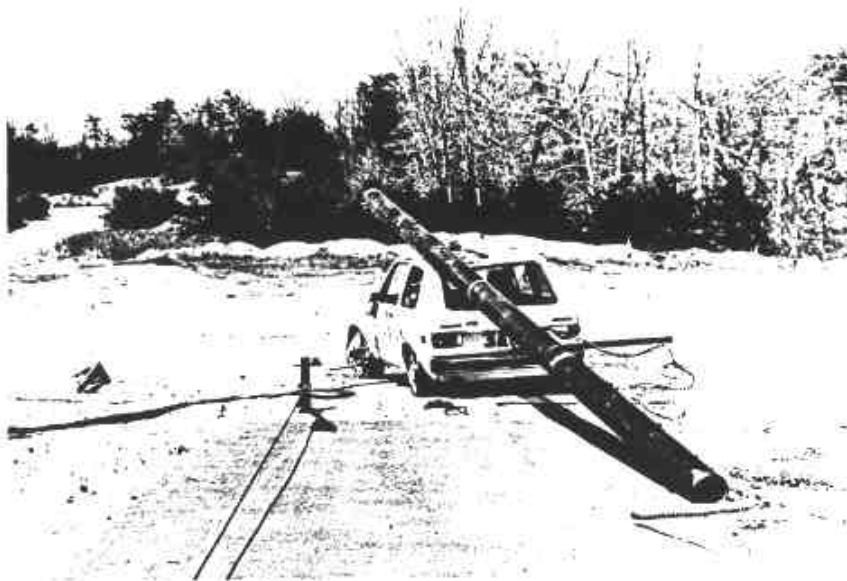
Figure 9. Post-Test Photograph of Test Vehicle,  
Rear View

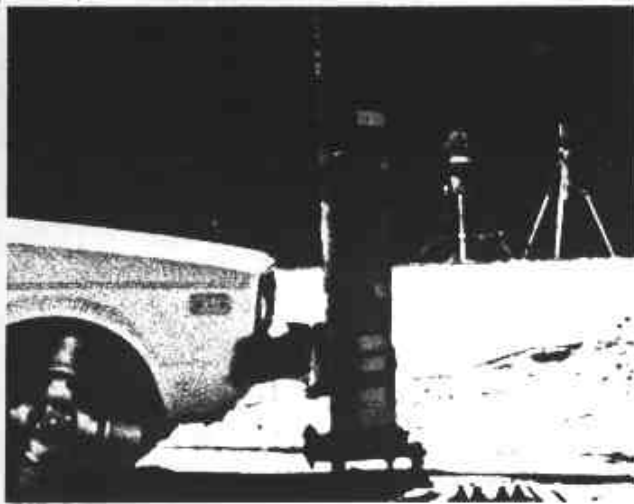
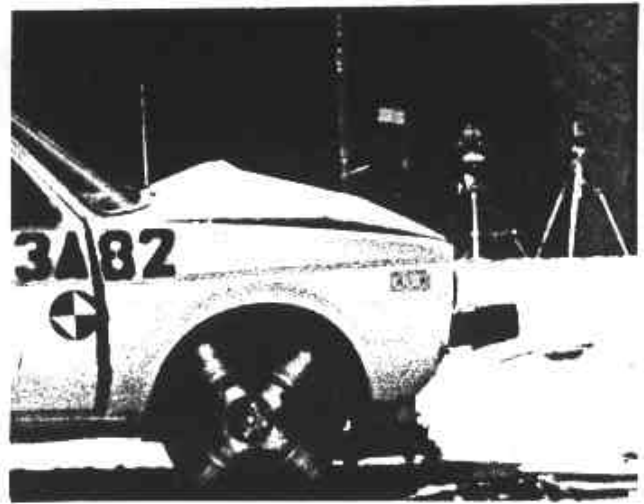
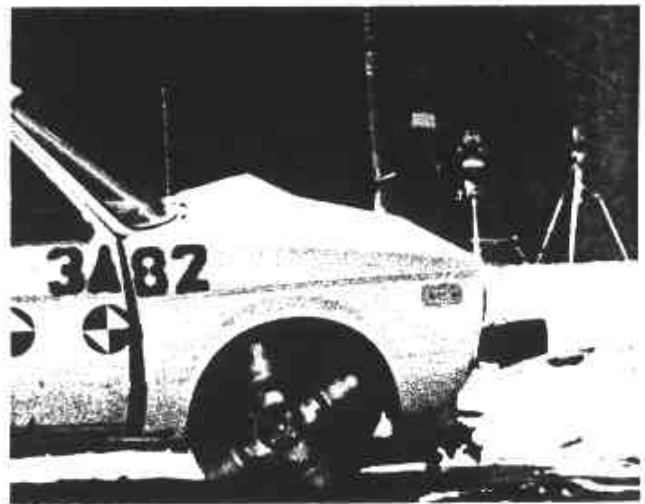
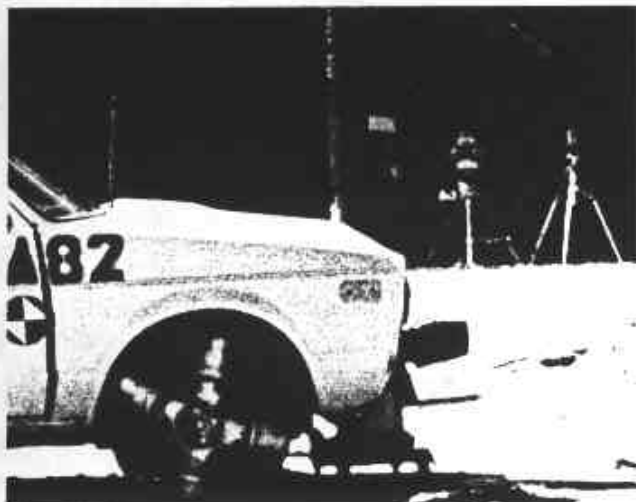
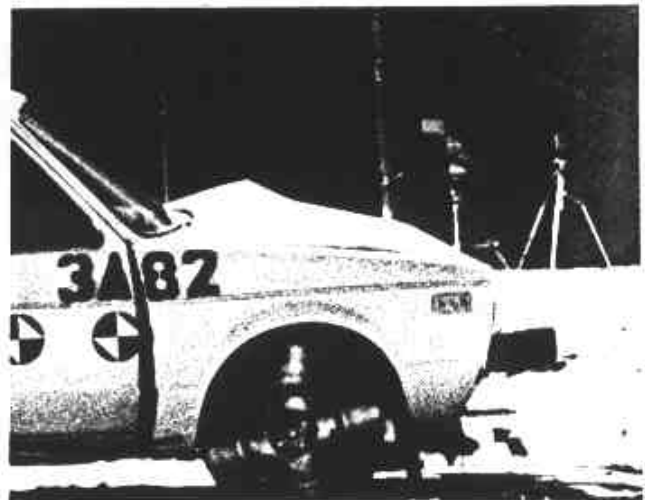
Figure 10. Test Sequence for the Initial Collision Event of Full Scale Crash Test Number 1469-3A82

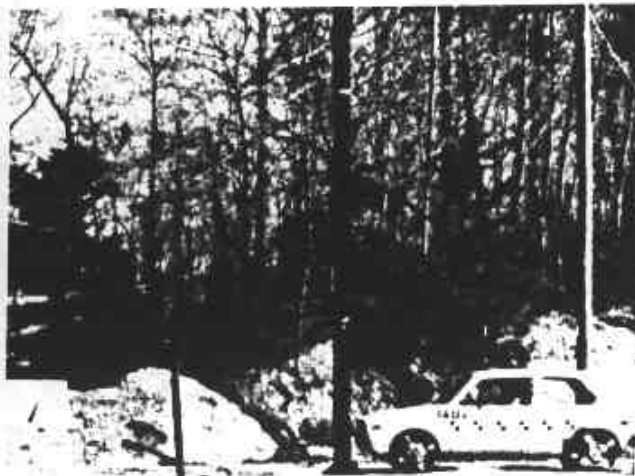
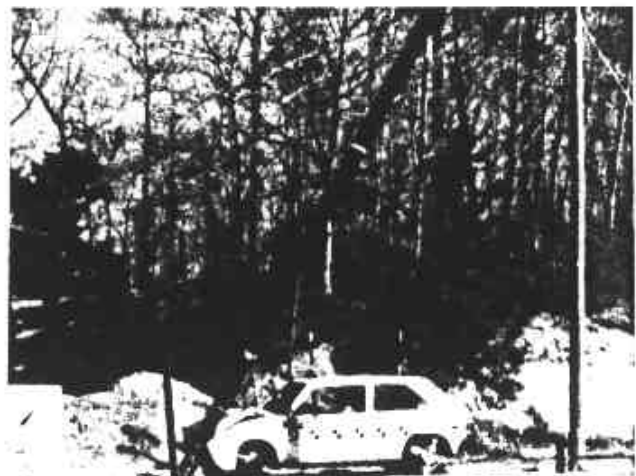
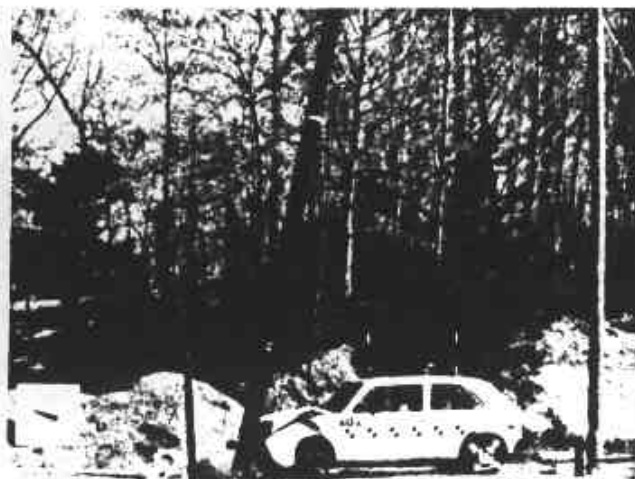
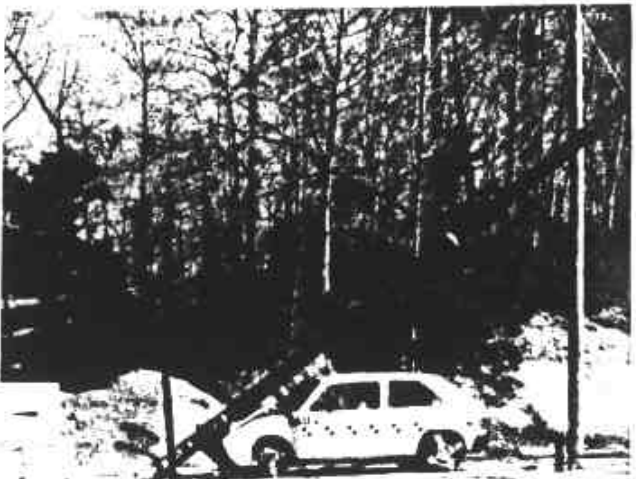
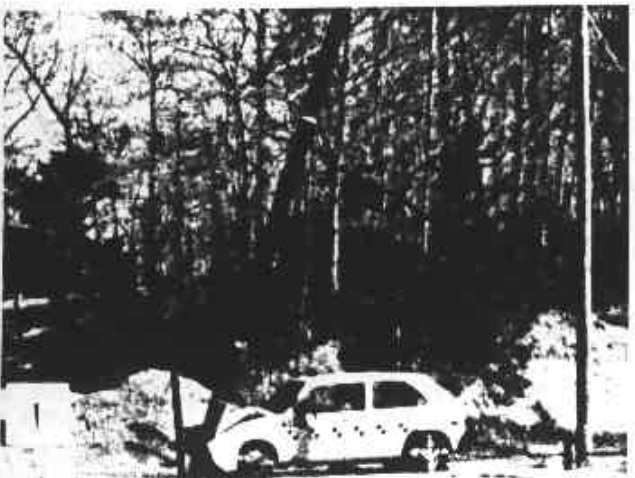
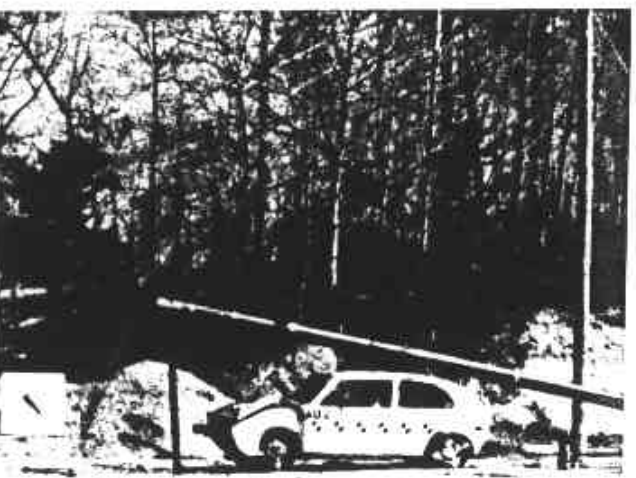
Figure 11. Test Sequence of the Entire Collision Event for Full Scale Crash Test Number 1469-3A82
