DOT 442

TABLE 1  
SUMMARY OF TEST CONDITIONS AND  
RESULTS FOR TEST NUMBER 1469-4A82

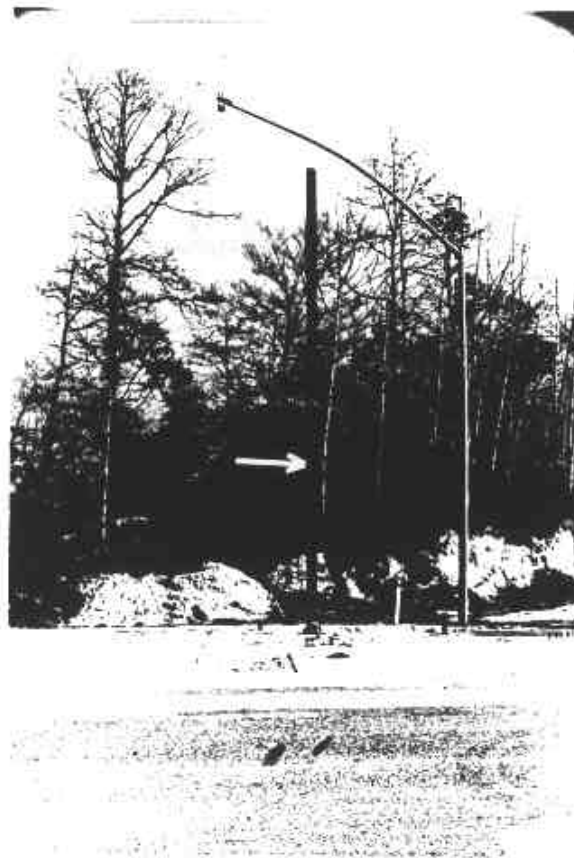
Figure 1. Pre-Crash Photograph of Surrogate Breakaway Luminaire Support

The physical properties of the surrogate breakaway luminaire support are contained in Table 2. The surrogate breakaway luminaire support incorporated a triangular 3-bolt slip base which was designed using the California state plan for a Type 31 support.<sup>13</sup> The luminaire support was installed using the guidelines provided by the California DOT.<sup>13</sup> The slip base was positioned so impact would occur against the lead bolt, which is equivalent to a 30° impact angle with respect to the mast arm.<sup>9</sup> The luminaire support did not have a mast arm attached during this test. The slip base was clamped together with three strain gaged bolts which were tightened to 14,000 pounds (62,300 N) each just prior to the test. The surrogate breakaway luminaire support is shown in Figure 1.

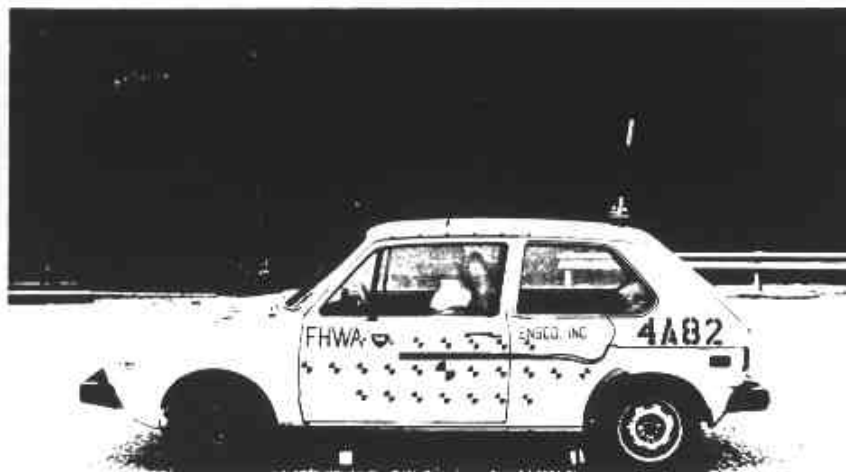
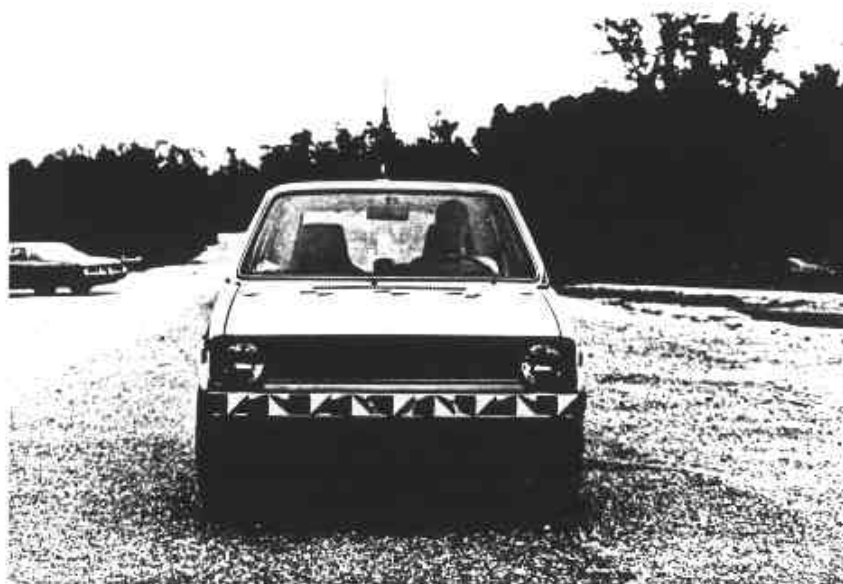
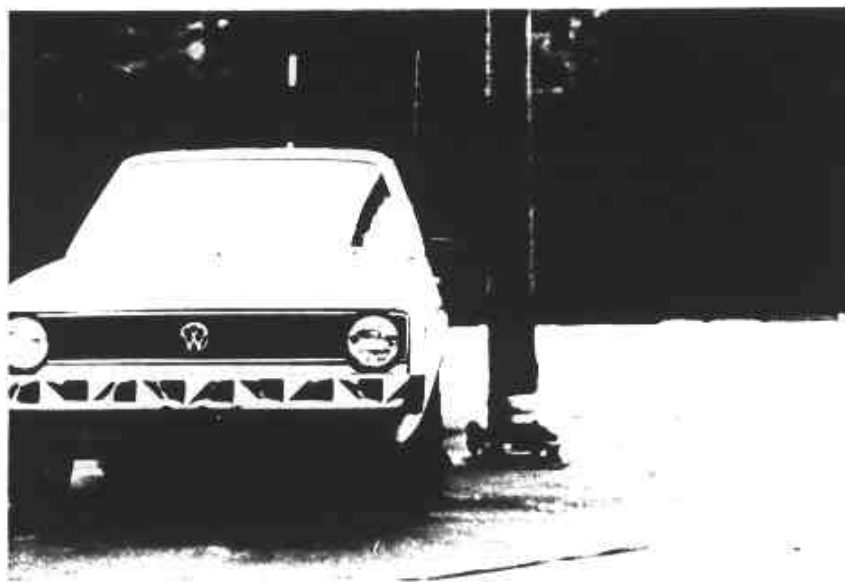
The vehicle was equipped with a triaxial accelerometer package mounted on the lateral centerline of the vehicle at the longitudinal location of the center of gravity. The vehicle was also equipped with a contact switch mounted on the left door to permit vehicle and occupant data to be measured relative to the time of impact. The test vehicle is shown in Figures 2 through 5.

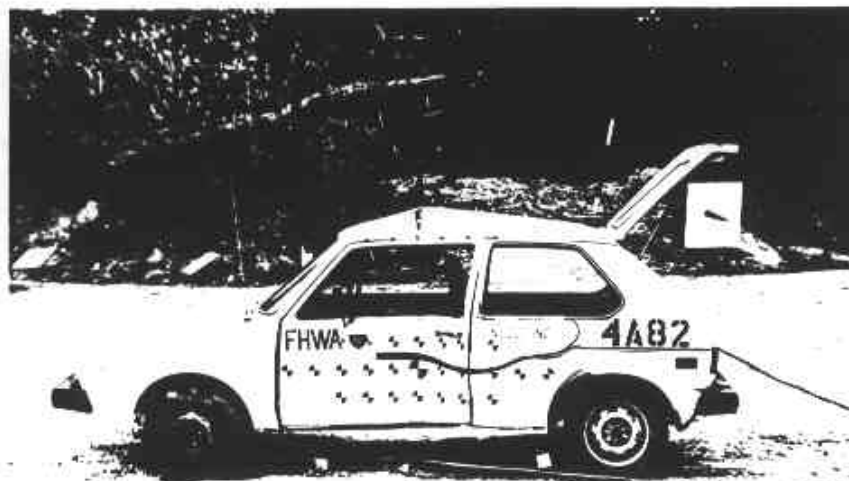
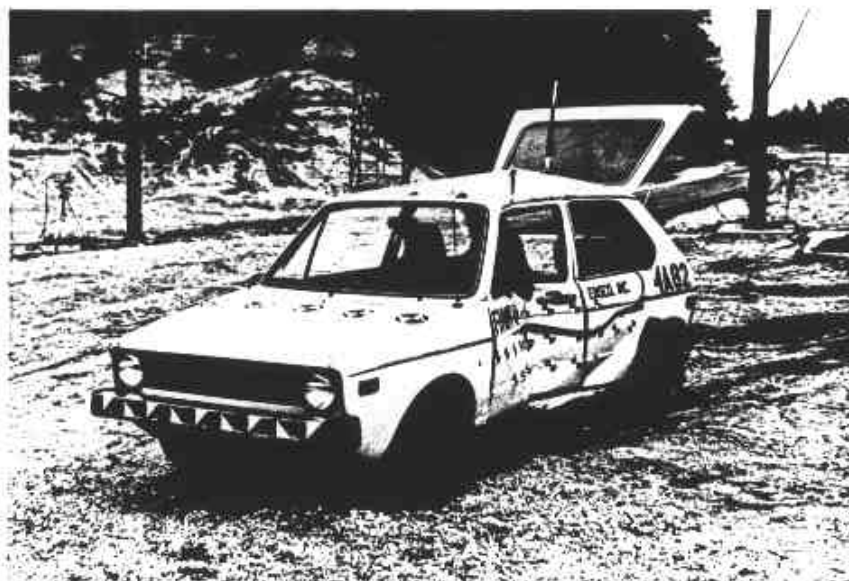
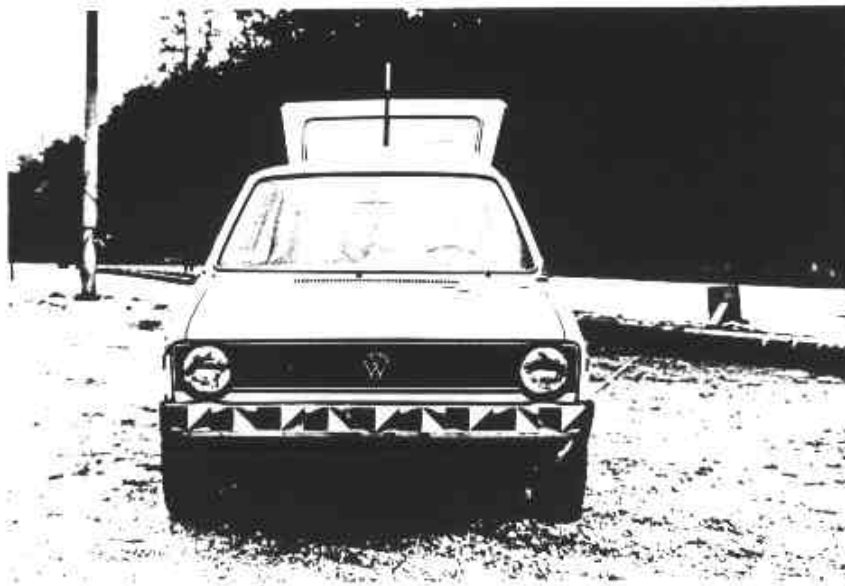
The impact conditions were 30.4 mph (13.58 m/s) at a point on the left door in line with the occupant 15.8 in (.40 m) behind the longitudinal location of the center of gravity of the vehicle in its inertial test configuration. The maximum residual crush of the vehicle at the impact point was 11.4 inches (.29 m). The maximum residual intrusion into vehicle compartment was 8.75 in (.22 m). Photographs of the vehicle and luminaire support after the collision event are shown in Figures 6 through 9.

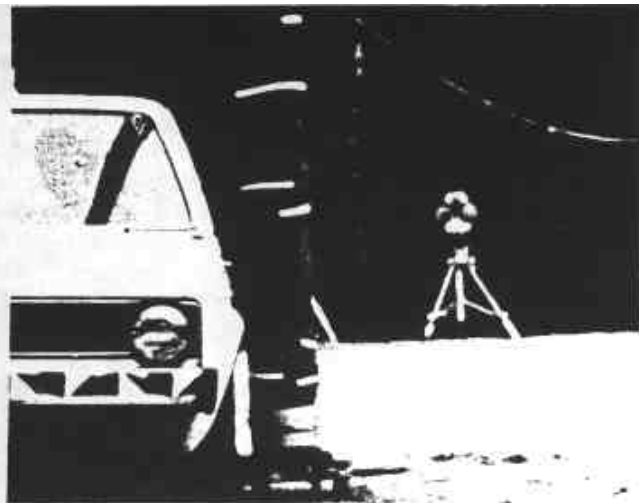
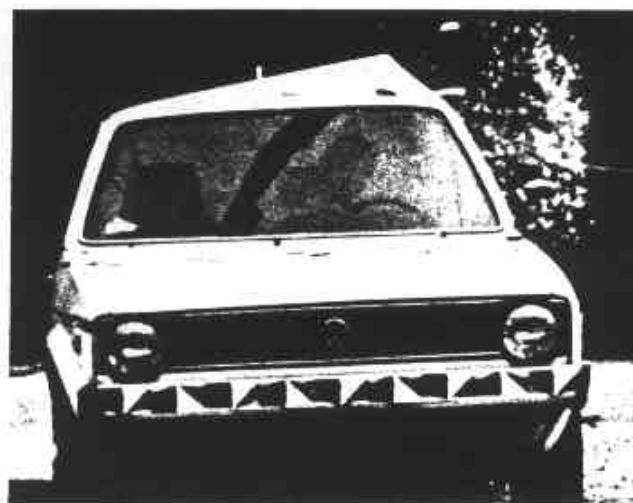
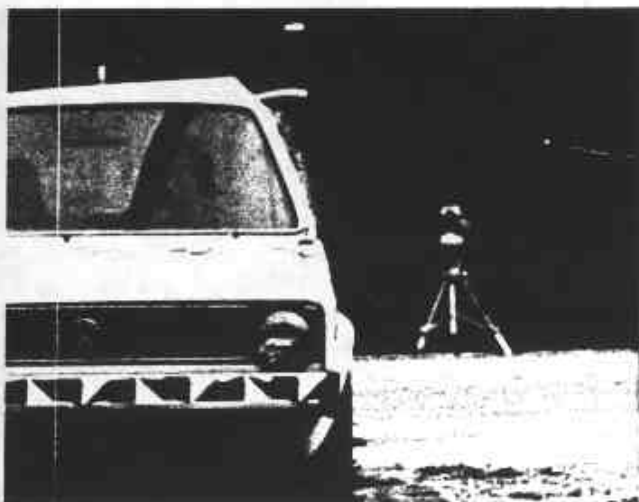
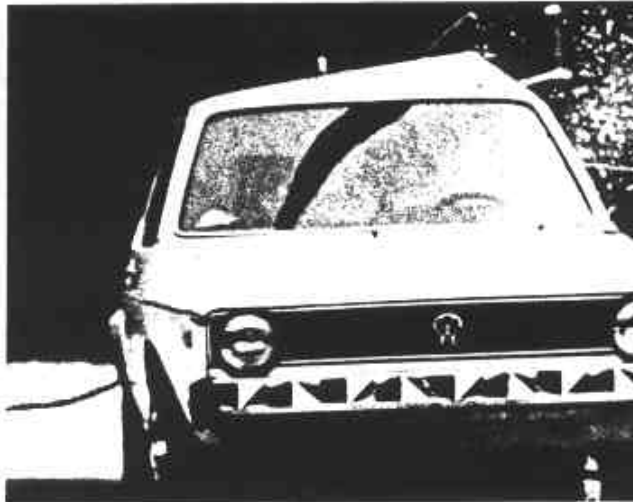
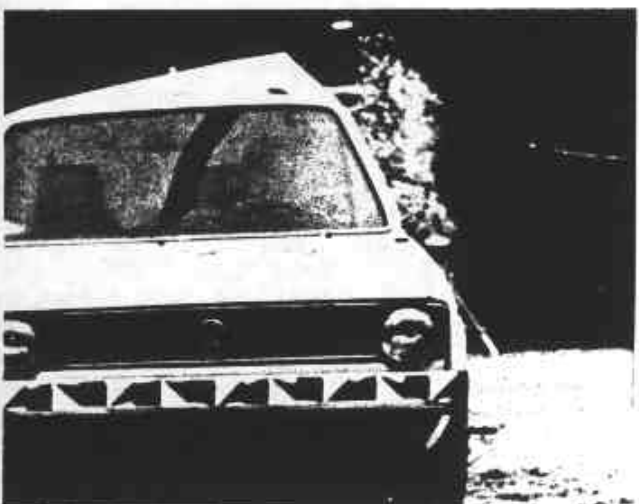
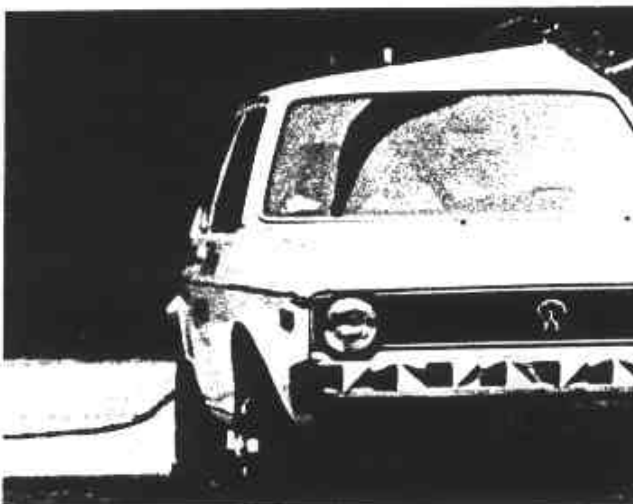
Figure 10. Test Sequence for the Initial Collision Event  
of Full Scale Crash Test Number 1469-4A82

Initiation of the breakaway fracture mechanism of the luminaire support occurred at approximately .020 seconds after impact. The force levels at the time of initiation of the breakaway fracture mechanism of the luminaire support were 25,600 pounds and 31,600 pounds based on the vehicle acceleration data filtered at SAE Class 60 and 180, respectively.

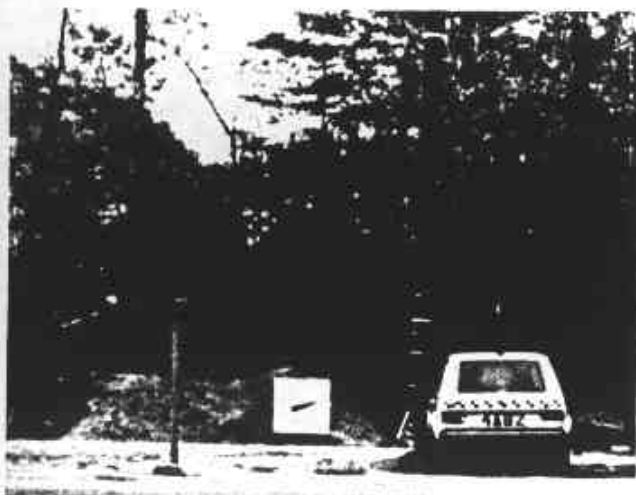
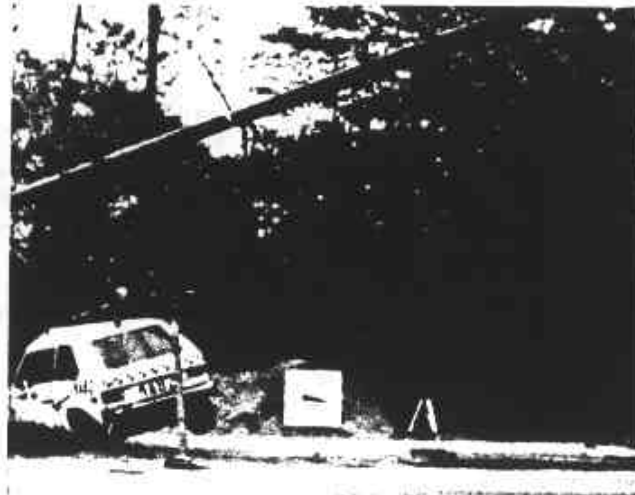
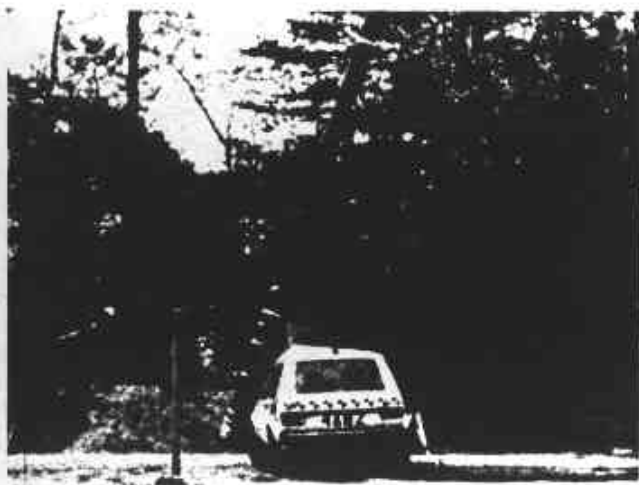
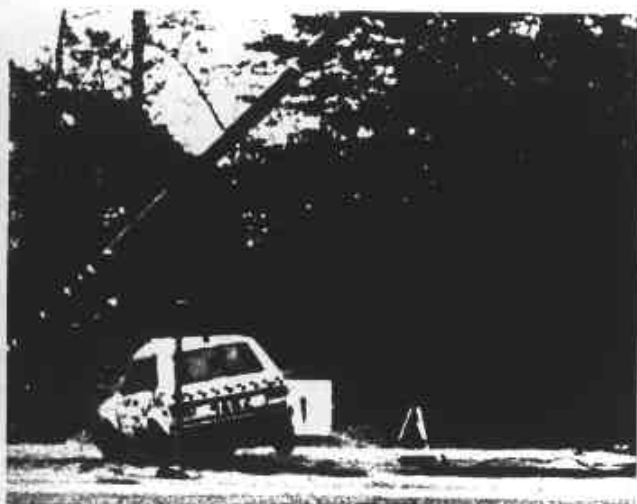
Figure 11. Test Sequence of the Entire Collision Event  
for Full Scale Crash Test Number 1469-4A82

After the initial separation from the vehicle the luminaire support translated forward at a speed of 14.2 f/s (4.33 m/s) with a rotation rate of 2.15 rad/sec. The luminaire support rotated up and over the test vehicle without any secondary impacts. As the support rotated away, vehicle yawed counter clockwise and rolled up on its left tires and wheels. The maximum roll angle was less than  $10^{\circ}$ . The vehicle then settled back on all 4 tires and continued forward away from the impact area after yawing a total of about  $72^{\circ}$ . The final resting position was about 13 feet to the right of the impact approach path and 44.6 feet downstream. The top of the luminaire support impacted the ground 3.3 feet behind and .4 feet to the right of the original center line position of the luminaire support. The test sequence is depicted in Figures 10 and 11. The dimensional relationships for full scale crash test number 1469-4A82 are shown in Figure 12. The residual test vehicle crush and interior intrusion resulting from the collision event were measured at the locations shown in Figure 13 and are given in Table 8.
