REPORT NO. 6851-V-5

NEW CAR ASSESSMENT AND STANDARDS

1982 VOLKSWAGEN SCIROCCO

NHTSA 703-5-540

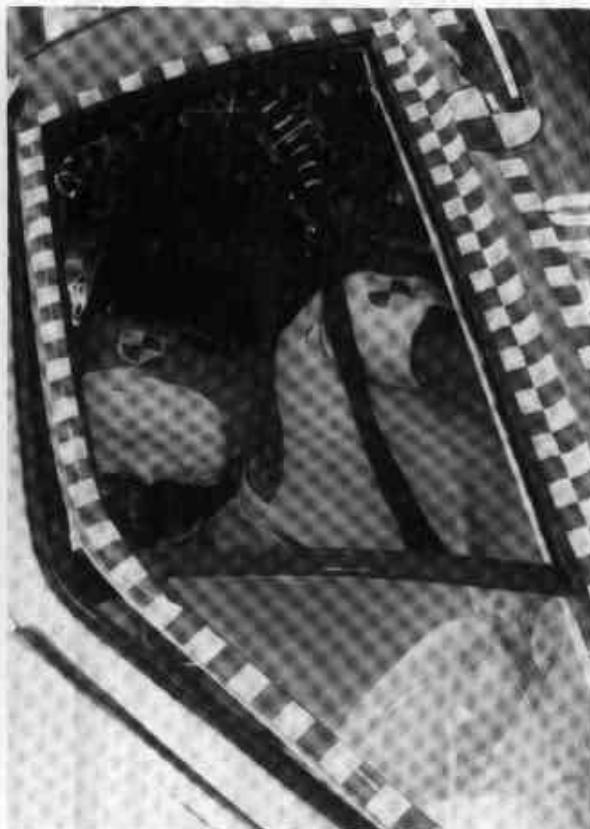
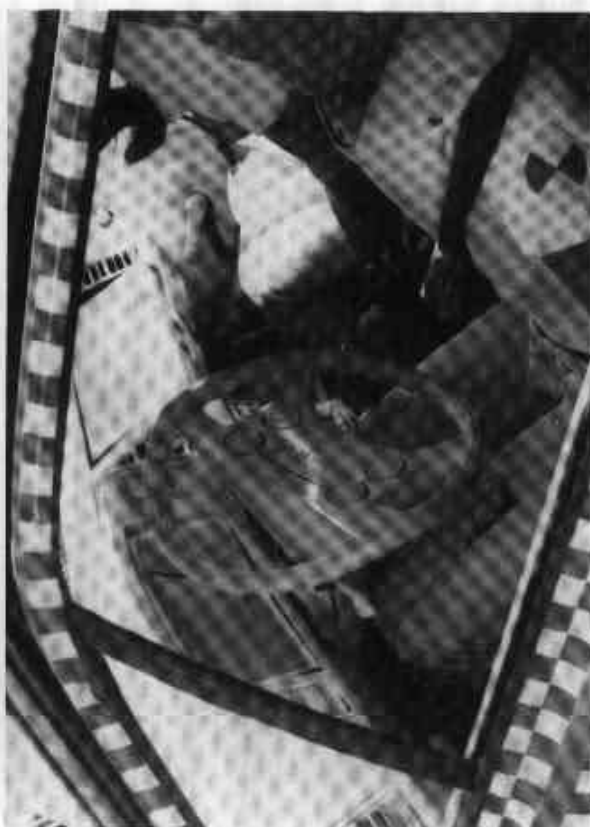
FIGURE A-10 PRE- AND POST-TEST DRIVER VIEWS

The driver failed to comply with the FMVSS 208 Head Injury Criteria with a HIC number of 1473 but did comply with the chest and femur injury criteria with maximum chest decelerations over 3 milliseconds of 54 g's and femur loads of 275 and 330 pounds. The driver's head struck the upper steering wheel rim and center hub. Belt spool-out for the driver was 2.75 inches and belt stretch was .62 inches per foot, both measured between the retractor and the "D" ring.

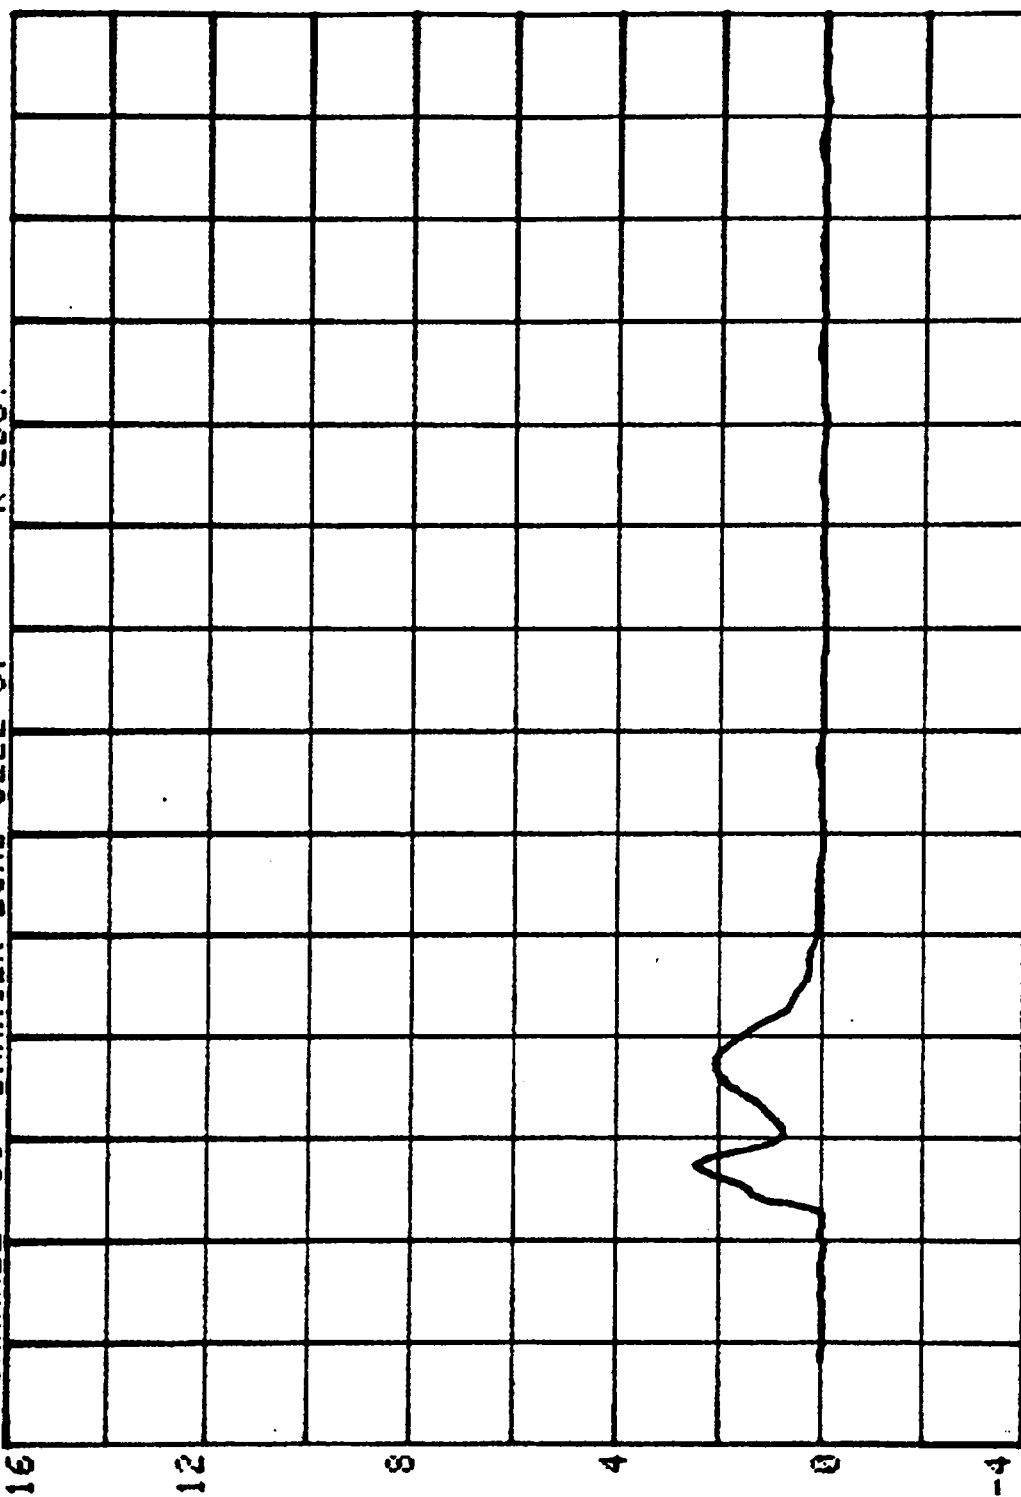
CHANNEL 61 BARRIER LOAD CELL C8 RUN= 540 SERIES= 5 K LBS.

The 71 channels of data were recorded on six 14-channel FM tape recorders. Appendix B contains the vehicle and dummy response data traces, and the Injury Criteria Value is presented in Table 9. All 71 data channels checked out prior to the test and the only data loss experienced during impact was Barrier Load Cell B9. Since load cell B9 is located on the far right side of the barrier (Figure 9), it probably experienced no force at impact. Load Cell B9 was not included in the summation of total load cell barrier forces.
