REPORT NO. 6851-V-6

NEW CAR ASSESSMENT AND STANDARDS  
ENFORCEMENT INDICANT TESTING  
FMVSS NOS. 212, 219 AND 301-75

SAAB SCANIA  
1982 SAAB 900  
4-DOOR SEDAN

NHTSA 703-6-541

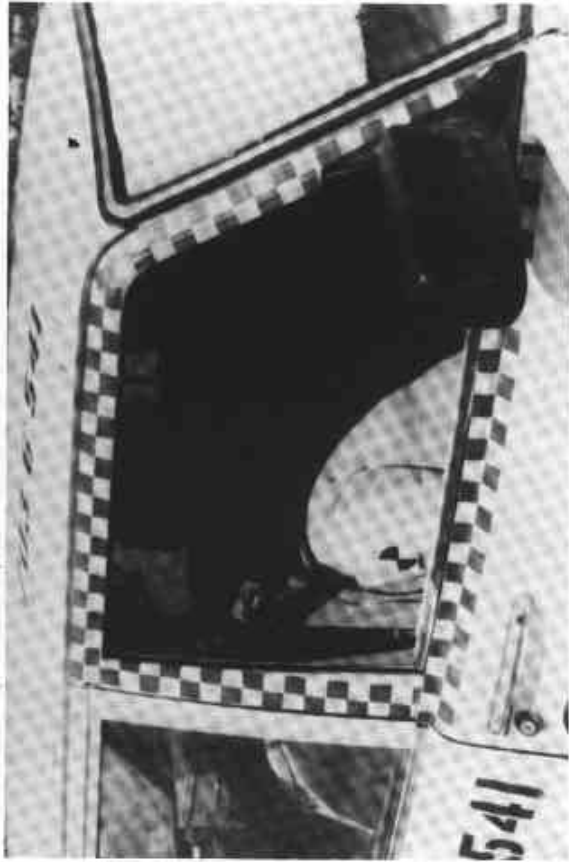
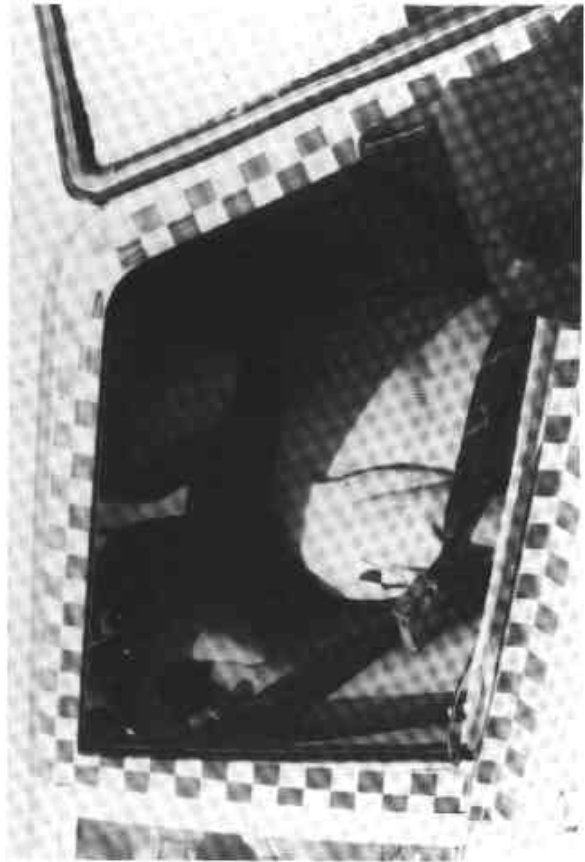
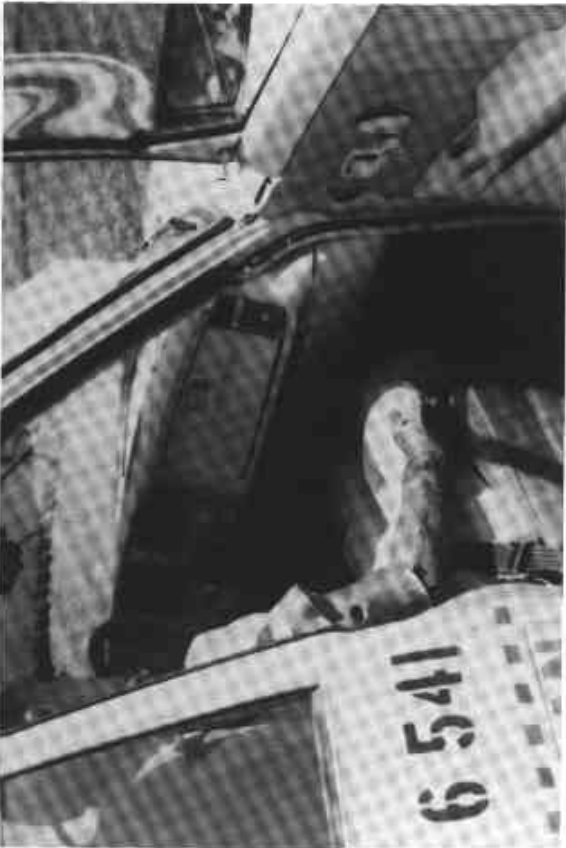
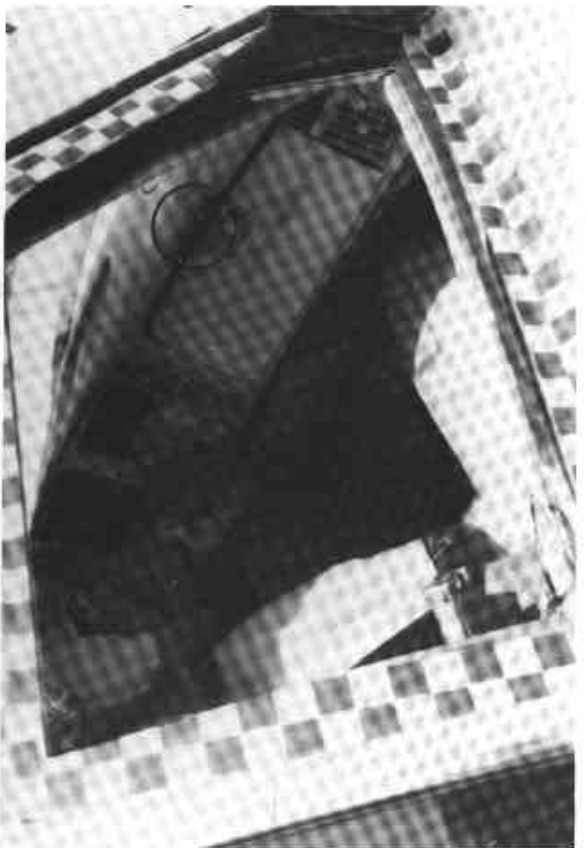
Figure A-11 Pre- and Post-Test Right Front Passenger Views

The right front passenger head struck the dash panel (Figure A-11) and failed to comply with the FMVSS 208 Head Injury Criteria with a HIC of 1164 but did comply with a maximum chest deceleration over 3 msec. of 35 g's
