REPORT NO. 971-3882-49-M

OCCUPANT RESPONSE  
AND  
VEHICLE ACCELERATION  
IN A  
30 MPH FRONTAL IMPACT TEST

FORD MOTOR COMPANY  
1983 FORD R100 RANGER STYLESIDE - PICKUP  
NHTSA 830603

FINAL REPORT

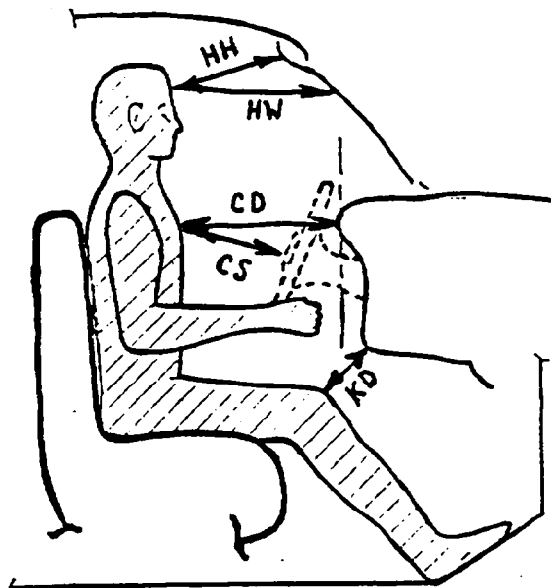
TABLE 3-2

PART 572 DUMMY PRE-TEST CLEARANCE DISTANCES

DRIVER

HH = 17.5 in.

HW = 20.7 in.

HR = 9.1 in.

HS = 11.5 in.

CD = 23.0 in.

CS = 13.4 in.

AD = 5.0 in.

HD = 7.5 in.

KD = 7.6 in.

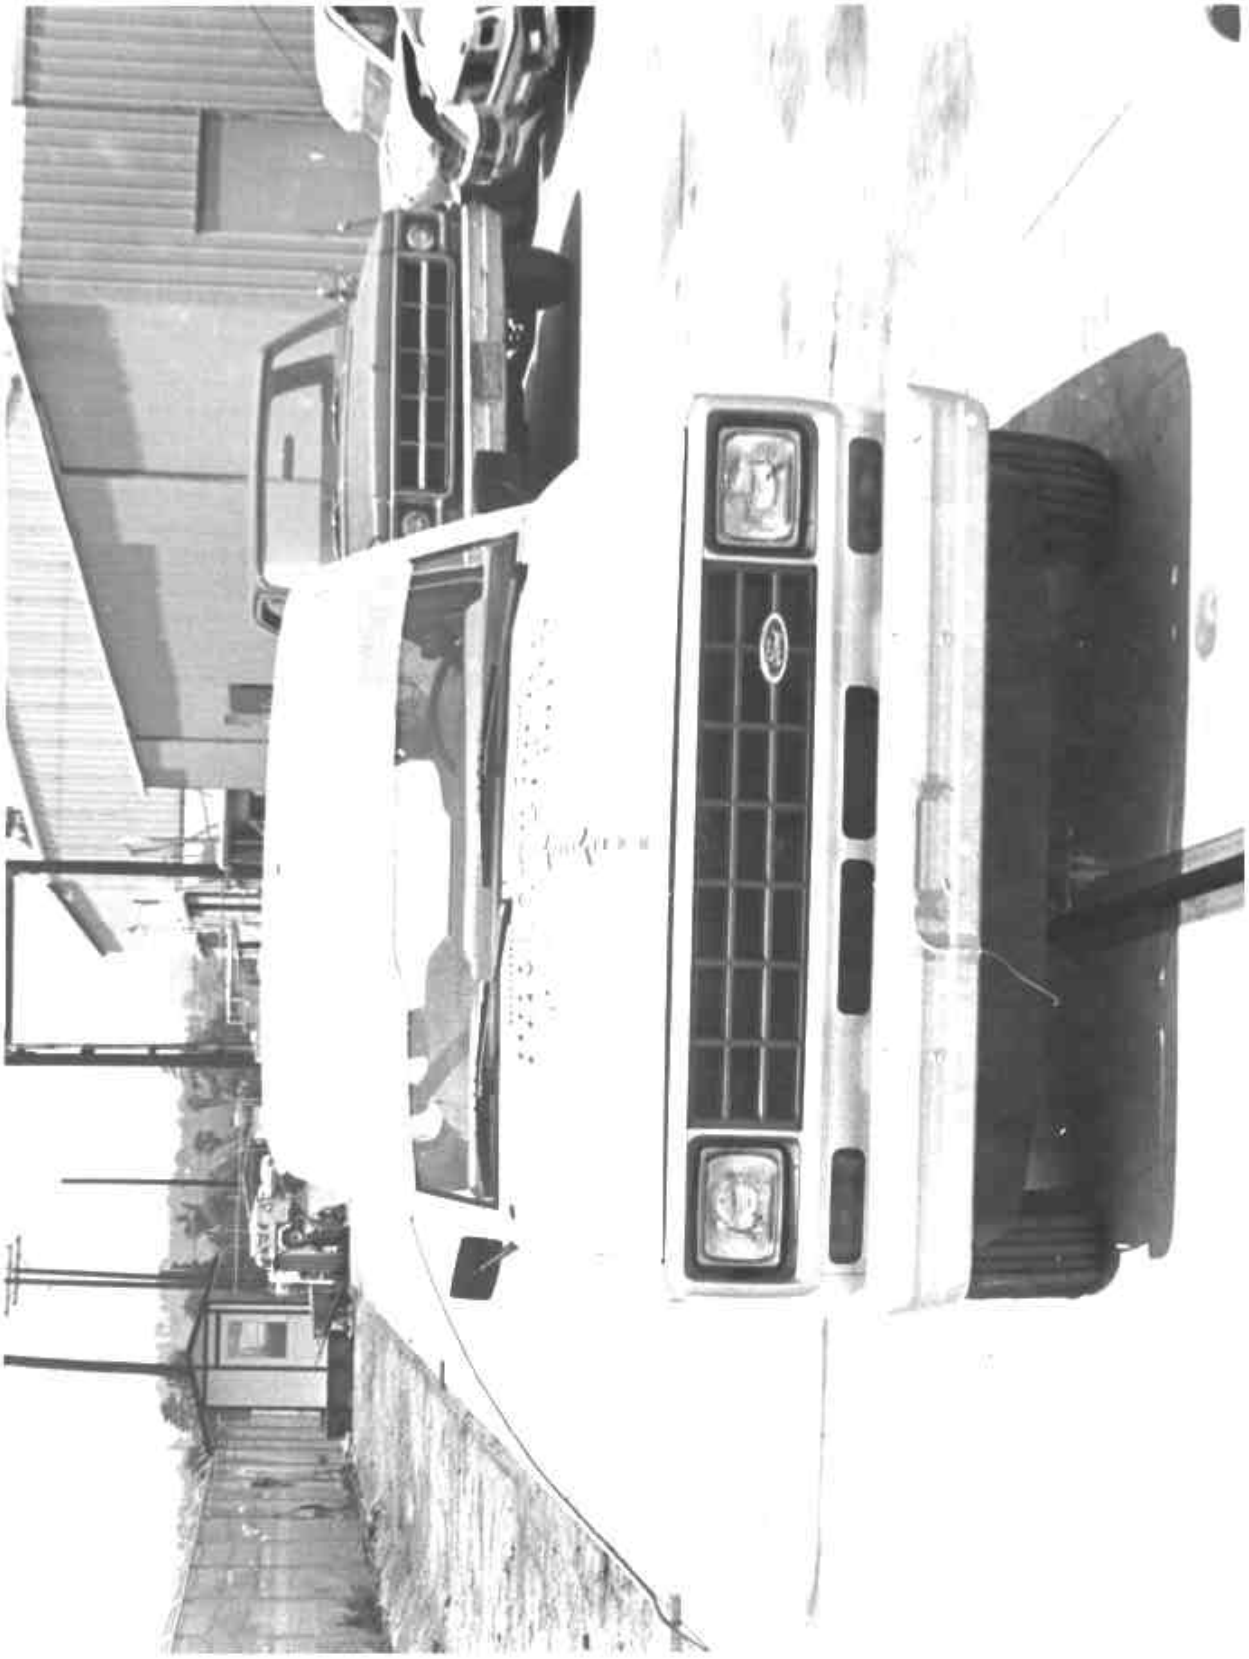
Figure 3-1  
1983 Ford R100 Ranger Styleside - Pickup  
NHTSA 830603  
Pre-Test, Full Front View

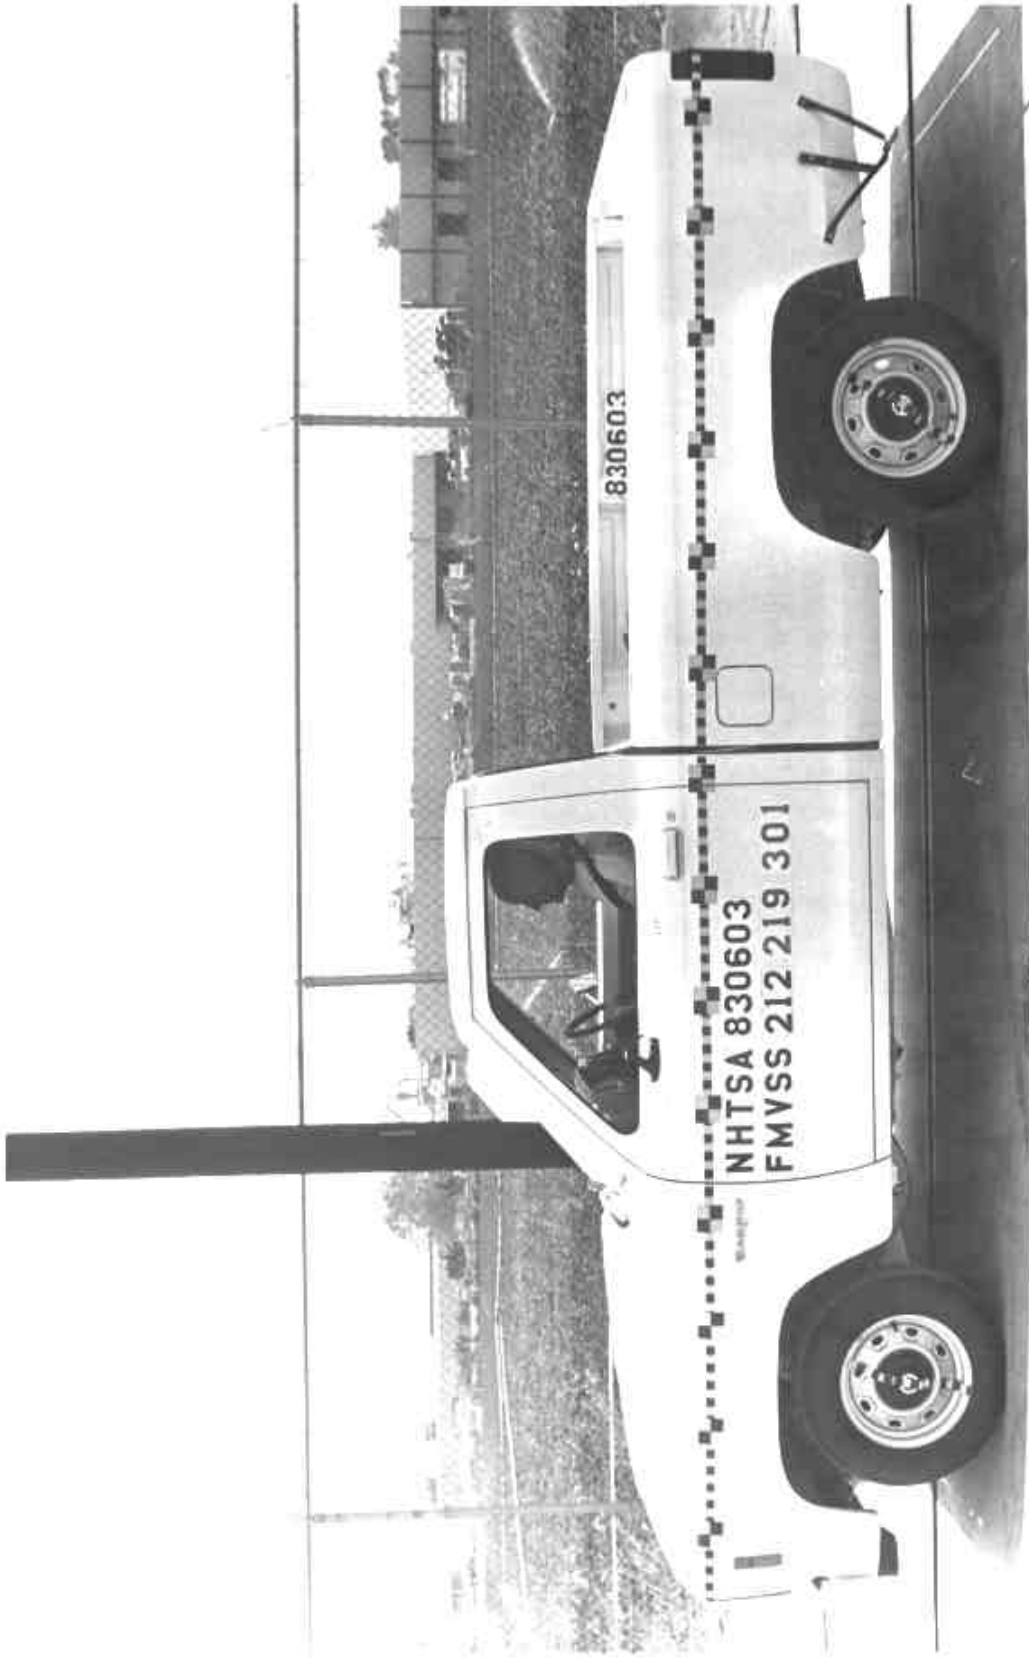
Figure 3-2  
1983 Ford R100 Ranger Styleside - Pickup  
NHTSA 830603  
Pre-Test, Left Side View

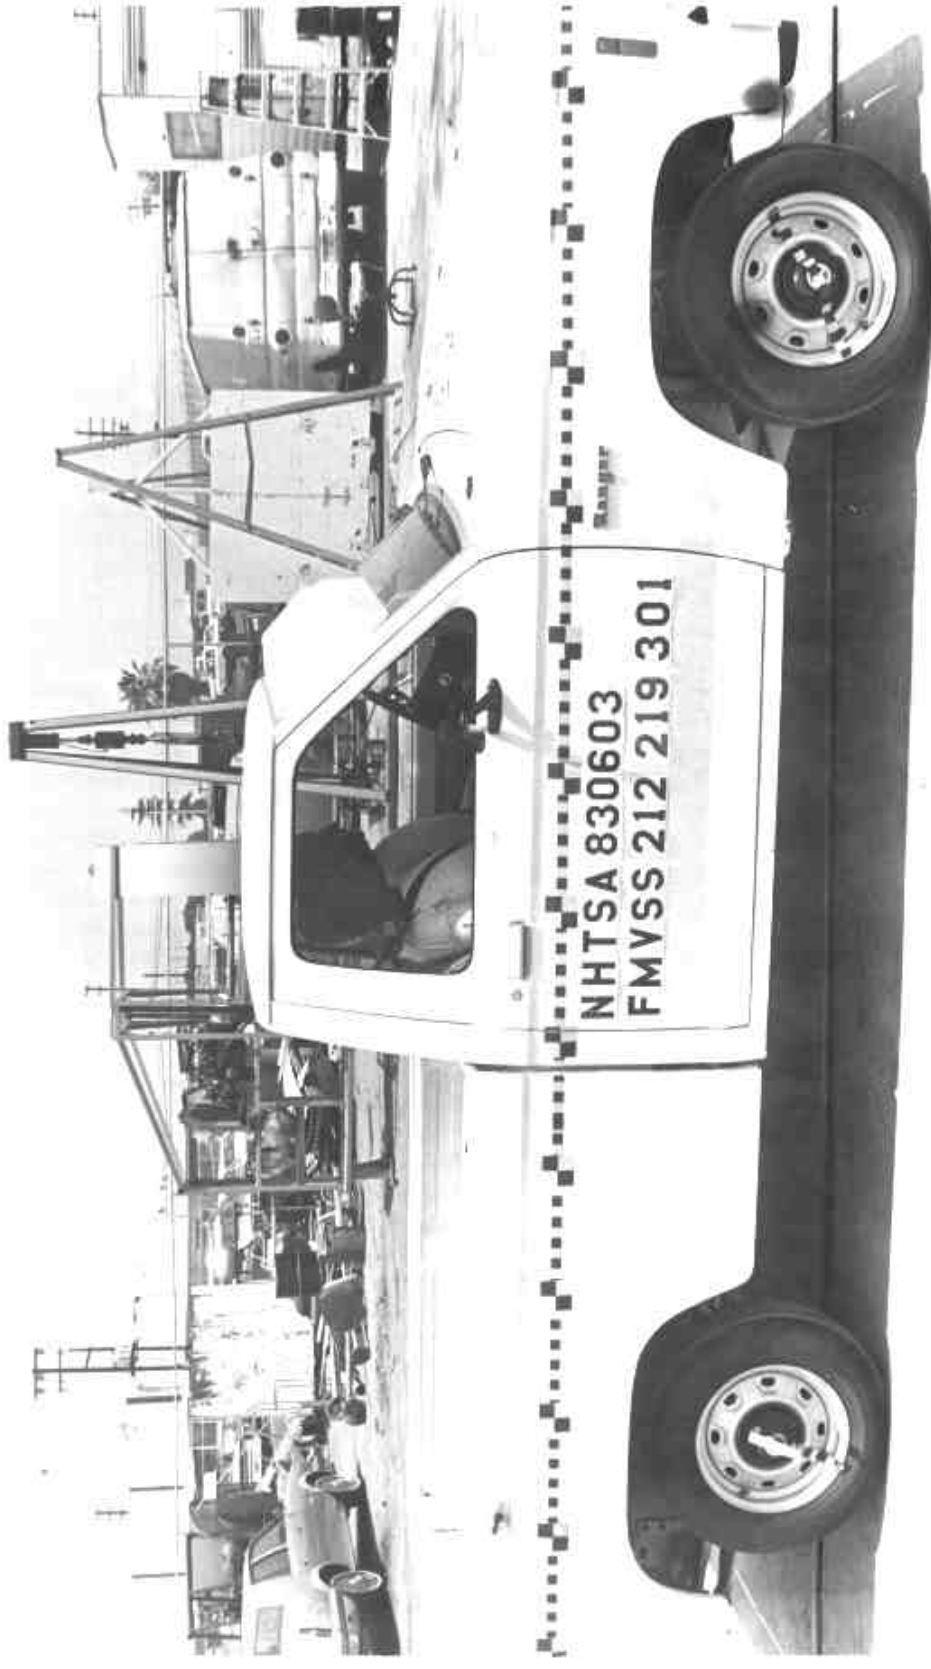
Figure 3-3  
1983 Ford R100 Ranger Styleside - Pickup  
NHTSA 830603  
Pre-Test, Right Side View

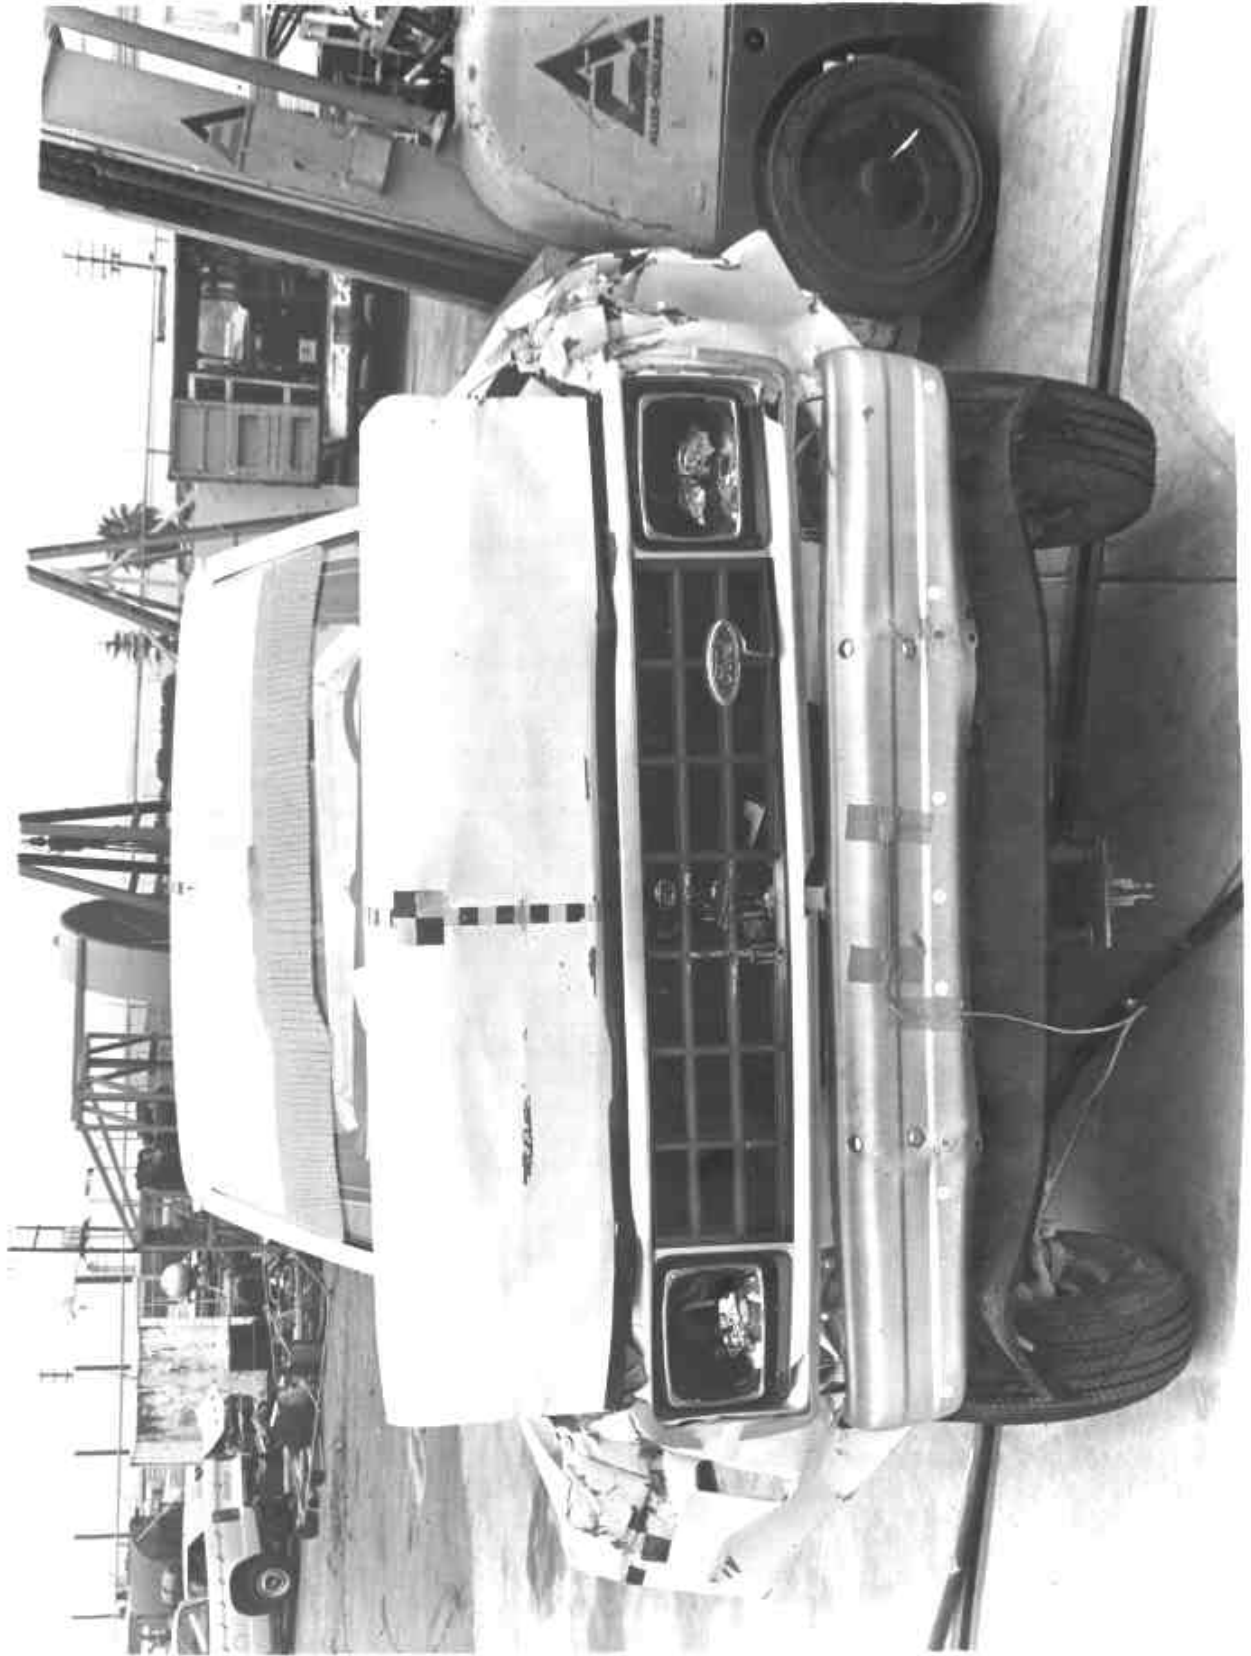
Figure 3-4  
1983 Ford R100 Ranger Styleside - Pickup  
NHTSA 830603  
Post-Impact, Full Front View

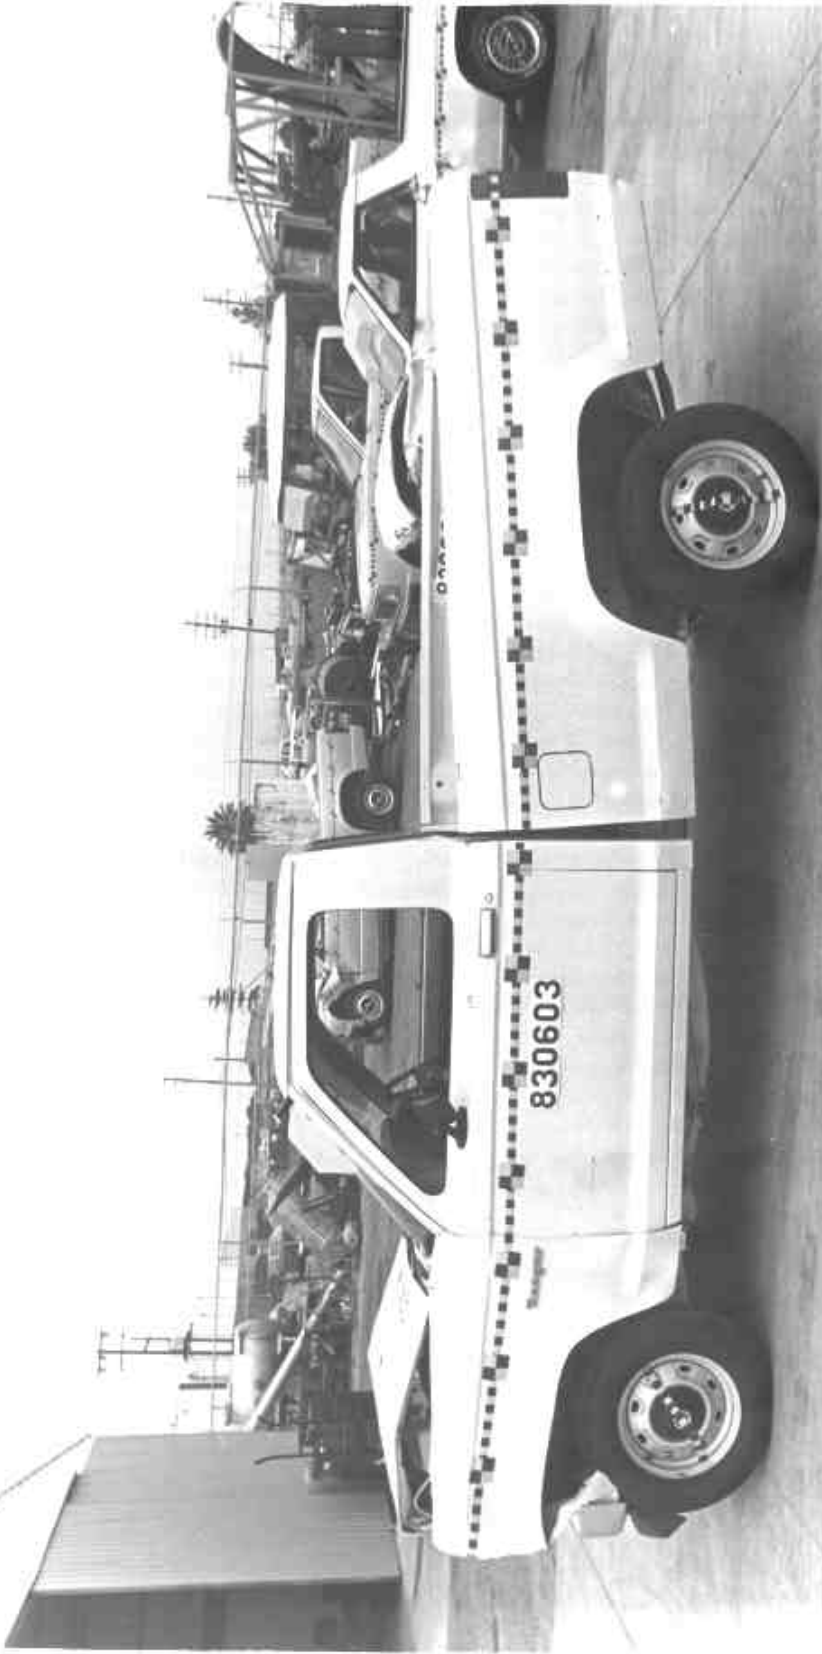
Figure 3-5

Post-Impact, Left Side View

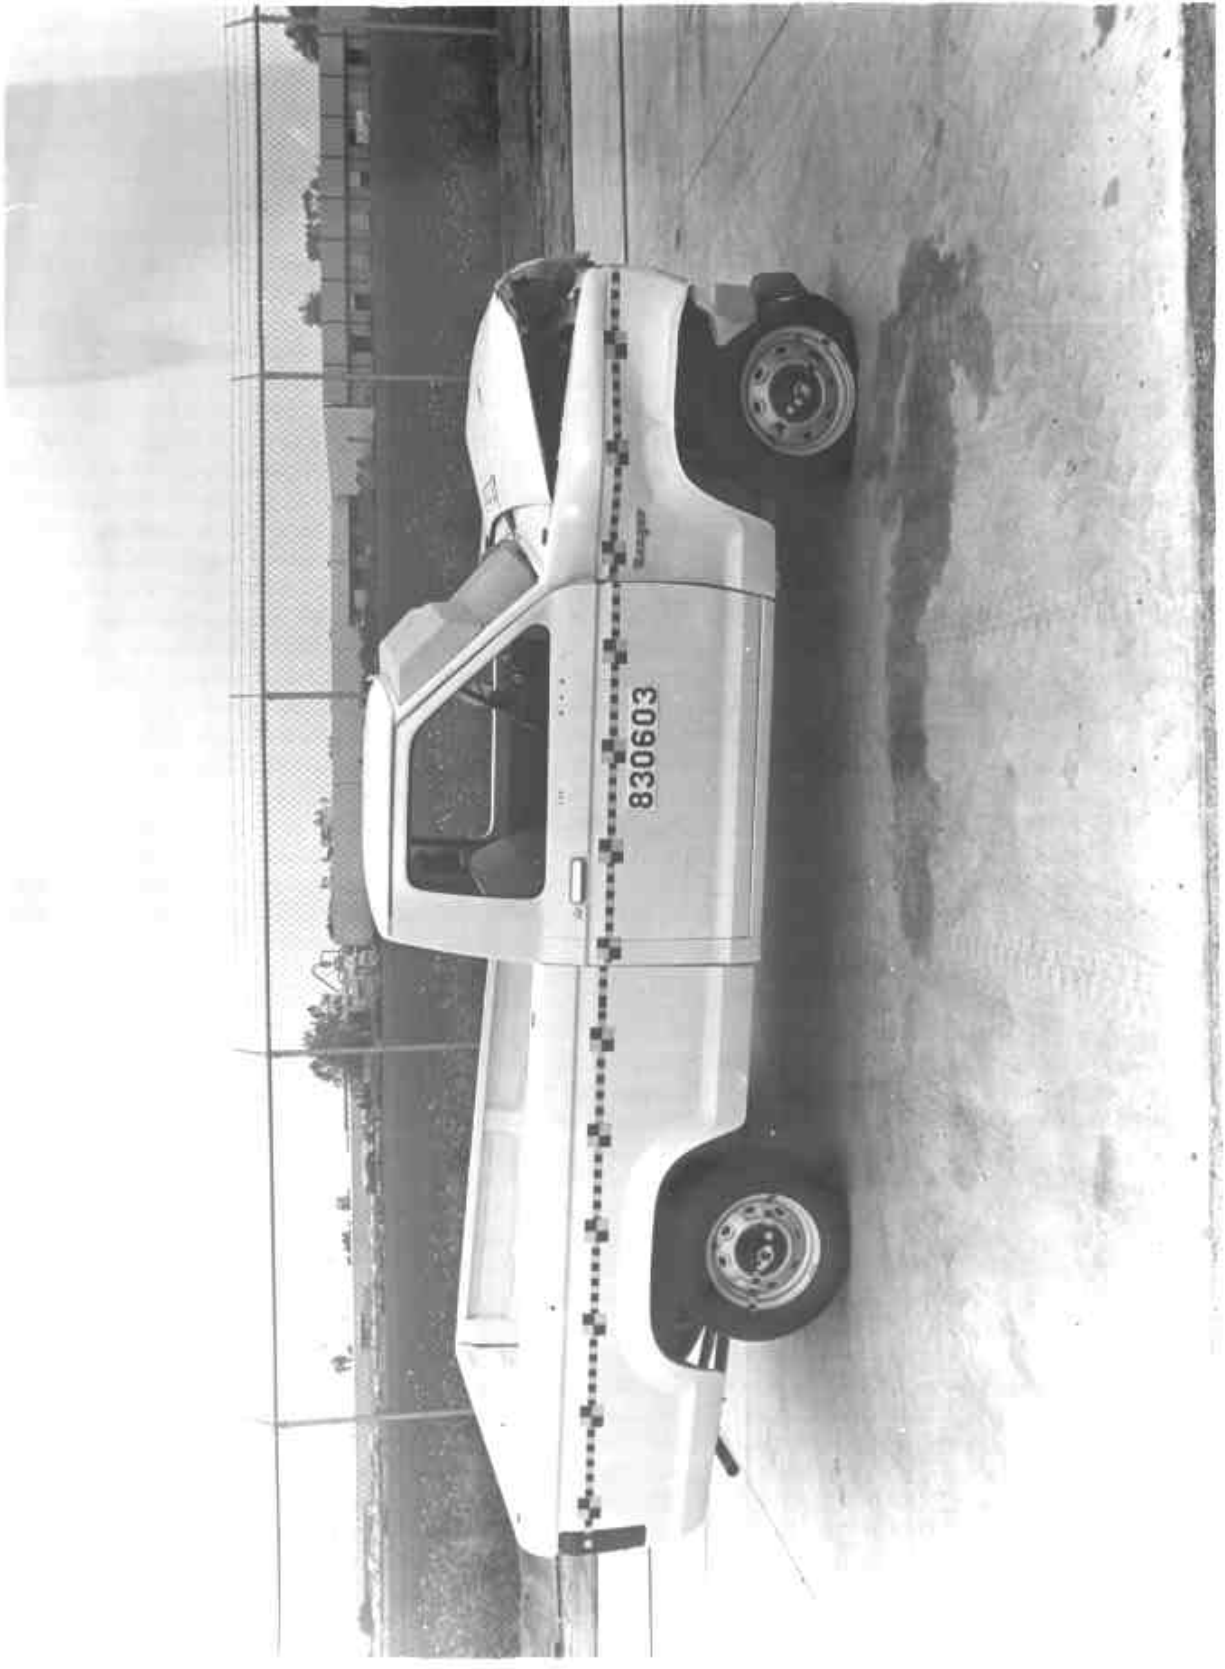
Figure 3-6  
1983 Ford R100 Ranger Styleside - Pickup  
NHTSA 830603  
Post-Impact, Right Side View

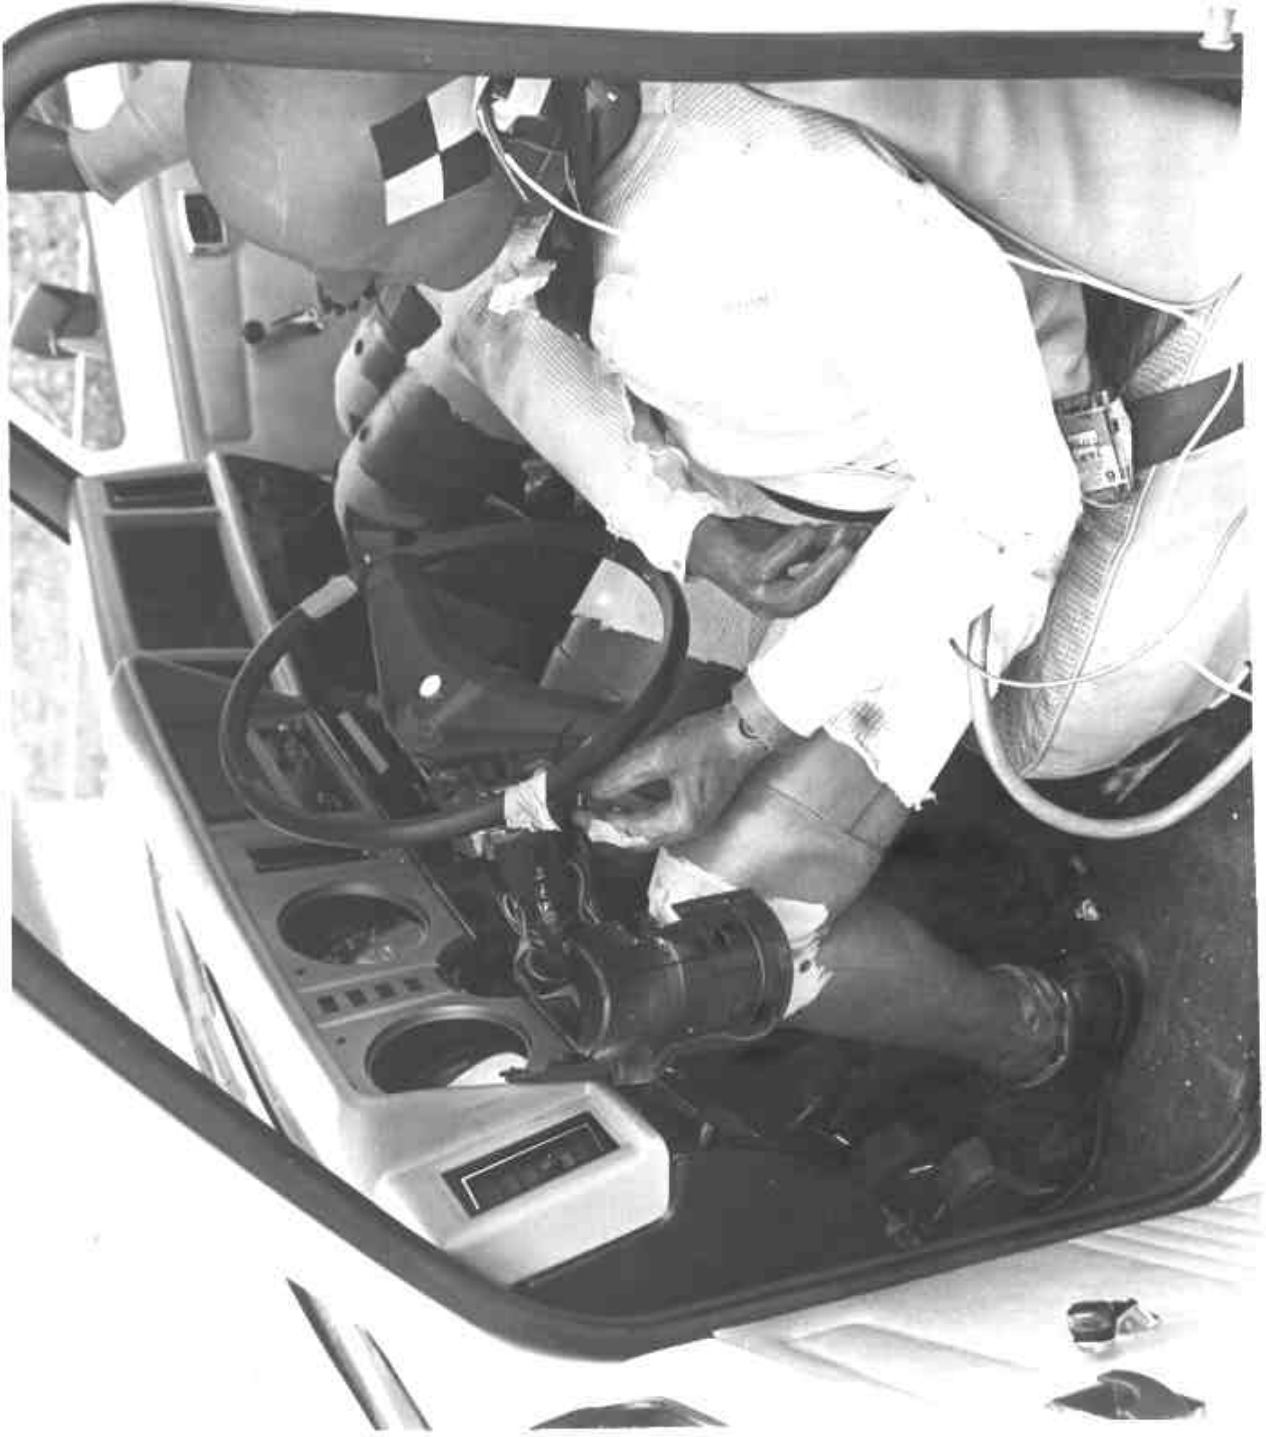
Figure 3-11  
1983 Ford R100 Ranger Styleside - Pickup  
NHTSA 830603  
Post-Impact, Driver Dummy View

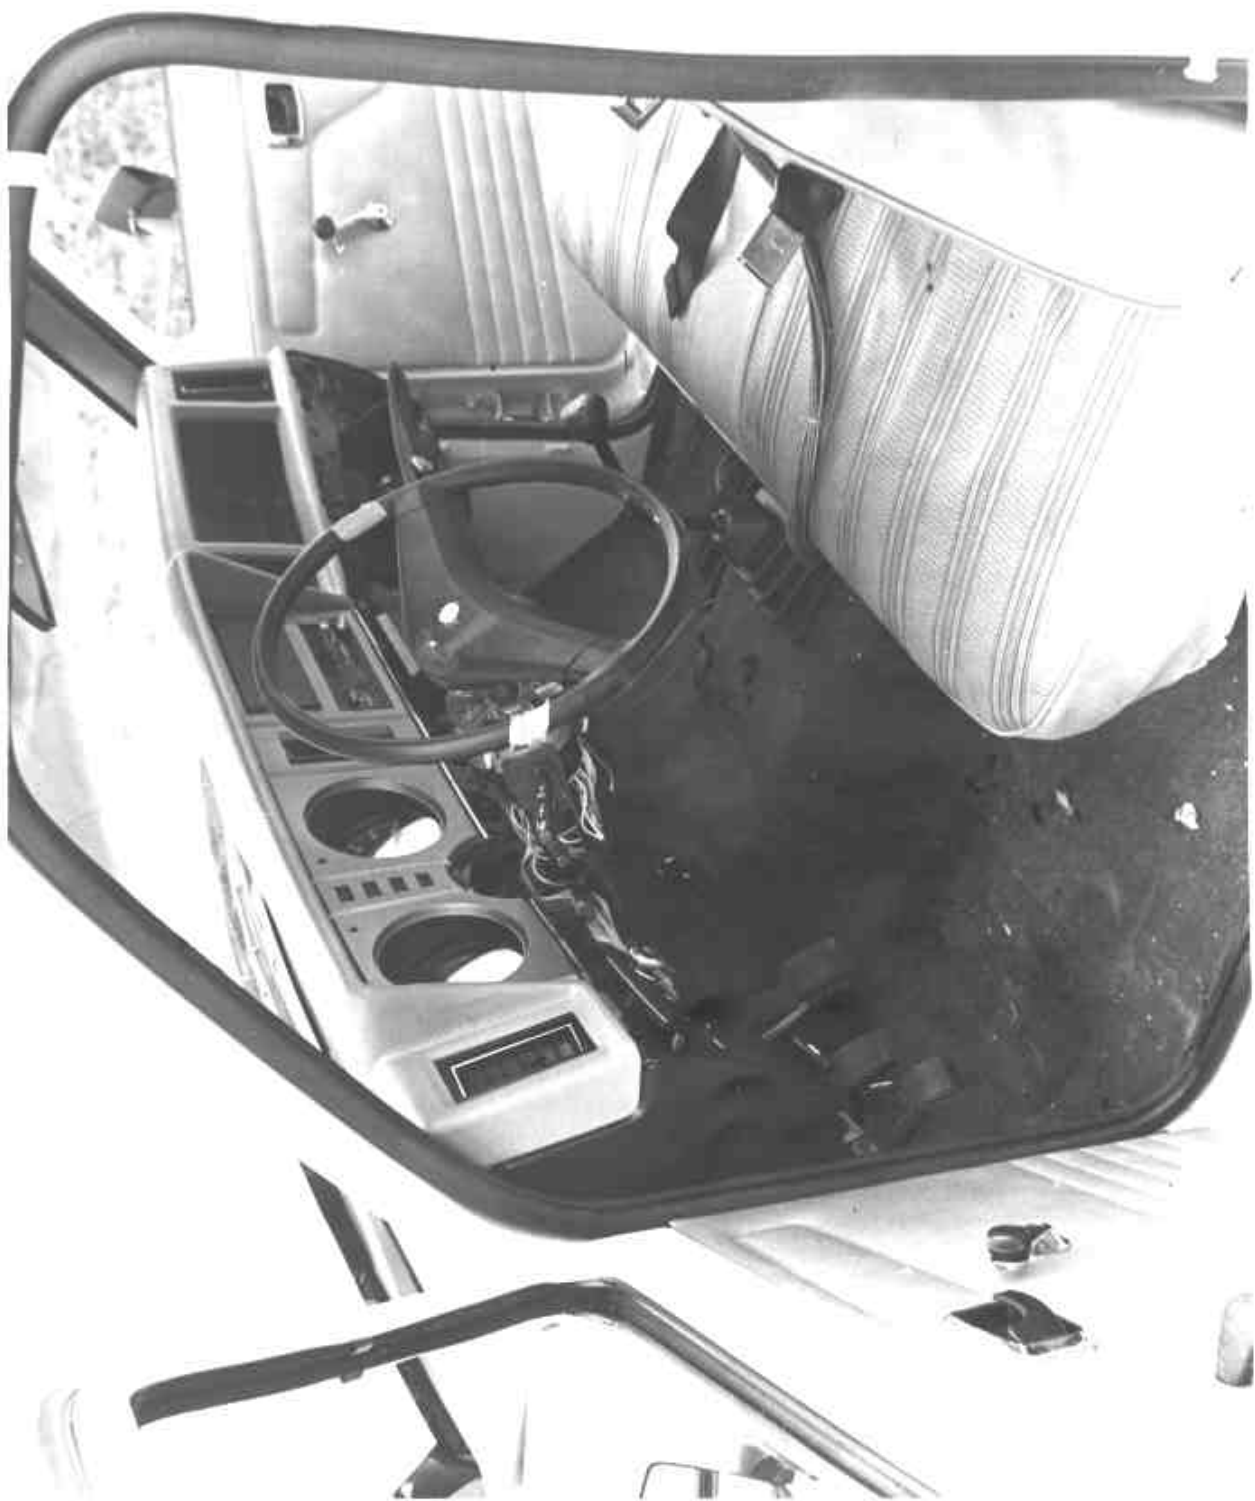
Figure 3-12  
1983 Ford R100 Ranger Styleside - Pickup  
NHTSA 830603  
Post-Impact, Driver Dummy Contact Area

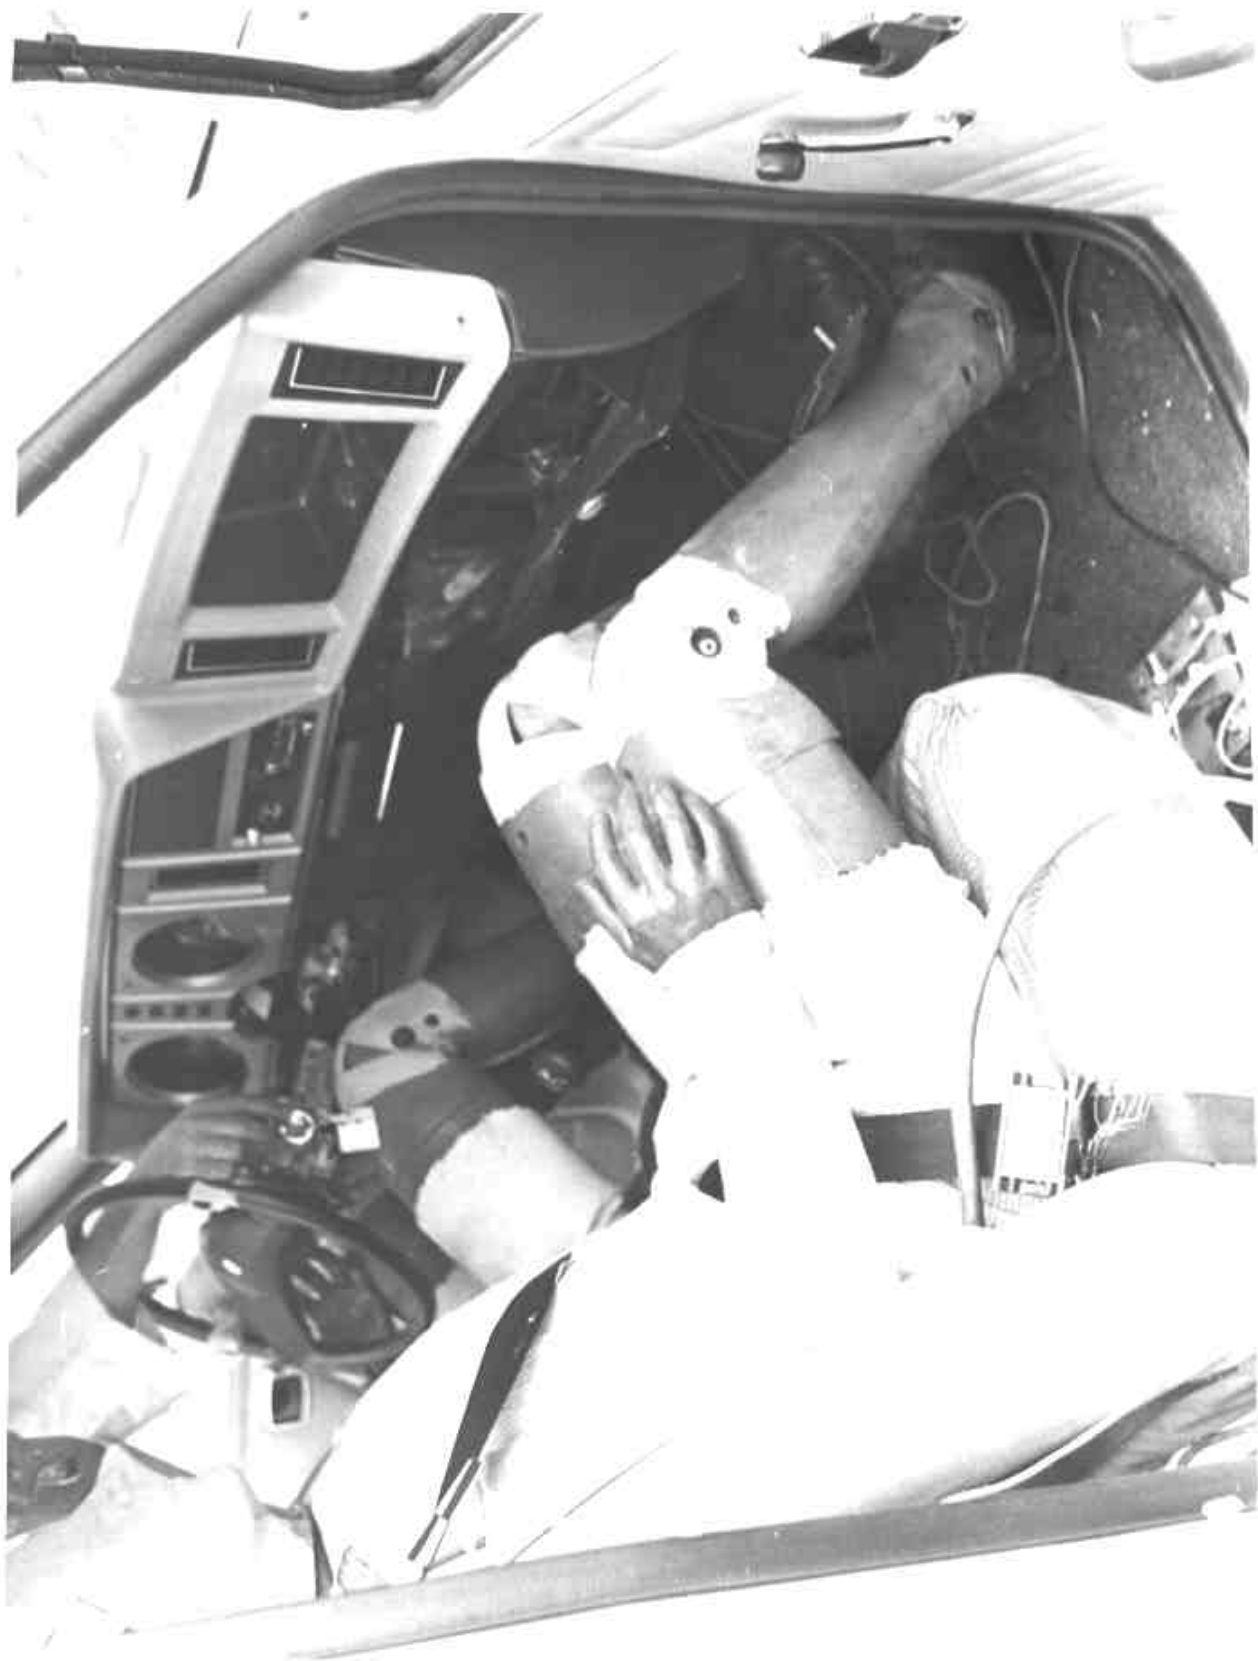
Figure 3-13  
1983 Ford R100 Ranger Styleside - Pickup  
NHTSA 830603  
Post-Impact, Passenger Dummy View

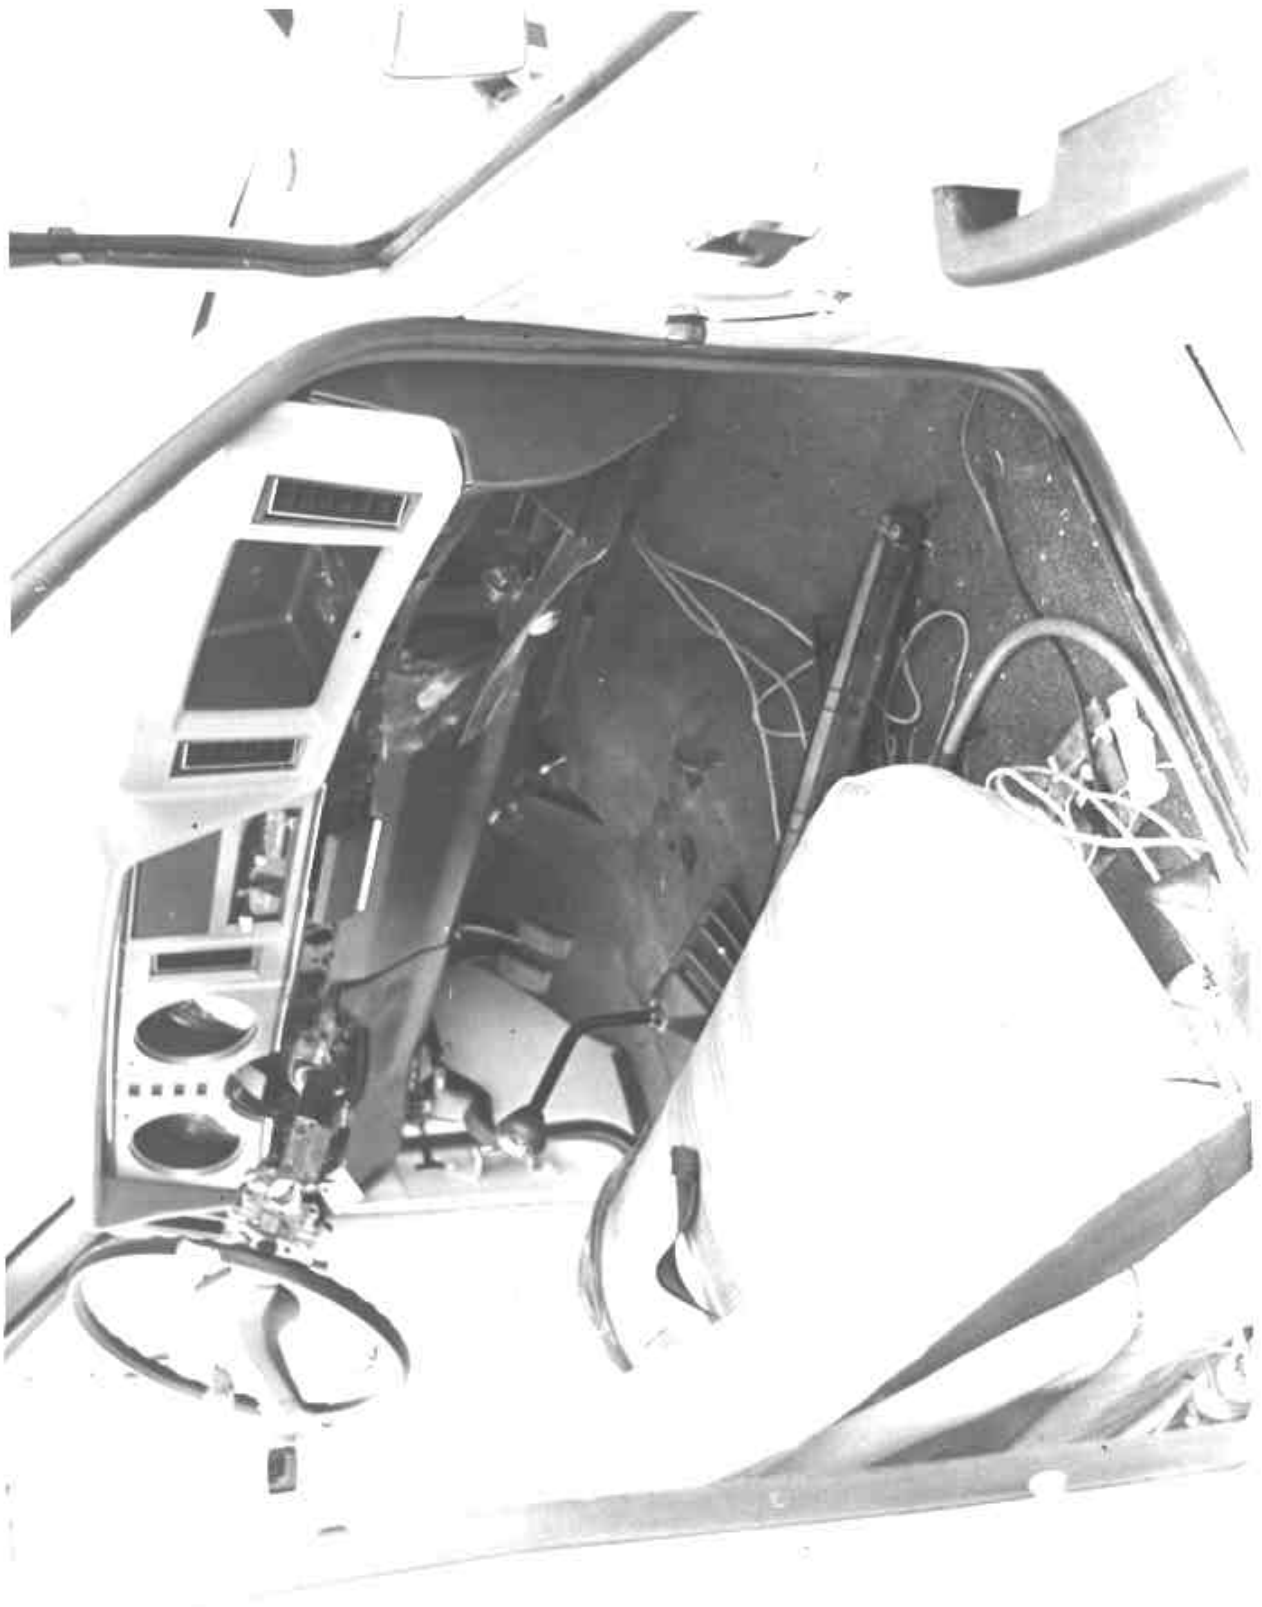
Figure 3-14  
1983 Ford R100 Ranger Styleside - Pickup  
NHTSA 830603  
Post-Impact, Passenger Dummy Contact Area

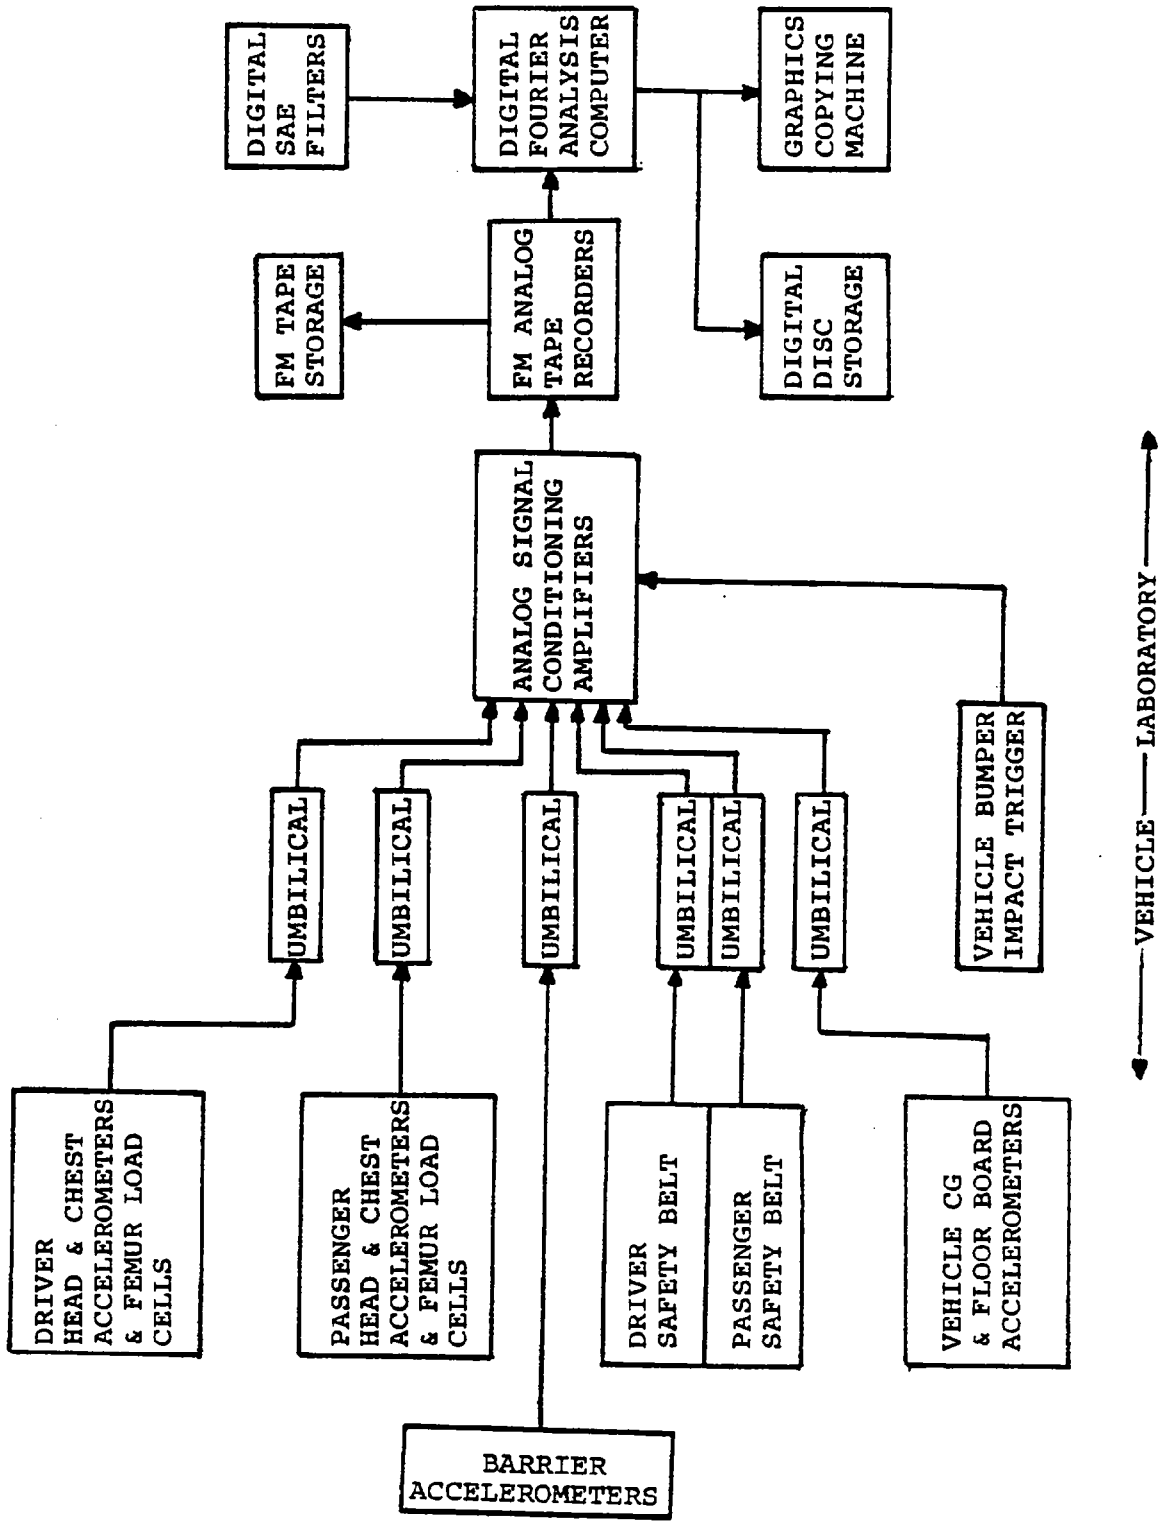
FIGURE 4-1

VEHICLE AND OCCUPANT CRASH IMPACT DATA ACQUISITION SYSTEM

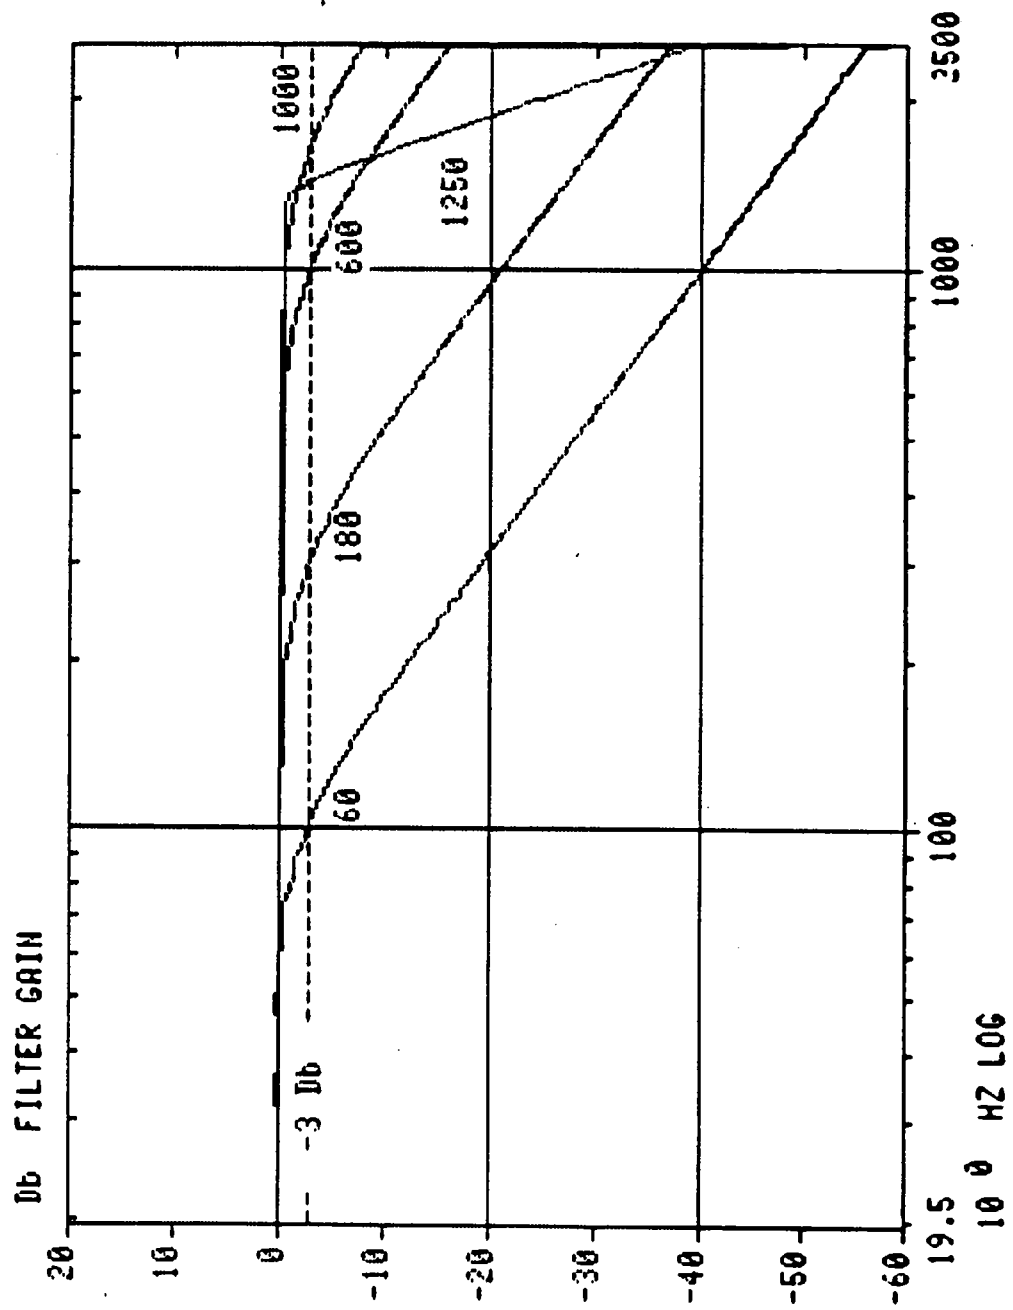
FIGURE 4-2

SAE FILTER ROLL OFF IS 12 DB/OCTAVE, ANALOG FILTER ROLL OFF IS 48 DB/O

Figure 4-2 illustrates the SAE class 60, 180, 600 and 1000 filters applied to the data. These filters are in accordance with SAE J211a, Instrumentation for Impact Tests. These recommended filters are quadratic double pole with 65% damping and a 12 db/octave rolloff. They are applied to the data using a Fast Fourier Transform (FFT) of the data, frequency domain multiplication, and an inverse Fast Fourier Transform (FFT) of the product.

It should be noted that in Figure 4-2 the predigitizing analog filter attenuates data above the 1250 Hz or 1650 Hz cutoff frequency. This has no effect on the class 60 or class 180 data. The class 600 data is within SAE J211a recommendation to 1900 Hz and -20 db. Above 1900 Hz the class 600 data is attenuated at 48 db/octave instead of 24 db/octave. This has very negligible effect on the class 600 data. The modification of class 1000 data, by predigitizing filter, is attenuation of ~~24~~ db/octave above
