REPORT NO. 971-3882-49-M

OCCUPANT RESPONSE  
AND  
VEHICLE ACCELERATION  
IN A  
30 MPH FRONTAL IMPACT TEST

FORD MOTOR COMPANY  
1983 FORD R100 RANGER STYLESIDE - PICKUP  
NHTSA 830603

FINAL REPORT

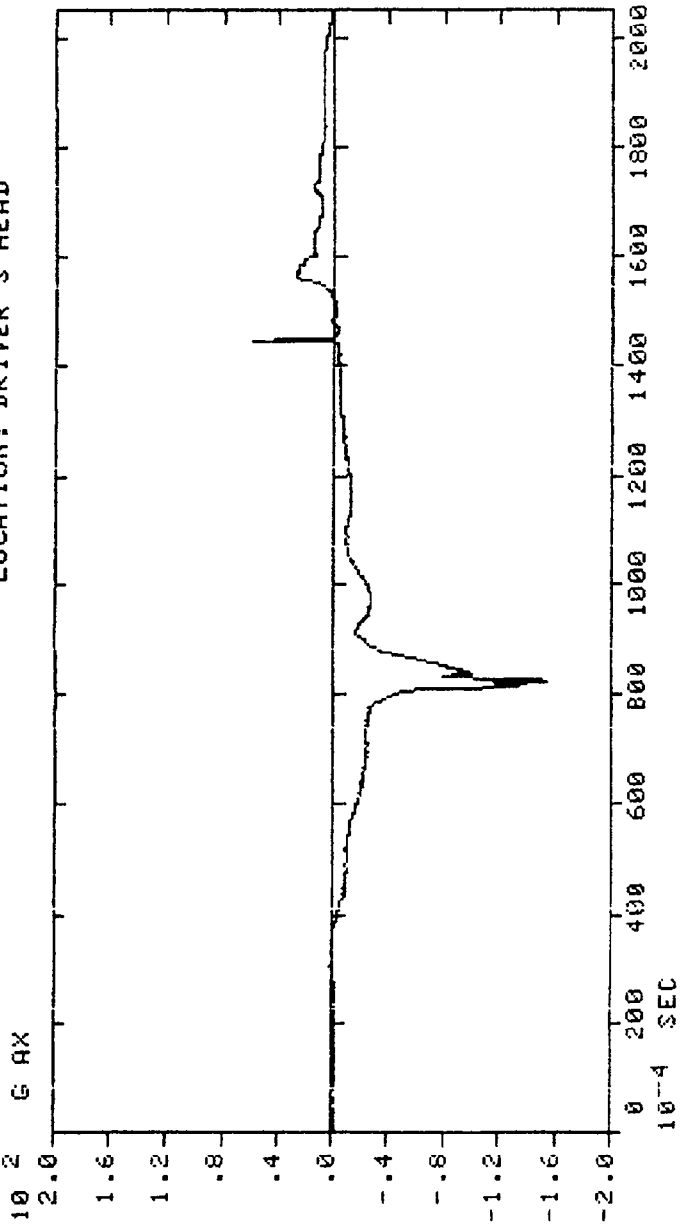
MJO NO.: 971-3882-49  
FILTER: CLASS 1000  
ACCELEROMETER: TAPE 1, CH 1  
DIRECTION: FORWARD  
LOCATION: DRIVER'S HEAD

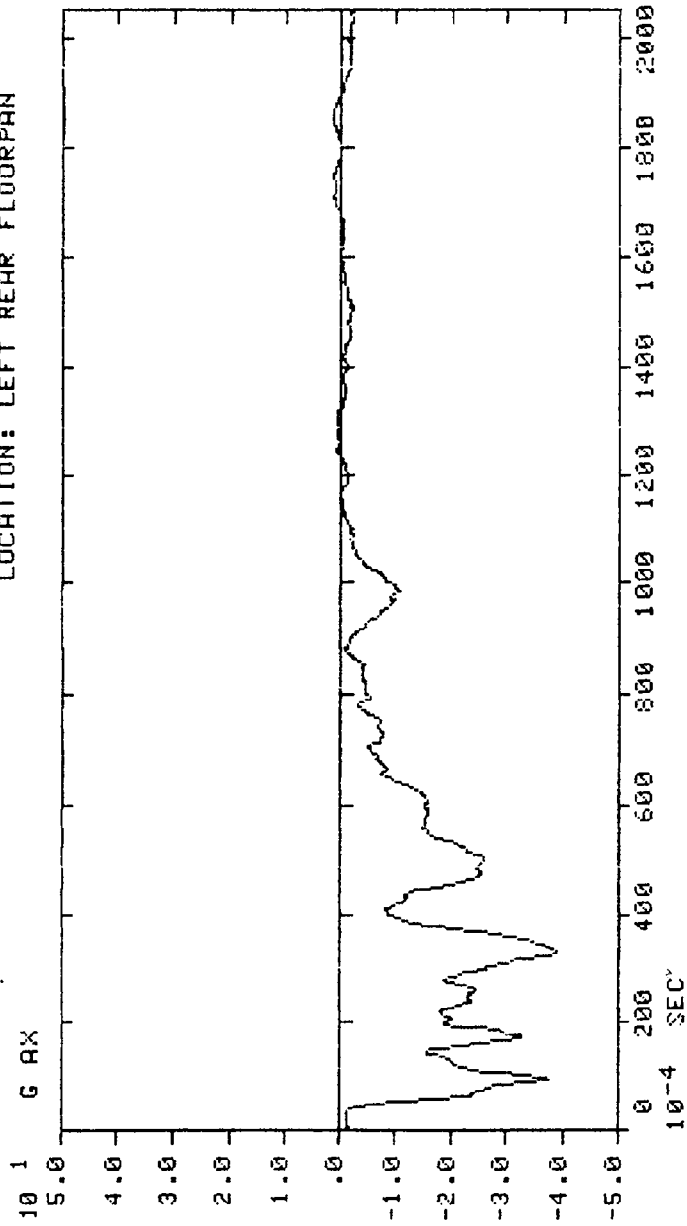
MJO NO.: 971-3882-49  
FILTER: CLASS 60  
ACCELEROMETER: TAPE 1, CH 11  
DIRECTION: FORWARD  
LOCATION: LEFT REAR FLOORPAN

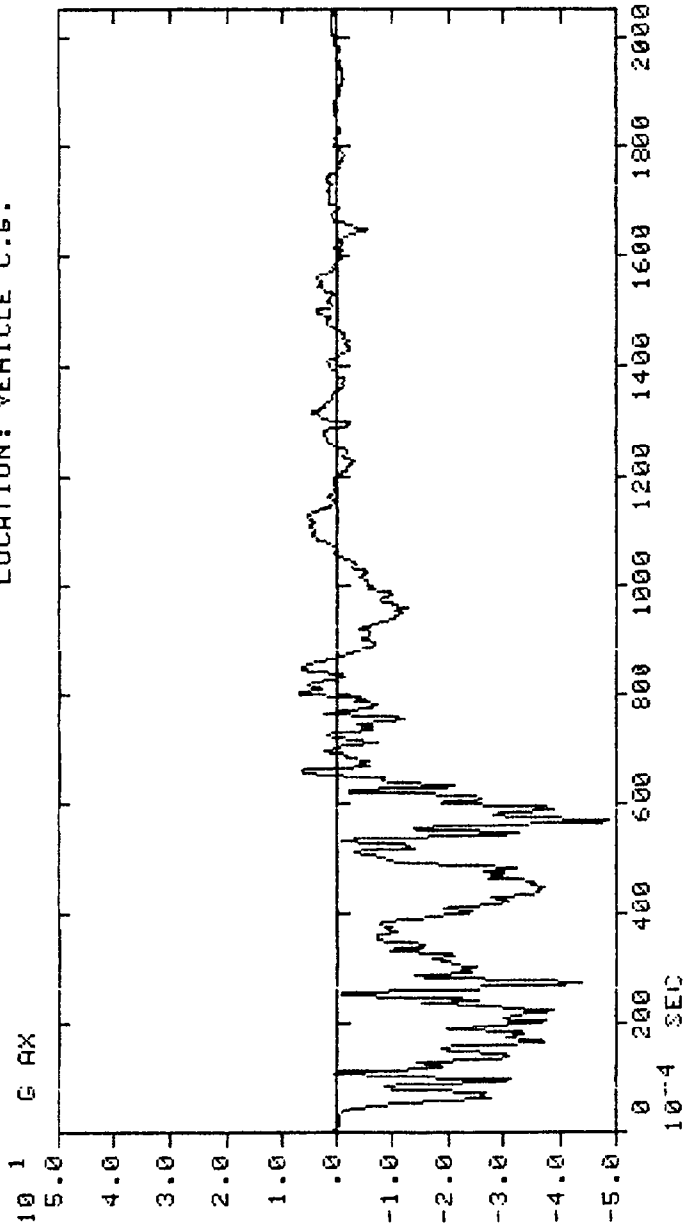
MJO NO.: 971-3882-49  
FILTER: CLASS 180  
ACCELEROMETER: TAPE 1, CH12  
DIRECTION: FORWARD  
LOCATION: VEHICLE C.G.
