LABORATORY PROCEDURES TO DETERMINE THE  
BREAKAWAY BEHAVIOR OF LUMINAIRE SUPPORTS  
IN MINI-SIZED VEHICLE COLLISIONS

LOW SPEED FORTY-FIVE DEGREE  
IMPACT OF A MINICOMPACT SEDAN  
AND A VALIDATED SURROGATE  
BREAKAWAY LUMINAIRE SUPPORT

TEST RESULTS REPORT

TEST NUMBER 1469-5A82

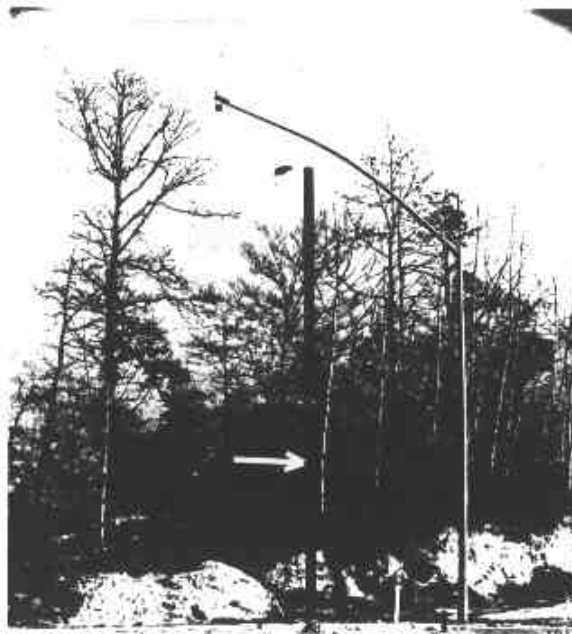
Figure 1. Pretest Photograph of Surrogate Breakaway Luminaire Support

The physical properties of the surrogate breakaway luminaire support are contained in Table 2. The surrogate breakaway luminaire support incorporated a triangular 3-bolt slip base which was designed using the California state plan for a Type 31 support.<sup>13</sup> The luminaire support was installed using the guidelines provided by the California DOT.<sup>13</sup> The slip base was positioned so impact would occur against the lead bolt, which is equivalent to a  $30^{\circ}$  impact angle with respect to the mast arm.<sup>9</sup> The luminaire support did not have a mast arm attached during this test. The slip base was clamped together with three strain gaged bolts which were tightened to 14,000 pounds (62,300 N) each just prior to the test. The surrogate breakaway luminaire support is shown in Figure 1.

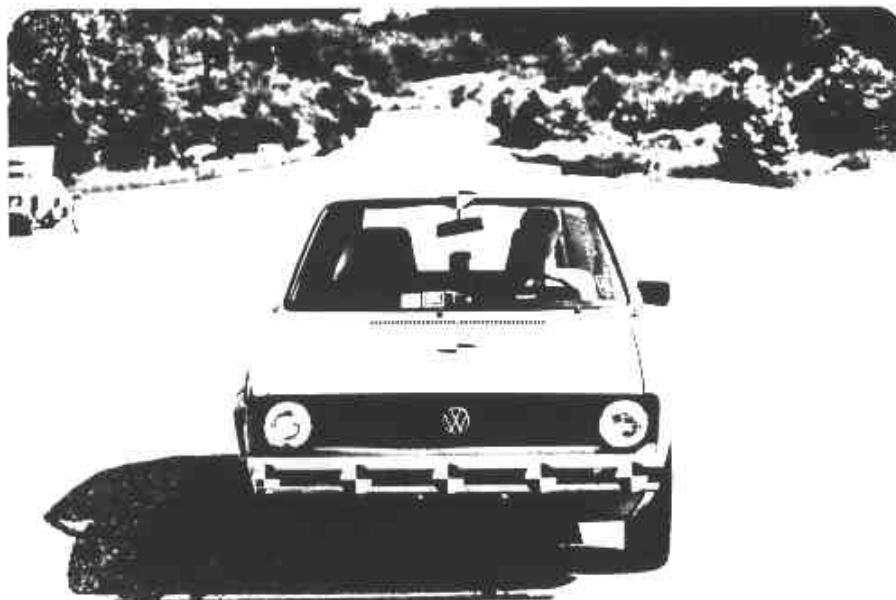
Figure 3. Pretest Photograph of Test Vehicle  
Front View

The vehicle was equipped with a triaxial accelerometer package mounted on the lateral centerline of the vehicle at the longitudinal location of the center of gravity. The vehicle was also equipped with a contact switch mounted on the left side at the location of the A pillar to permit vehicle and occupant data to be measured relative to the time of impact. The test vehicle is shown in Figures 2 through 5.

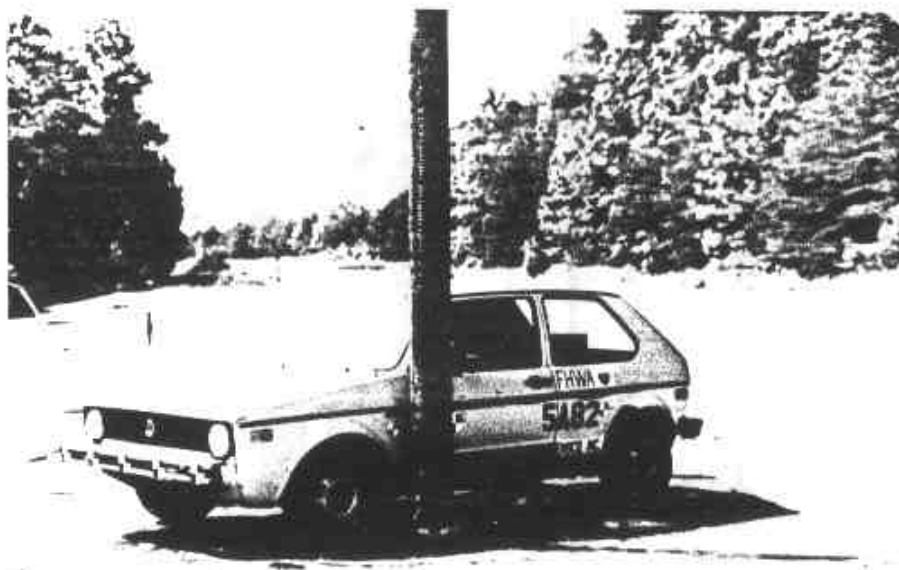
Figure 4. Pretest Photograph of Test Vehicle  
Shown Next to Surrogate Luminaire  
Support, Left Angle View

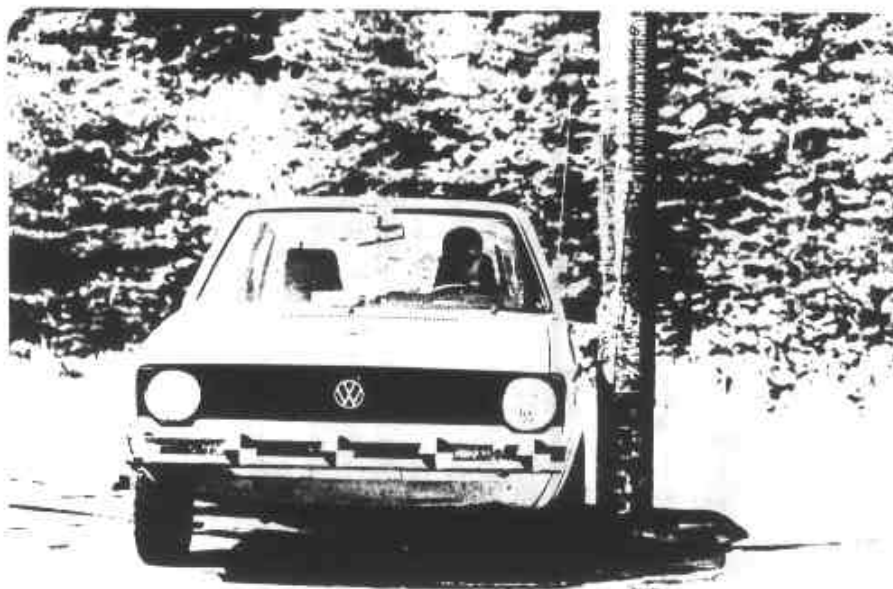
Figure 5. Pretest Photograph of Test Vehicle  
Shown Next to Surrogate Luminaire  
Support, Front View

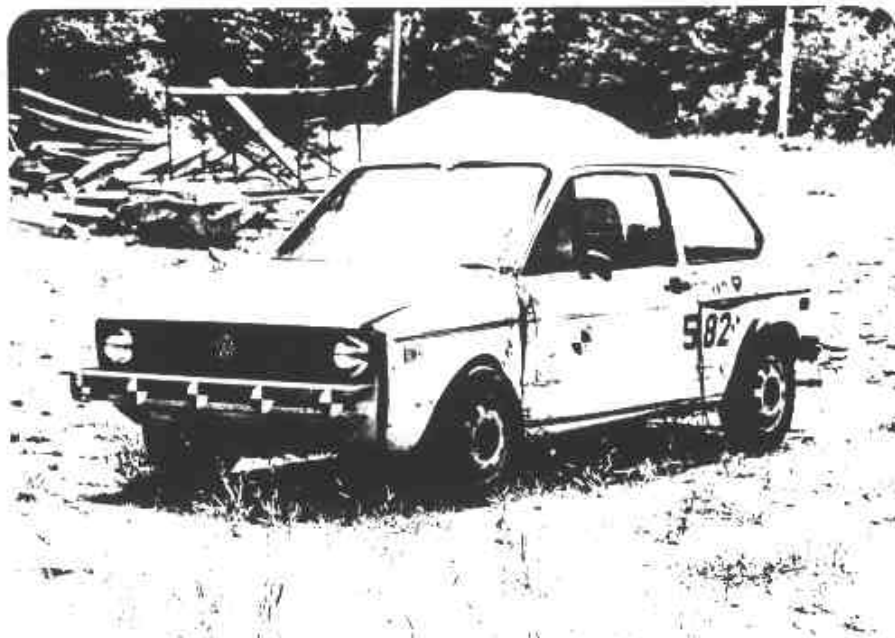
Figure 7. Post-Test Photograph of Test Vehicle,  
Left Angle View

The impact conditions were 30.0 mph (13.39 m/s) at the A pillar on the left side of the vehicle 12.9 in (.33 m) ahead of the longitudinal location of the center of gravity of the vehicle in its inertial test configuration. The maximum residual crush of the vehicle at the impact point was 7.38 inches (.19 m). The maximum residual intrusion into vehicle compartment was 7.50 in (.19 m). Photographs of the vehicle after the collision event are shown in Figures 6 through 9.

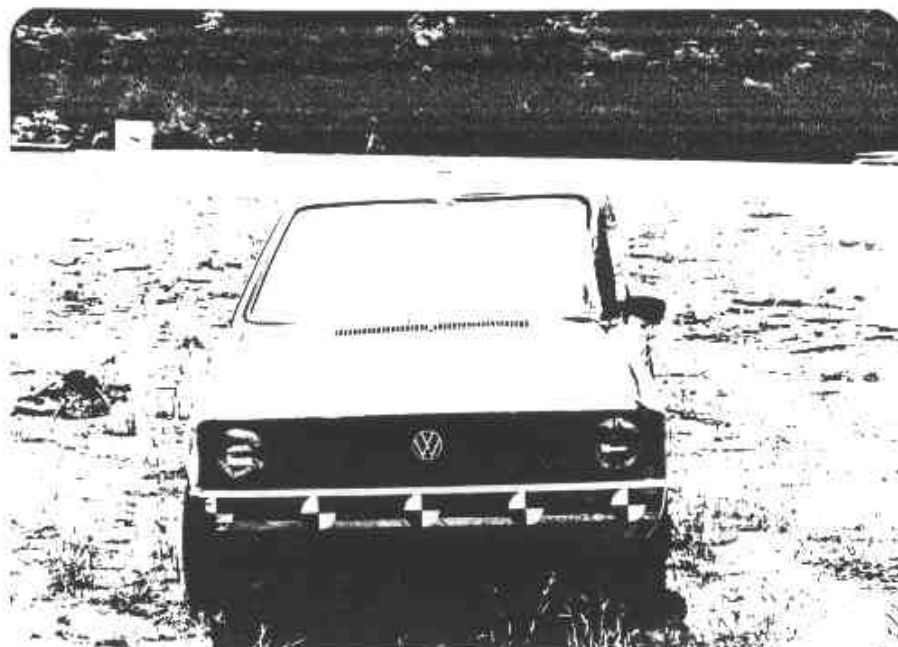
Figure 8. Post-Test Photograph of Test Vehicle,  
Front View

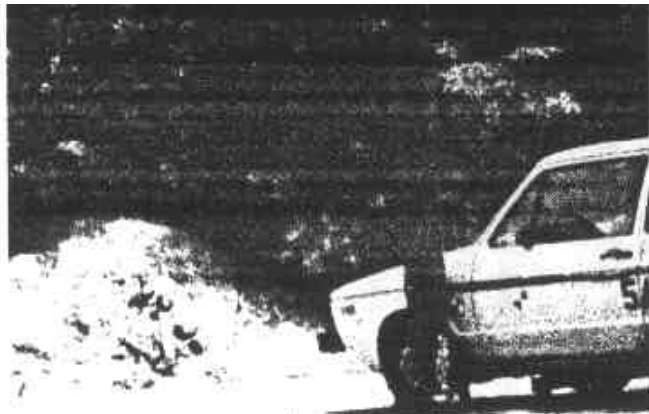
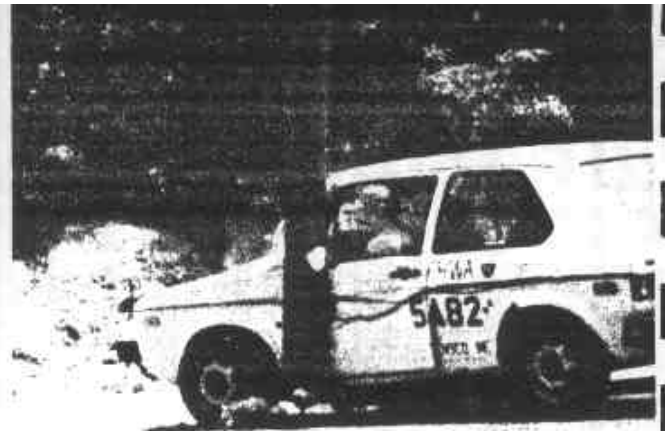
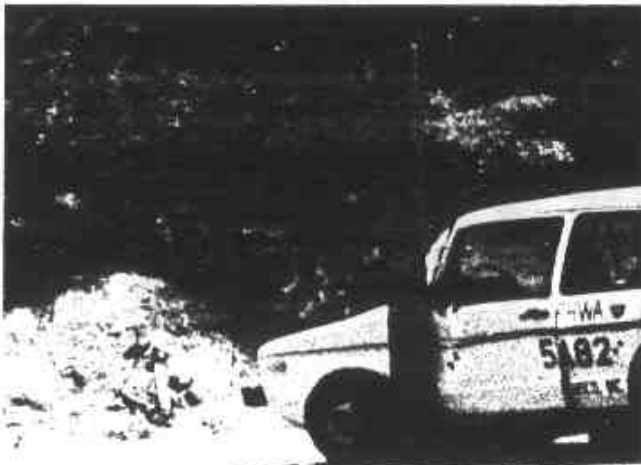
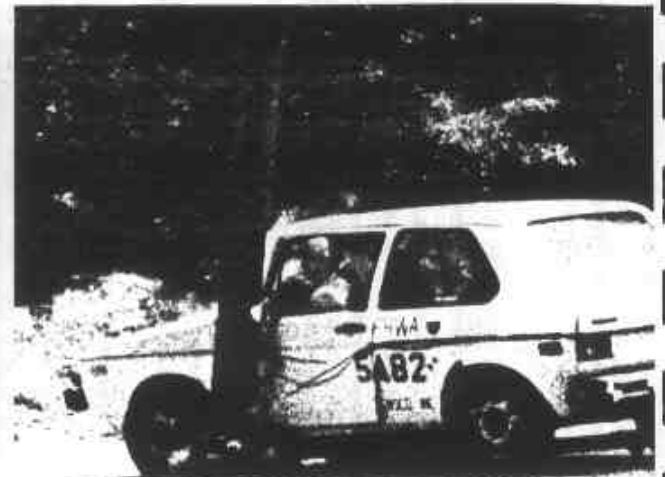
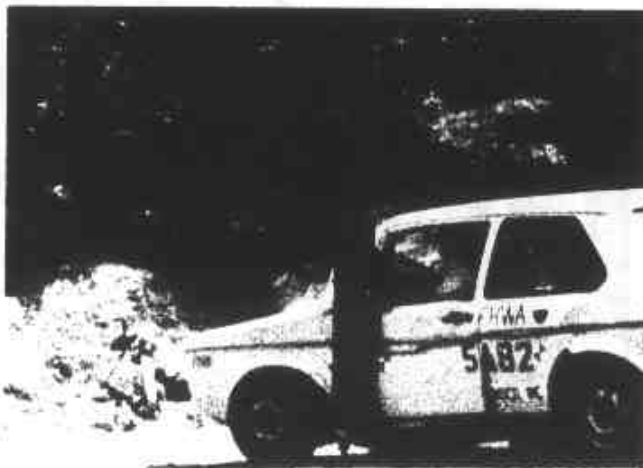
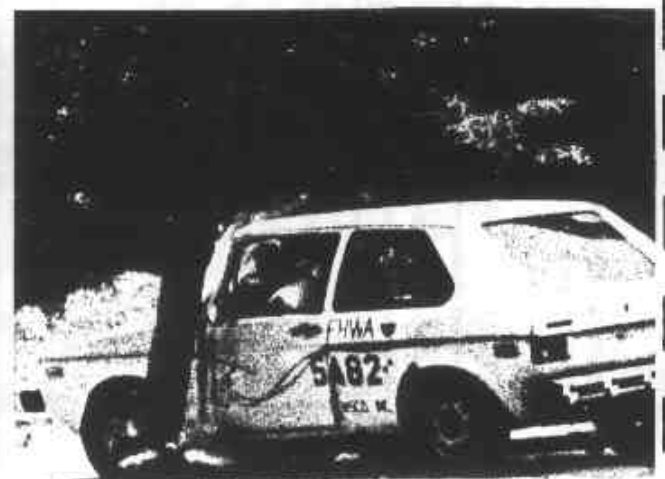
Figure 10. Test Sequence for the Initial Collision Event of Full Scale Crash Test Number 1469-5A82

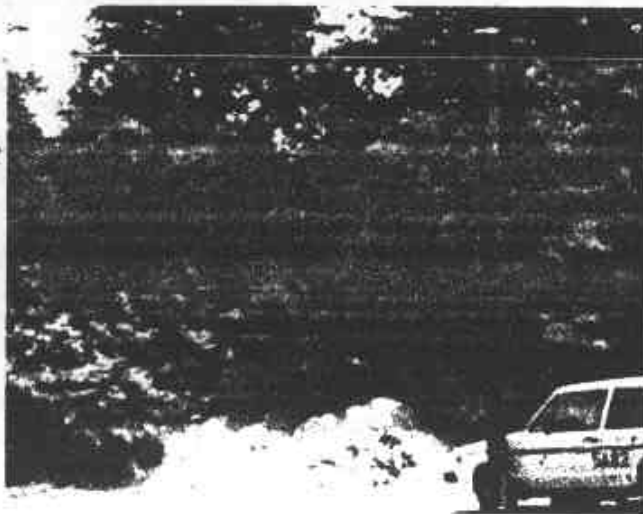
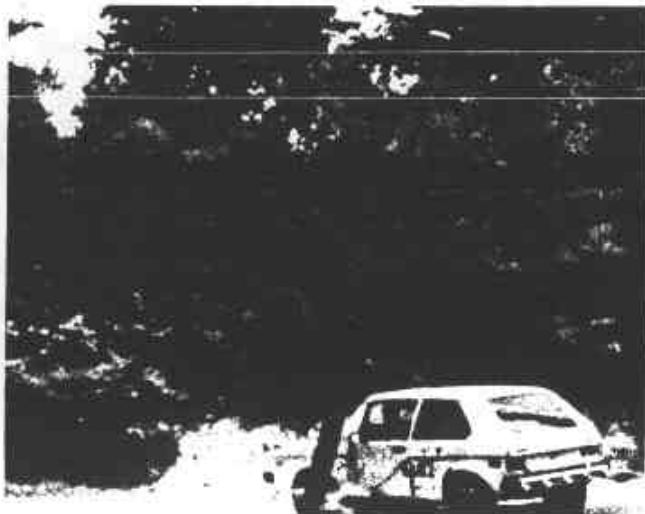
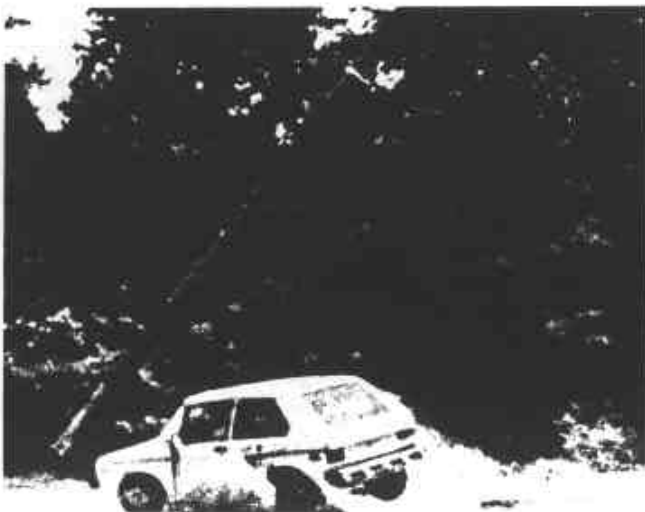
Figure 11. Test Sequence of the Entire Collision Event  
of Full Scale Crash Test Number 1469-5A82
