NEW VEHICLE ASSESSMENT FOR SIDE IMPACT PROTECTION

1982 VOLKSWAGEN RABBIT - STRUCK VEHICLE

1982 CHEVROLET CITATION - STRIKING VEHICLE

CALSPAN REPORT NO. 7132-V-1

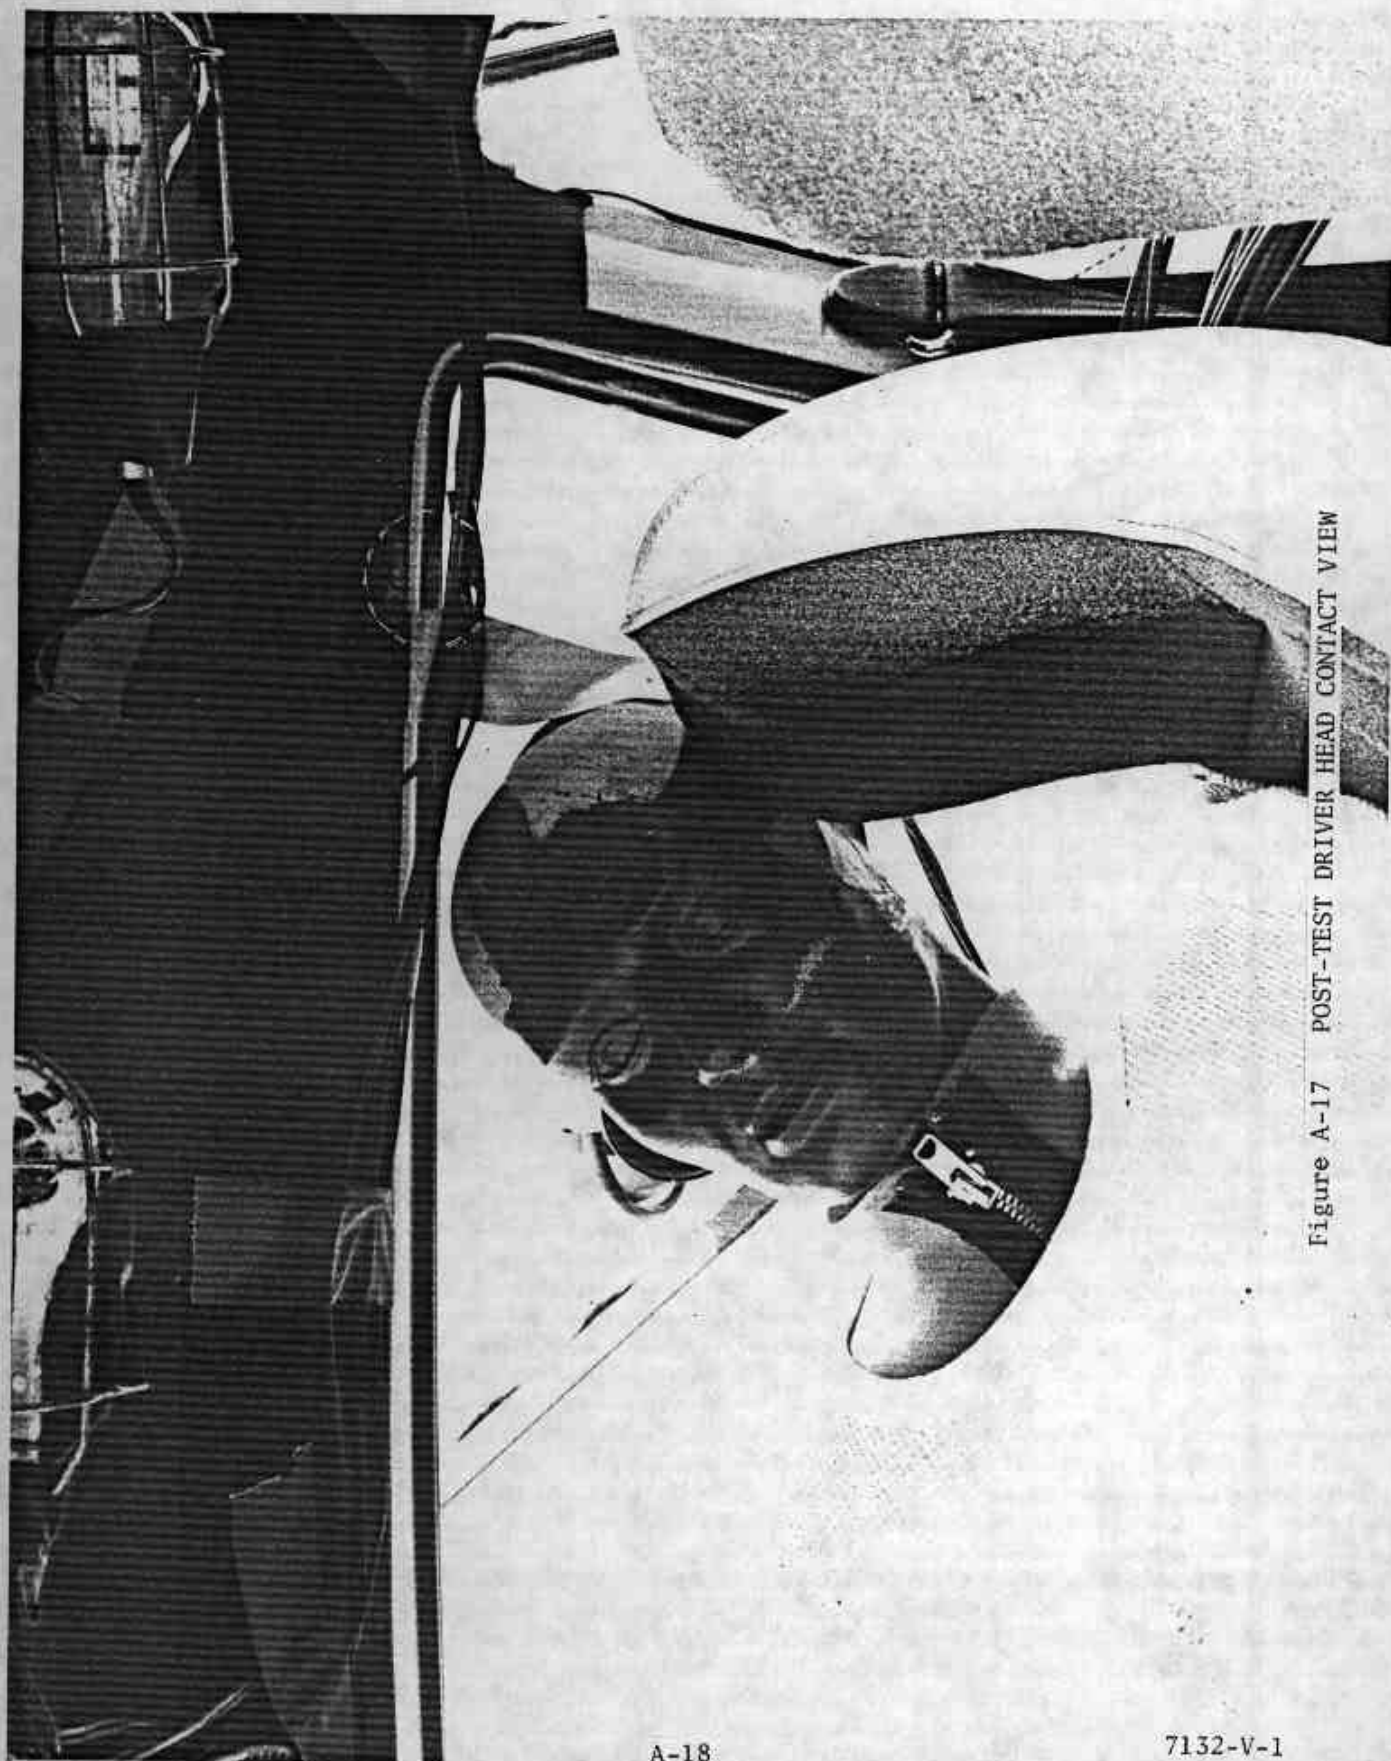
Figure A-17 POST-TEST DRIVER HEAD CONTACT VIEW

| | <u>Driver</u> | | <u>Passenger</u> | |
|---|---|--|---|--|
| | <u>Left Side Window &amp; Hood of Veh. #2</u> | | <u>Left Roof Header</u> | |
