NEW VEHICLE ASSESSMENT FOR  
SIDE IMPACT PROTECTION

CAR-TO-CAR SIDE IMPACT TESTING  
TWO VEHICLE MOVING  
90° SIDE IMPACT TEST  
1981 CHEVROLET CITATION  
AT 34.56 MPH  
TO 1982 VOLKSWAGEN RABBIT  
AT 17.6 MPH

TEST REPORT  
June 1983

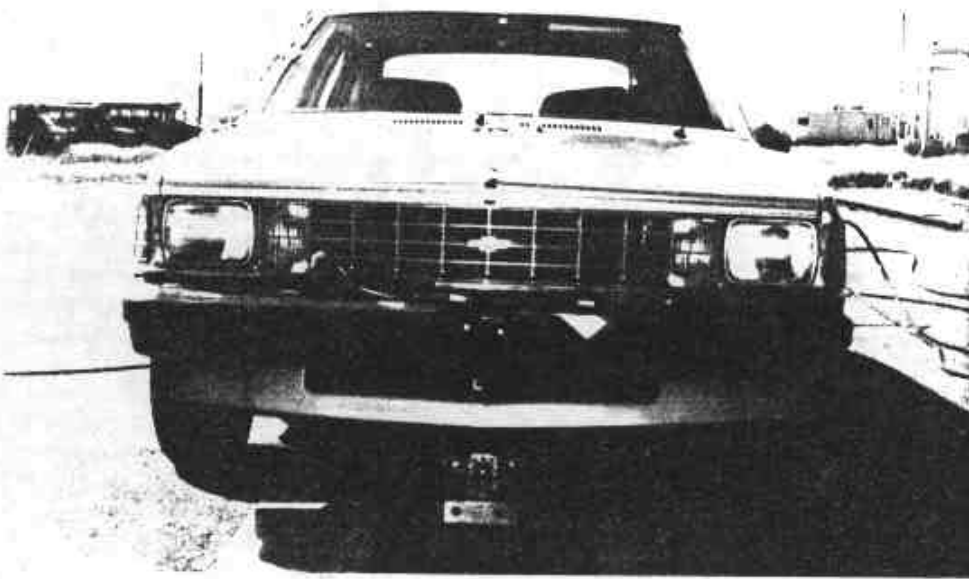
FIGURE A-1. PRE-TEST FRONT VIEW OF "BULLET" VEHICLE - 90° TWO VEHICLE MOVING SIDE IMPACT - 1981 CITATION AT 35 MPH TO 1982 VOLKSWAGEN RABBIT AT 17.5 MPH.

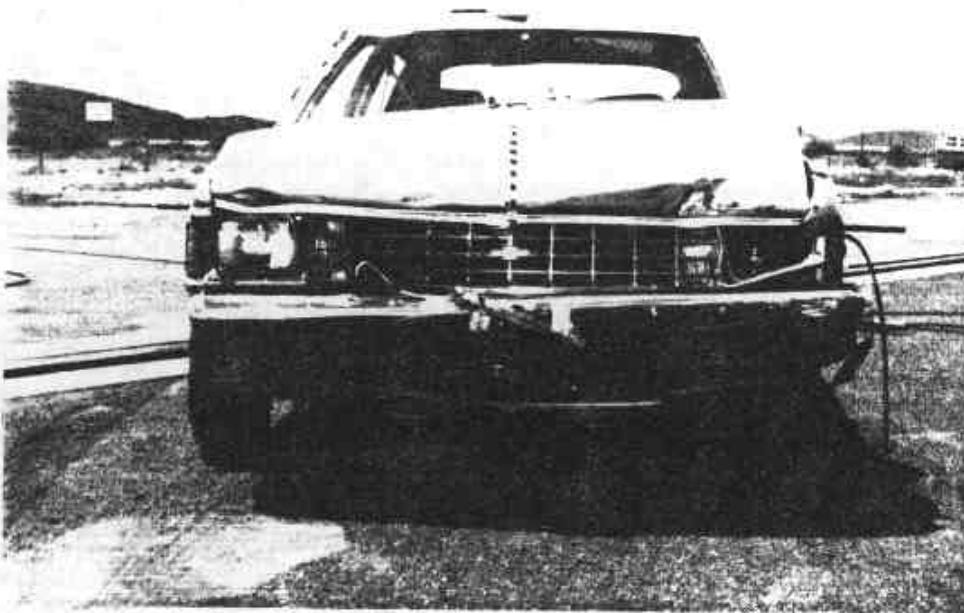
FIGURE A-2. POST-TEST FRONT VIEW OF "BULLET" VEHICLE - 90° TWO VEHICLE MOVING SIDE IMPACT - 1981 CITATION AT 35 MPH TO 1982 VOLKSWAGEN RABBIT AT 17.5 MPH.

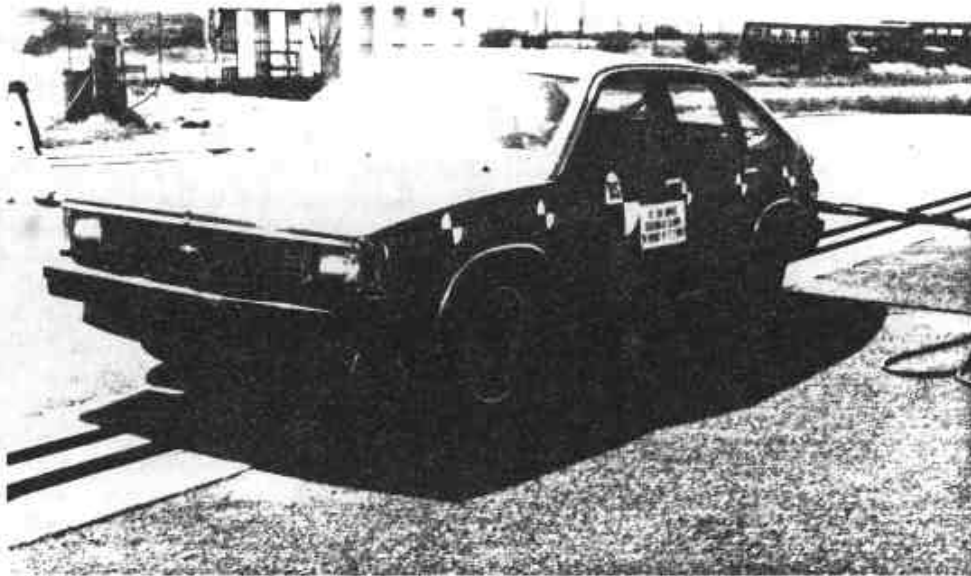
FIGURE A-3. PRE-TEST LEFT SIDE VIEW OF "BULLET" VEHICLE - 90° TWO VEHICLE MOVING SIDE IMPACT - 1981 CITATION AT 35 MPH TO 1982 VOLKSWAGEN RABBIT AT 17.5 MPH.

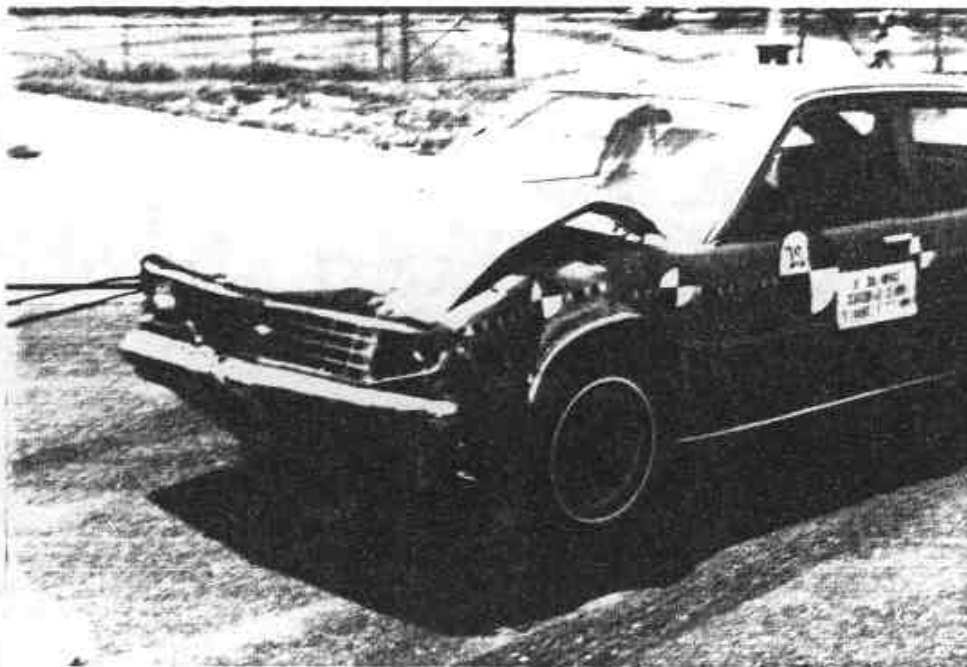
FIGURE A-4. POST-TEST LEFT SIDE VIEW OF "BULLET" VEHICLE - 90° TWO VEHICLE MOVING SIDE IMPACT - 1981 CITATION AT 35 MPH TO 1982 VOLKSWAGEN RABBIT AT 17.5 MPH.

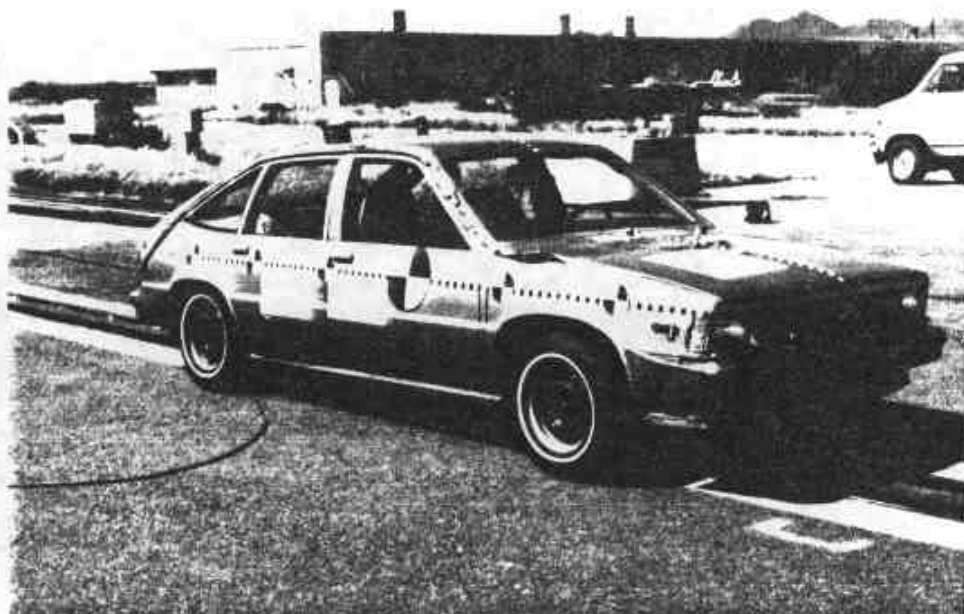
FIGURE A-5. PRE-TEST RIGHT SIDE "BULLET" VEHICLE - 90° TWO VEHICLE MOVING SIDE IMPACT - 1981 CITATION AT 35 MPH TO 1982 VOLKSWAGEN RABBIT AT 17.5 MPH.

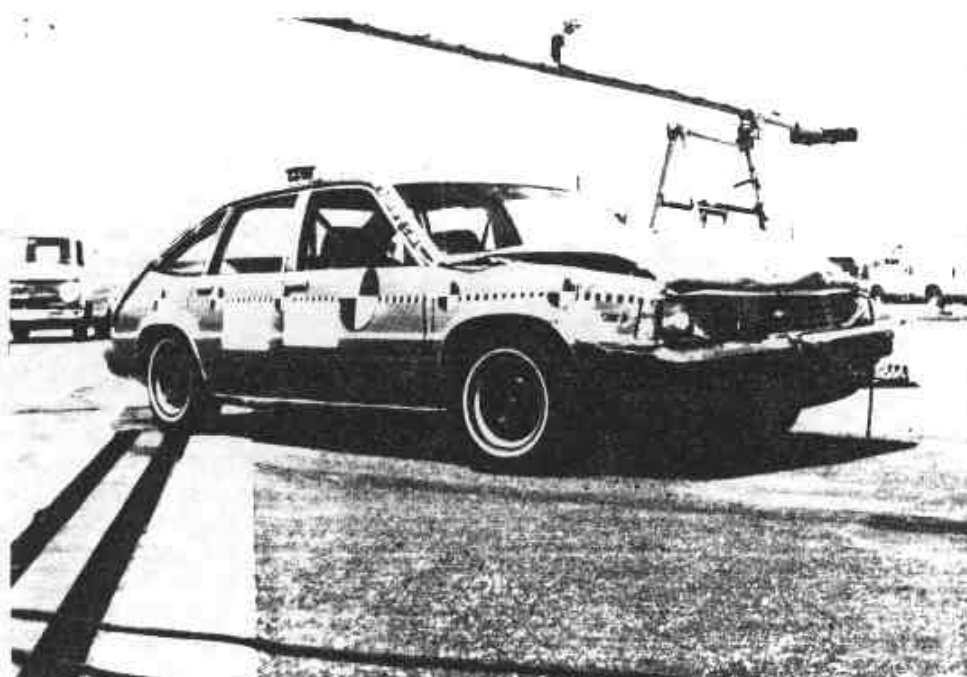
FIGURE A-6. POST-TEST RIGHT SIDE VIEW OF "BULLET" VEHICLE - 90° TWO VEHICLE MOVING SIDE IMPACT - 1981 CITATION AT 35 MPH TO 1982 VOLKSWAGEN RABBIT AT 17.5 MPH.

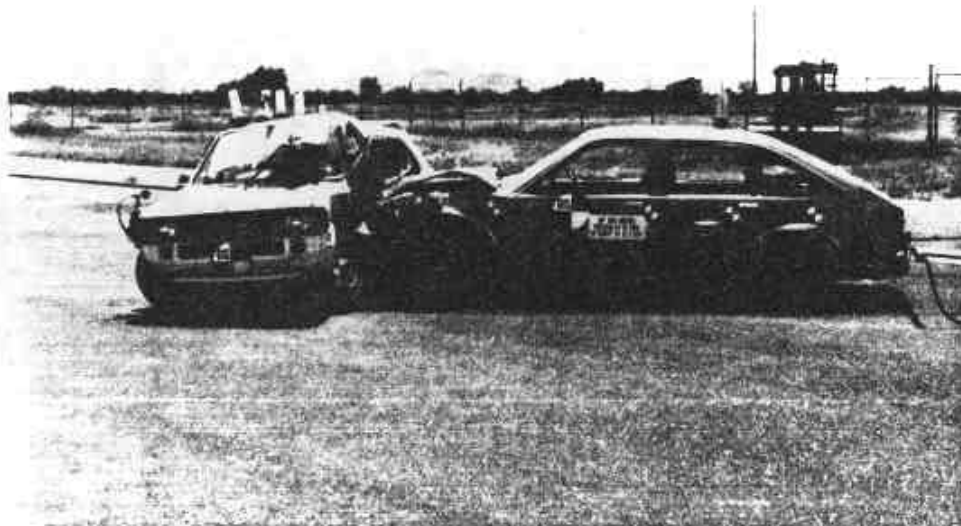
FIGURE A-8. POST-TEST FRONT VIEW OF VEHICLE MATCHUP - 90° TWO VEHICLE MOVING SIDE IMPACT - 1981 CITATION AT 35 MPH TO 1982 VOLKSWAGEN RABBIT AT 17.5 MPH.

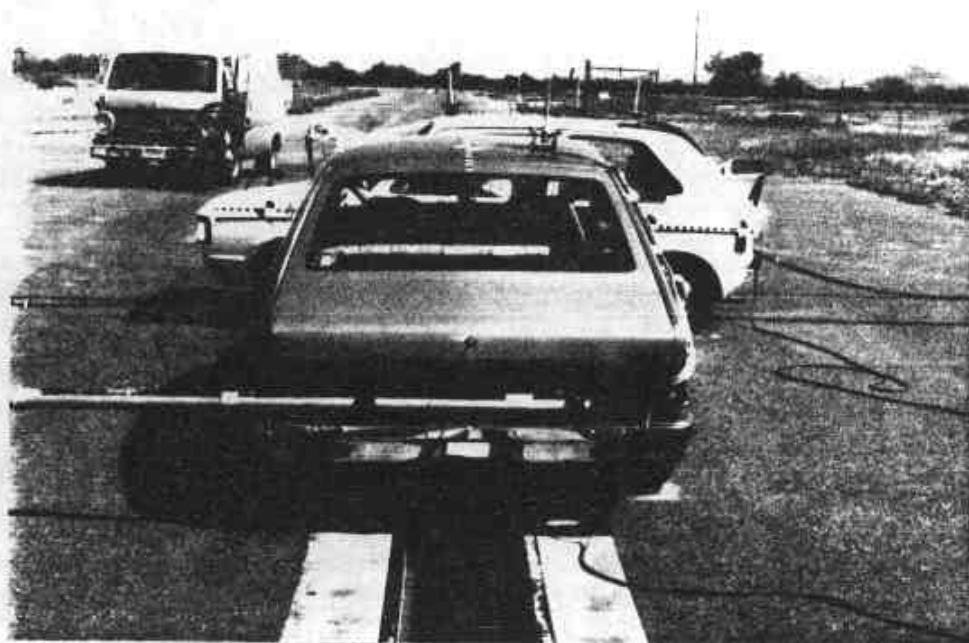
FIGURE A-9. PRE-TEST REAR VIEW OF VEHICLE MATCHUP - 90° TWO VEHICLE MOVING SIDE IMPACT - 1981 CITATION AT 35 MPH TO 1982 VOLKSWAGEN RABBIT AT 17.5 MPH.

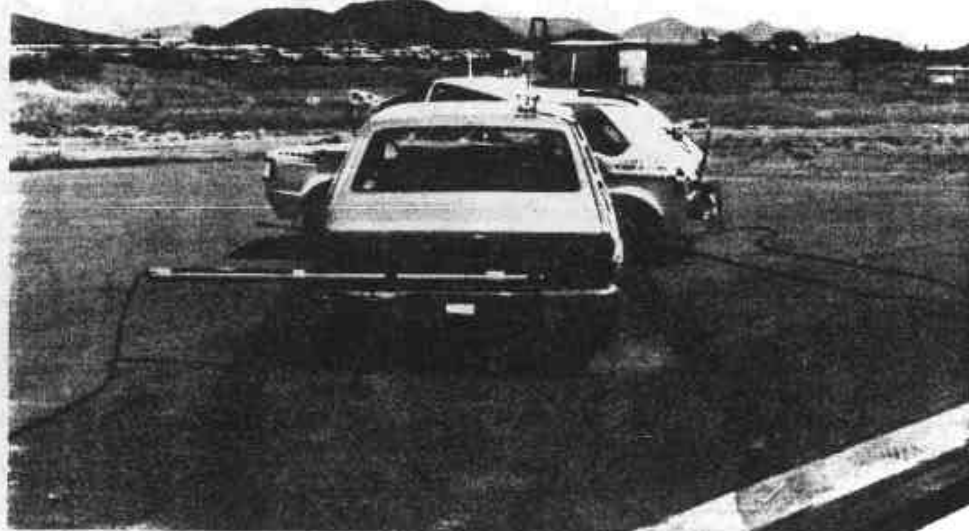
FIGURE A-10. POST-TEST REAR VIEW OF VEHICLE MATCHUP - 90° TWO VEHICLE MOVING SIDE IMPACT - 1981 CITATION AT 35 MPH TO 1982 VOLKSWAGEN RABBIT AT 17.5 MPH.

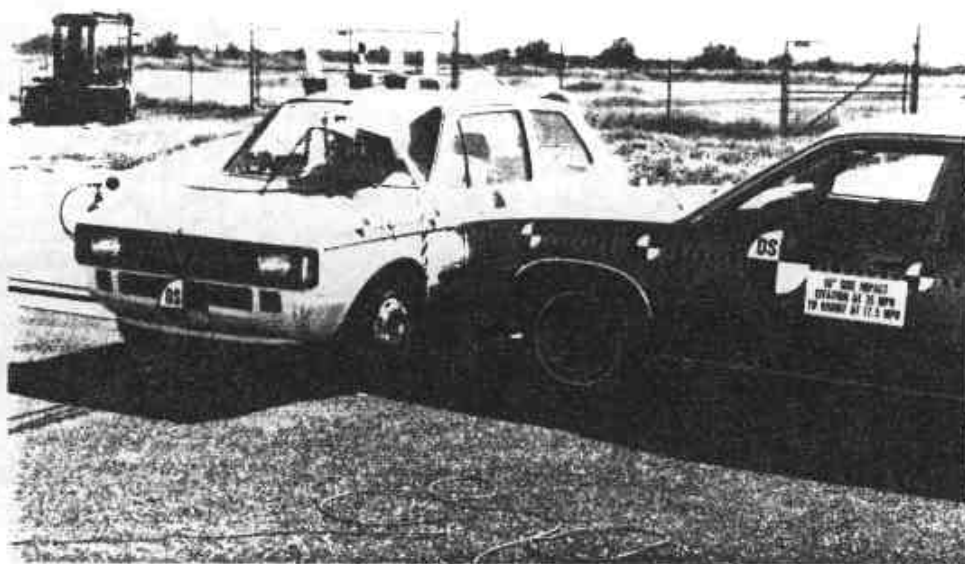
FIGURE A-11. PRE-TEST FRONT VIEW OF VOLKSWAGEN RABBIT - 90° TWO VEHICLE MOVING SIDE IMPACT - 1981 CITATION AT 35 MPH TO 1982 VOLKSWAGEN RABBIT AT 17.5 MPH.

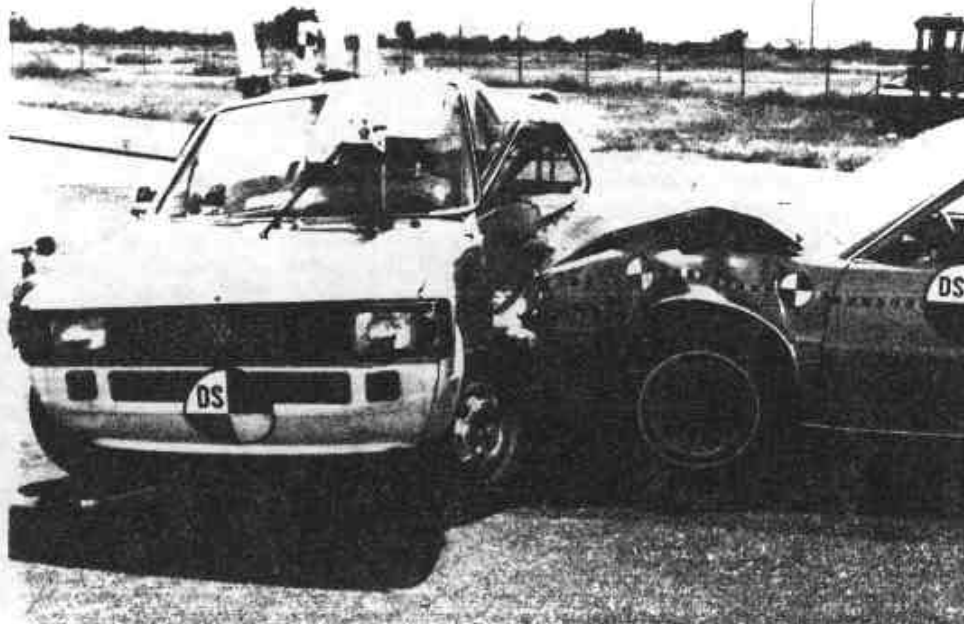
FIGURE A-12. POST-TEST FRONT VIEW OF VOLKSWAGEN RABBIT - 90° TWO VEHICLE MOVING SIDE IMPACT - 1981 CITATION AT 35 MPH TO 1982 VOLKSWAGEN RABBIT AT 17.5 MPH.

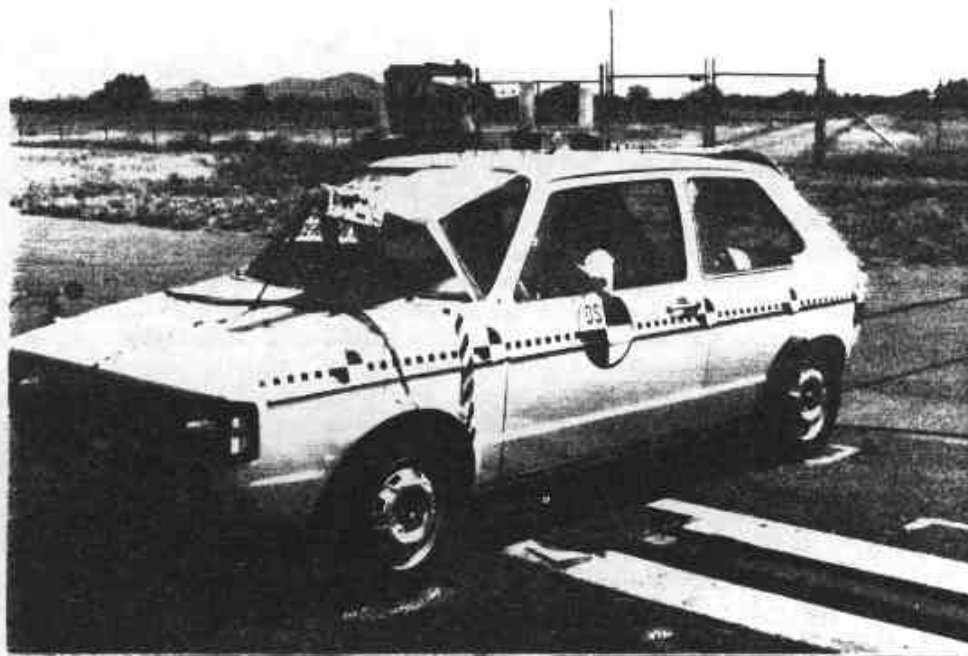
FIGURE A-13. PRE-TEST FRONT OBLIQUE VIEW OF VOLKSWAGEN RABBIT -  
90° TWO VEHICLE MOVING SIDE IMPACT - 1981 CITATION  
AT 35 MPH TO 1982 VOLKSWAGEN RABBIT AT 17.5 MPH.

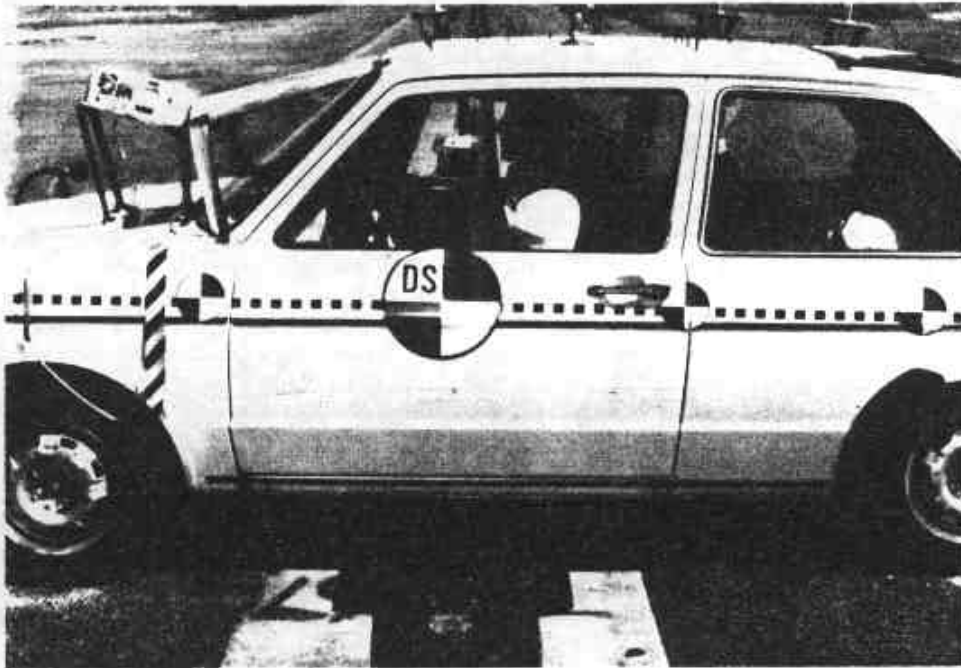
FIGURE A-14. PRE-TEST LEFT SIDE VIEW OF VOLKSWAGEN RABBIT - 90° TWO VEHICLE MOVING SIDE IMPACT - 1981 CITATION AT 35 MPH TO 1982 VOLKSWAGEN RABBIT AT 17.5 MPH.

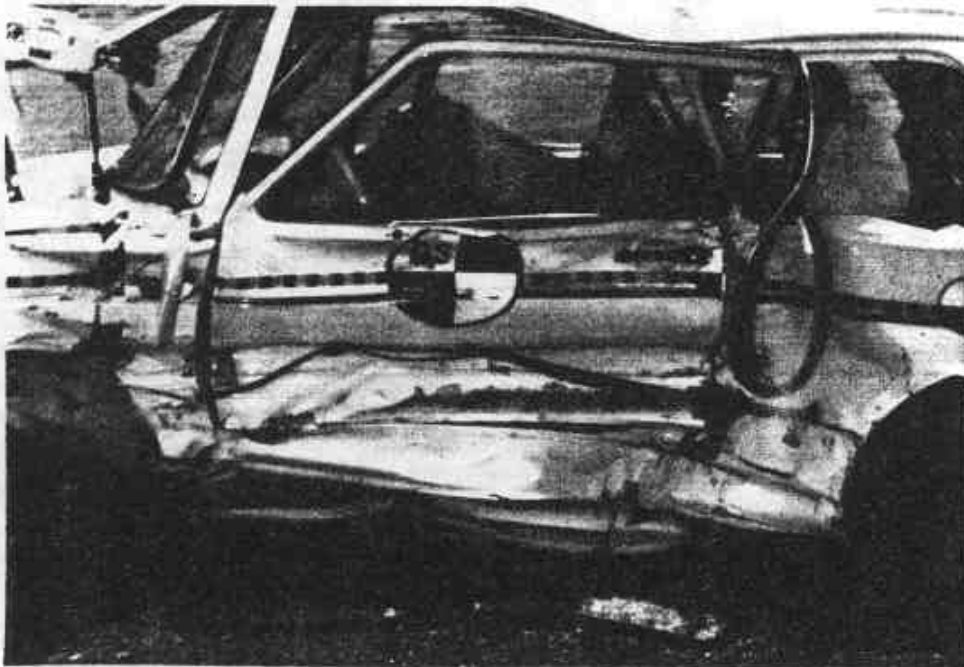
FIGURE A-15. POST-TEST LEFT SIDE OF VOLKSWAGEN RABBIT - 90° TWO VEHICLE MOVING SIDE IMPACT - 1981 CITATION AT 35 MPH TO 1982 VOLKSWAGEN RABBIT AT 17.5 MPH.

Backlight/Windshield Windshield cracked but intact. Left side window broken. Some retention loss on left side of windshield.

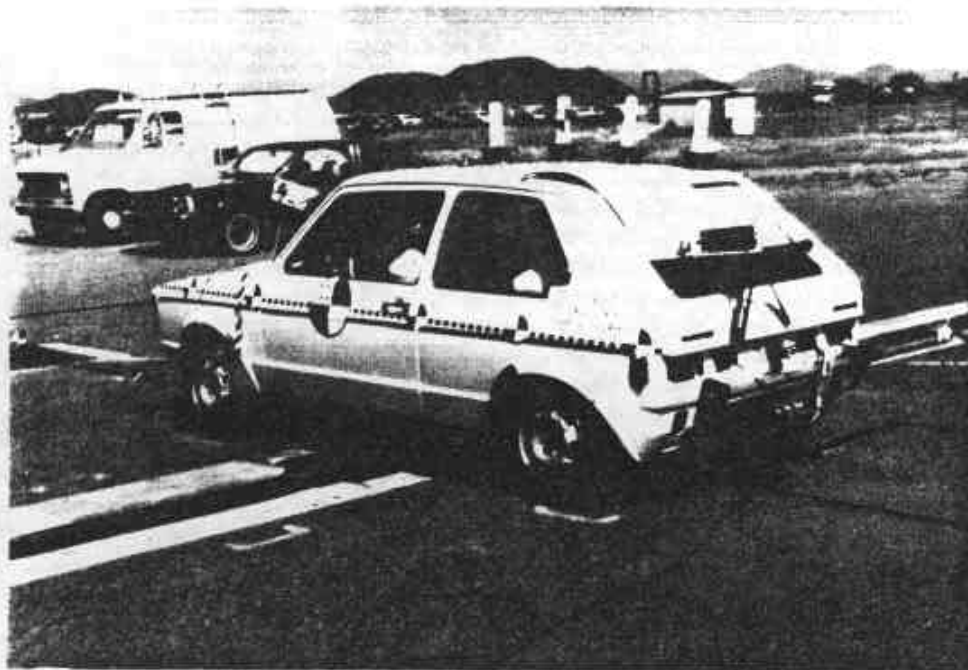
FIGURE A-16. PRE-TEST REAR OBLIQUE OF VOLKSWAGEN RABBIT - 90°  
TWO VEHICLE MOVING SIDE IMPACT - 1981 CITATION AT  
35 MPH TO 1982 VOLKSWAGEN RABBIT AT 17.5 MPH.

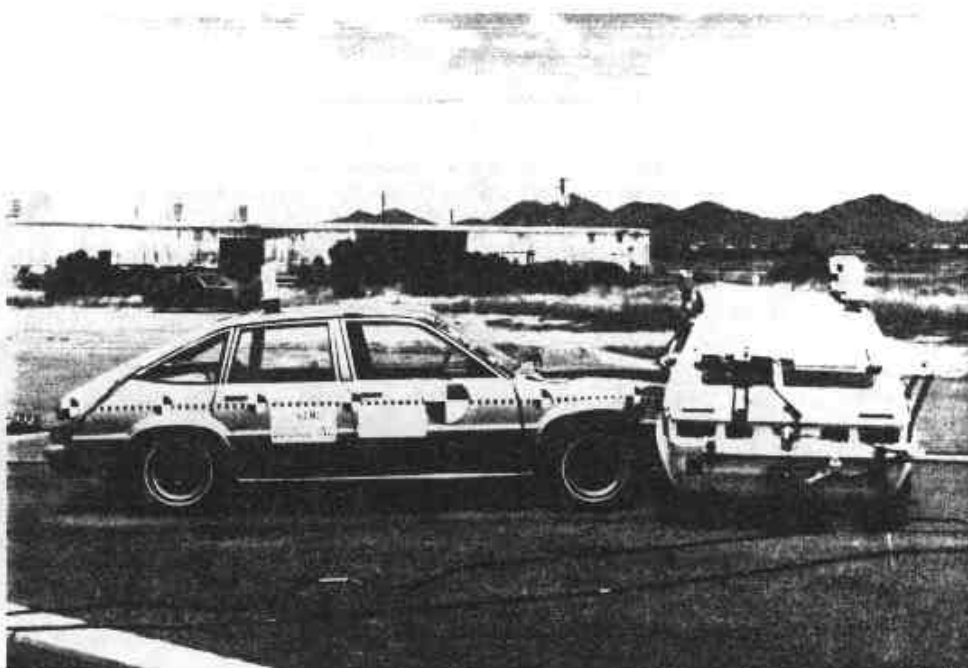
FIGURE A-20. POST-TEST REAR VIEW OF VOLKSWAGEN RABBIT - 90° TWO VEHICLE MOVING SIDE IMPACT - 1981 CITATION AT 35 MPH TO 1982 VOLKSWAGEN RABBIT AT 17.5 MPH.

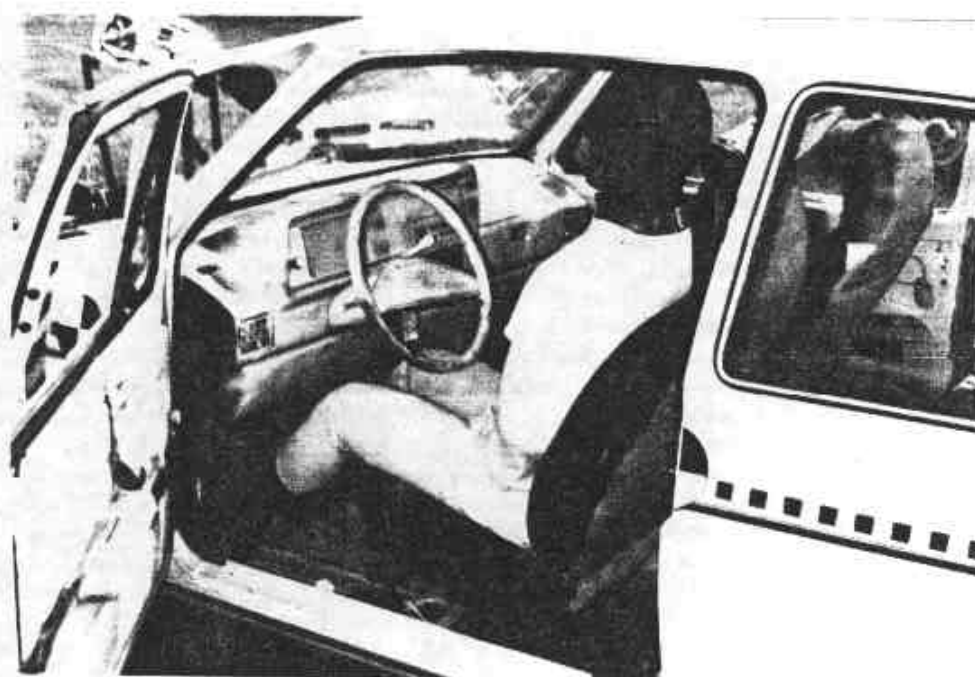
FIGURE A-21b. PRE-TEST DRIVER DUMMY POSITION (LEFT SIDE) - 90°  
TWO VEHICLE MOVING SIDE IMPACT - 1981 CITATION  
AT 35 MPH TO 1982 VOLKSWAGEN RABBIT AT 17.5 MPH.

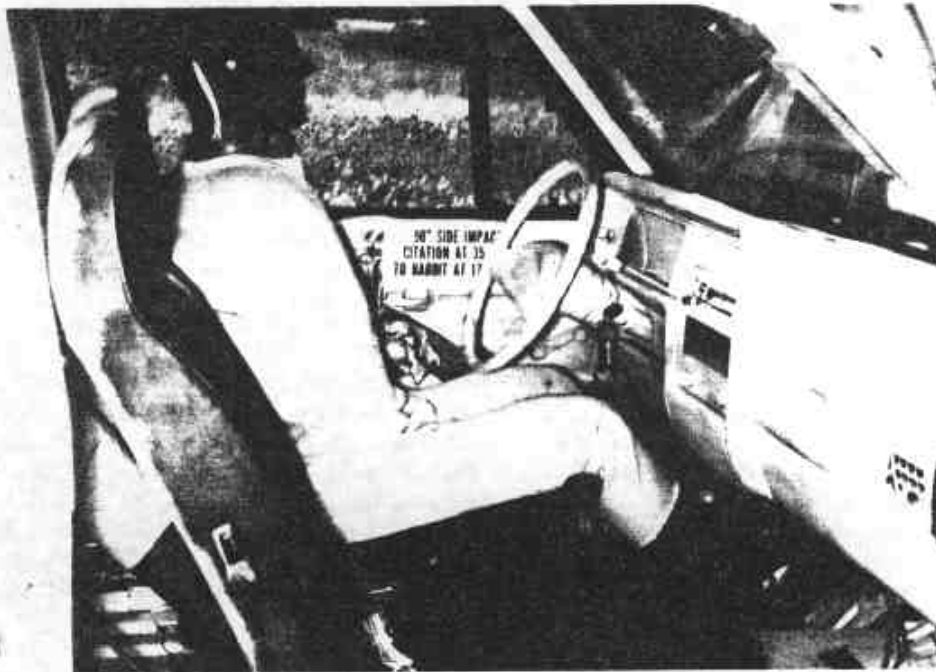
FIGURE A-22a. PRE-TEST DRIVER DUMMY POSITION (RIGHT SIDE) - 90° TWO VEHICLE MOVING SIDE IMPACT - 1981 CITATION AT 35 MPH TO 1982 VOLKSWAGEN RABBIT AT 17.5 MPH.

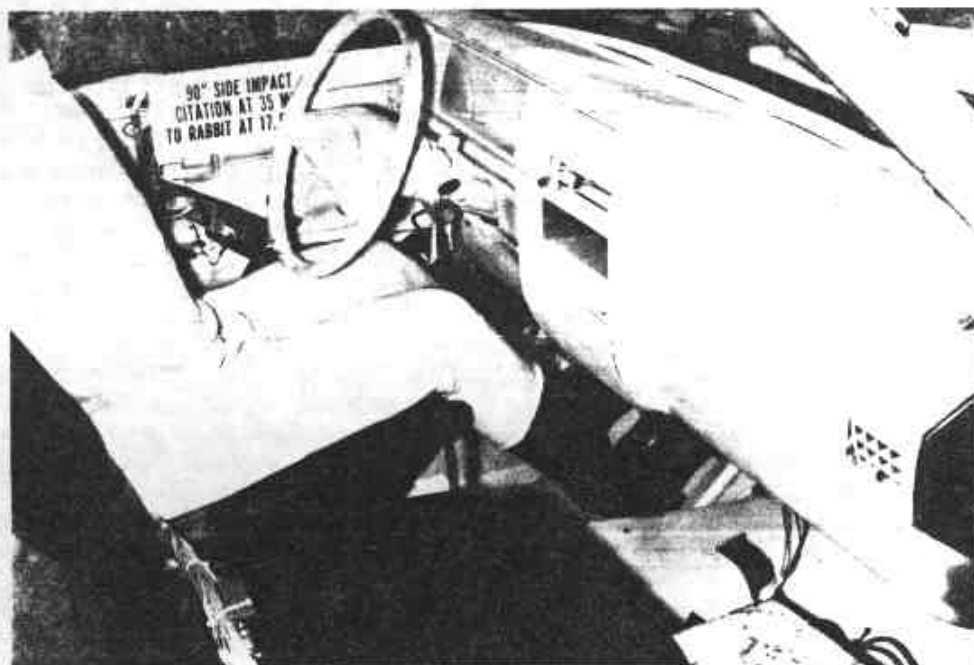
FIGURE A-22b. PRE-TEST DRIVER DUMMY POSITION (RIGHT SIDE) - 90° TWO VEHICLE MOVING SIDE IMPACT - 1981 CITATION AT 35 MPH TO 1982 VOLKSWAGEN RABBIT AT 17.5 MPH.

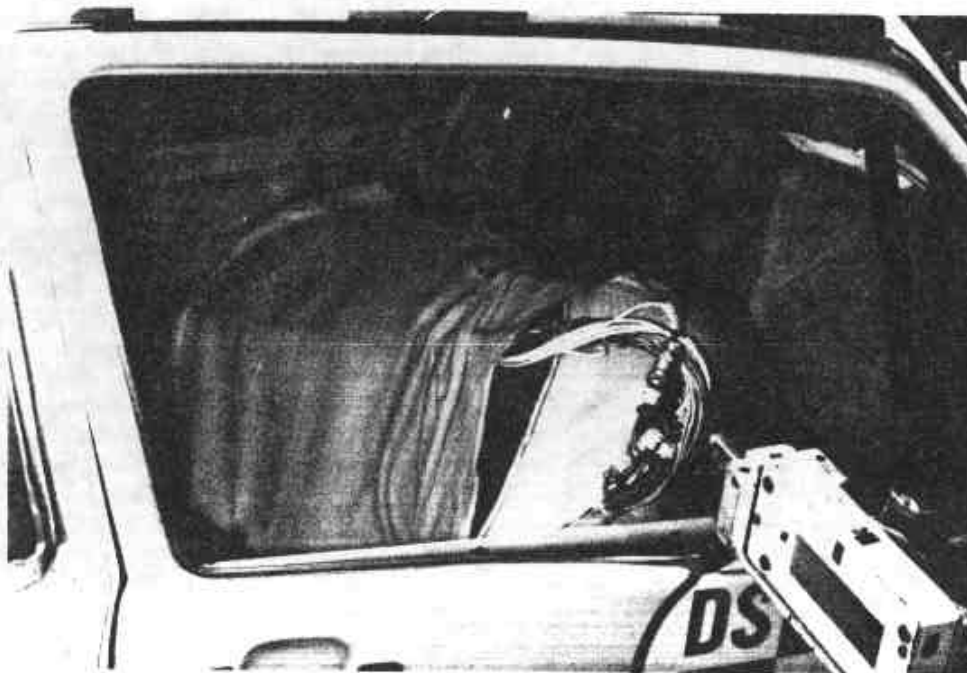
FIGURE A-24. PRE-TEST PASSENGER DUMMY POSITION (LEFT SIDE) - 90° TWO VEHICLE MOVING SIDE IMPACT - 1981 CITATION AT 35 MPH TO 1982 VOLKSWAGEN RABBIT AT 17.5 MPH.

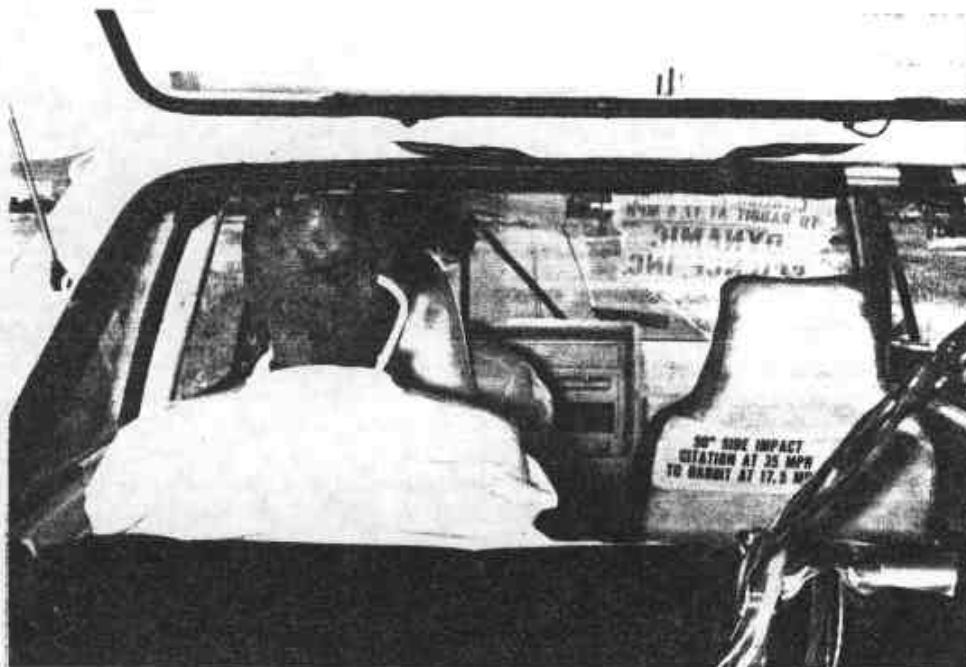
FIGURE A-25. PRE-TEST PASSENGER DUMMY POSITION (REAR) - 90° TWO VEHICLE MOVING SIDE IMPACT - 1981 CITATION AT 35 MPH TO 1982 VOLKSWAGEN RABBIT AT 17.5 MPH.

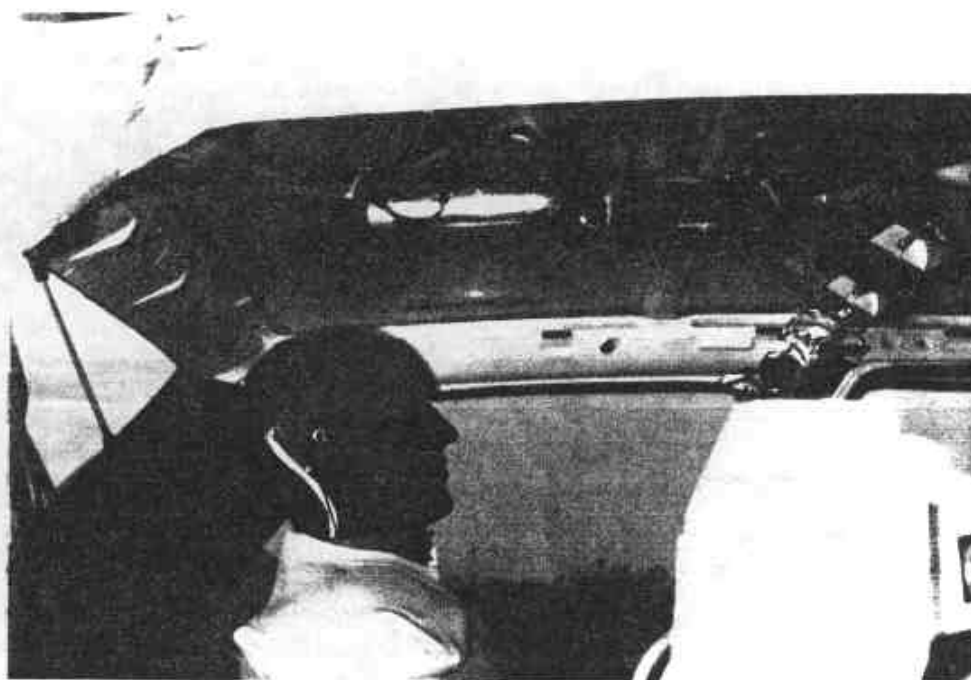
FIGURE A-26a. PRE-TEST PASSENGER DUMMY POSITON (RIGHT SIDE) - 90°  
TWO VEHICLE MOVING SIDE IMPACT - 1981 CITATION AT  
35 MPH to 1982 VOLKSWAGEN RABBIT AT 17.5 MPH.

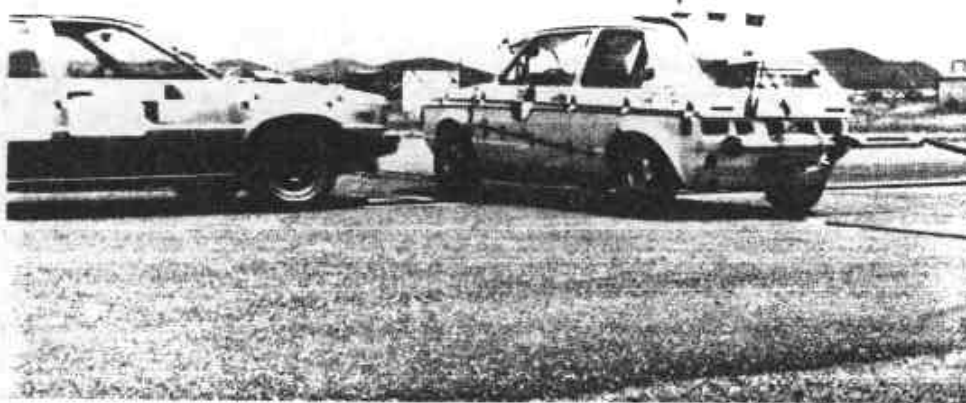
FIGURE A-28a. IMPACT SEQUENCE - 90° TWO VEHICLE MOVING SIDE  
IMPACT - 1981 CITATION AT 35 MPH TO 1982  
VOLKSWAGEN RABBIT AT 17.5 MPH.

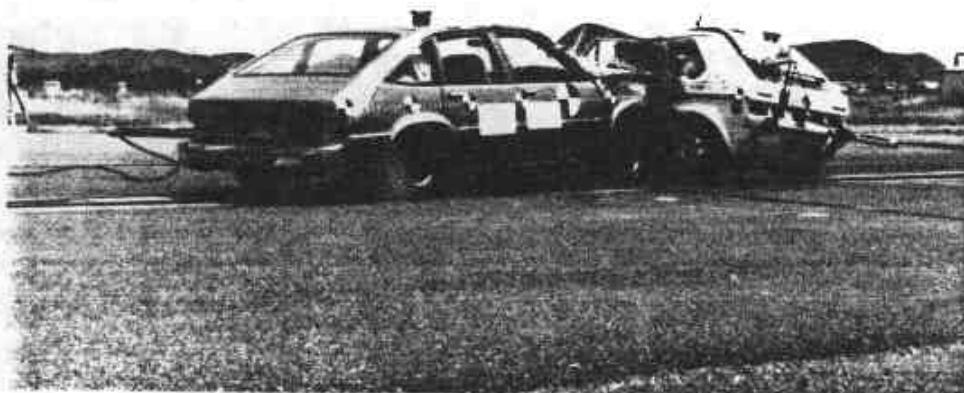
FIGURE A-28b. IMPACT SEQUENCE - 90° TWO VEHICLE MOVING SIDE  
IMPACT - 1981 CITATION AT 35 MPH TO 1982  
VOLKSWAGEN RABBIT AT 17.5 MPH.

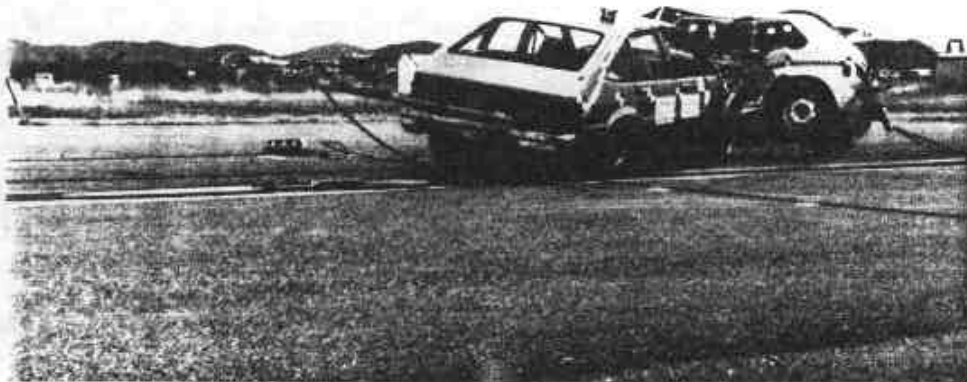
**FIGURE A-28c. IMPACT SEQUENCE - 90° TWO VEHICLE MOVING SIDE  
IMPACT - 1981 CITATION AT 35 MPH TO 1982  
VOLKSWAGEN RABBIT AT 17.5 MPH.**

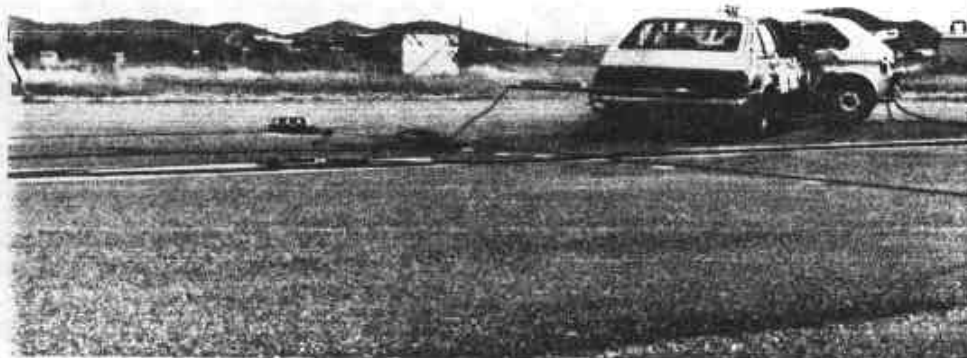
**FIGURE A-28d. IMPACT SEQUENCE - 90° TWO VEHICLE MOVING SIDE  
IMPACT - 1981 CITATION AT 35 MPH TO 1982  
VOLKSWAGEN RABBIT AT 17.5 MPH.**
