TEST REPORT

TEST DESCRIPTION: Moving Barrier Side Impactor (MBSI) into Citation Door with Modified Side Structure and GTR Padding (46.45 mph, Driver Side Occupant, 60 Degree Impact)

MIV TEST NUMBER: 4

MCR TECHNOLOGY, INC.  
TEST NUMBER: 2600

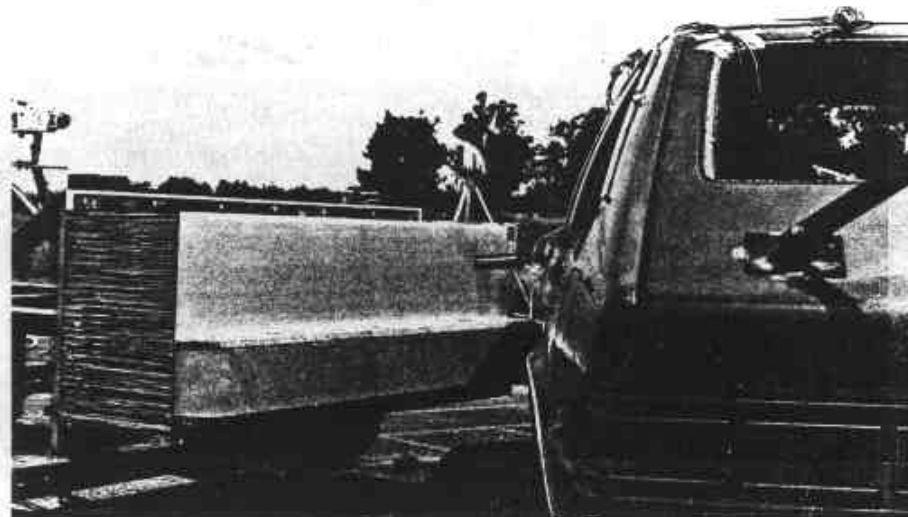
Figure 6. ALIGNMENT OF MBSI TO CITATION

The MBSI was towed into the stationary Citation at an angle 41 degrees relative to the Citation longitudinal centerline (see diagram below). The MBSI nose was oriented to strike at an angle of 60 degrees relative to the Citation centerline. Thus it simulated a 60 degree side impact with a crabbing angle of 19 degrees. The crabbing velocity ( $V_{CR}$ ) was 46.45 mph. This condition is representative of a 90 degree impact in which the impacting and impacted vehicles are moving forward at 35.07 and 17.53 mph, respectively.

The first point of contact was intended to be 89.5 inches forward of the rear axle centerline.\* The actual point of impact was approximately  $\frac{1}{2}$  inch ahead of that point. The Citation rocker panel to ground distances were: LF = 8.12 inches; RF = 7.87 inches; LR = 7.5 inches; RR = 7.75 inches.

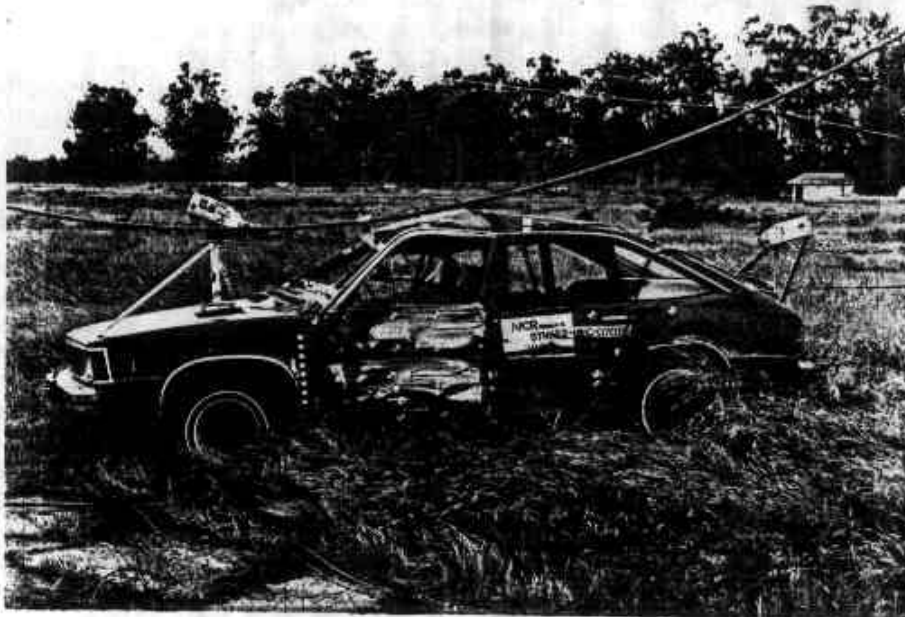
FIGURE 12. VEHICLE DAMAGE - DRIVERS SIDE

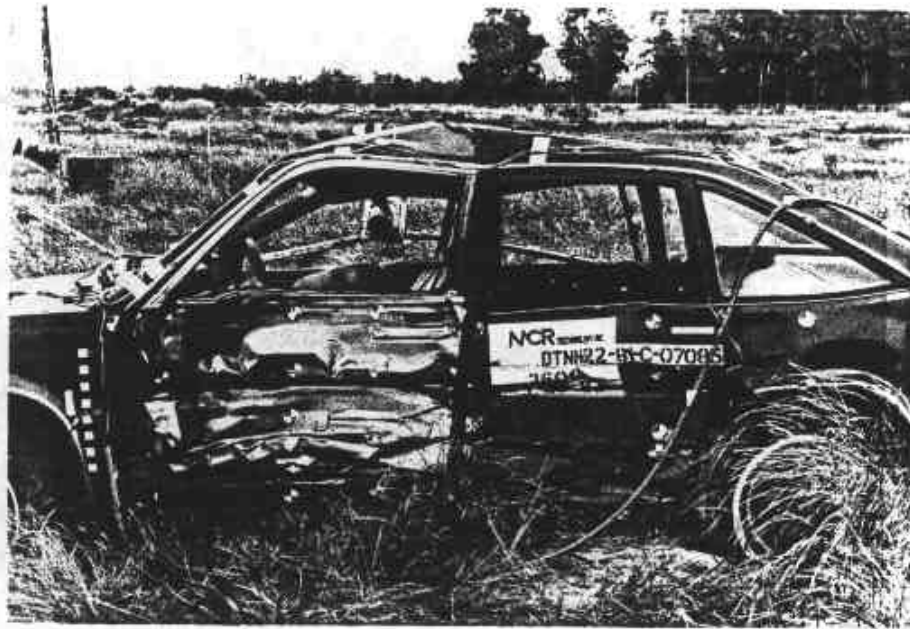
FIGURE 13. CLOSE UP OF VEHICLE DAMAGE - DRIVERS SIDE

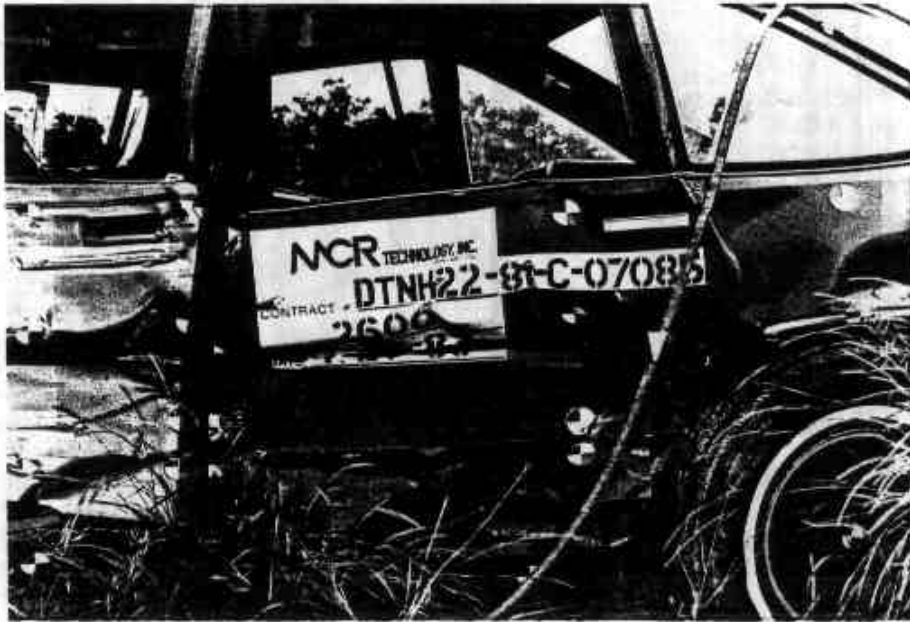
FIGURE 15. DAMAGE TO VEHICLE DRIVER SIDE REAR DOOR AREA

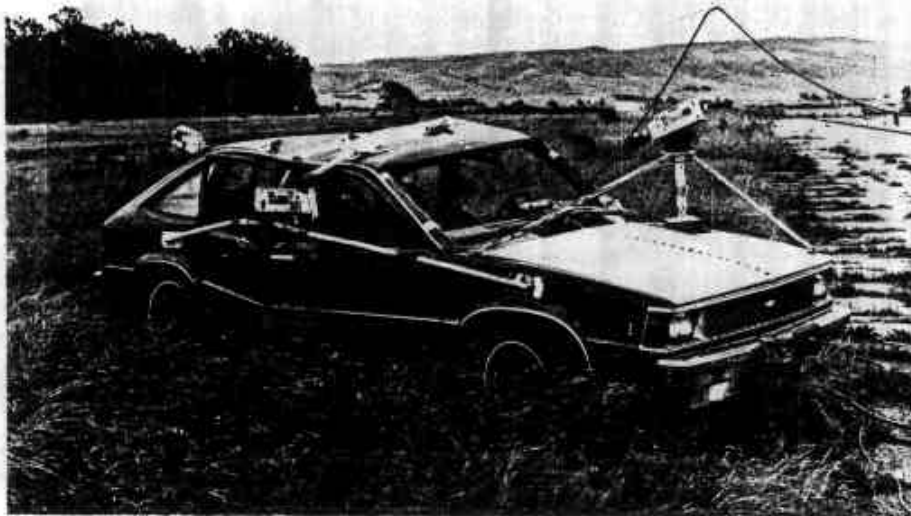
FIGURE 16. VEHICLE DAMAGE - PASSENGER SIDE

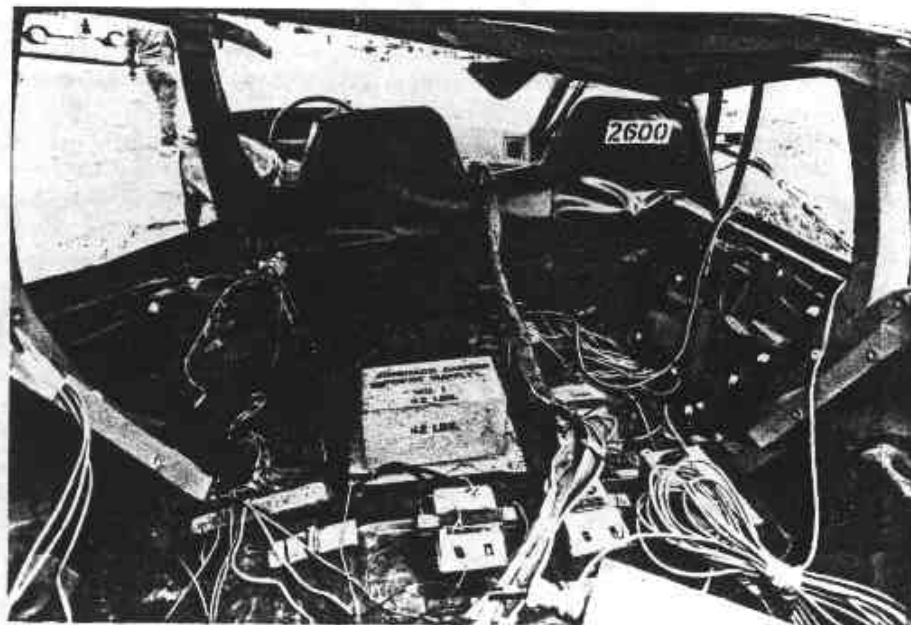
FIGURE 18. INTERIOR DAMAGE - REAR VIEW
