Dynamic Science Report No. 3154-83-046/2104

AIR BAG FLEET RETROFIT PROGRAM  
CRASH TESTS

TEST NO. 3154-3  
1981 DODGE DIPLOMAT  
4-DOOR SEDAN

TEST REPORT

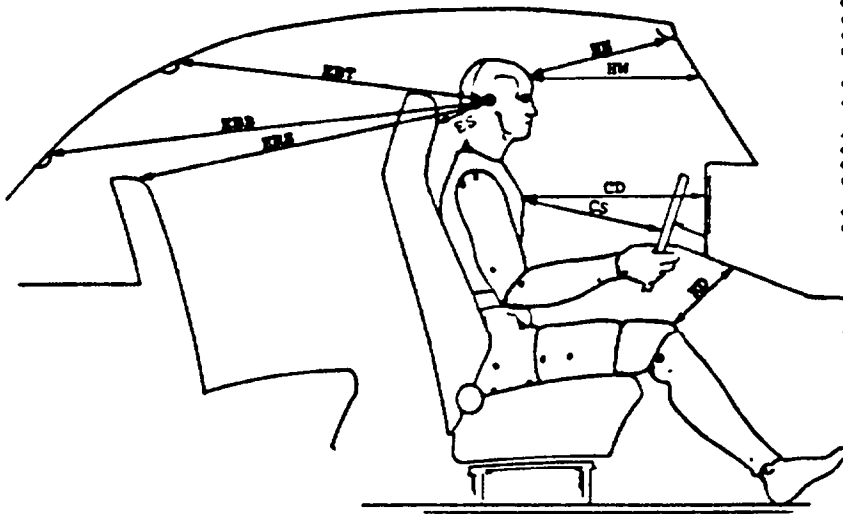
**PART 572 DUMMY IN-VEHICLE POSITION RECORDING SHEET**

Driver	Passenger
HH	14.5	
HW	20.2	
CD	21.5	
CS	12.5	
KD L	7.1	
KD R	6.5	
Torso		Torso
Angle	17°	Angle °
Seat Back		Seat Back
Angle	20°	Angle °
HSW	18.8

- HH = Head to Windshield Header
  - HW = Head to Windshield
  - CD = Chest to Dash
  - CS = Chest to Steering Wheel
  - KD = Knees to Dash
  - HR = Head to Side Roof
  - HS = Head to Side Window
  - AD = Arm to Door
  - HD = Hip to Door
  - KK - Knee to Knee
- Torso and seat back angles are relative to vertical.

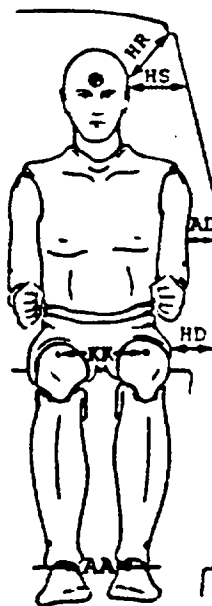
Driver	Passenger
HR	5.7	
HS	10.1	
AD	4.2	
HD	6.8	
KK	11.0	
AA	10.0

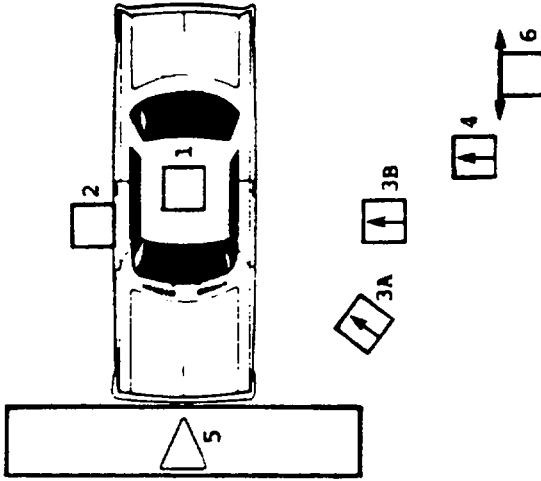
CAMERA LOCATIONS

- CAMERA SYMBOLS
- PIT
  - GROUND
  - BARRIER
  - OVERHEAD
  - ON-BOARD
  - PANNING
- FRAME RATE
1. 1000 fr/sec
  2. 200 fr/sec
  3. Other 24 fr/sec
  4. 400 fr/sec
  5. 500 fr/sec
- TIMING LIGHT SPEED
1. 100 Hz (10 msec/light)
  2. 200 Hz (5 msec/light)
  3. Other

Loc. No.	Location	Field of View	Lens Size	Frm Rate	Tmng Spd	Ser No	Impact Dist-X	C.L. Dist-Y	CAM Hght-Z
1	On-board vehicle roof	Over driver shoulder at dummy and airbag	8	4	1	7	NA	NA	NA
2	On-board pass. door	90° view of driver dummy & air bag deployment	8	4	1	12	NA	NA	NA
3A	Left side ground based	Close-up of driver dummy through windows	16	4	1	M10	103"	84"	70"
3B	Left side ground based	Close-up of driver dummy through windows	16	4	1	M11	103"	84"	70"
4	Left side ground based	Overall view of vehicle throughout crash event	16	4	1	M3	106"	436"	52"
5	Barrier overhead	View of air bag deployment through windshield	10	4	1	M7	17"	0	111.5"
6	Ground based panning	Overall view of vehicle through crash event	Var.	3	-	-	-	-	-

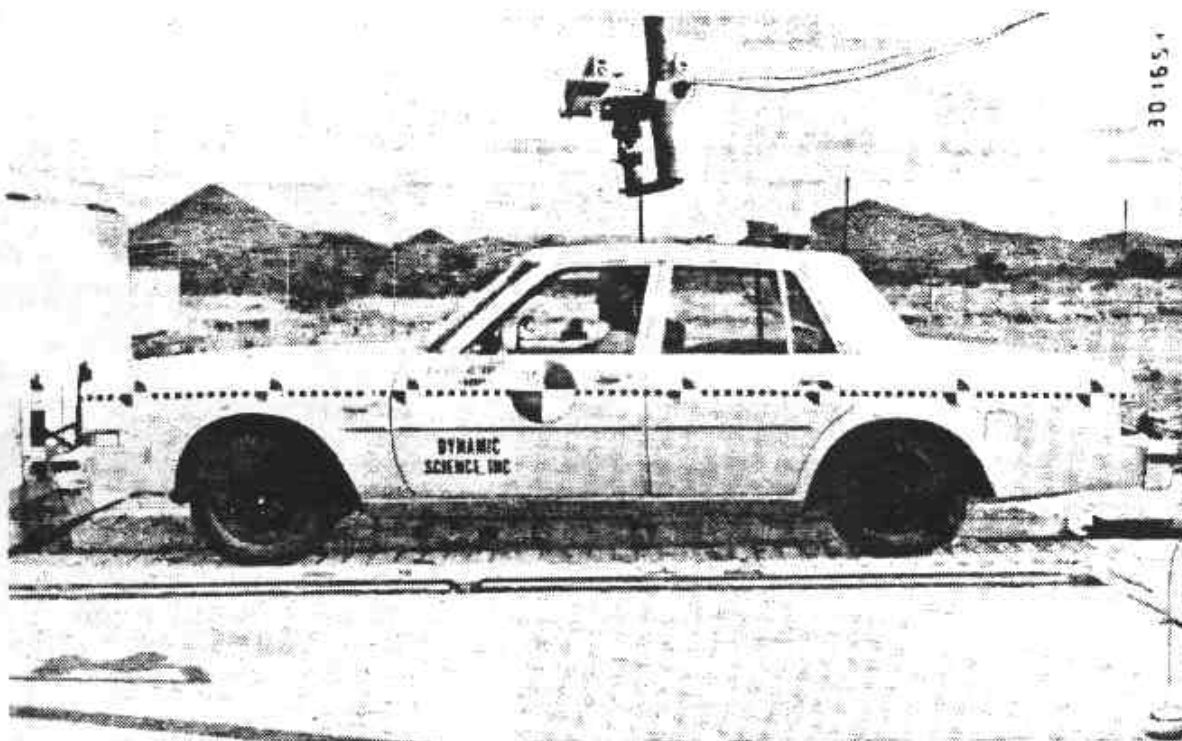
FIGURE B-1. PRE-TEST OVERALL VIEW OF VEHICLE.

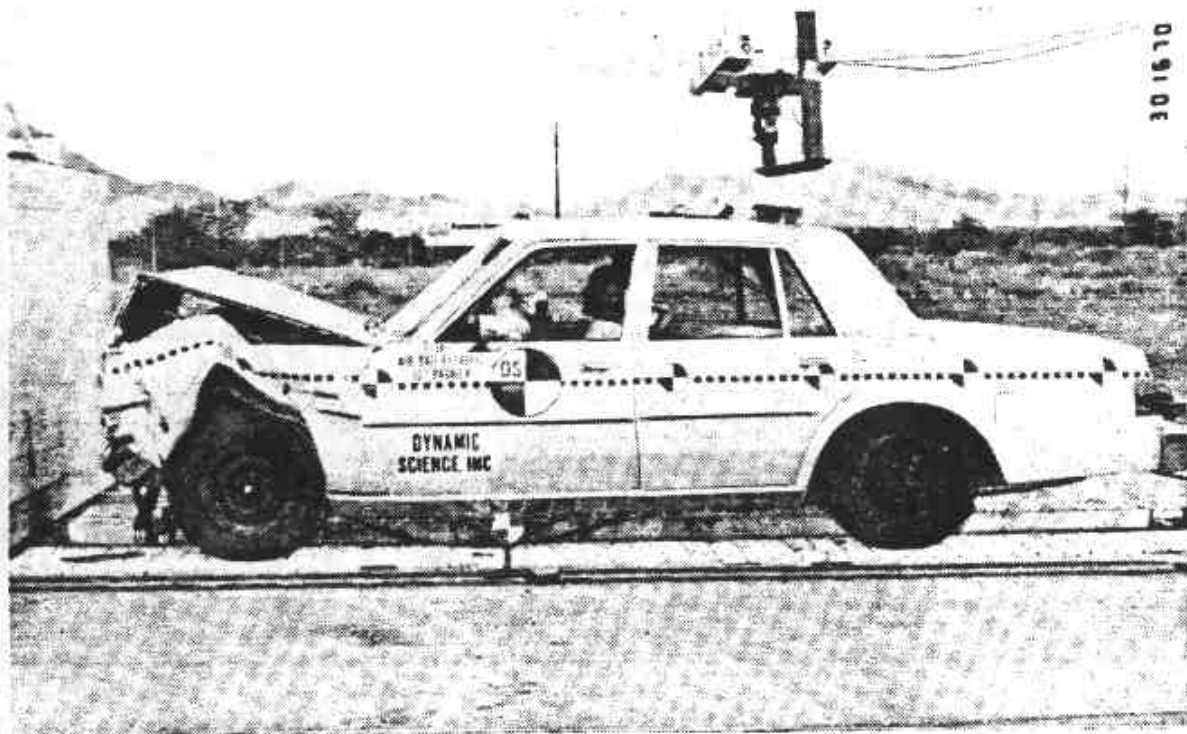
FIGURE B-2. POST-TEST OVERALL VIEW OF VEHICLE.

Vehicle Length: Pre-test =	R <u>201.8</u>	€ <u>204.8</u>	L <u>201.7</u>
Post-test =	R <u>182.7</u>	€ <u>183.5</u>	L <u>182.8</u>
Crush =	R <u>19.1</u>	€ <u>21.3</u>	L <u>18.9</u>

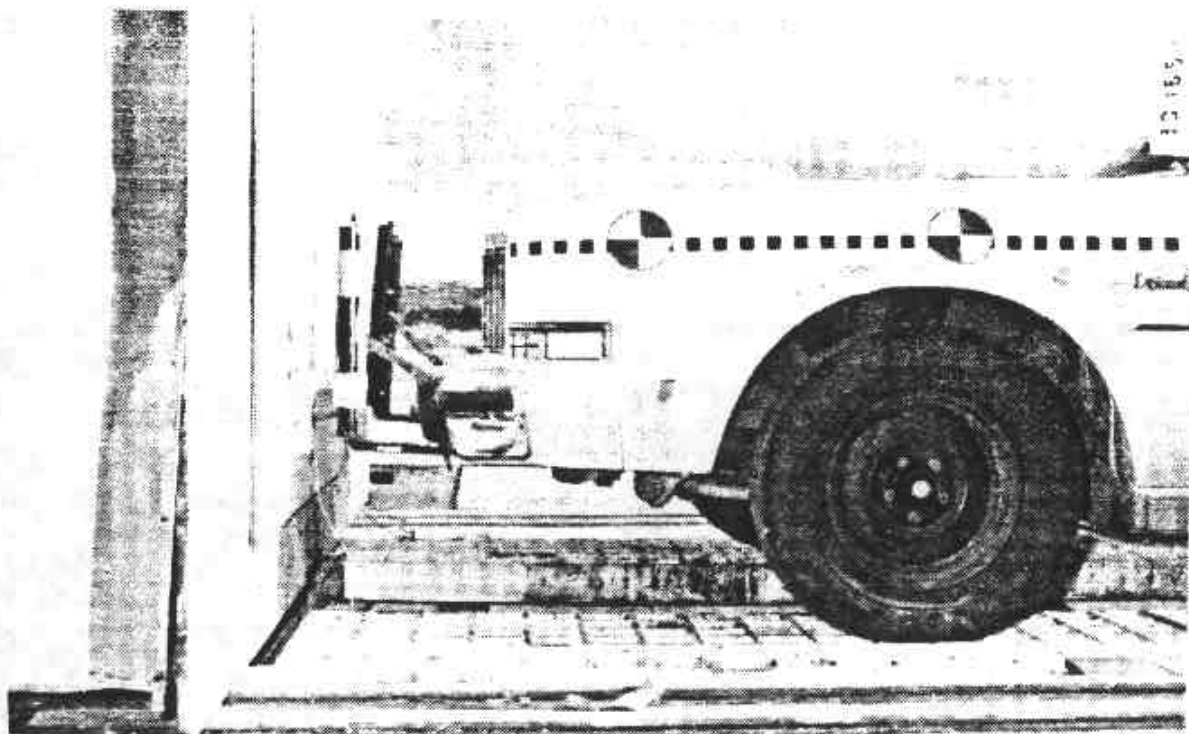
FIGURE B-3. PRE-TEST VIEW OF VEHICLE FRONT.

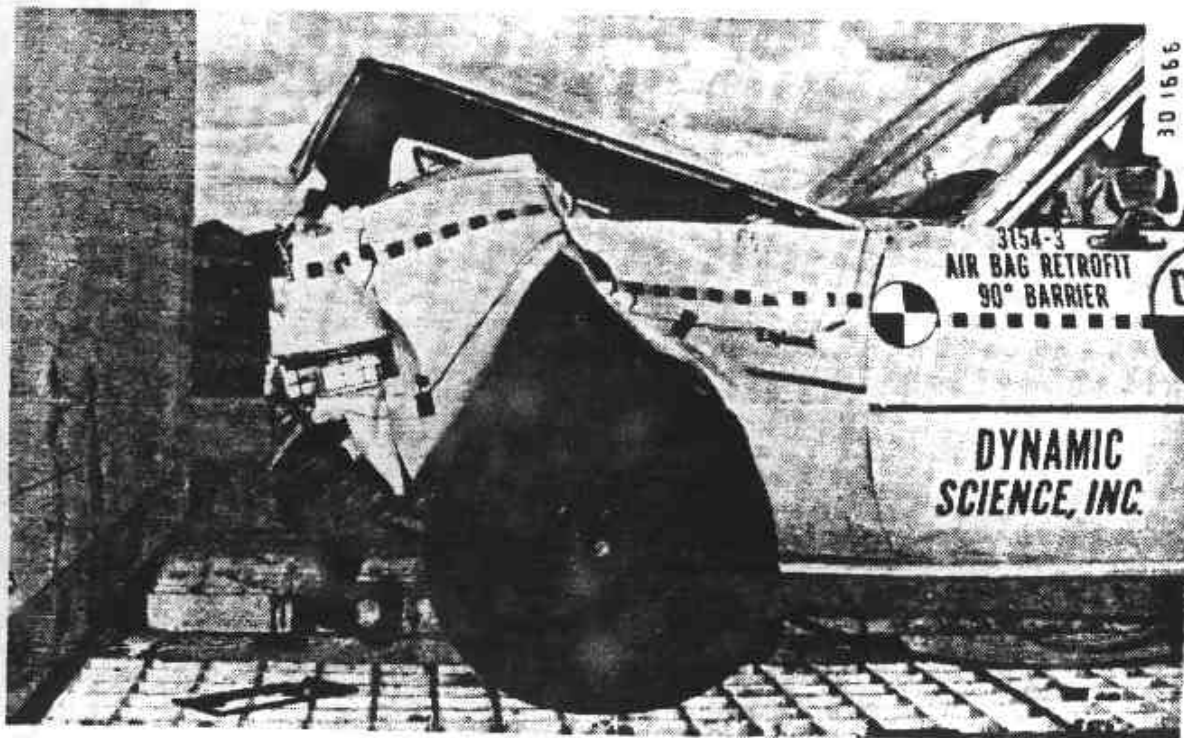
FIGURE B-4. POST-TEST VIEW OF VEHICLE FRONT.

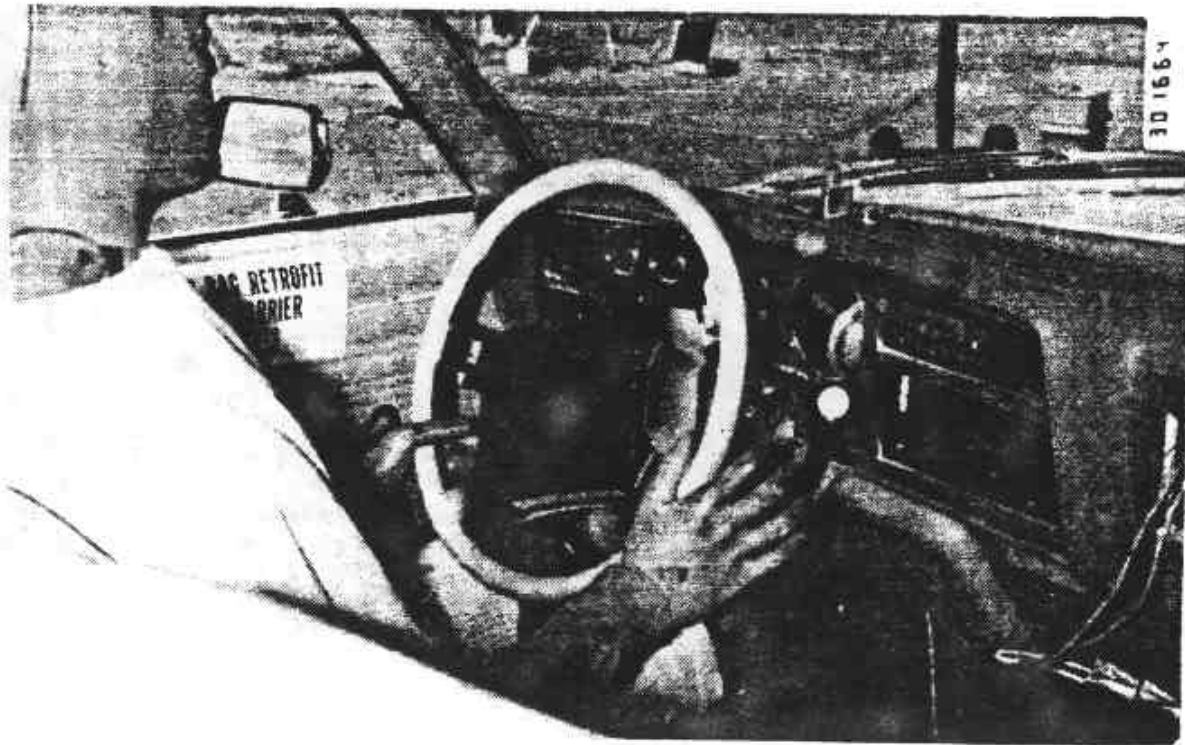
FIGURE B-5. PRE-TEST VIEW OF DRIVER.

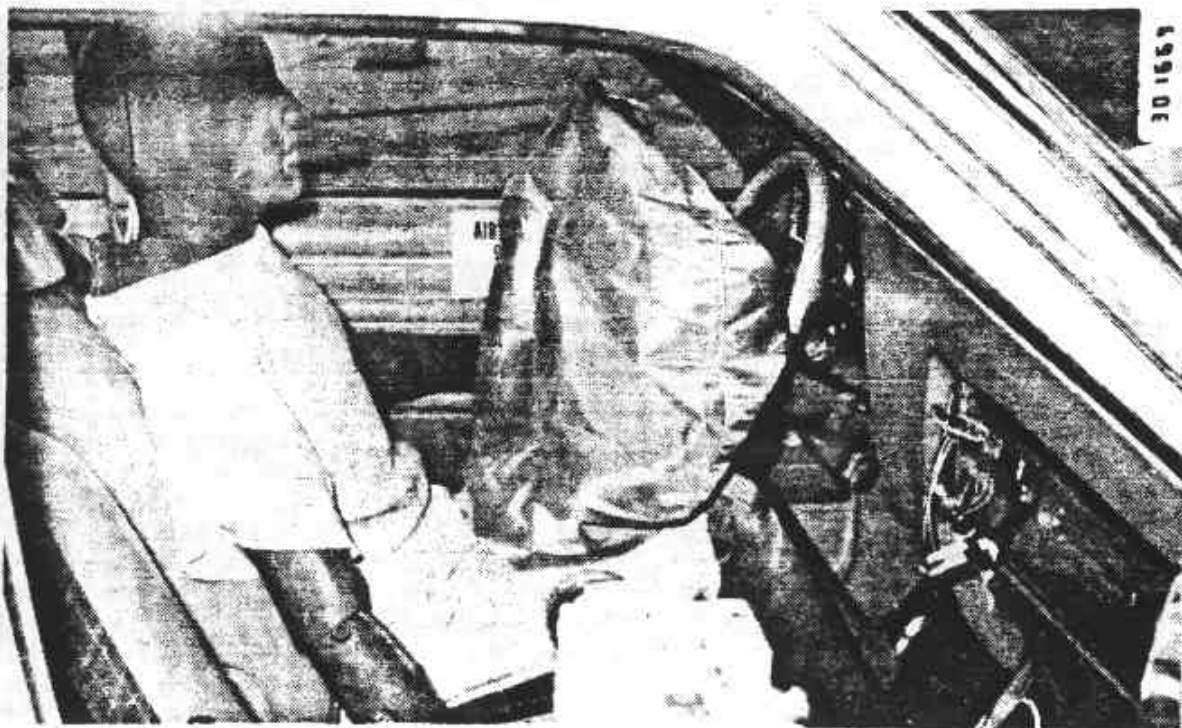
FIGURE B-6. POST-TEST VIEW OF DRIVER.

<u>Driver</u>	<u>Passenger</u>
Head	<u>Air bag</u>	<u></u>
Chest	<u>Air bag</u>	<u></u>
Abdomen	<u></u>	<u></u>
Left Knee	<u>Knee bolster</u>	<u></u>
Right Knee	<u>Knee bolster</u>	<u></u>

Backlight/Windshield Windshield cracking on driver side due to force of air bag contact.

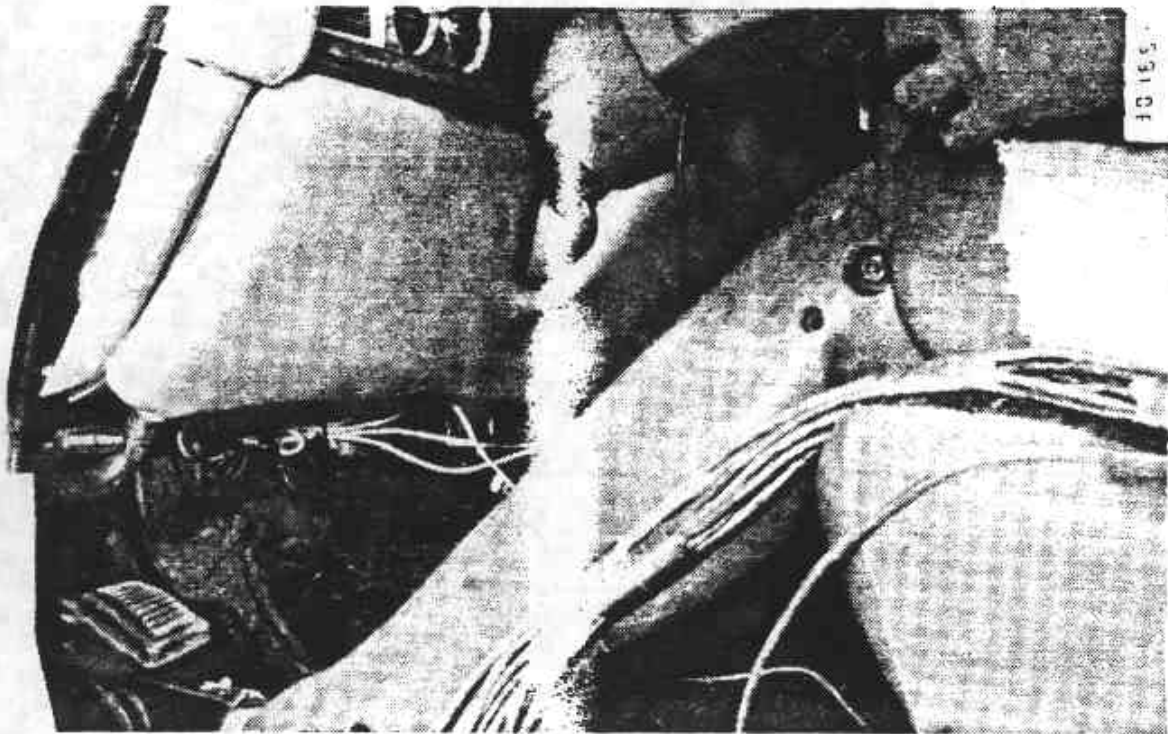
FIGURE B-7. PRE-TEST VIEW OF KNEE BOLSTER.
