REPORT NO. 212-MSE-83-003
219-MSE-83-003
301-MSE-83-003

NHTSA NEW VEHICLE ASSESSMENT AND
STANDARDS ENFORCEMENT INDICANT TESTING
FMVSS 212, 219, & 301-75

1983 Mitsubishi Cordia

FINAL REPORT

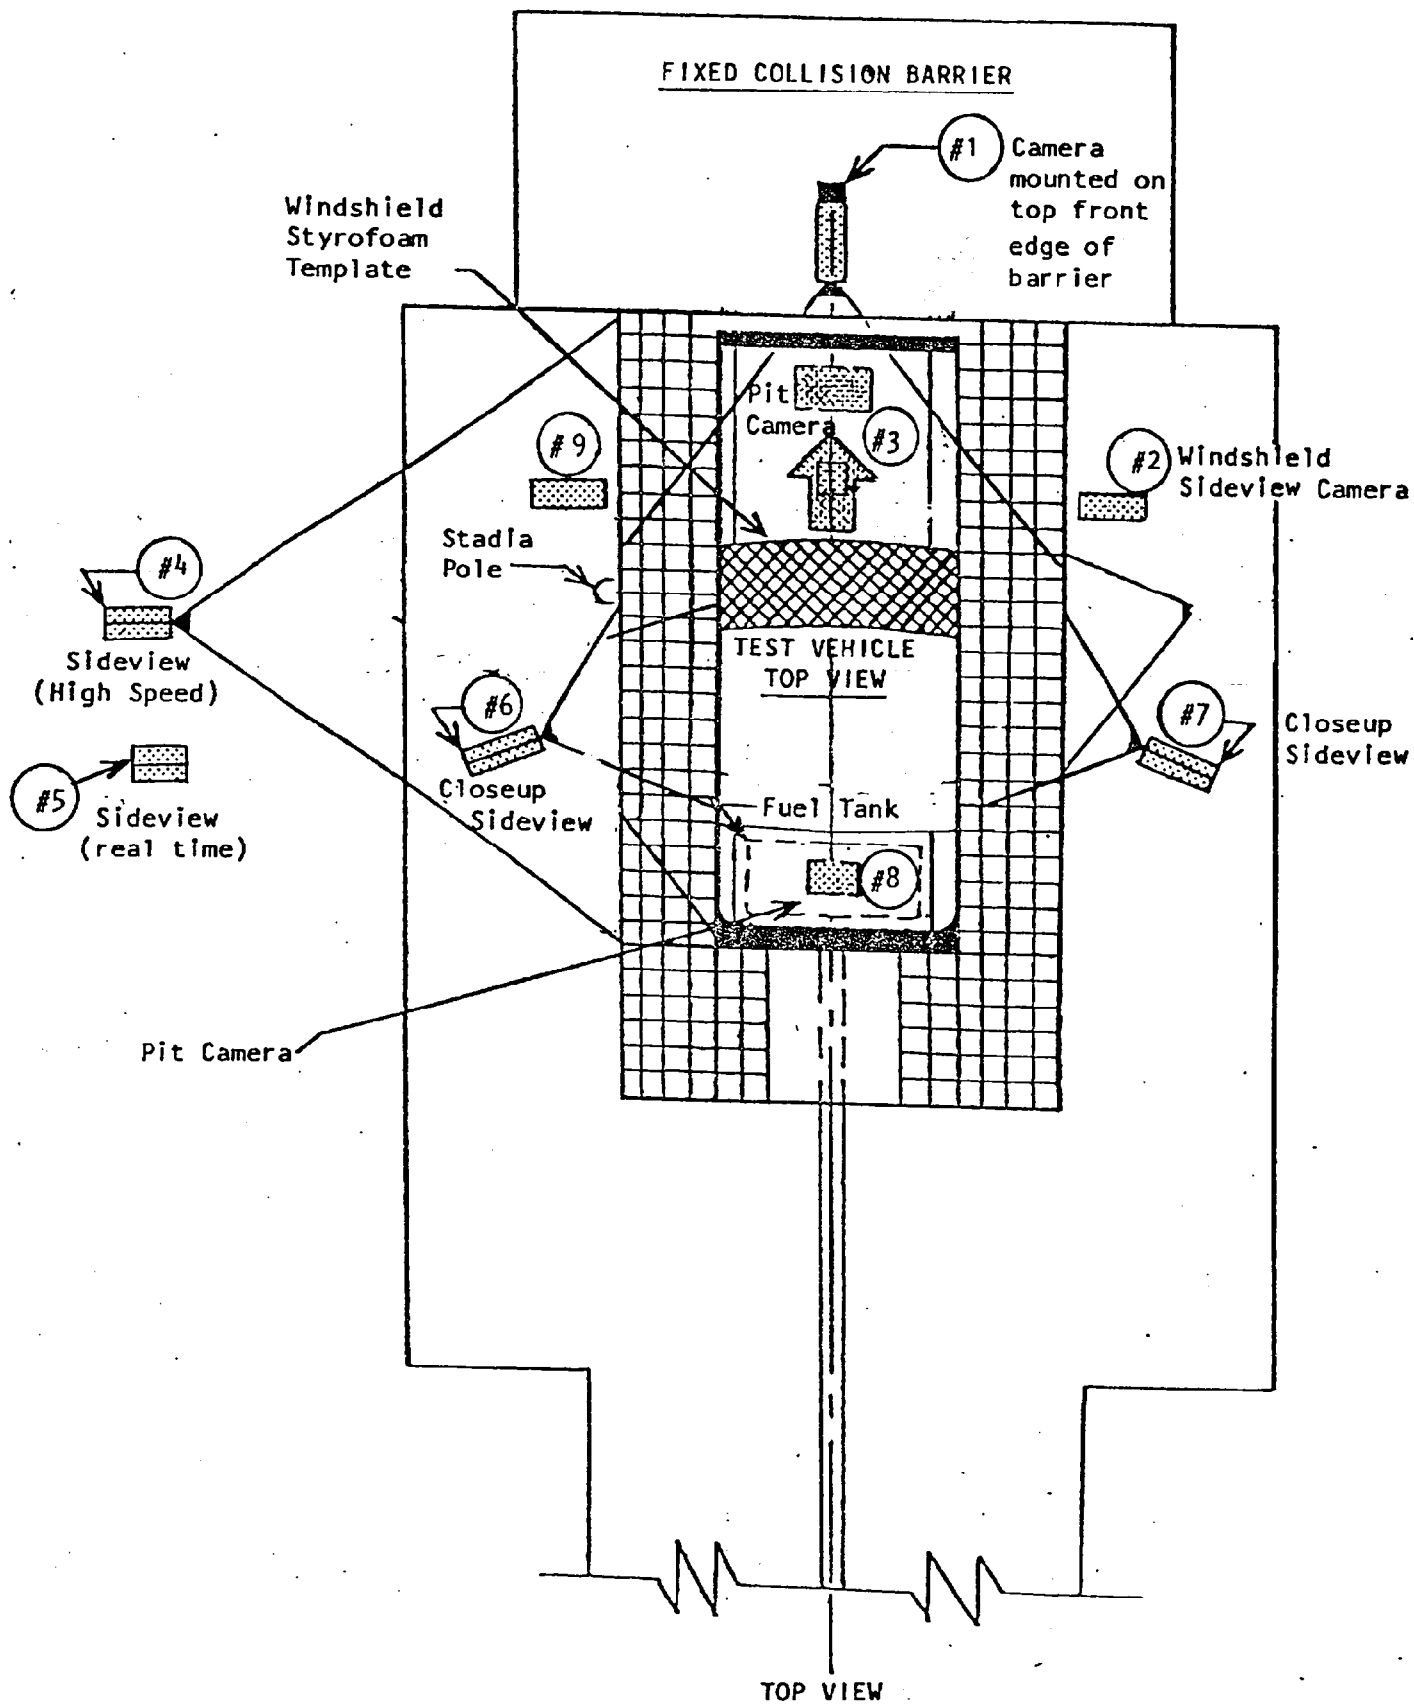
FIGURE 1 CAMERA LOCATIONS

Loc. No.	Location	Field of View	Lens Size	Frame Rate	Timing Speed	Mfg/Serial Number	Impact Dist-X in.	Center-line Dist-Y in.	Camera Height in.	Film Quality
1	Overhead (Barrier)	Windshield styrofoam up to barrier-vehicle contact if possible	16 mm	734 fps	None	HIMAC 135	6	6	156	Good
2	Ground Based (Right)	Windshield	20 mm	907 fps	None	HIMAC 138	0	108	65	Good
3	Pit	Engine underside and fuel pump	13 mm	648 fps	None	PHOTO-SONICS 45	51	2	-59	Good
4	Ground Based (Left)	Views entire left side of vehicle	50 mm	562 fps	None	FASTAX 1258	96	-944	65	Good
5	Ground Based	Documentary	Zoom	24 fps	None	ARIFLEX NR6837	489	-972	57	Good
6	Ground Based	Driver dummy closeup	25 mm	615 fps	.001 sec	FASTAX 41650	195	-340	66	Good
7	Ground Based	Passenger dummy closeup	25 mm	857 fps	.001 sec	HIMAC 143	108	160	62	Good
8	Pit	Fuel tank	13 mm	605 fps	.001 sec	PHOTO-SONICS 573	59	- 4	-51	Good
9	Ground Based (Left)	Same view as Camera No. 6	25 mm	562 fps	None	FASTAX 41667	10	-106	66	Good

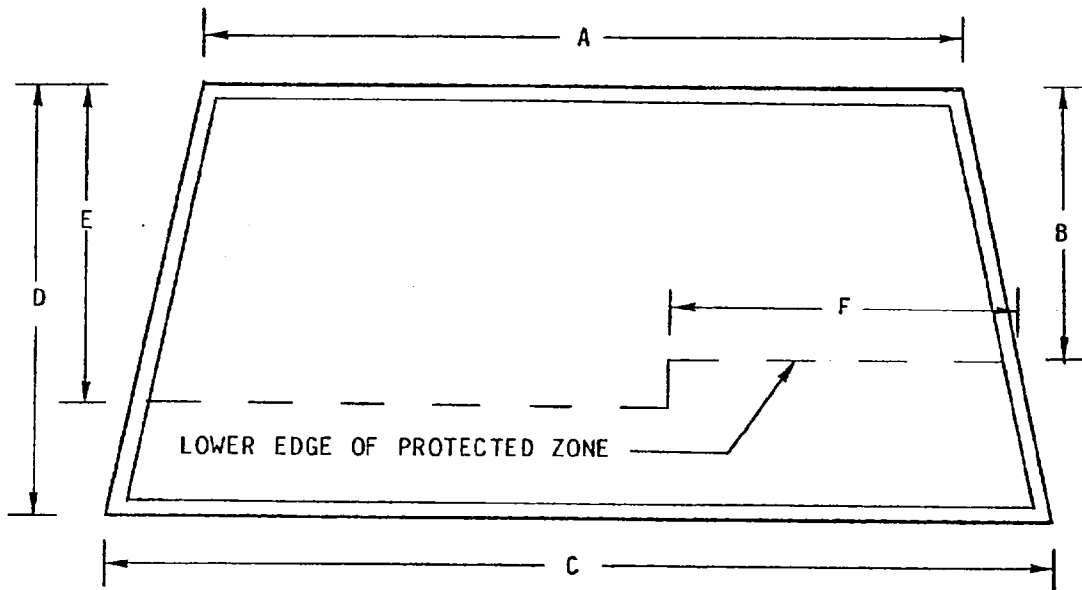
FRONT VIEW OF WINDSHIELD

Provide all dimensions necessary to reproduce the protected zone.
Method of adhering styrofoam to the windshield:

Glued with GE silicone sealant.

A = 39 1/2 D = 24 3/8
B = 16 E = 18 3/8
C = 53 1/2 F = 29

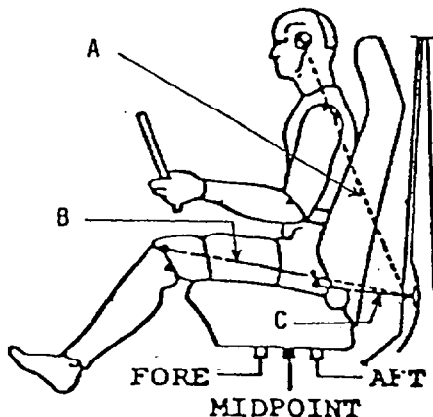
DRIVER ATD

Dimension	(in.)	(θ°)	Dimension	(in.)	(θ°)
A	25 1/8	26	A	24 3/4	23
B	30 3/8	90	B	30 5/8	91
C	13 1/8	103	C	13 1/2	105
Torso Angle = 12°			Torso Angle = 10°		
Seat Back Angle = 21°			Seat Back Angle = 19°

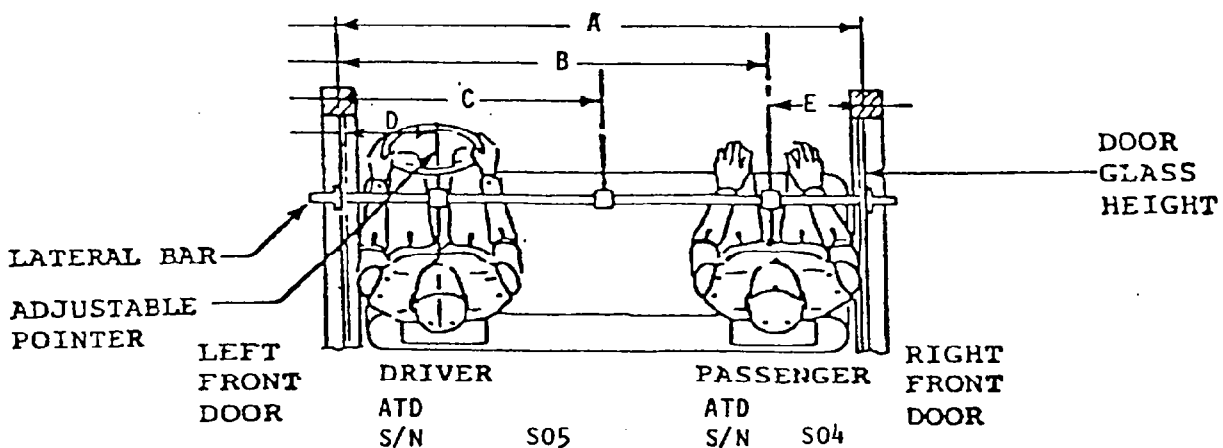
A = 54 7/8 D = 15 3/4
 B = 38 1/2 E = 16 3/8
 C = 27 1/2

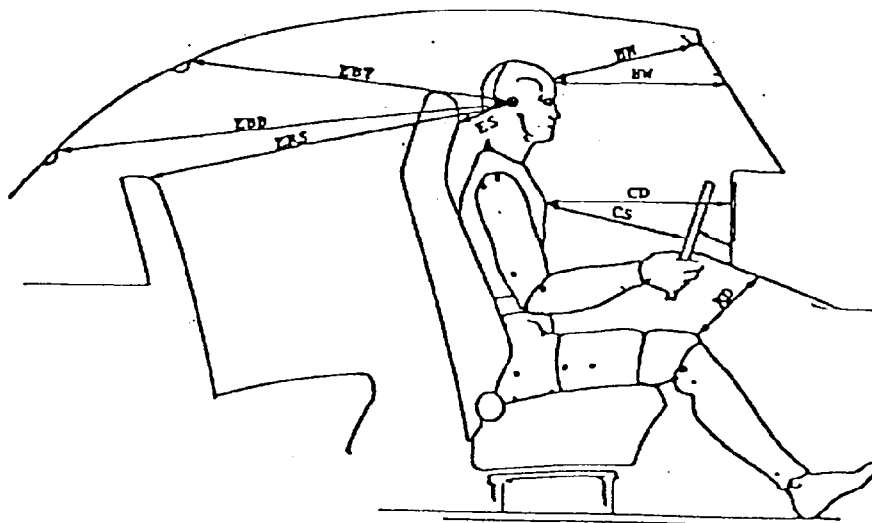
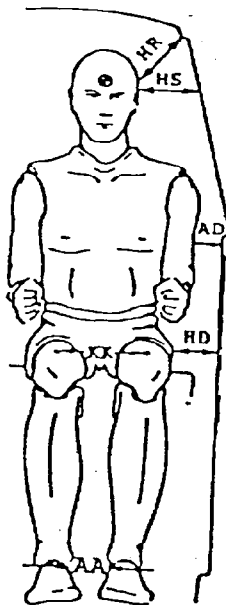
TABLE 9 PART 572 ATD IN-VEHICLE POSITION

DRIVER	PASSENGER
HH	9 1/8	9
HW	13 1/8	12 7/8
CD	21	20 1/8
CS	12 7/8	--
KD L	6 1/4	8 1/8
KD R	5 1/8	7

DRIVER	PASSENGER
HR	5 5/8	5 1/2
HS	8 7/8	7 3/8
AD	3 1/4	4 1/2
HD	7 5/8	7
KK	14 3/8	11 3/4
AA	12 3/4	8 1/2

HH = Head to Windshield Header
 HW = Head to Windshield
 CD = Chest to Dash
 CS = Chest to Steering Wheel
 KD = Knees to Dash
 HR = Head to Side Roof
 HS = Head to Side Window
 AD = Arm to Door
 HD = Hip to Door
 KK = Knee to Knee
 AA = Ankle to Ankle

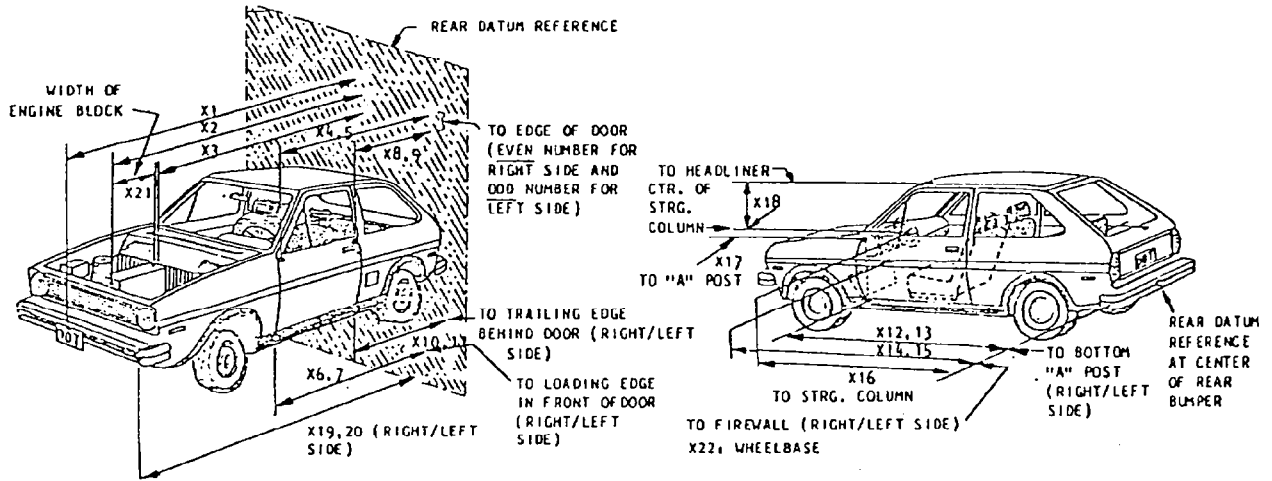
TABLE 13 PRE-/POST-TEST STATIC MEASUREMENT DATA

The maximum static crush of the vehicle was 19 5/8 inches. After impact both the driver's door and passenger's door were opened without tools. The windshield was slightly cracked near its upper left corner. All other vehicle glazing remained intact.

REFERENCE DIMENSION	PRE-TEST MEASUREMENT	POST-TEST MEASUREMENT	CHANGE
X1	172 7/8	153 1/4	-19 5/8
X2	146 1/4	139 3/4	- 6 1/2
X3	126 1/2	123 5/8	- 2 7/8
X4	113 7/8	114	+ 1/8
X5	114 1/16	113 7/8	- 3/16
X6	114 7/16	114 3/16	- 1/4
X7	114 1/2	114 1/8	- 3/8
X8	67 7/8	68 1/2	+ 5/8
X9	68 1/4	68	- 1/4
X10	69 1/4	69 1/8	- 1/8
X11	69 3/8	69 1/4	- 1/8
X12	114	113 7/8	- 1/8
X13	114 1/8	113 15/16	- 3/16
X14	118 11/16	118 5/8	- 1/16
X15	118 1/4	117 7/8	- 3/8
X16	99 5/8	99 3/8	- 1/4
X17	16	17 3/4	+ 1 3/4
X18	16 1/2	16 1/2	0
X19	170 1/2	151 3/8	-19 1/8
X20	169 5/8	152 3/8	-17 1/4
X21	11 1/2	11 1/2	0
X22	96 5/16	92 1/2	- 3 13/16

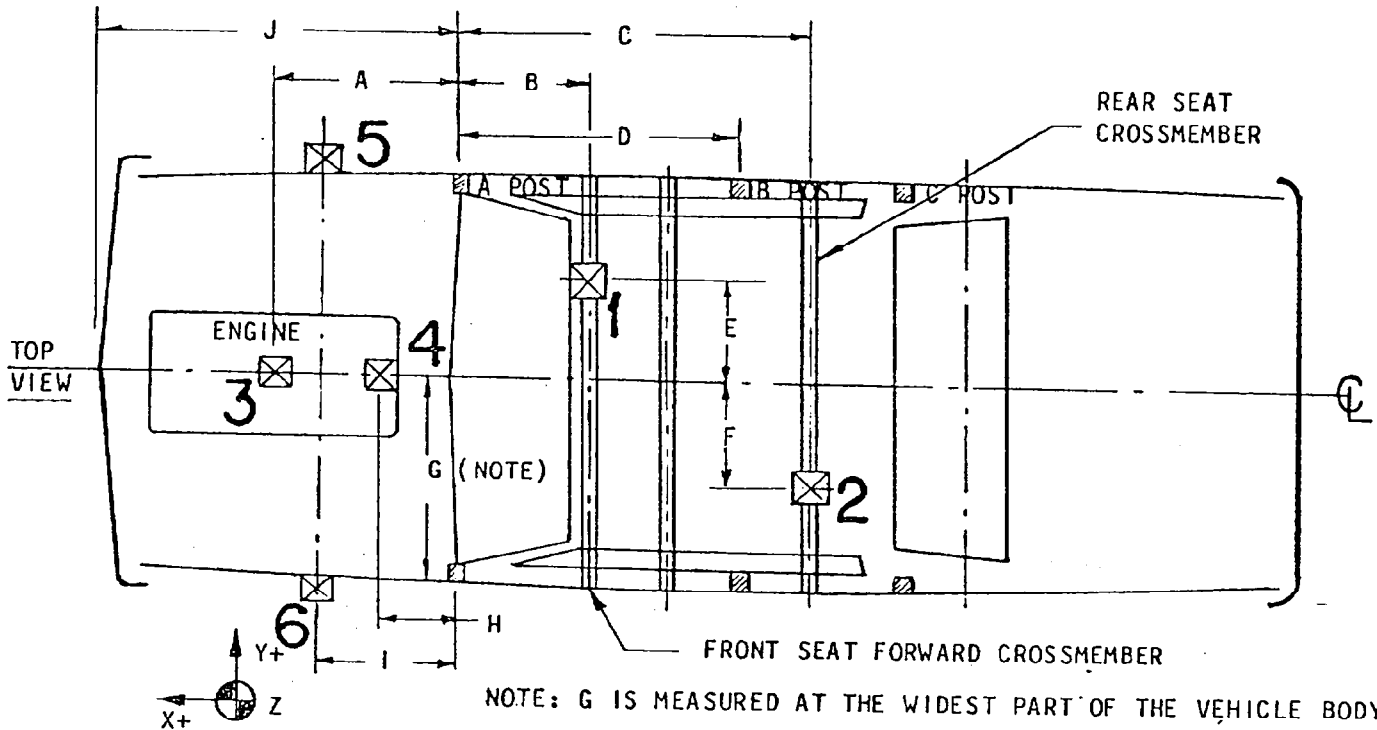
TABLE 14 VEHICLE ACCELEROMETER LOCATION AND DATA SUMMARY

LOCATION NO. AND DESCRIPTION	LOCATION DIMENSION (IN.)	AXIS	PEAK (G'S)		TIME TO PEAK(MSEC)	
			POSITIVE	NEGATIVE	POSITIVE	NEGATIVE
1 - Below Front Seat Area	E - 15 B - 15	X	3	36	115	63
2 - Below Rear Seat Area	F - 14 C - 35 1/2	X	3	34	119	64
3 - Top of Engine at Carb. Mount	A - 21 1/2	X	66	197	39	76
4 - Bottom of Engine at Oil Pan	H - 24 3/8	X	10	58	57	31
5 - Right Front Brake Caliper	I - 24 3/4	X	14	60	71	52
6 - Left Front Brake Caliper	I - 25 1/4	X	15	39	67	56
- Vehicle Half Width	G - 29 5/8	NOTE: NEGATIVE ACCELERATION IS REARWARD				
- Forward Most Point At \bar{c} to A Post	J - 58 1/2					
- Distance from 'A' post to 'B' post	D - 46 7/8

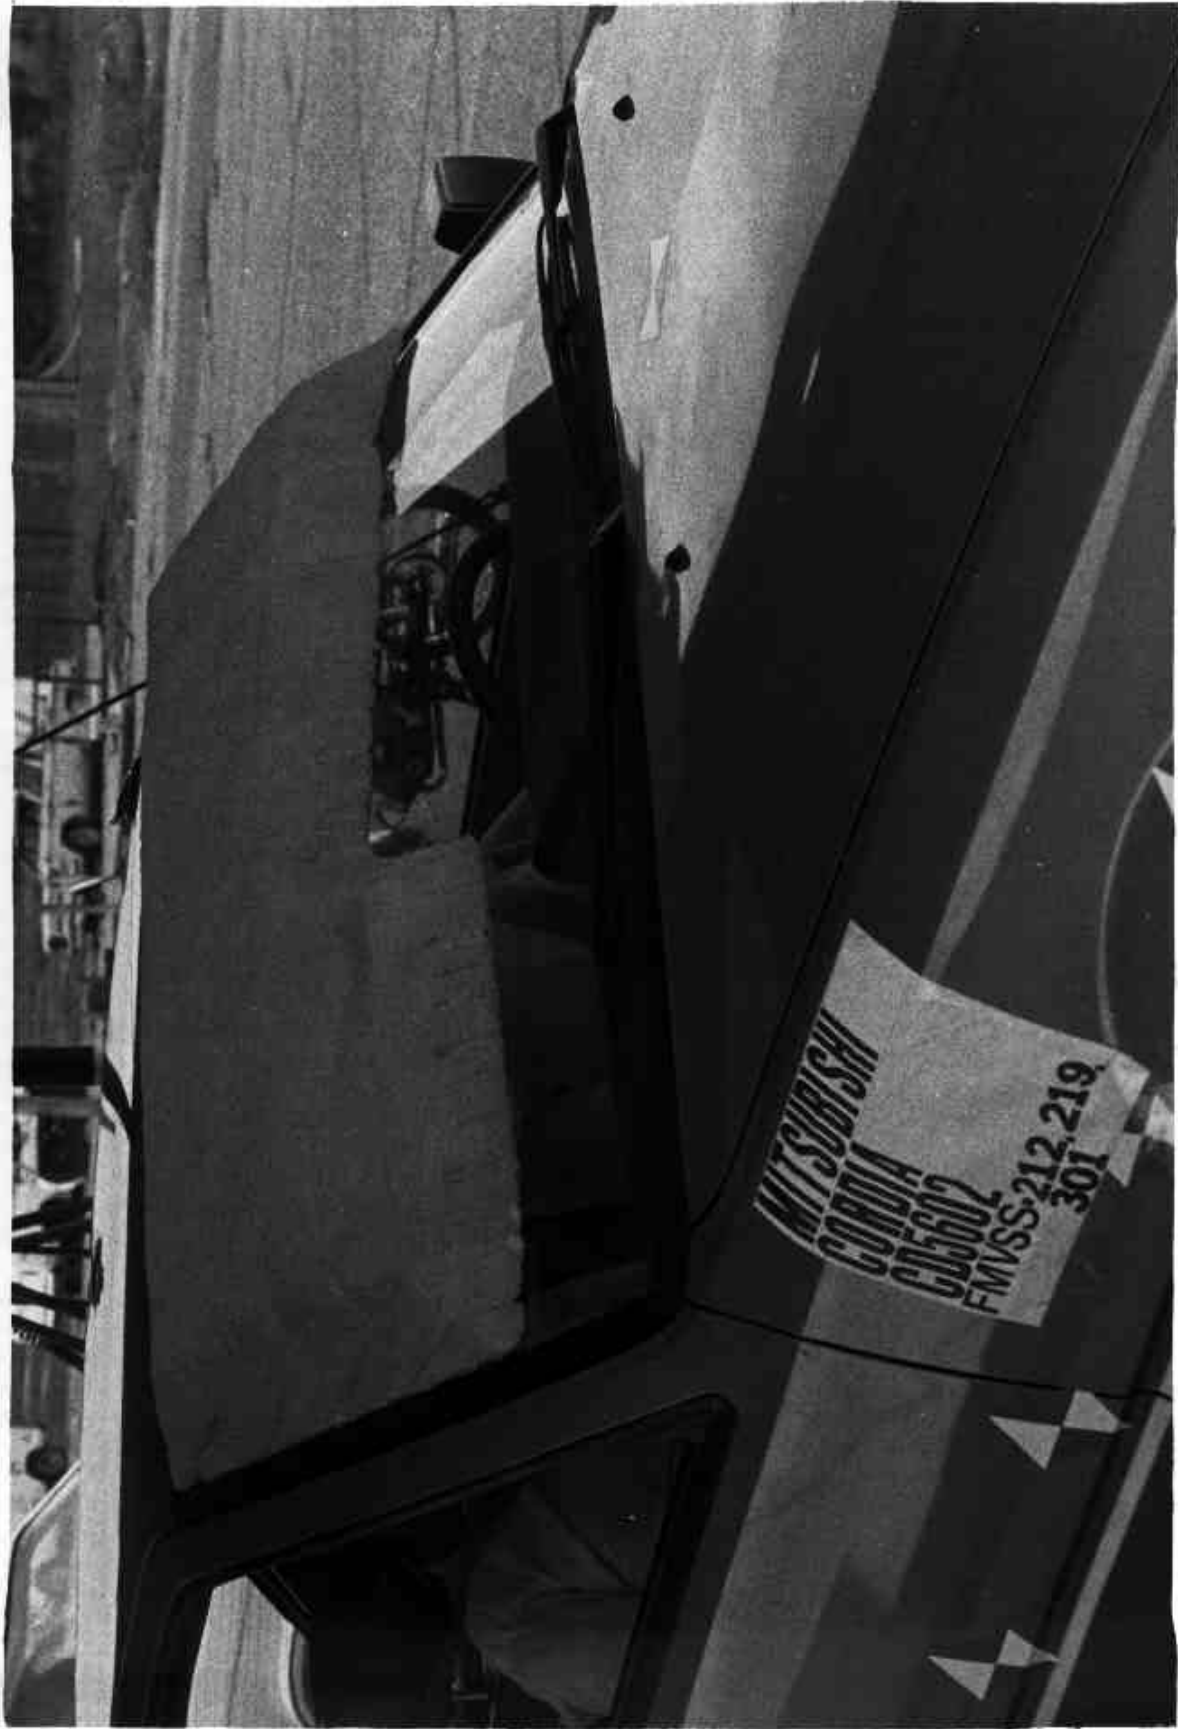
A-5 WINDSHIELD WITH STYROFOAM, PRETEST

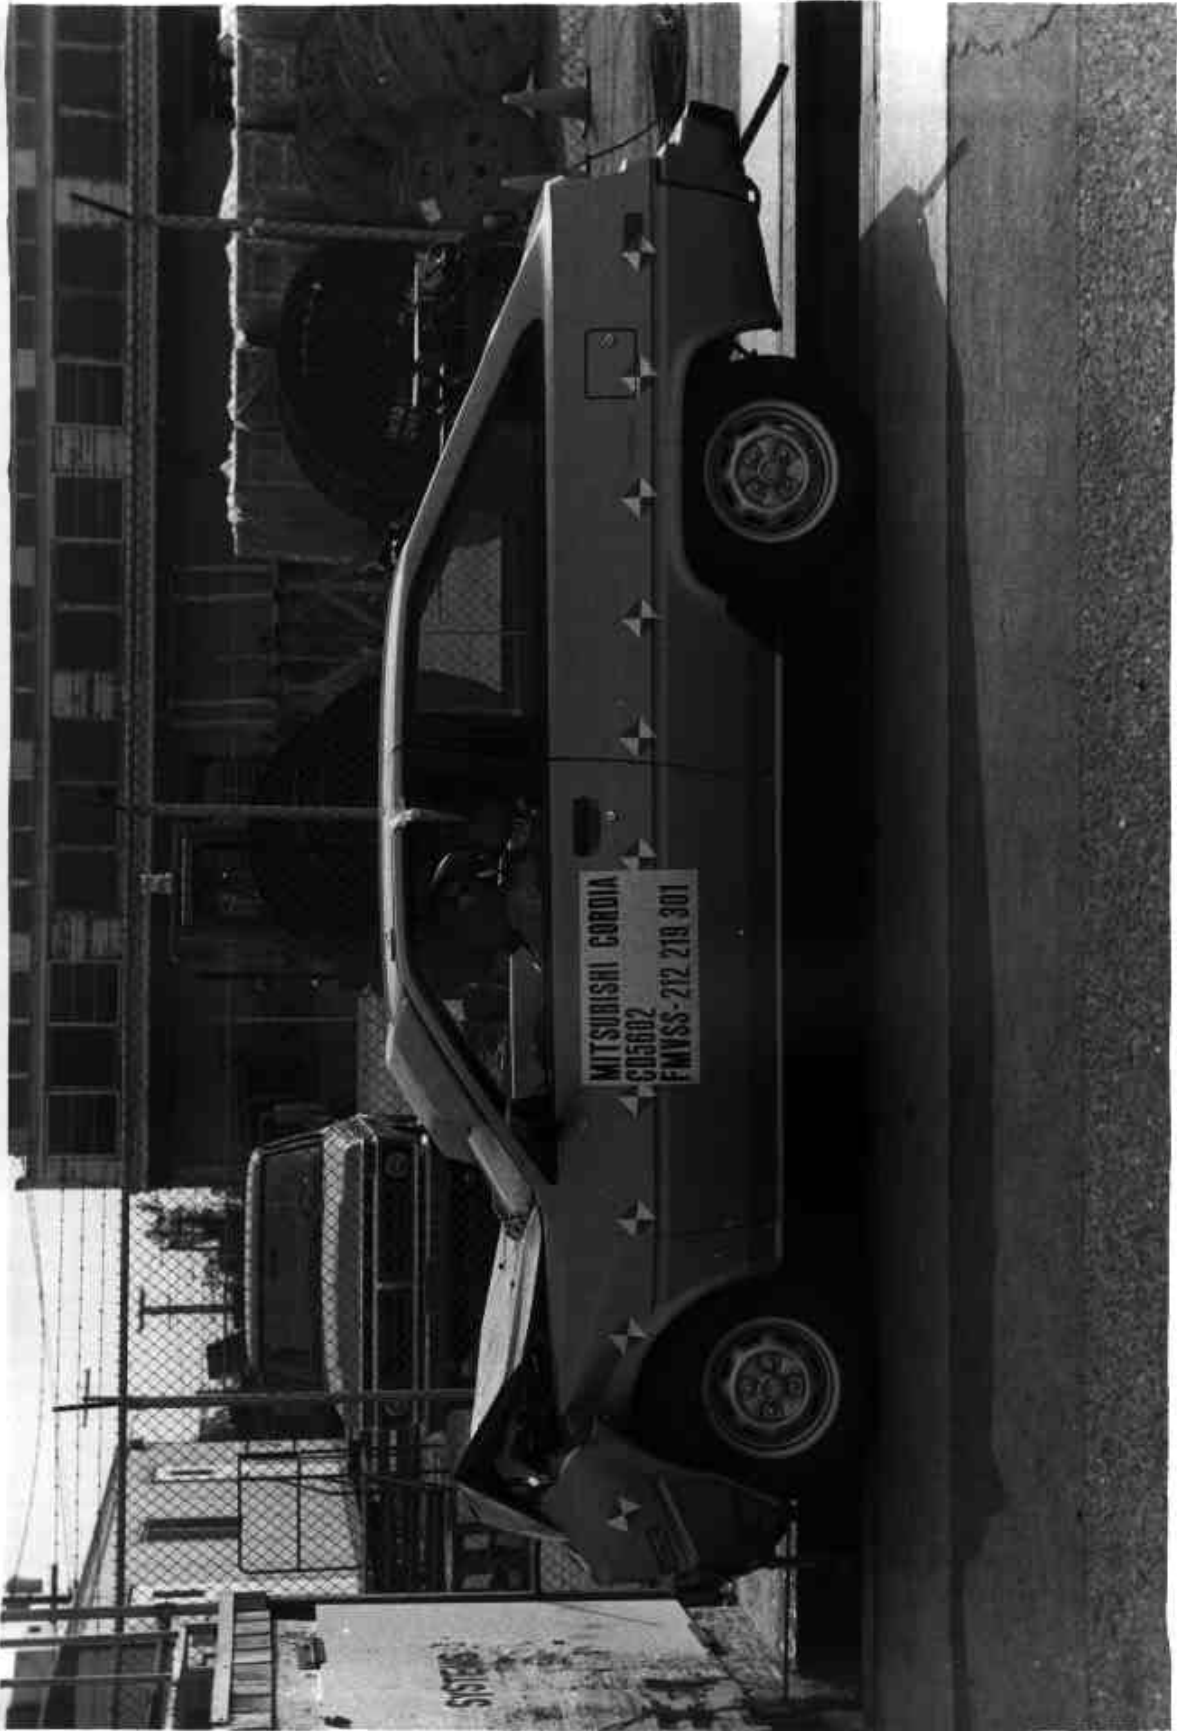
A-9 FULL LEFT SIDE, POSTTEST

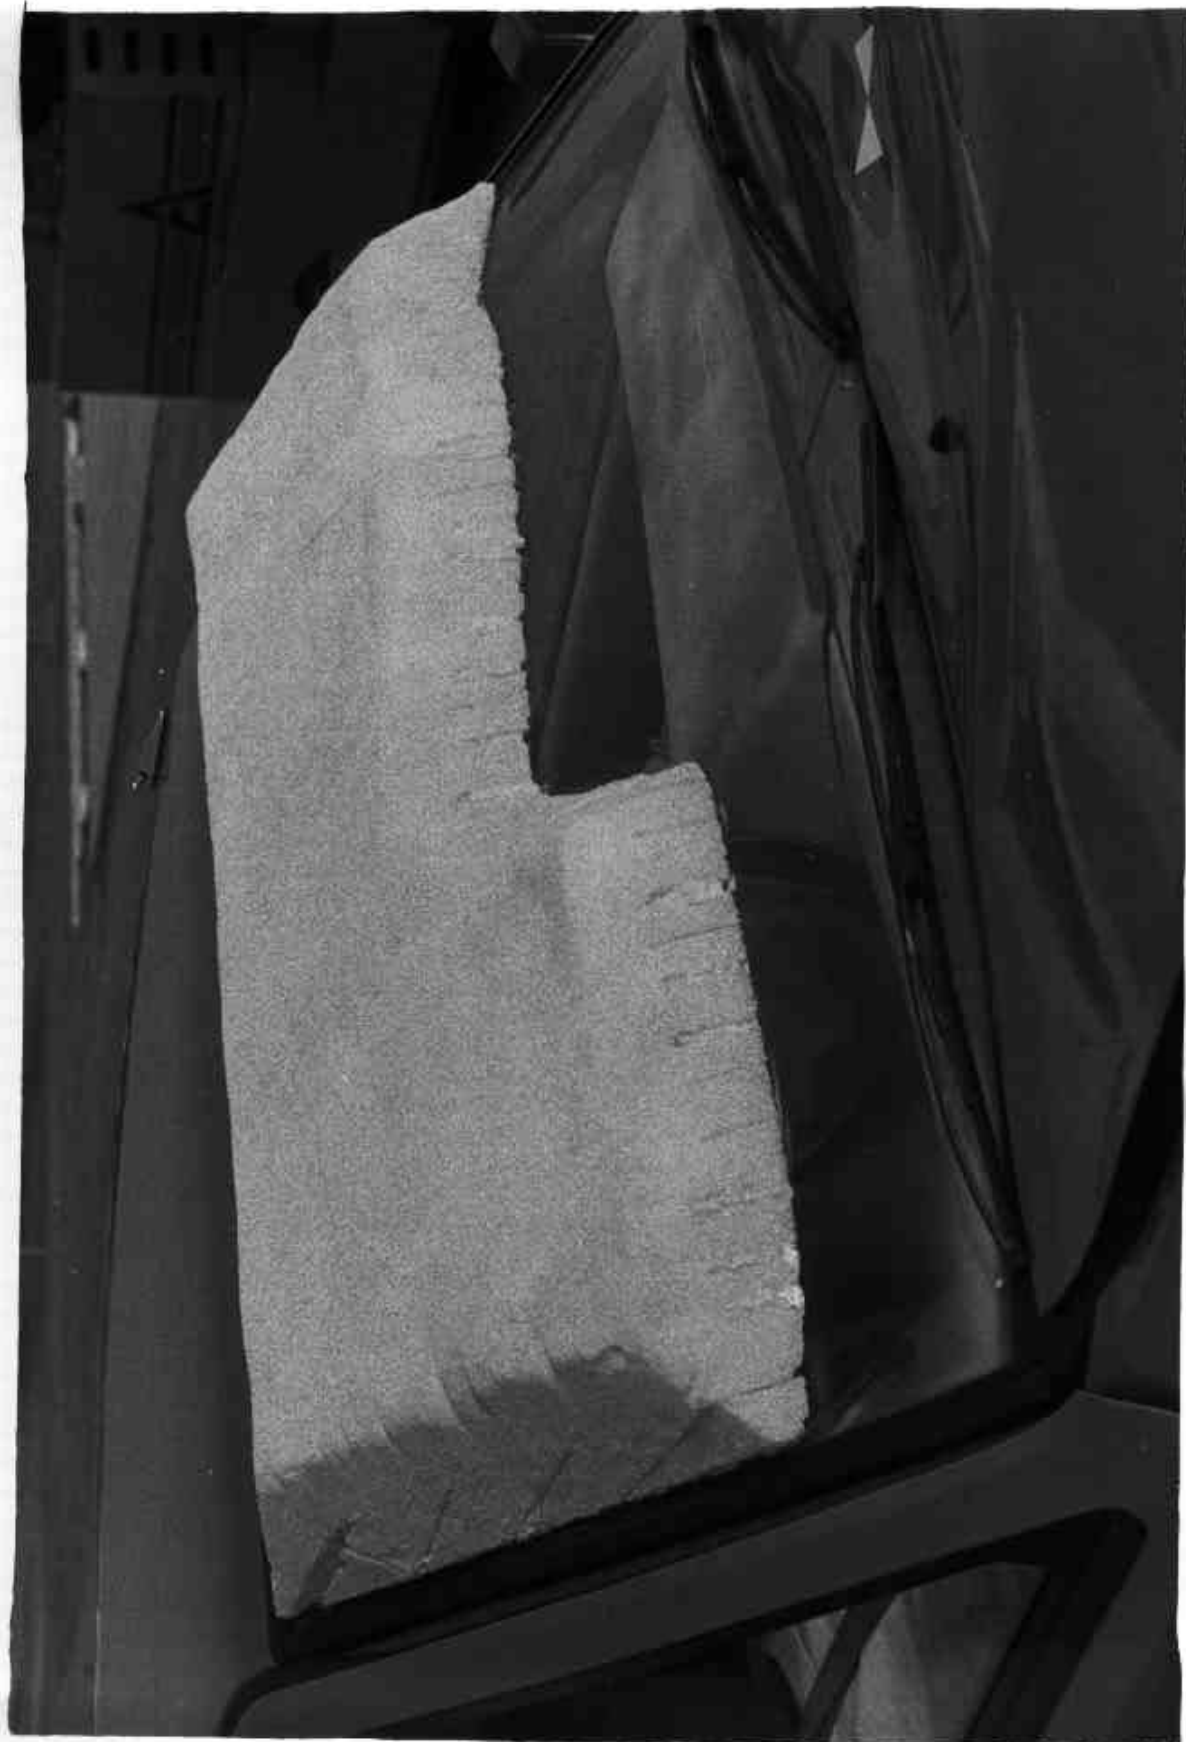
A-13 WINDSHIELD WITH STYROFOAM, POSTTEST

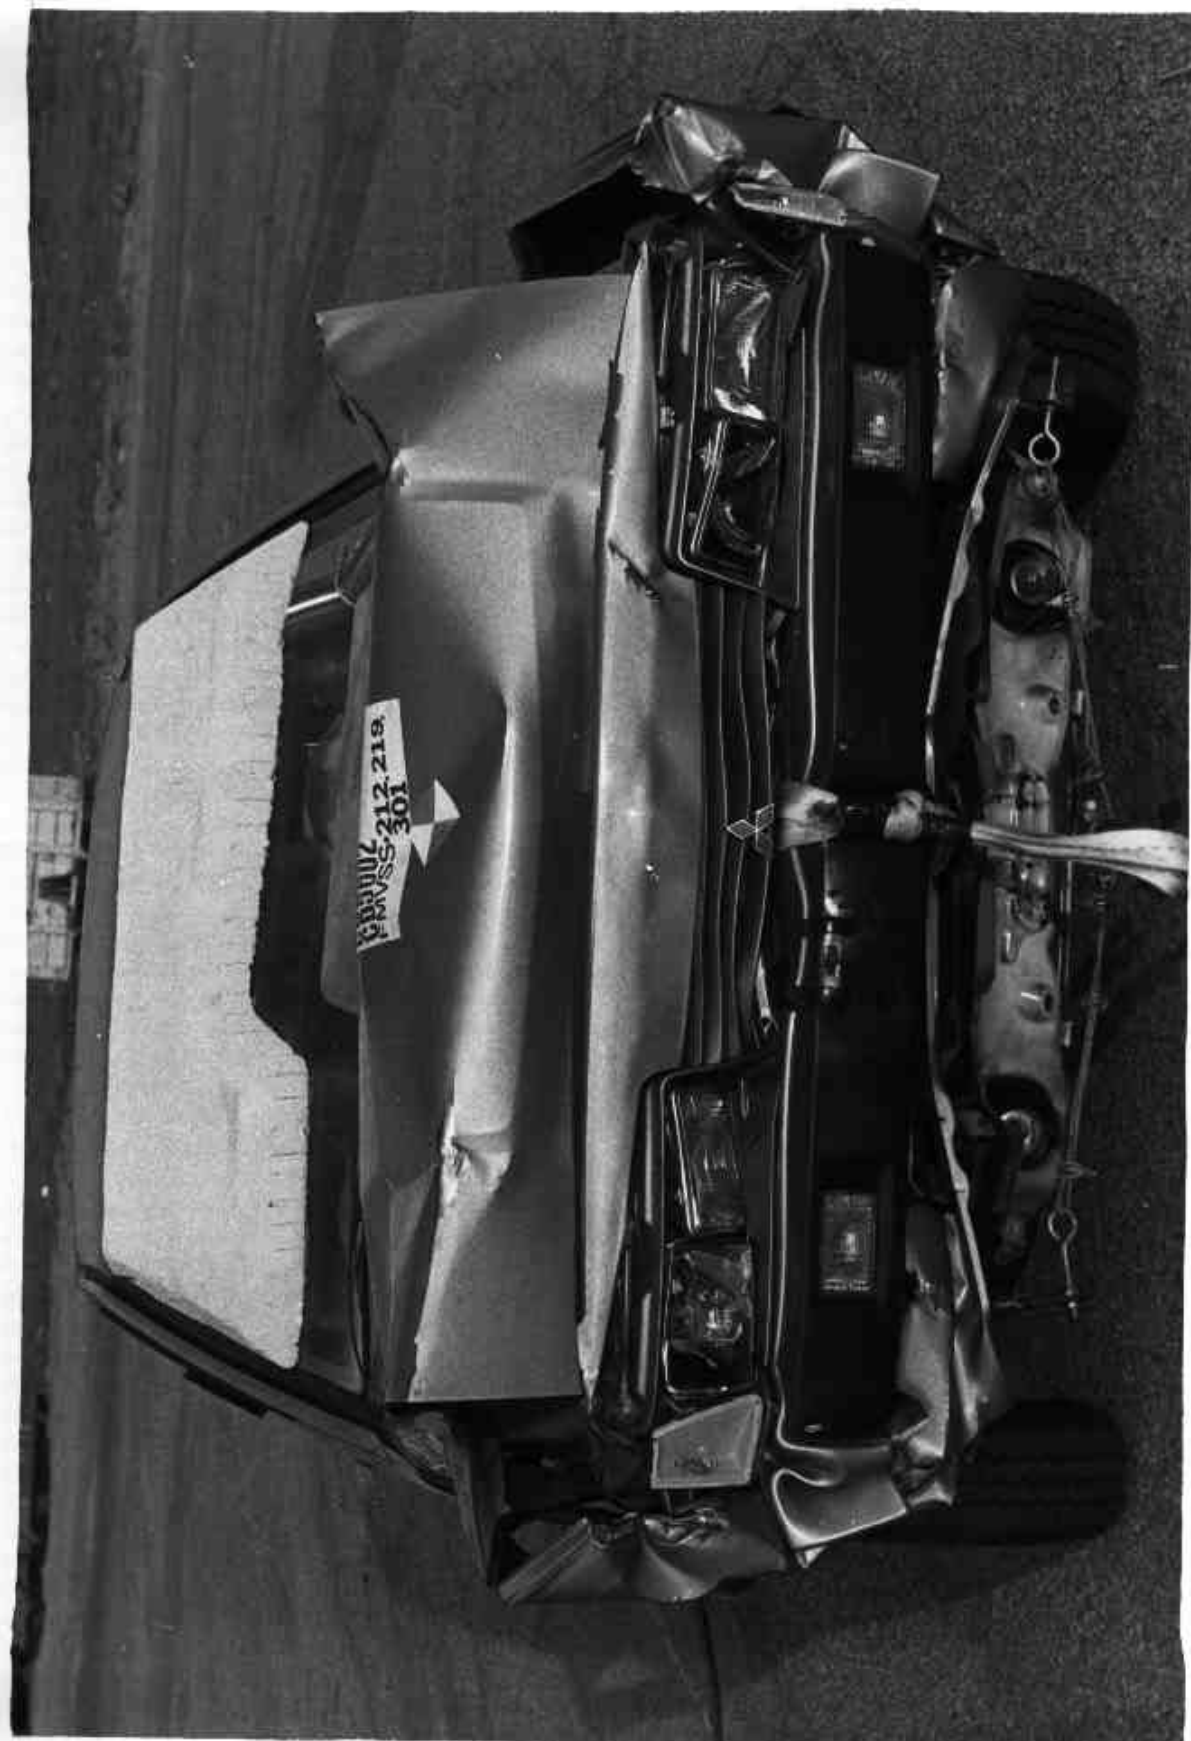
A-14 FULL FRONT VIEW, POSTTEST

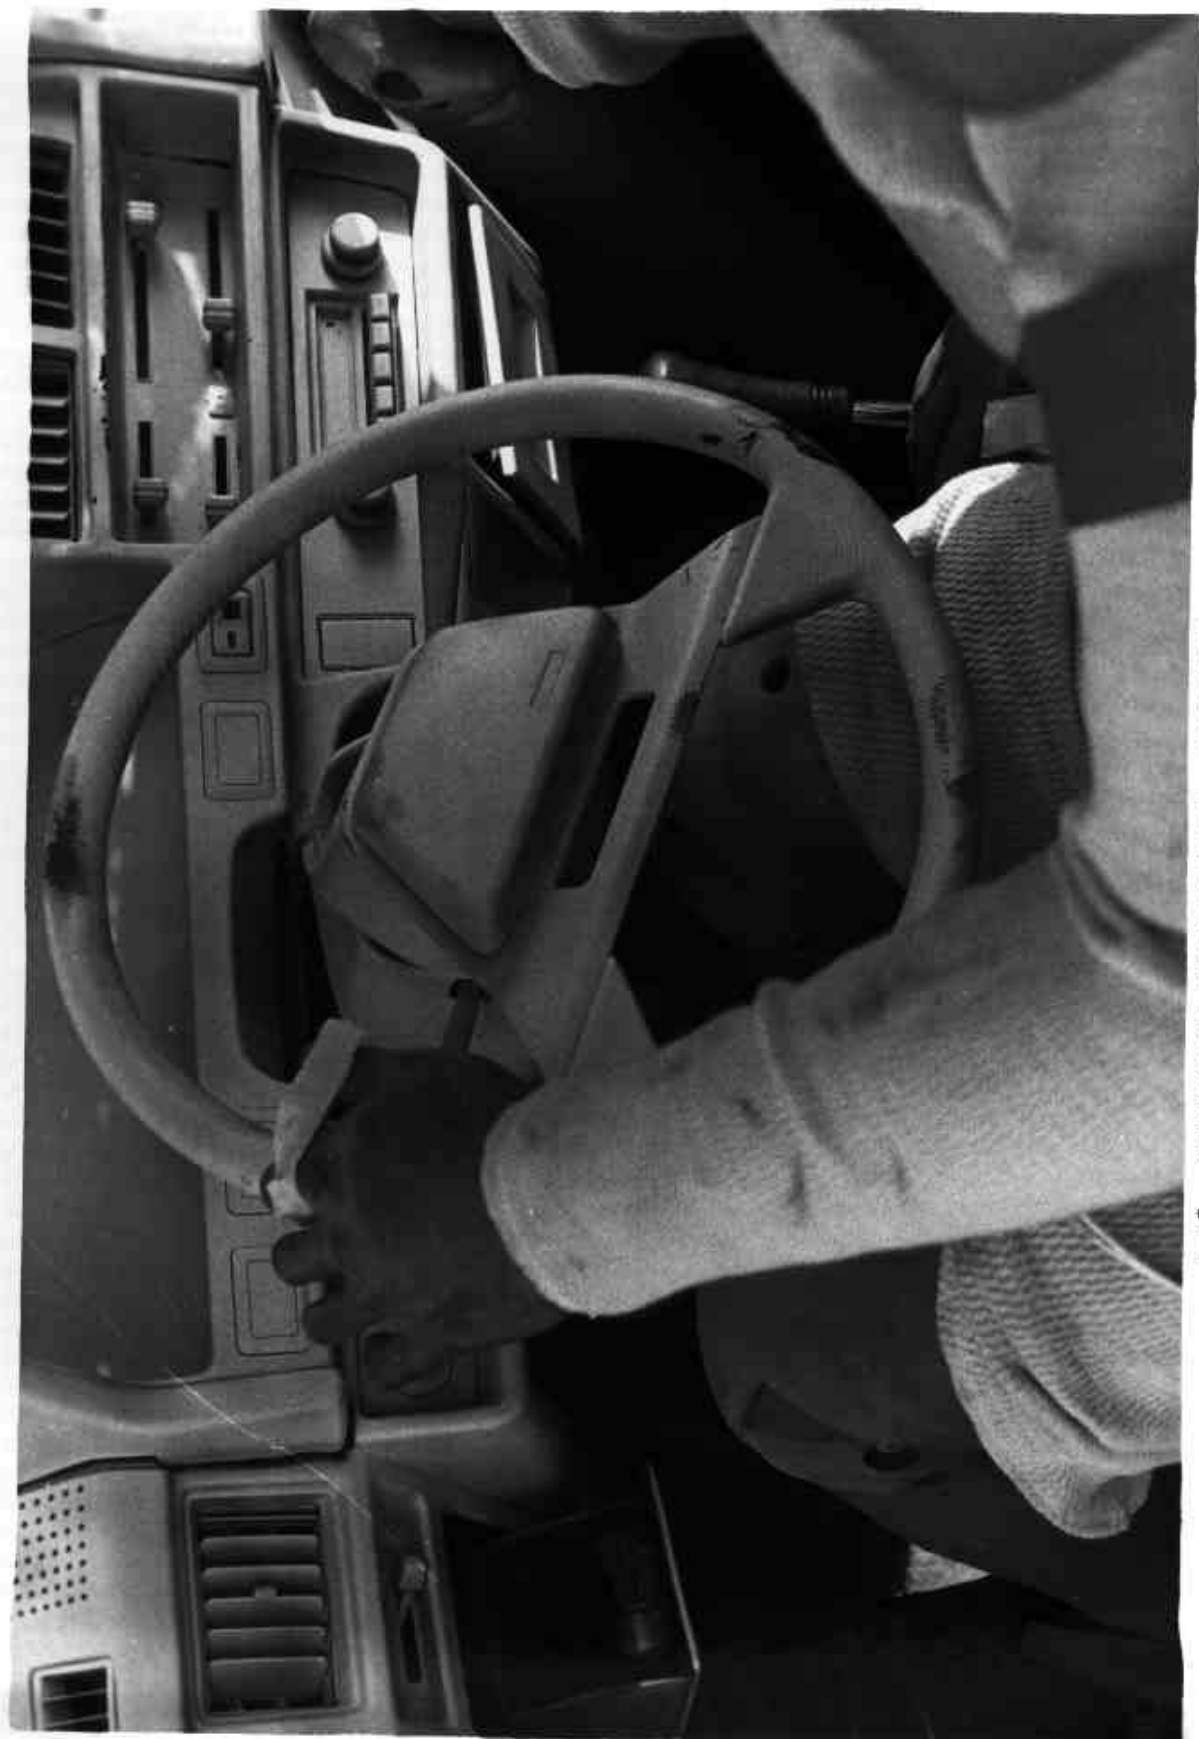
The driver ATD's head hit the steering wheel rim, and the top edge of the steering wheel hub. His chest hit the lower steering wheel rim. His knees hit the dash panel, and his left knee also hit the side of the steering column. The driver's Head Injury Criteria value of 885 maximum chest acceleration (resultant clipped) of 34 g's, maximum femur loads of 275 and 337 pounds satisfy the FMVSS 208 requirements.

The steering column moved downward relative to the dash panel approximately 1/4 inch. After the crash, the displacement link of the steering system was nearly perpendicular to the steering column. There were no signs of collapse in the steering column itself.

A-18 DRIVER ATD STEERING WHEEL, POSTTEST

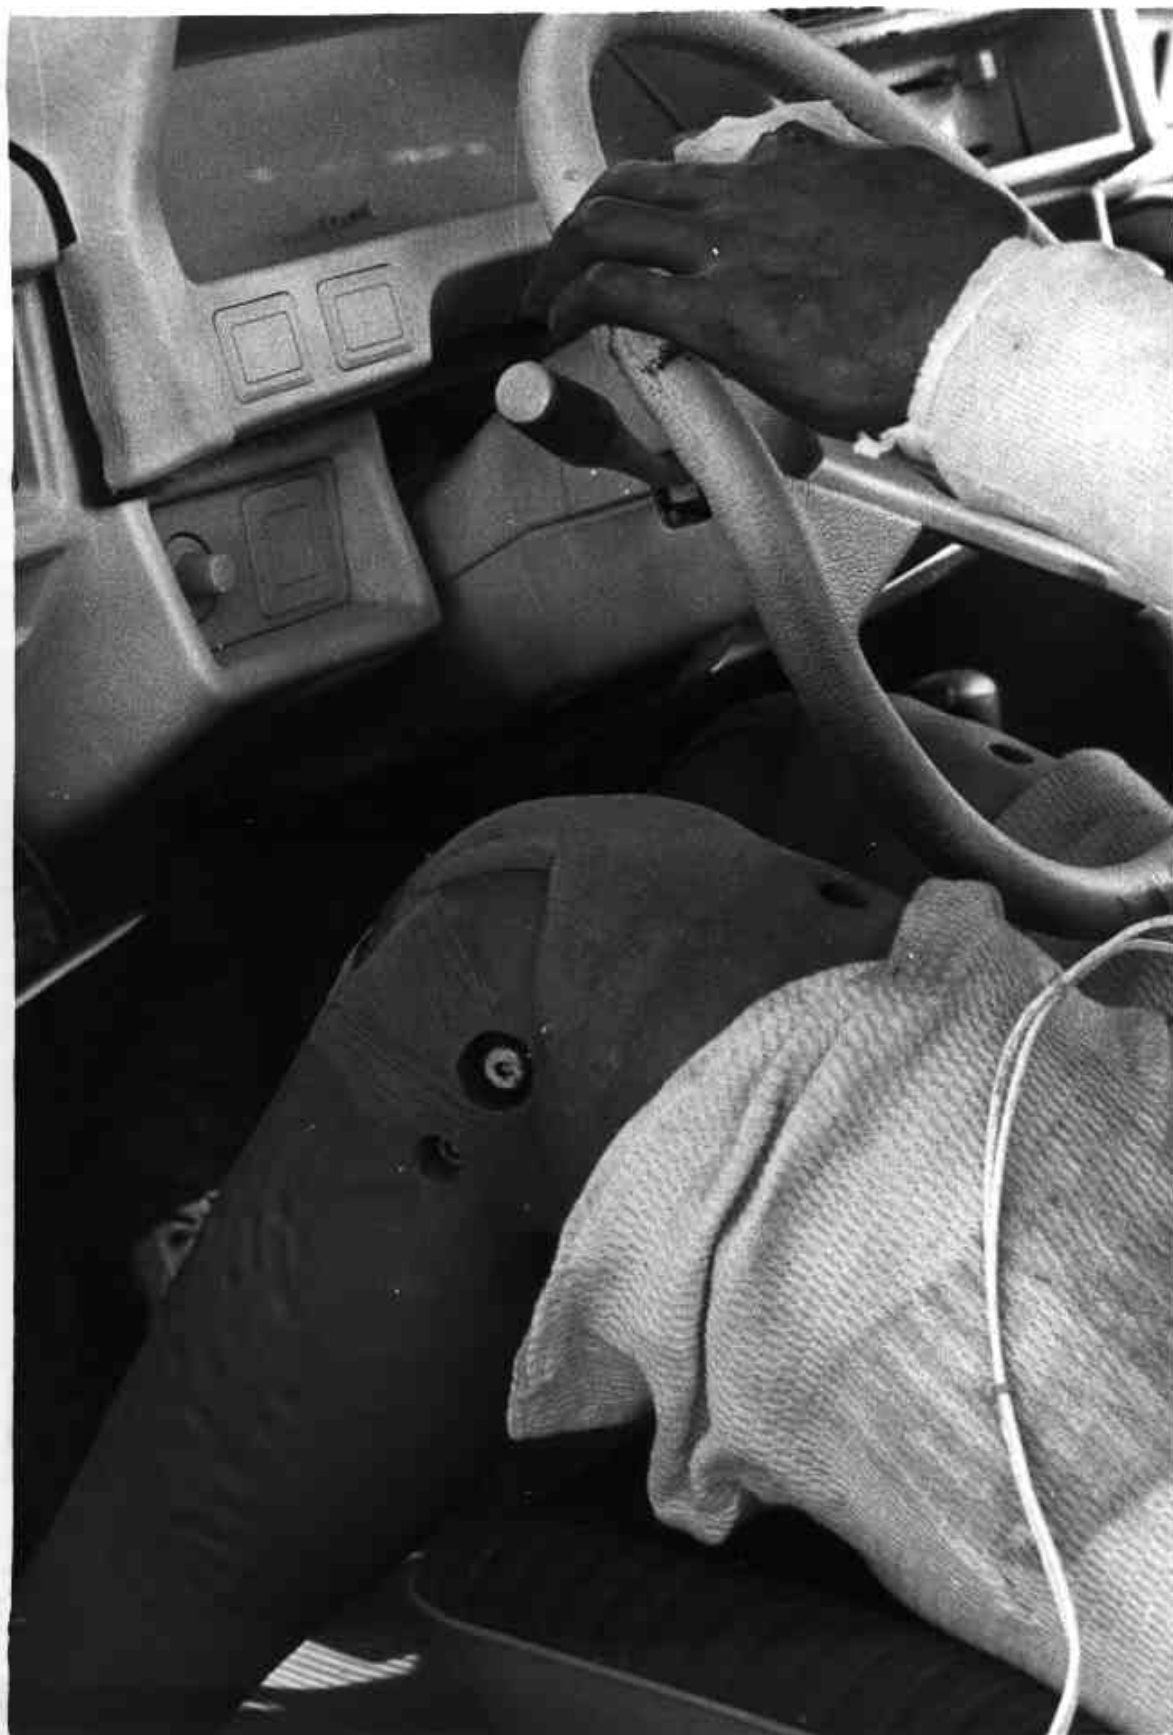
A-19 DRIVER ATD KNEES, POSTTEST

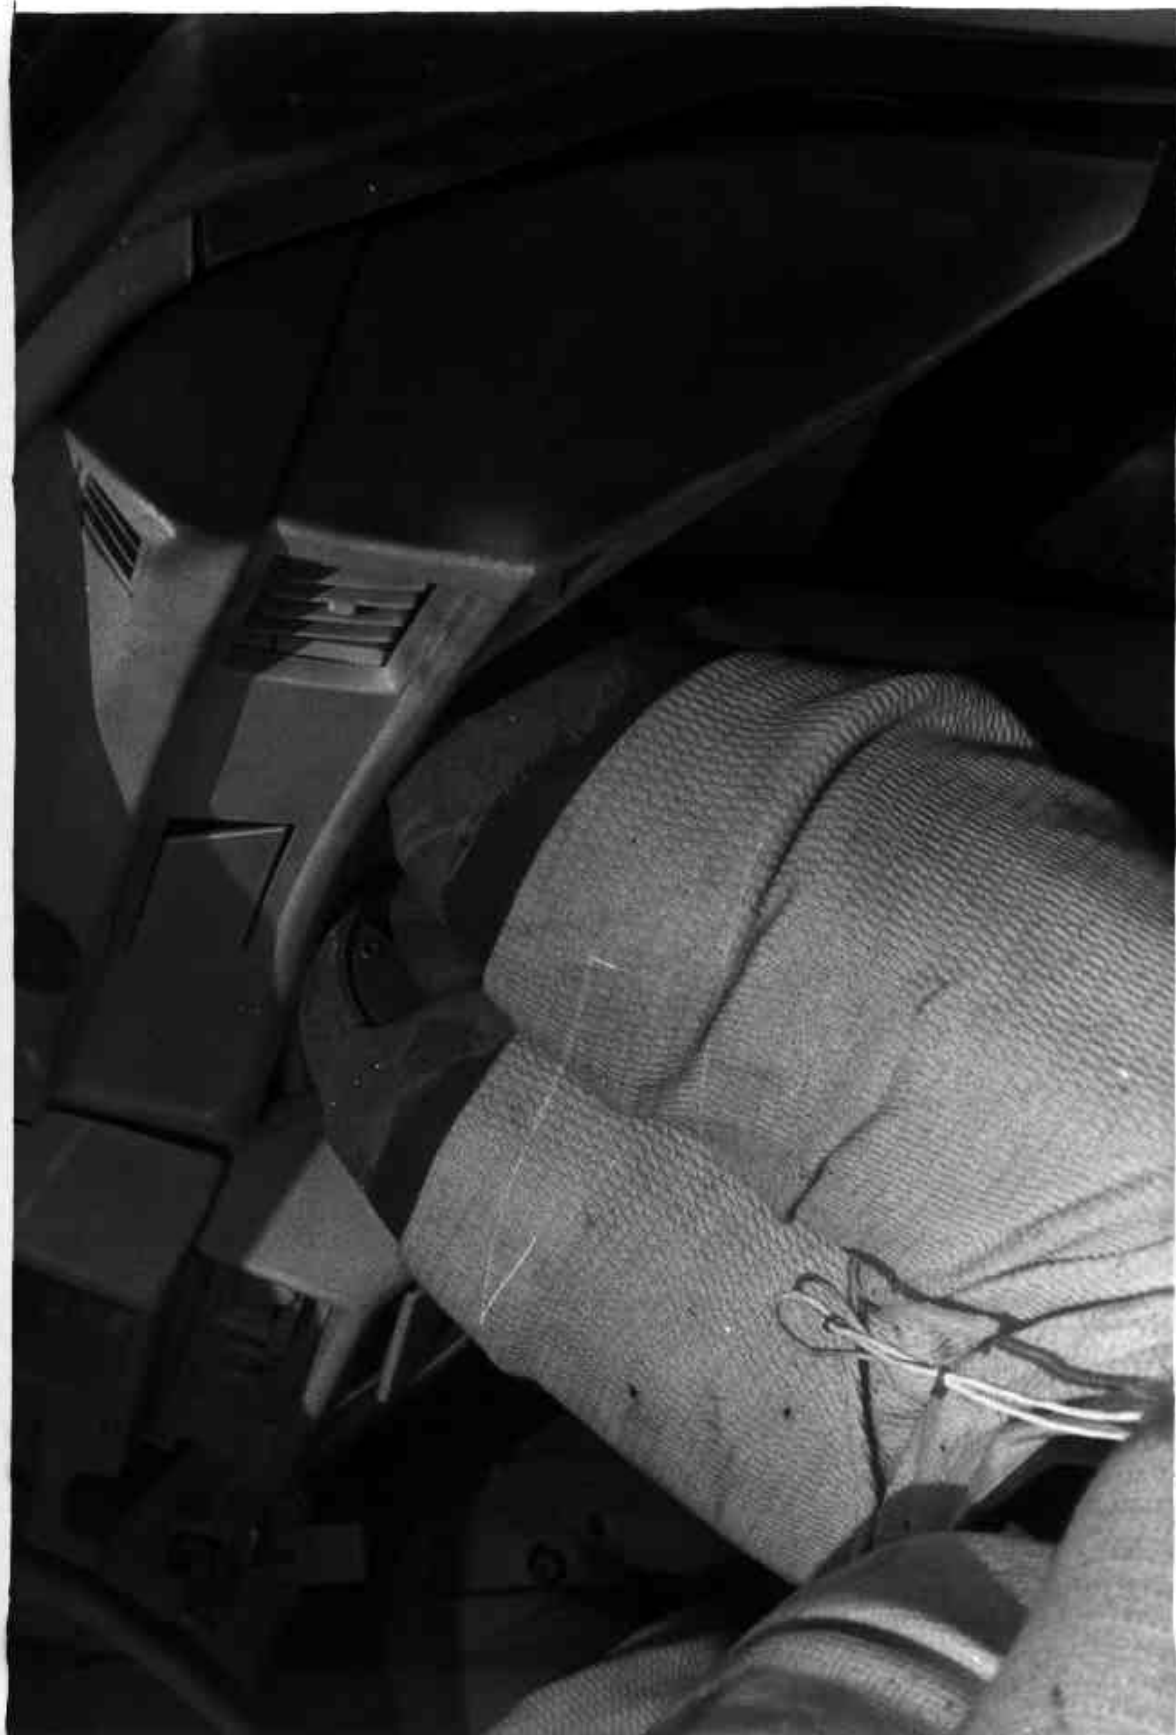
The passenger ATD's head hit the dash panel, and his knees pushed in the glove compartment door. The passenger's Head Injury Criteria value of 807, maximum chest acceleration (resultant clipped) of 34 g's, and a maximum femur loads of 945 and 510 pounds satisfy the FMVSS 208 requirements. Because of noise in the femur load cell data,

A-20 PASSENGER ATD KNEES, POSTTEST
