REPORT NO. 212-MSE-83-003
219-MSE-83-003
301-MSE-83-003

NHTSA NEW VEHICLE ASSESSMENT AND
STANDARDS ENFORCEMENT INDICANT TESTING
FMVSS 212, 219, & 301-75

1983 Mitsubishi Cordia

FINAL REPORT

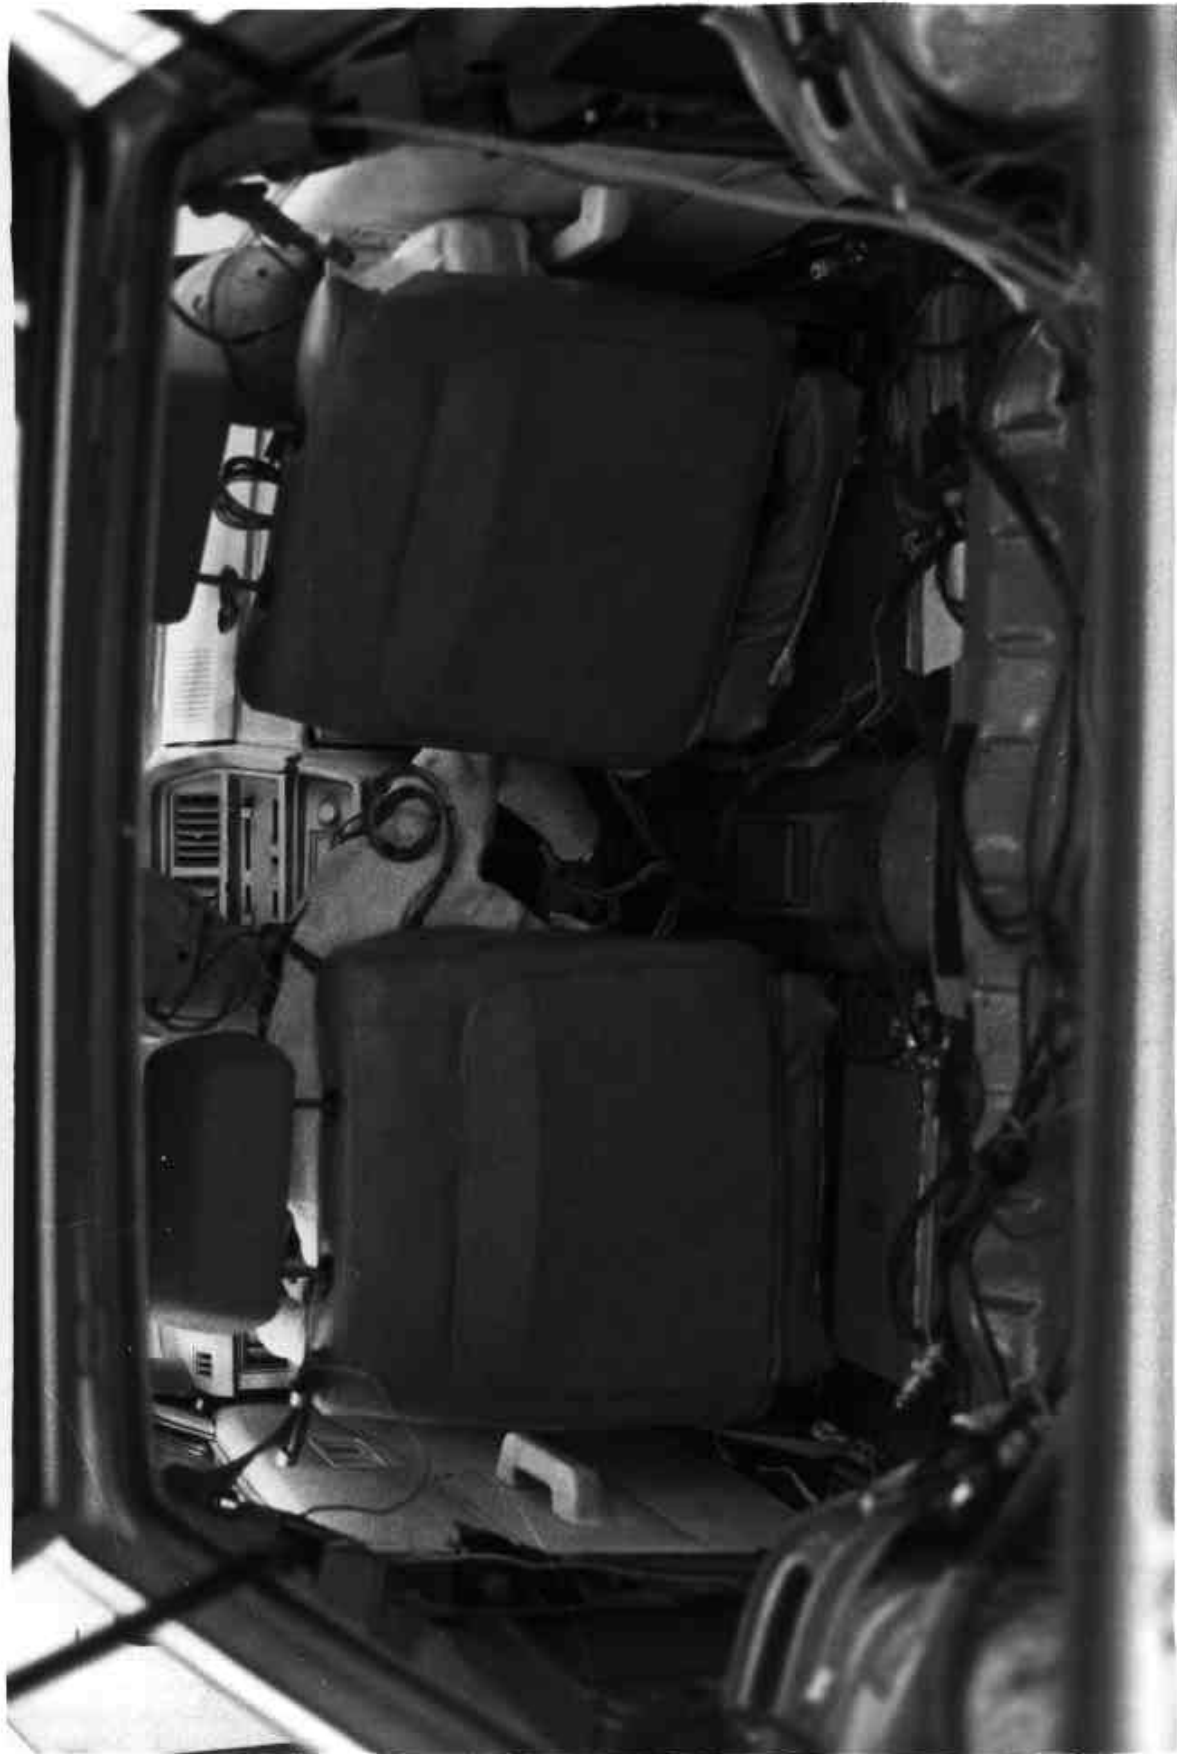
The left side of the passenger's seat came loose from its rail during the impact, allowing that side of the seat to move forward. The resulting rotation of the seat caused the right side of the seat to be disengaged from its rail. The right side of the seat did not appear to move appreciably.

A-21 SEAT POSITIONS, POSTTEST

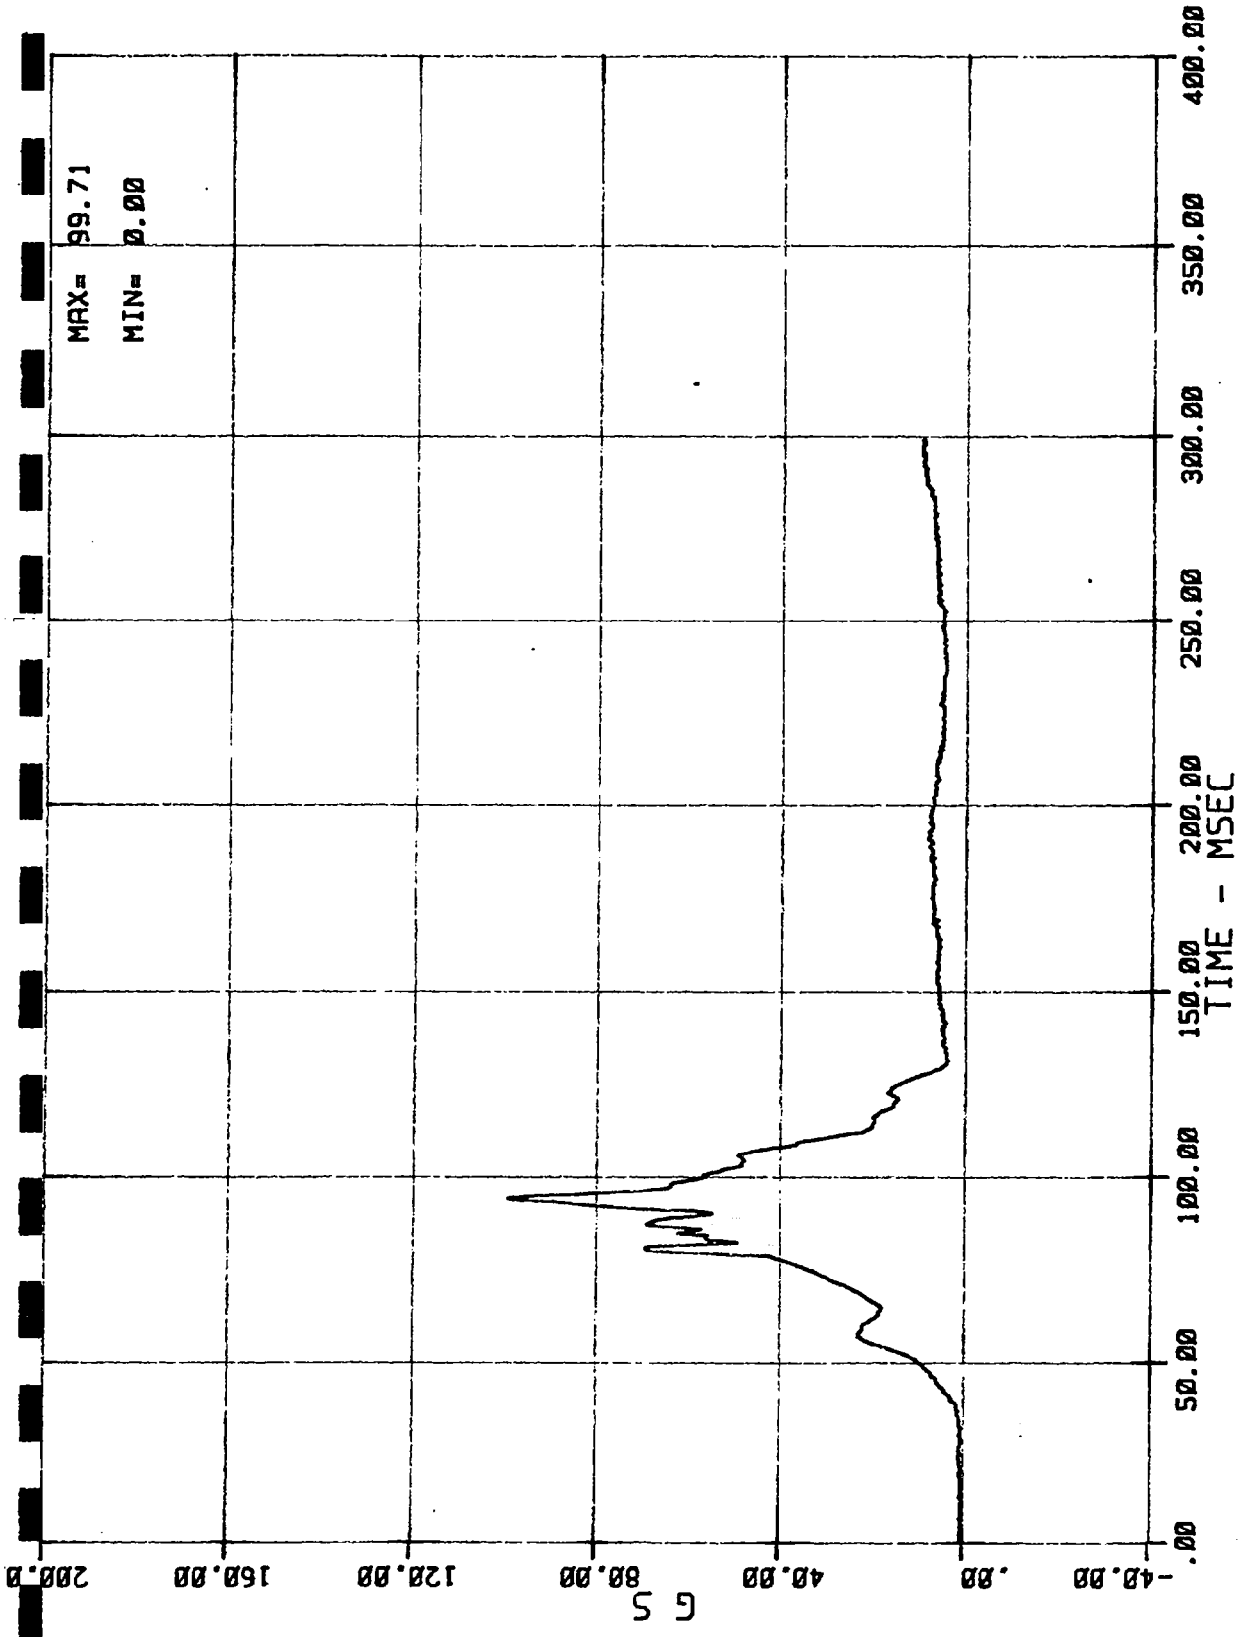
The driver ATD's head hit the steering wheel rim, and the top edge of the steering wheel hub. His chest hit the lower steering wheel rim. His knees hit the dash panel, and his left knee also hit the side of the steering column. The driver's Head Injury Criteria value of 885 maximum chest acceleration (resultant clipped) of 34 g's, maximum femur loads of 275 and 337 pounds satisfy the FMVSS 208 requirements.

DRIVERS HEAD RESULTANT ACCELERATION
MSE N99R33 1983 MITSUBISHI CORDIA 10/31/83

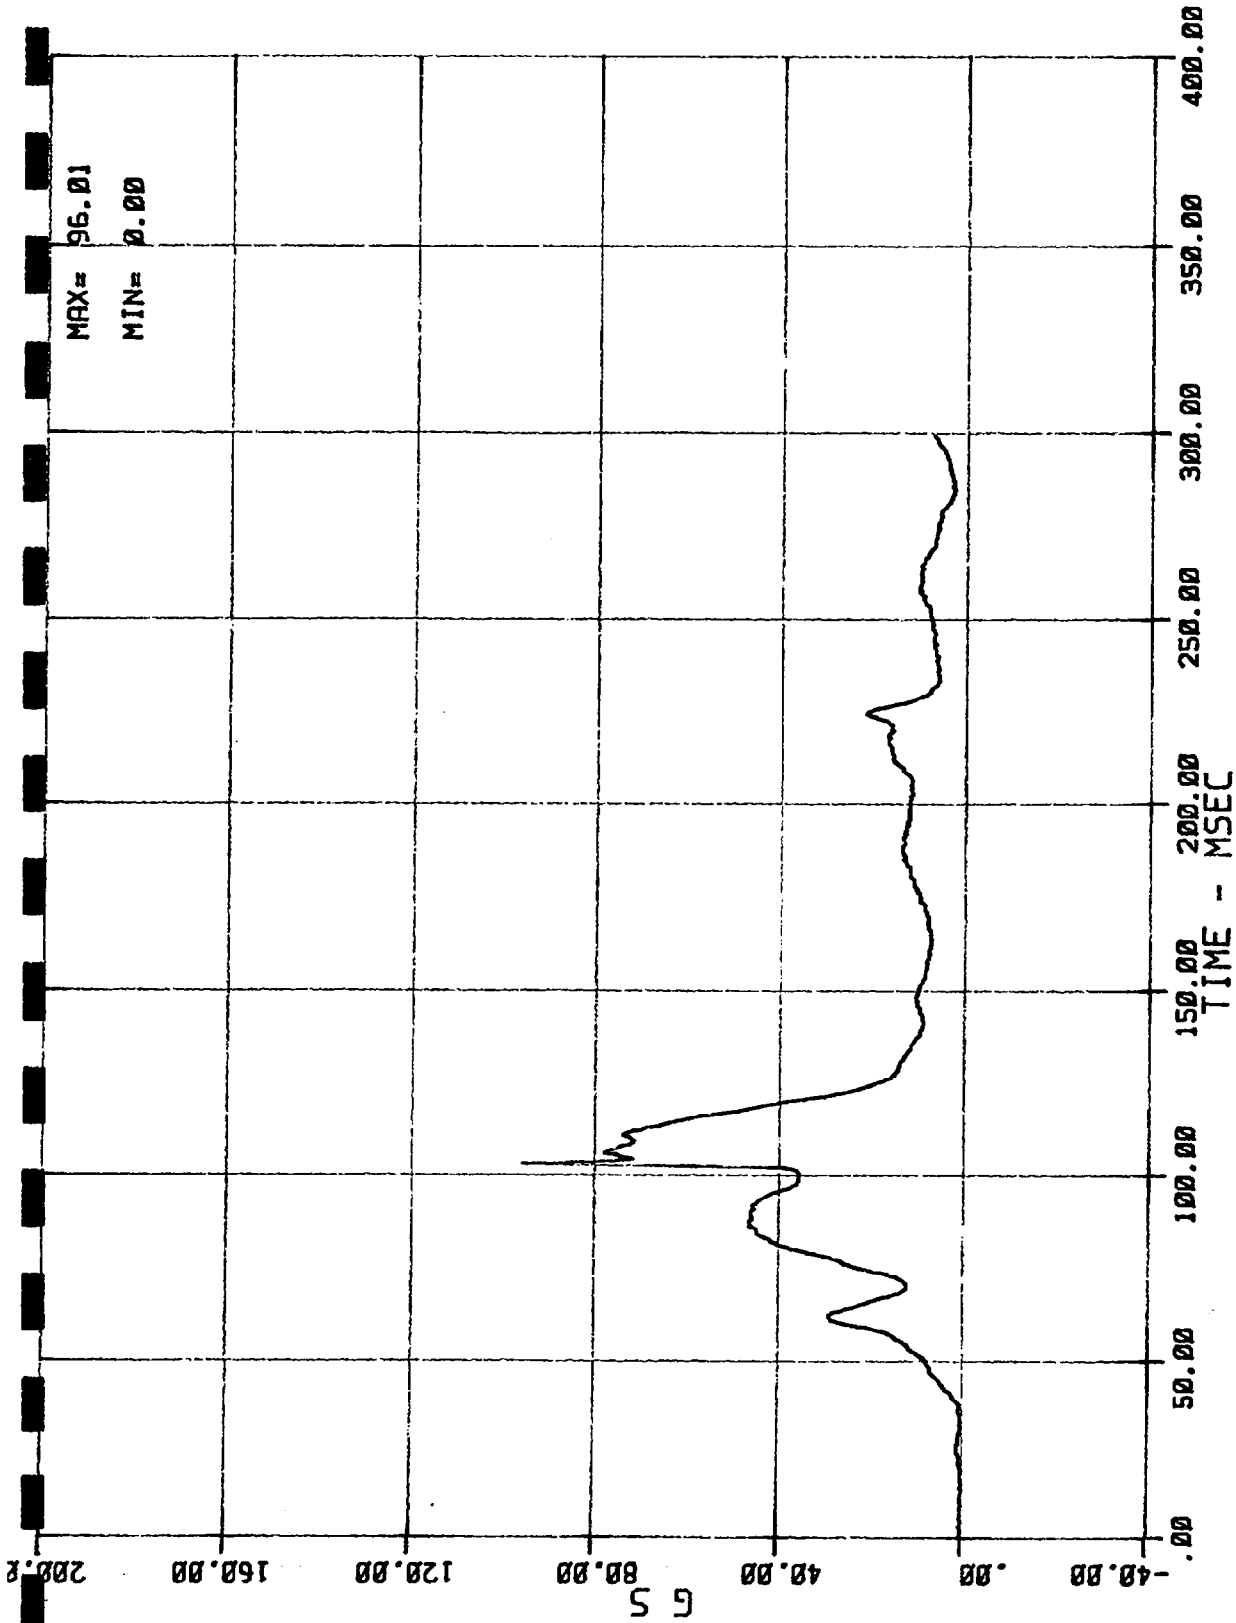
The passenger ATD's head hit the dash panel, and his knees pushed in the glove compartment door. The passenger's Head Injury Criteria value of 807, maximum chest acceleration (resultant clipped) of 34 g's, and a maximum femur loads of 945 and 510 pounds satisfy the FMVSS 208 requirements. Because of noise in the femur load cell data,

PASSENGERS HEAD RESULTANT ACCELERATION
MSE N99R33 1983 MITSUBISHI CORDIA
