FRONTAL IMPACT CRASH TESTS  
INVOLVING ALTERNATIVE VEHICLE  
DESIGNS UNDER VARYING  
CRASH CONDITIONS

TEST NO. 3156-4  
1983 HONDA ACCORD-TO-  
DEFORMABLE MOVING BARRIER  
FULL FRONTAL TEST AT 62.5 MPH  
2 DMB

TEST REPORT

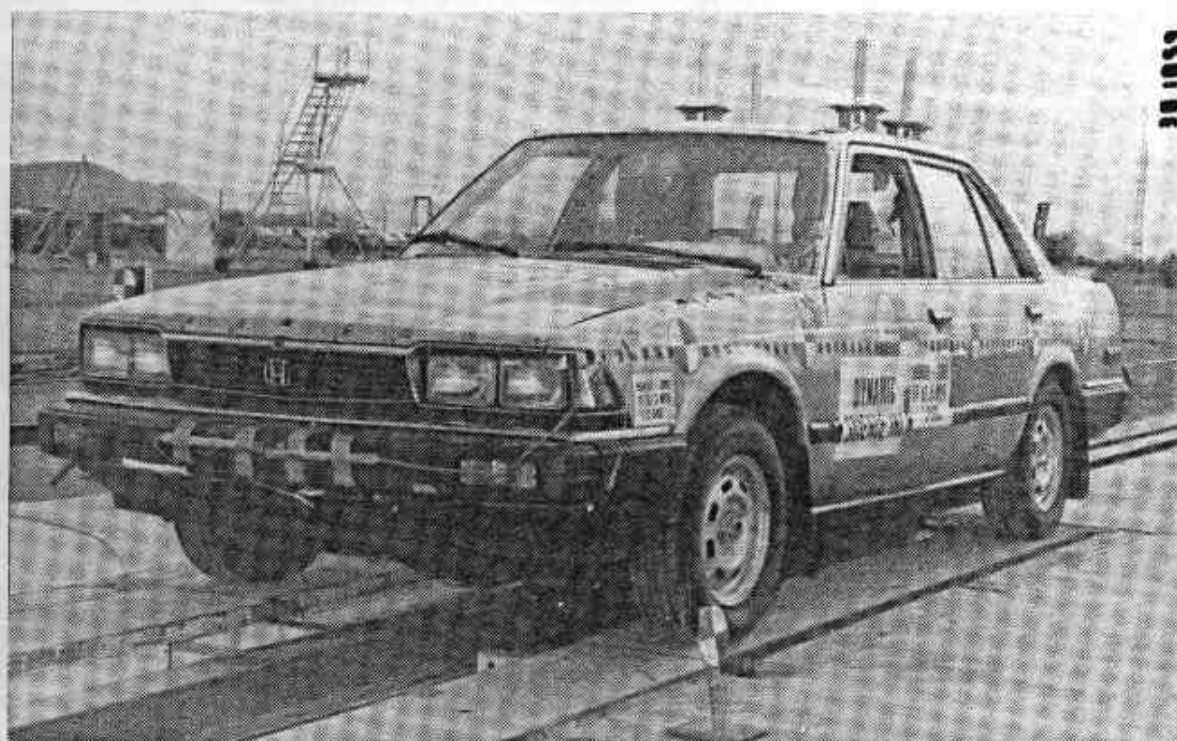
FIGURE B-1. PRE-TEST OBLIQUE FRONTAL VIEW OF 1983 HONDA ACCORD.

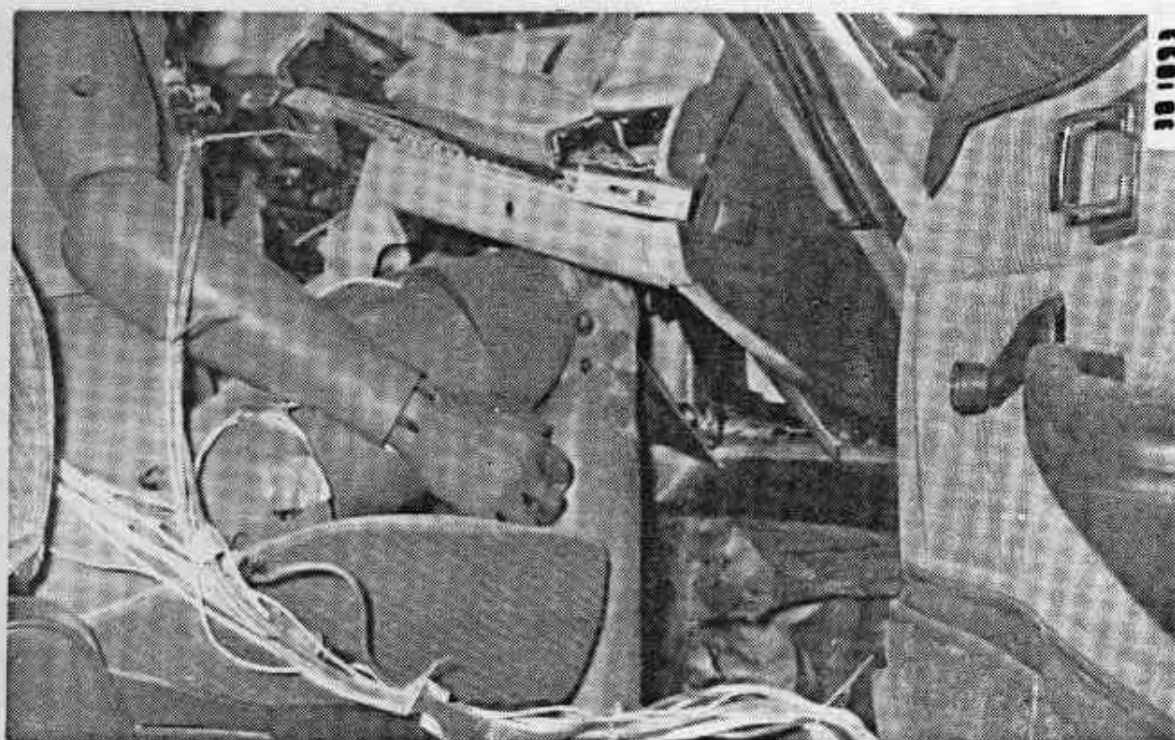
FIGURE B-8. POST-TEST VIEW OF OCCUPANT COMPARTMENT, PASSENGER SIDE.

| SEAT MOVEMENT | |
|---|---|
| Seat Back Failure | <u>None</u> <u>Failure, moved 20° forward</u> |
| Seat Shift (in.) | <u>Failure, moved full forward</u> <u>Failure, moved full forward</u> |
