REPORT NO. 301-NTW-83-005-271-6096-5

"COMPOSITE FY83"
FMVSS 301-75
VEHICLE SAFETY COMPLIANCE TESTING
FOR
FUEL SYSTEM INTEGRITY

CHRYSLER CORPORATION
1983 PLYMOUTH SCAMP - PICKUP
NHTSA CD0615

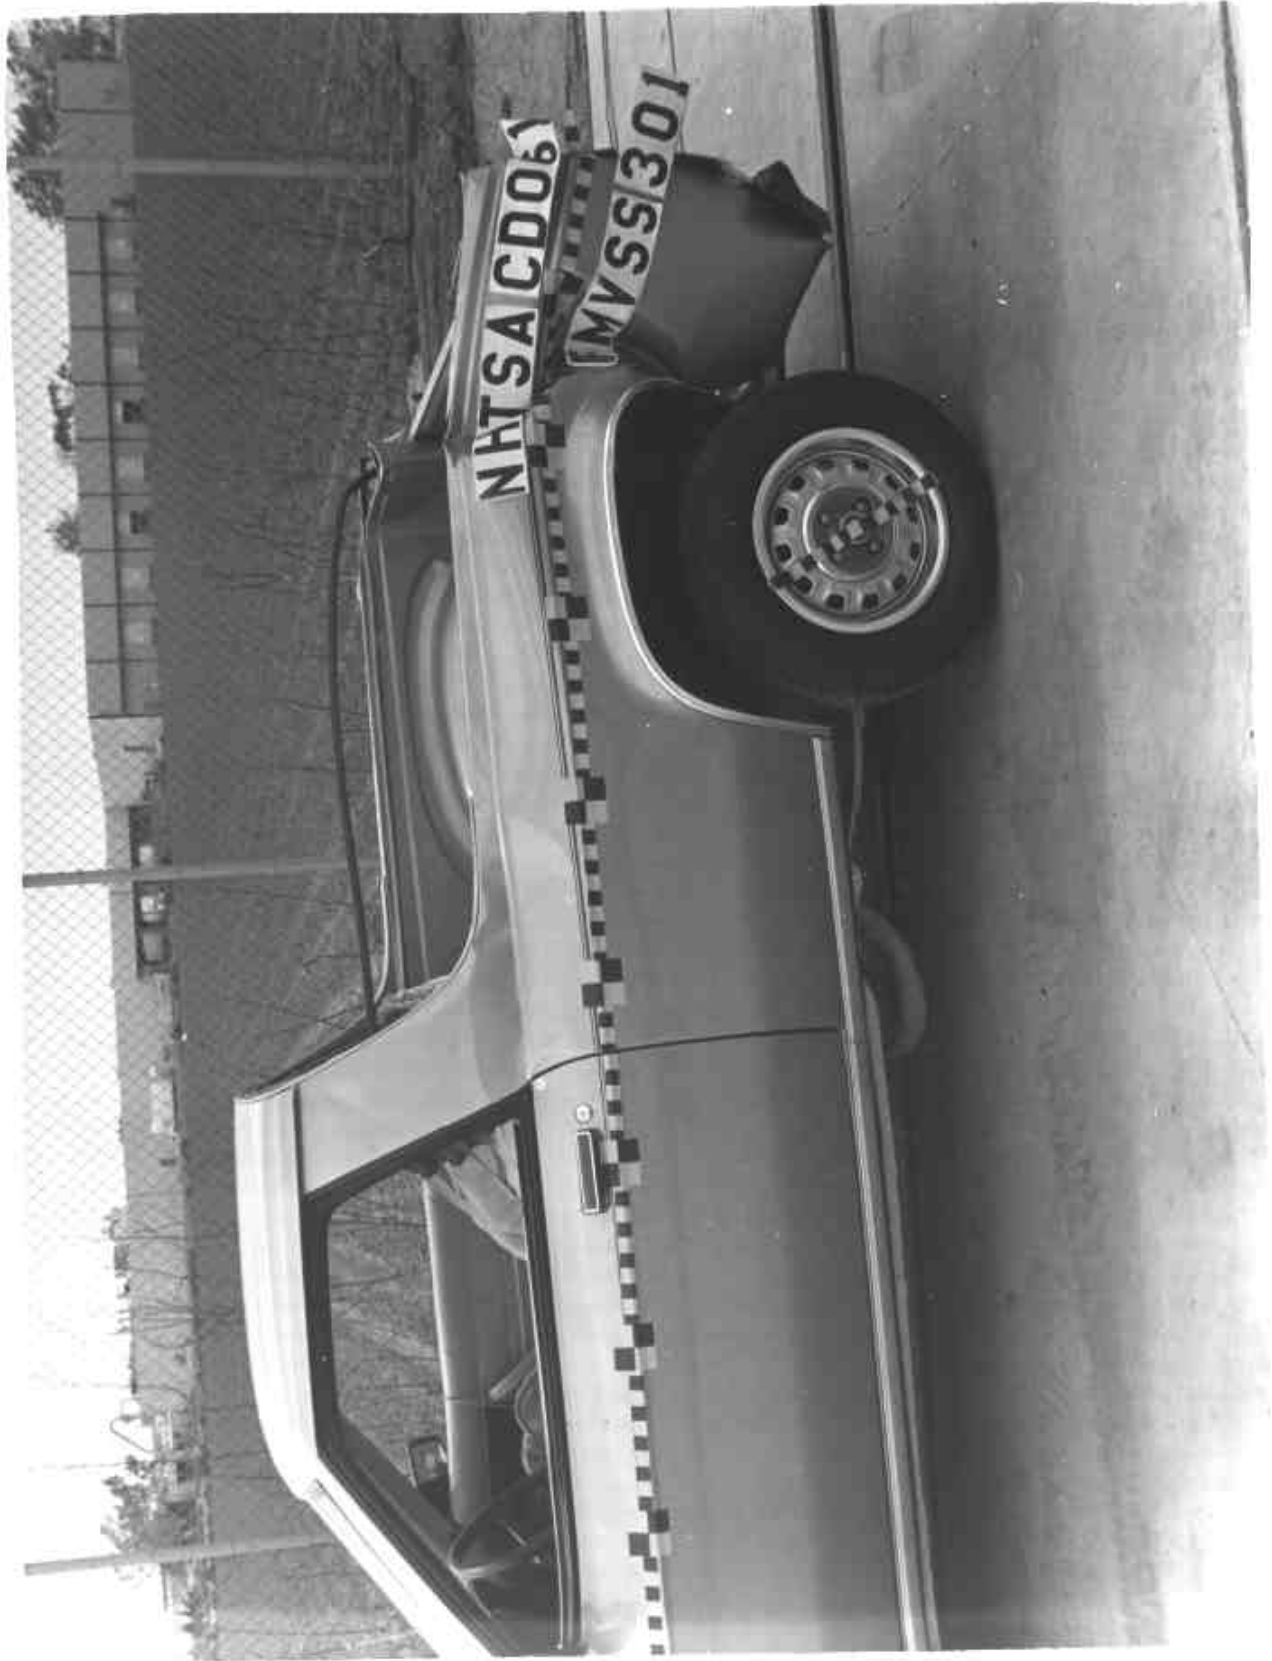
Figure 2-4
1983 Plymouth Scamp - Pickup
NHTSA CD0615
Post-Impact, Left Side View

Crush Details: Both frame rails buckled over rear axel, rear cab window shattered, both front seat backs bent backward and the rear cab wall deformed.

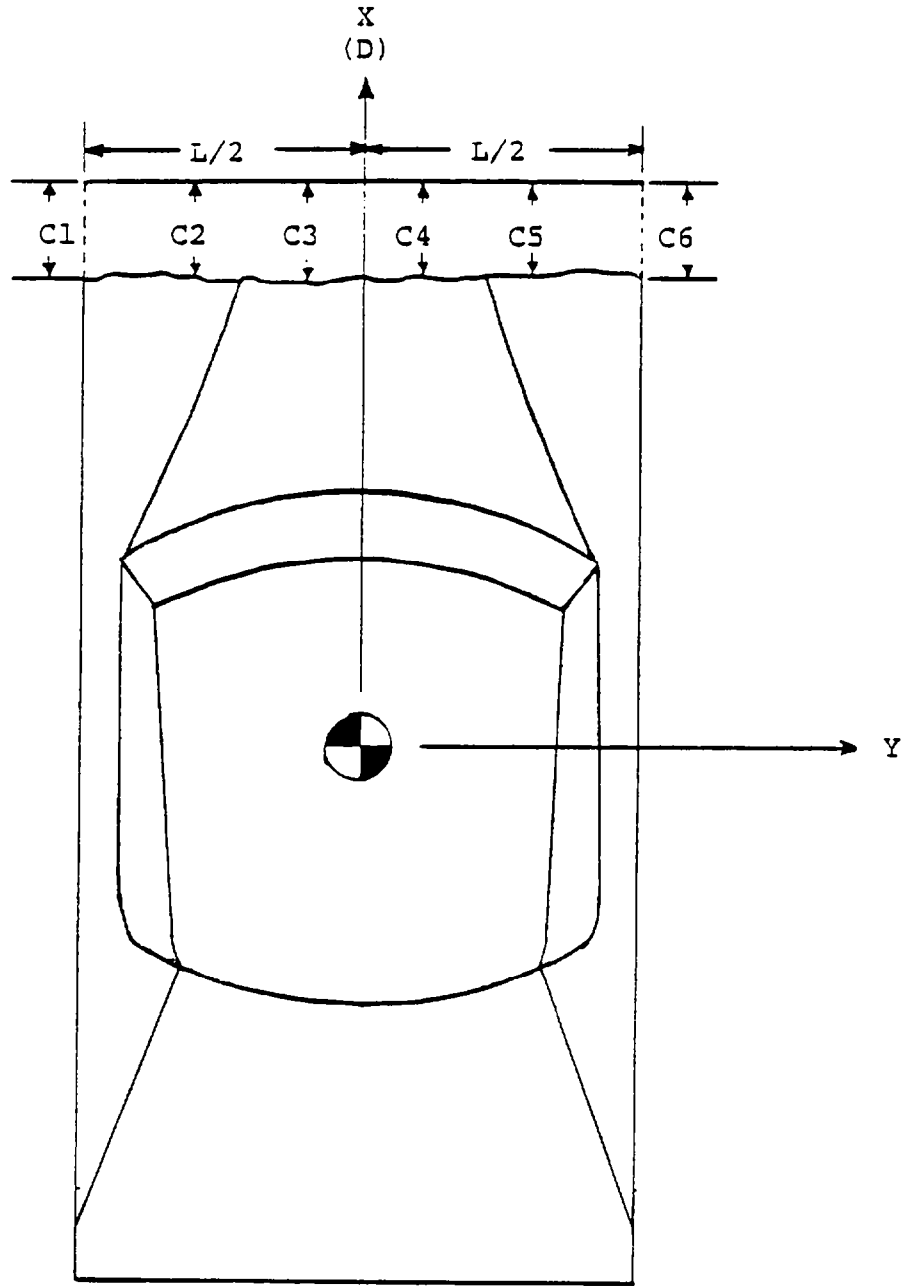
EXAMPLE
OF
DAMAGE DIMENSIONS
FRONTAL IMPACT

The following damage dimensions examples depict locations used to generate end damage depth profiles as defined in CRASH 2 User's Manual and are presented on the Staged Collision and Damage Data Sheet under Damage Profile: (Bumper/Frame Level) measurements. This desired measurement is the deflection (inches) into the test vehicle interior from the original, undeformed end dimension.

NOTE: D = distance between mid-point of L and X axis.

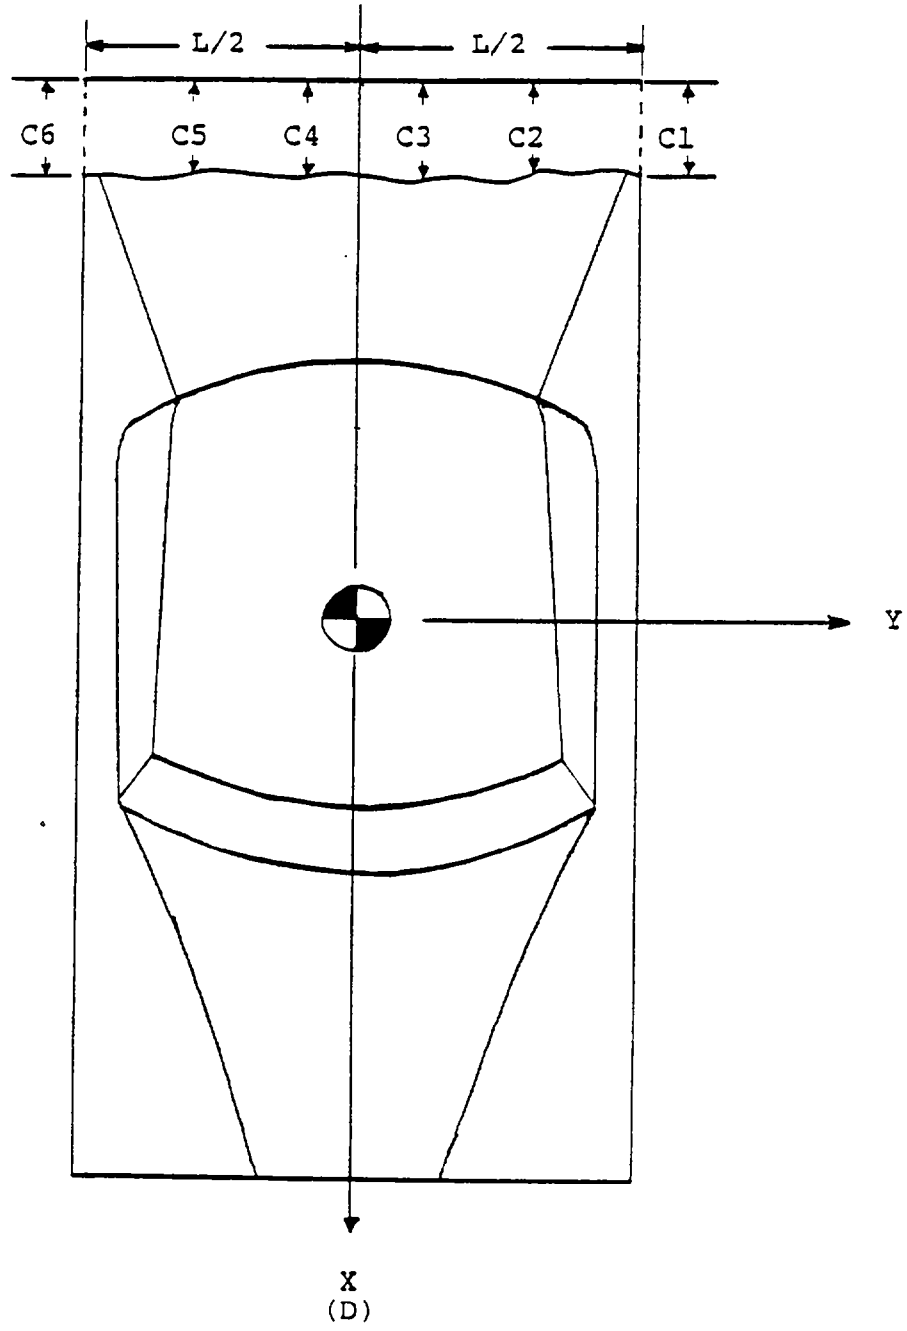
FIGURE 3-2
EXAMPLE
OF
DAMAGE DIMENSIONS
REAR IMPACT

NOTE: D = distance between mid-point of L and X axis.

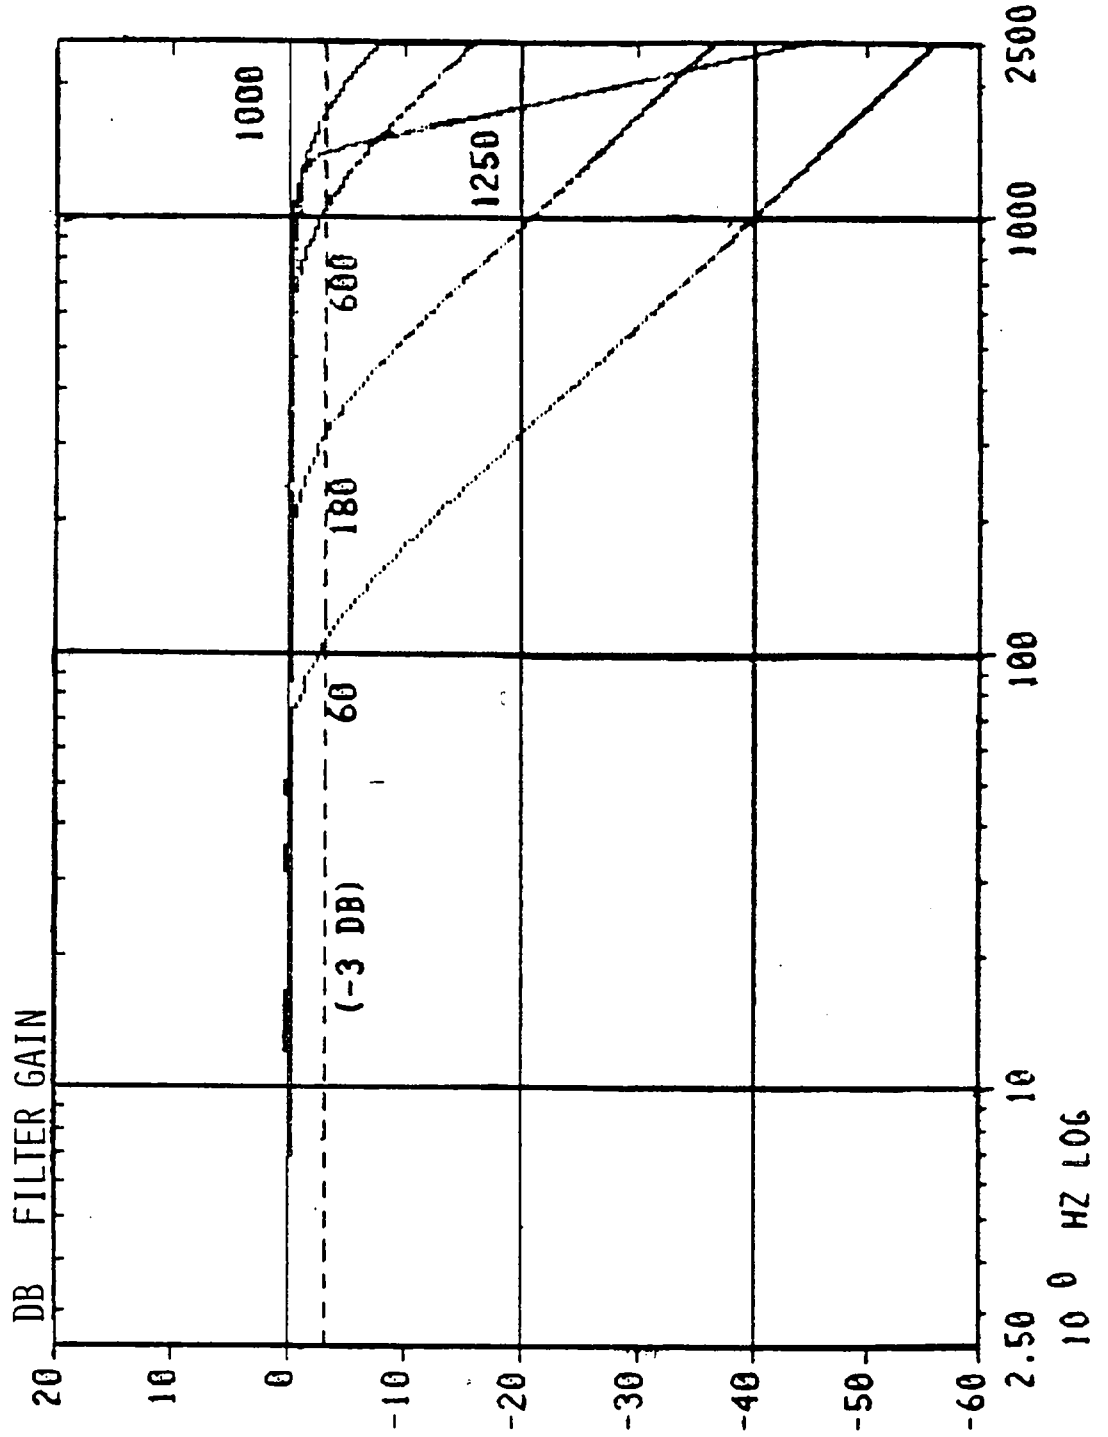
COMPARISON PLOT OF SAE CLASS 60, 180, 600, 1000 FILTERS AND THE DATA ANALYSIS 1250 HZ PREDIGITIZING ANALOG FILTER.

SAE FILTERS ROLL OFF IS 12DB/OCT, ANALOG FILTER ROLL OFF IS 60DB/OCT

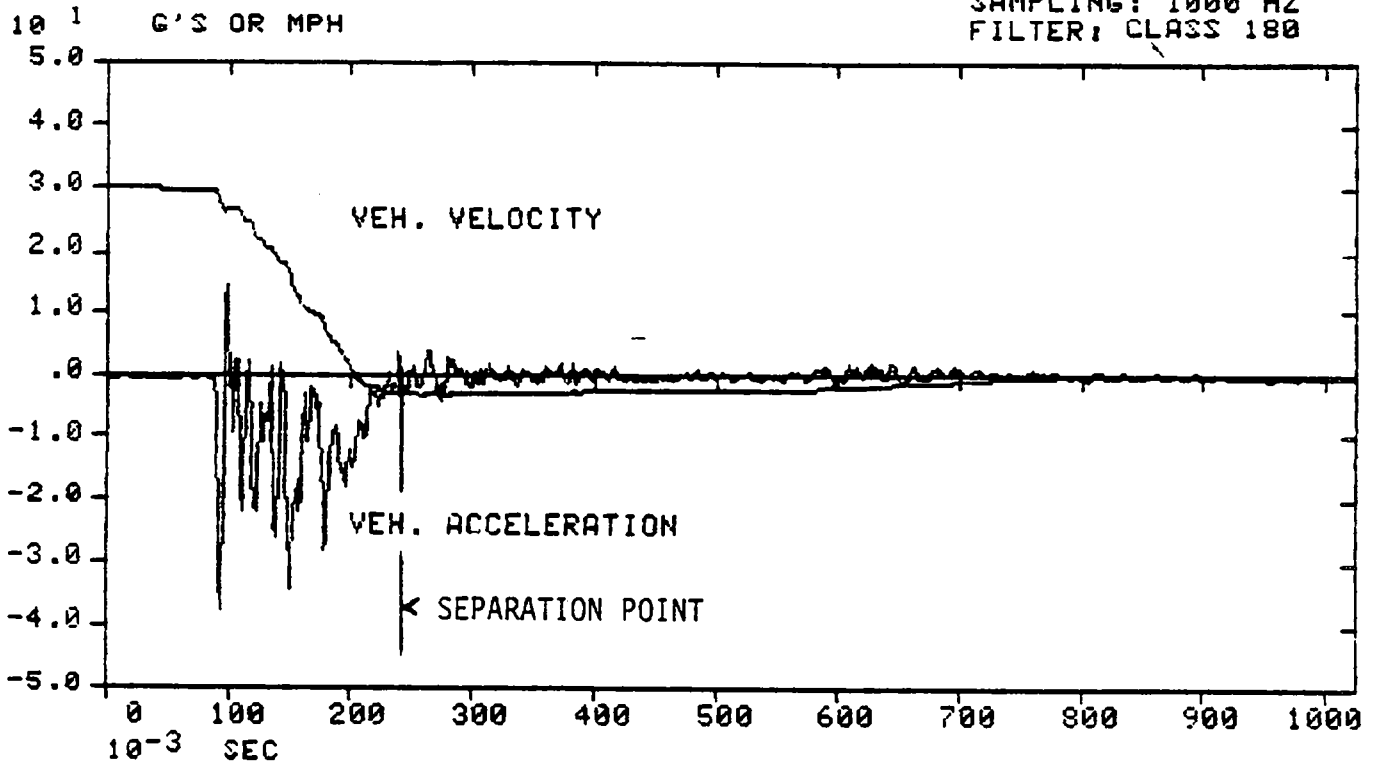
FIGURE 4-7

VEHICLE CG LONG. VELOCITY AND ACCELERATION

In addition to the data plots, a table listing the barrier closing speed, impact and vehicle separation times and delta velocities is given. Delta velocity is taken as the difference between the velocity at the moment of impact and the velocity at the moment of separation for the barrier or vehicle.
