REPORT NO. 301-NTW-83-006-271-6096-6

"COMPOSITE FY83"
FMVSS 301-75
VEHICLE SAFETY COMPLIANCE TESTING
FOR
FUEL SYSTEM INTEGRITY

MITSUBISHI MOTORS CORPORATION
1983 MITSUBISHI - PICKUP
NHTSA CD0620

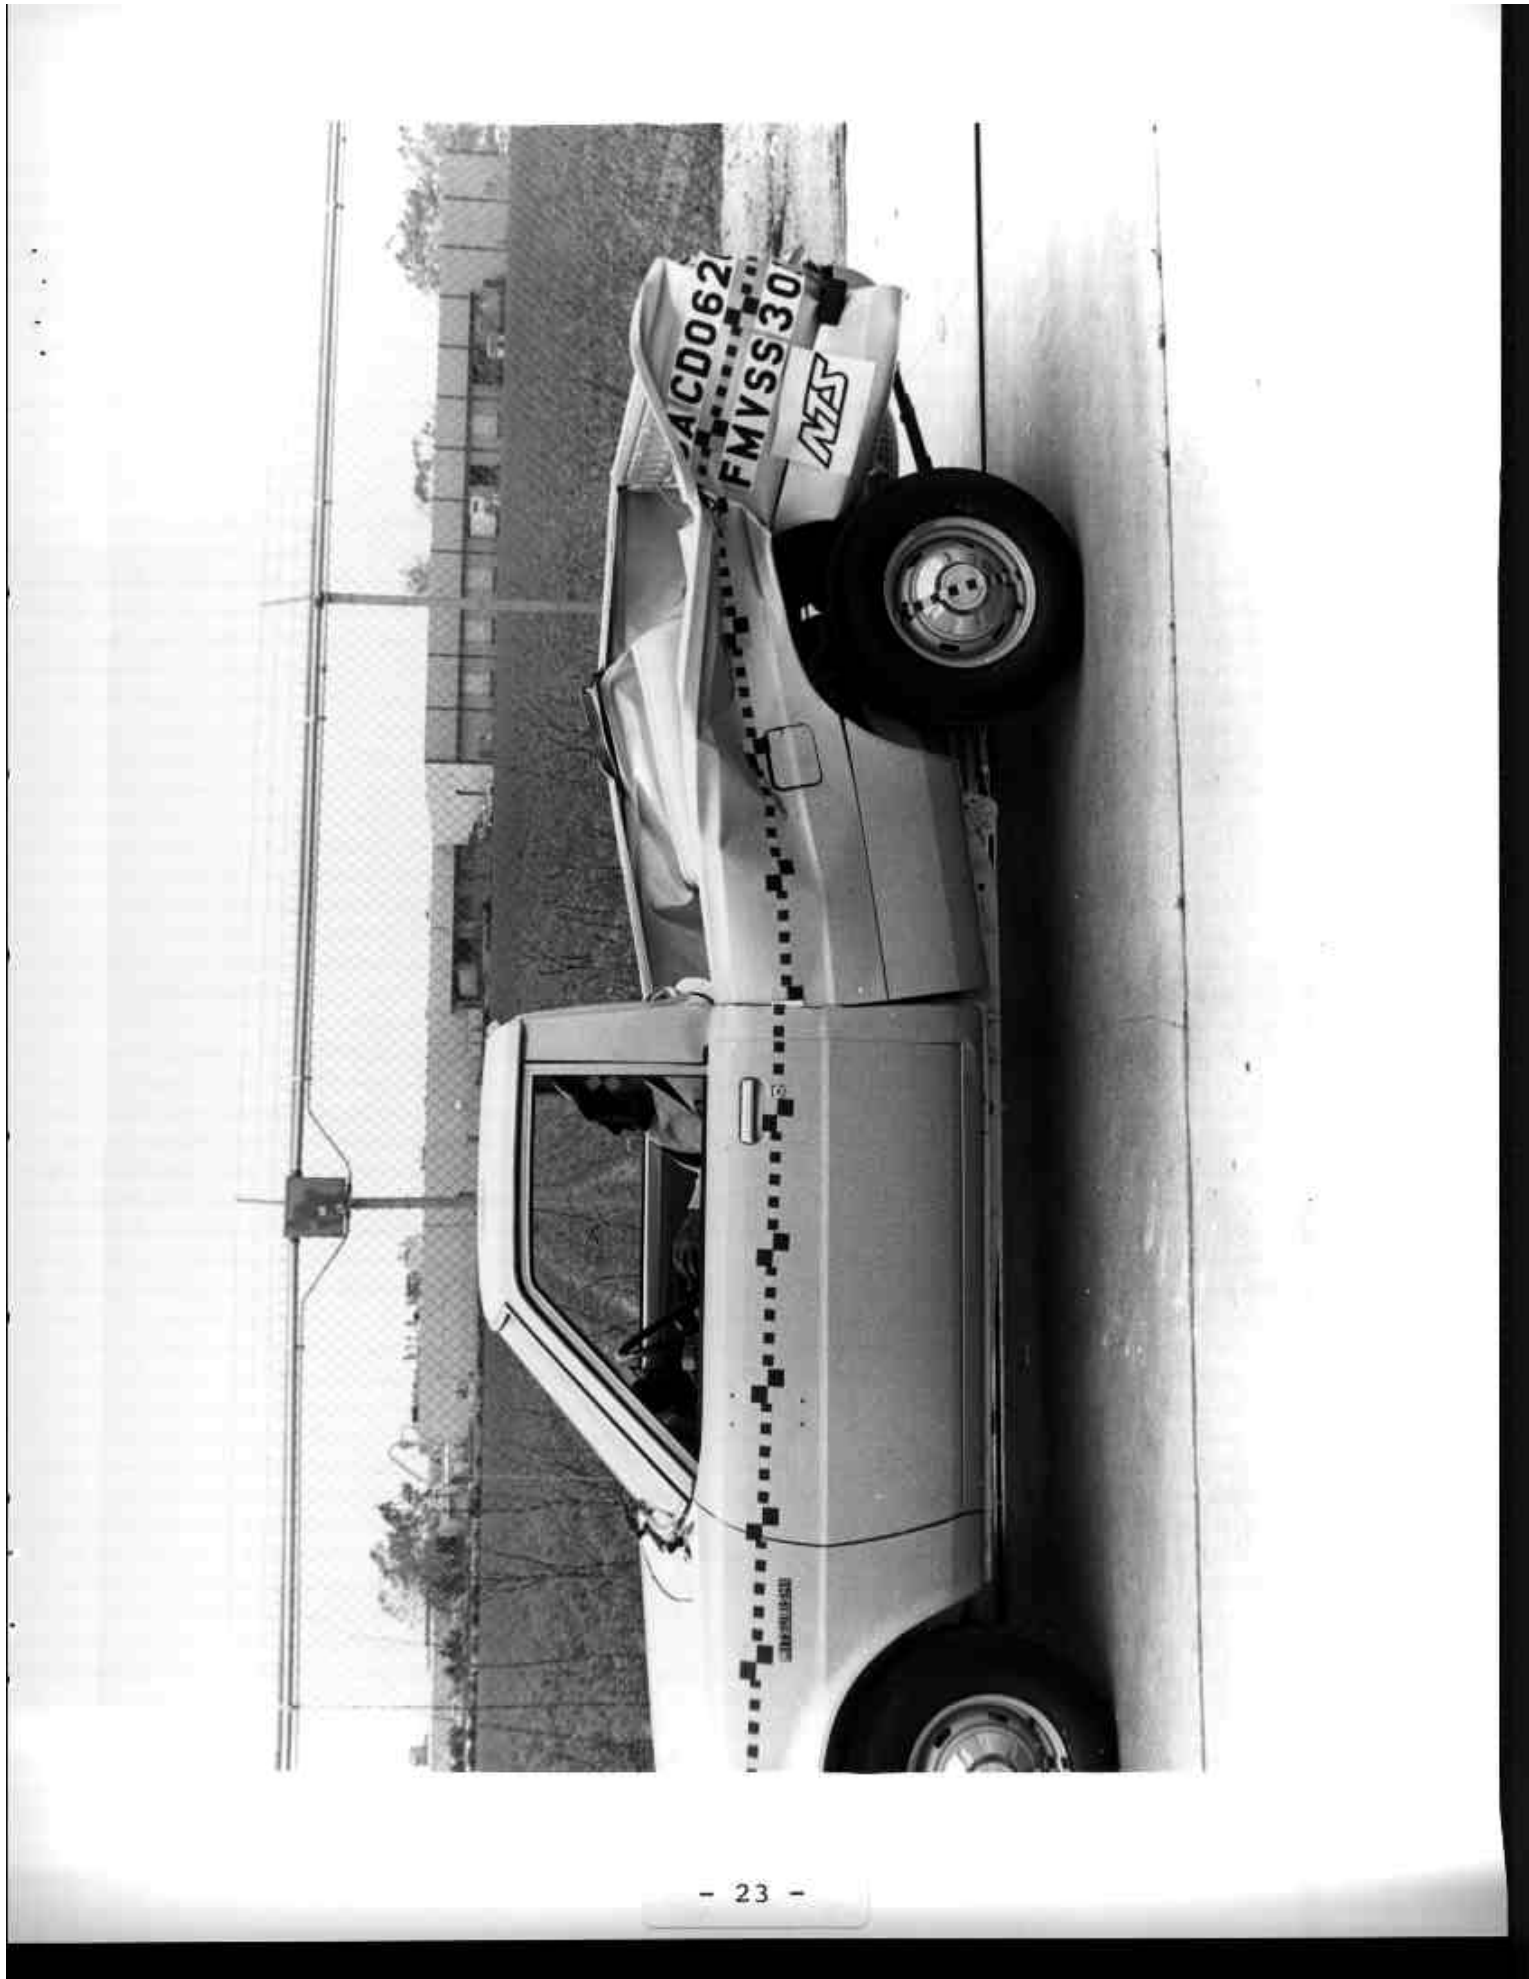
Figure 2-4
1983 Mitsubishi - Pickup
NHTSA CD0620
Post-Impact, Left Side View

Post-impact inspection of the test vehicle revealed almost all crush occurred rearward of the cab doors. The left and right frame rail buckled forward of the rear spring front frame mounting. The cargo box impacted the cab and the cab rear window ejected (unbroken). The seat back and cab wall were deformed. The spare tire (under cargo floor) remained inflated.

Crush Details: Both frame rails buckled forward of spring mounting, cargo box impacted cab and cab rear window ejected (unbroken)
