REPORT NO. 301-NTW-83-010-271-6096-10

"COMPOSITE FY83"
FMVSS 301-75
VEHICLE SAFETY COMPLIANCE TESTING
FOR
FUEL SYSTEM INTEGRITY

MITSUBISHI MOTORS CORPORATION
1983 MITSUBISHI MONTERO 4WD SPORT UTILITY
NHTSA CD0621

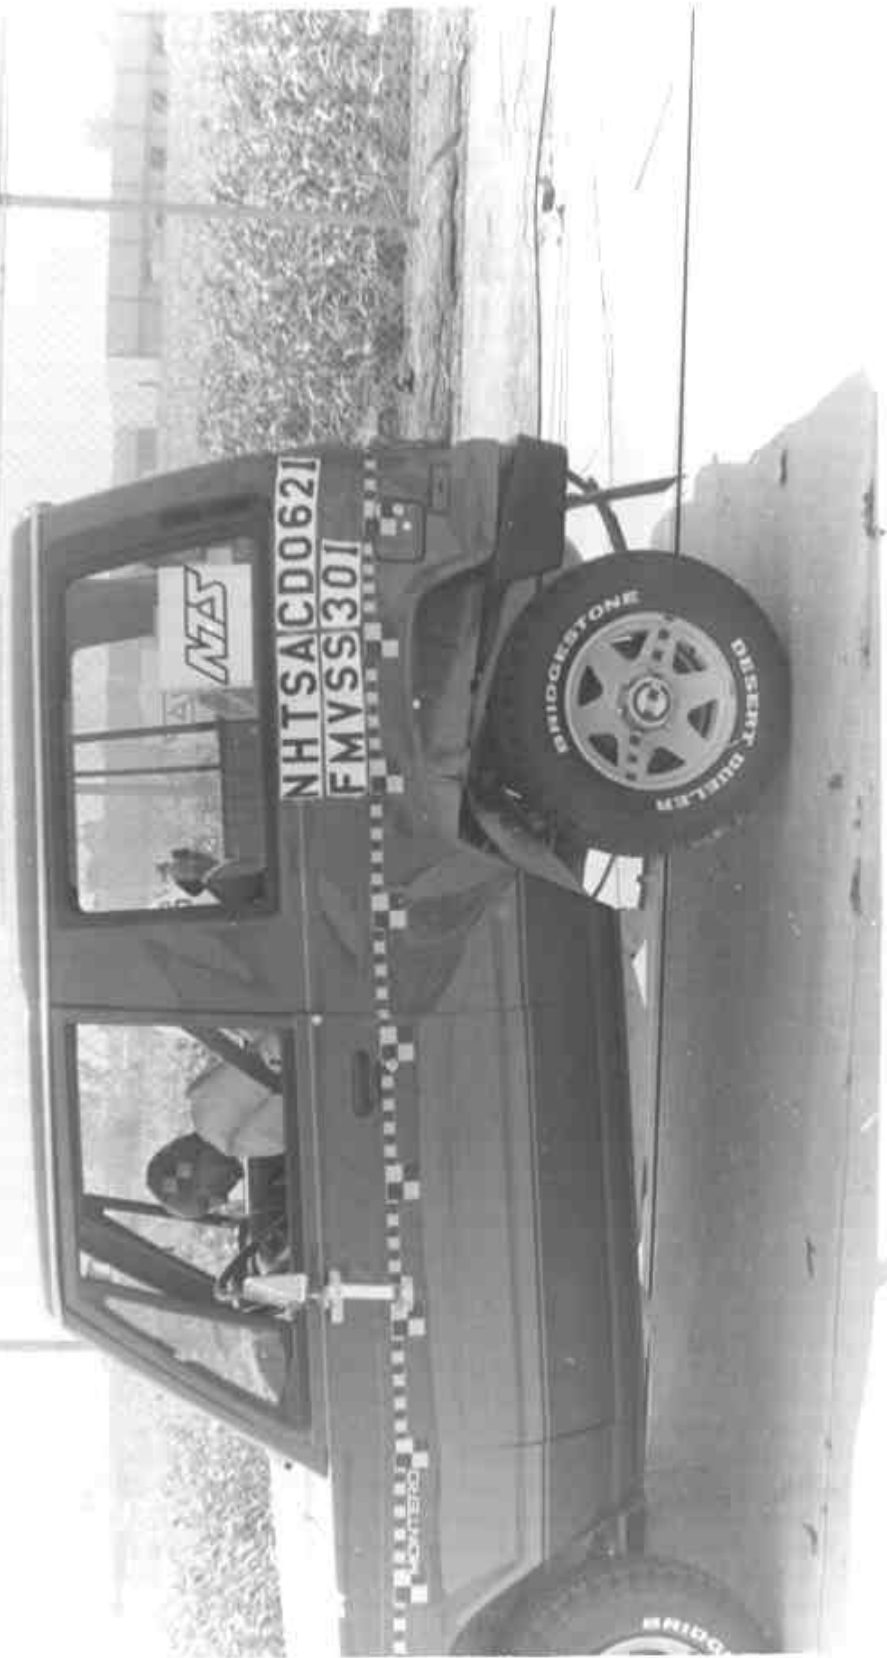
Figure 2-4
1983 Mitsubishi Montero 4WD Sport Utility
NHTSA CD0621
Post-Impact, Left Side View

Crush Details: Rear window shattered, both frame rails buckled over axel and front spring mounting, both front seats bent backward unto rear seat cushion.

Post-impact inspection of the test vehicle revealed almost all crush occurred rearward of the cab doors. The left and right frame rail buckled over the rear axel and forward of the rear spring front mounting. The rear window shattered and both front seat backs bent backward unto the rear seat cushion. The spare tire (attached to rear door) remained inflated.

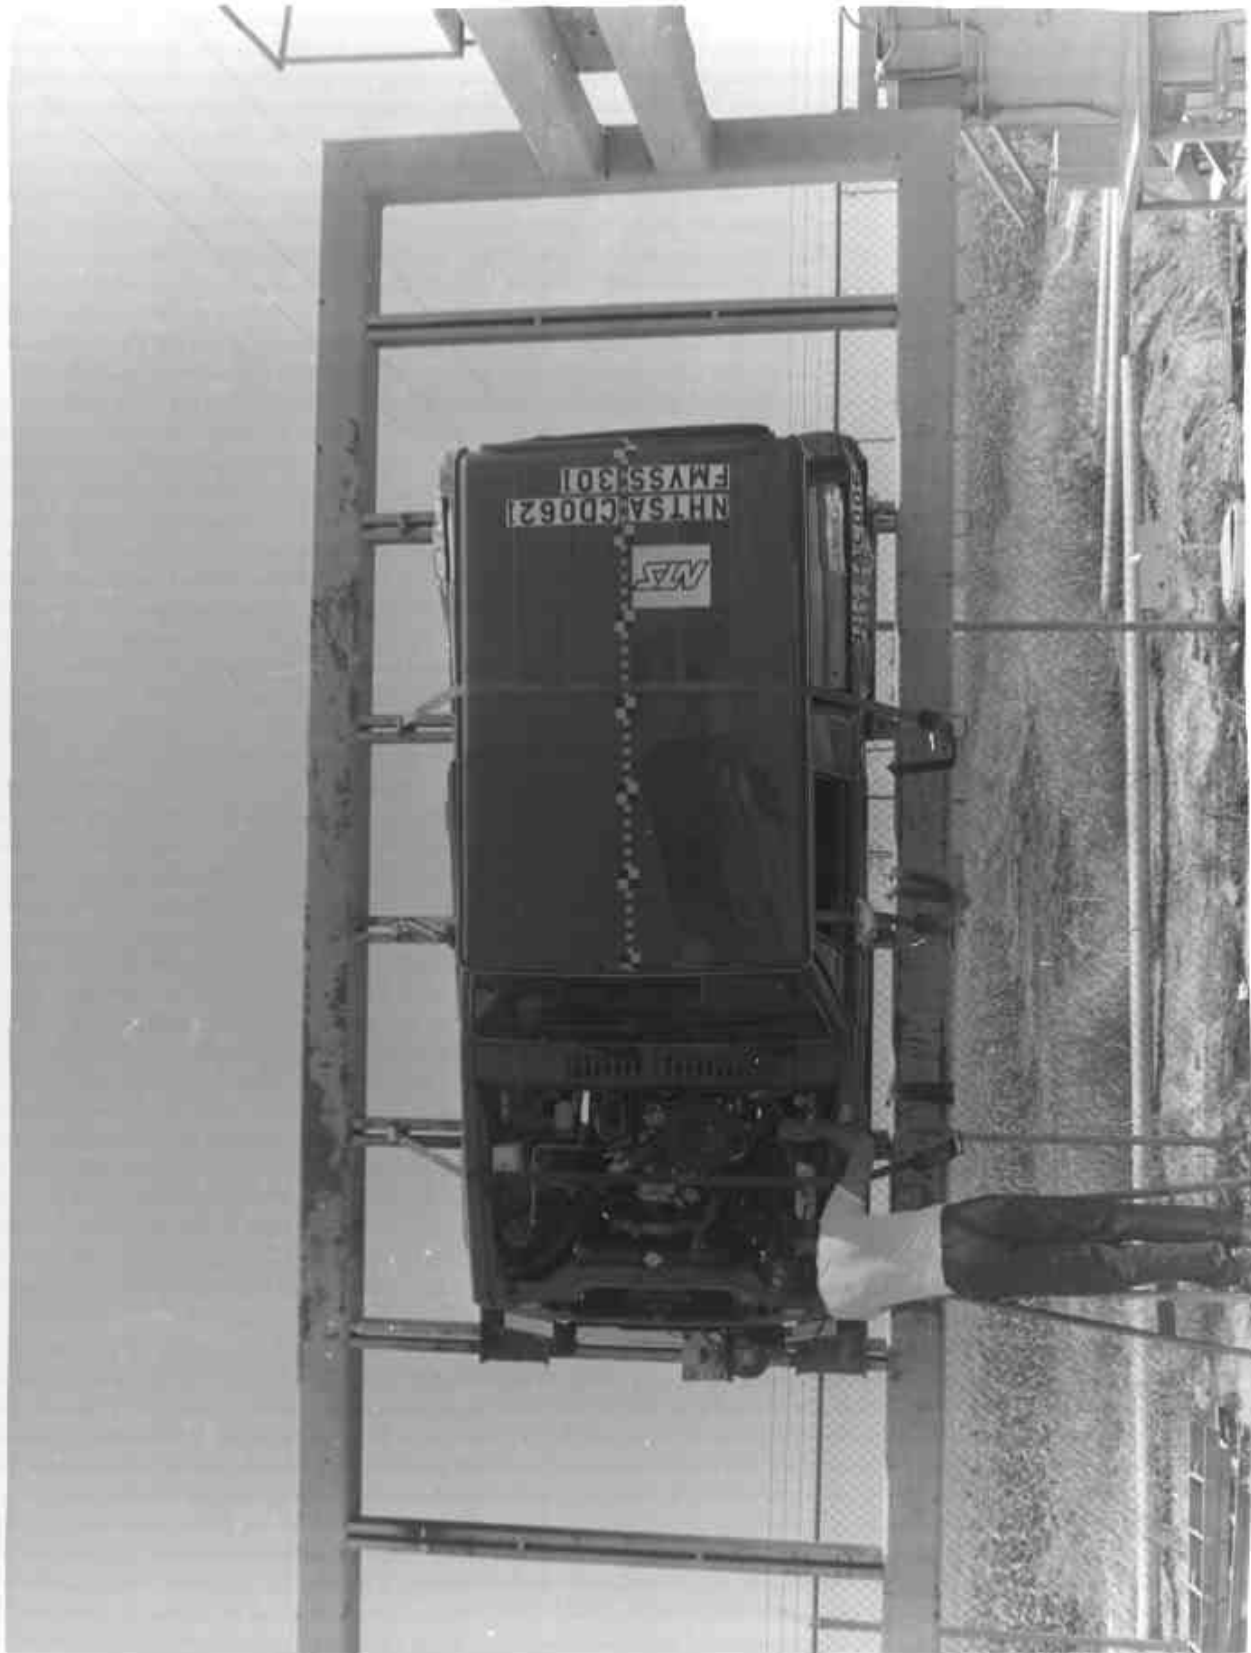
Figure 2-7

Fuel Spillage Location: Carburetor Air Cleaner Assembly Area

No fuel spillage was recorded following the test vehicle impact, nor during the time period before the start of the rollover test. However, fuel spillage was noted emitting from the carburetor air cleaner assembly area during the 90° and 270° test increment as recorded.

Post-Impact, Rollover Test, 90° Increment
