REPORT NOS. 212-CAL-84-190  
301-CAL-84-190

NHTSA NEW VEHICLE ASSESSEMENT AND  
STANDARDS ENFORCEMENT INDICANT TESTING

FMVSS 212 AND 301-75

DAIMLER BENZ AG  
1984 MERCEDES BENZ 300SD  
4-DOOR SEDAN

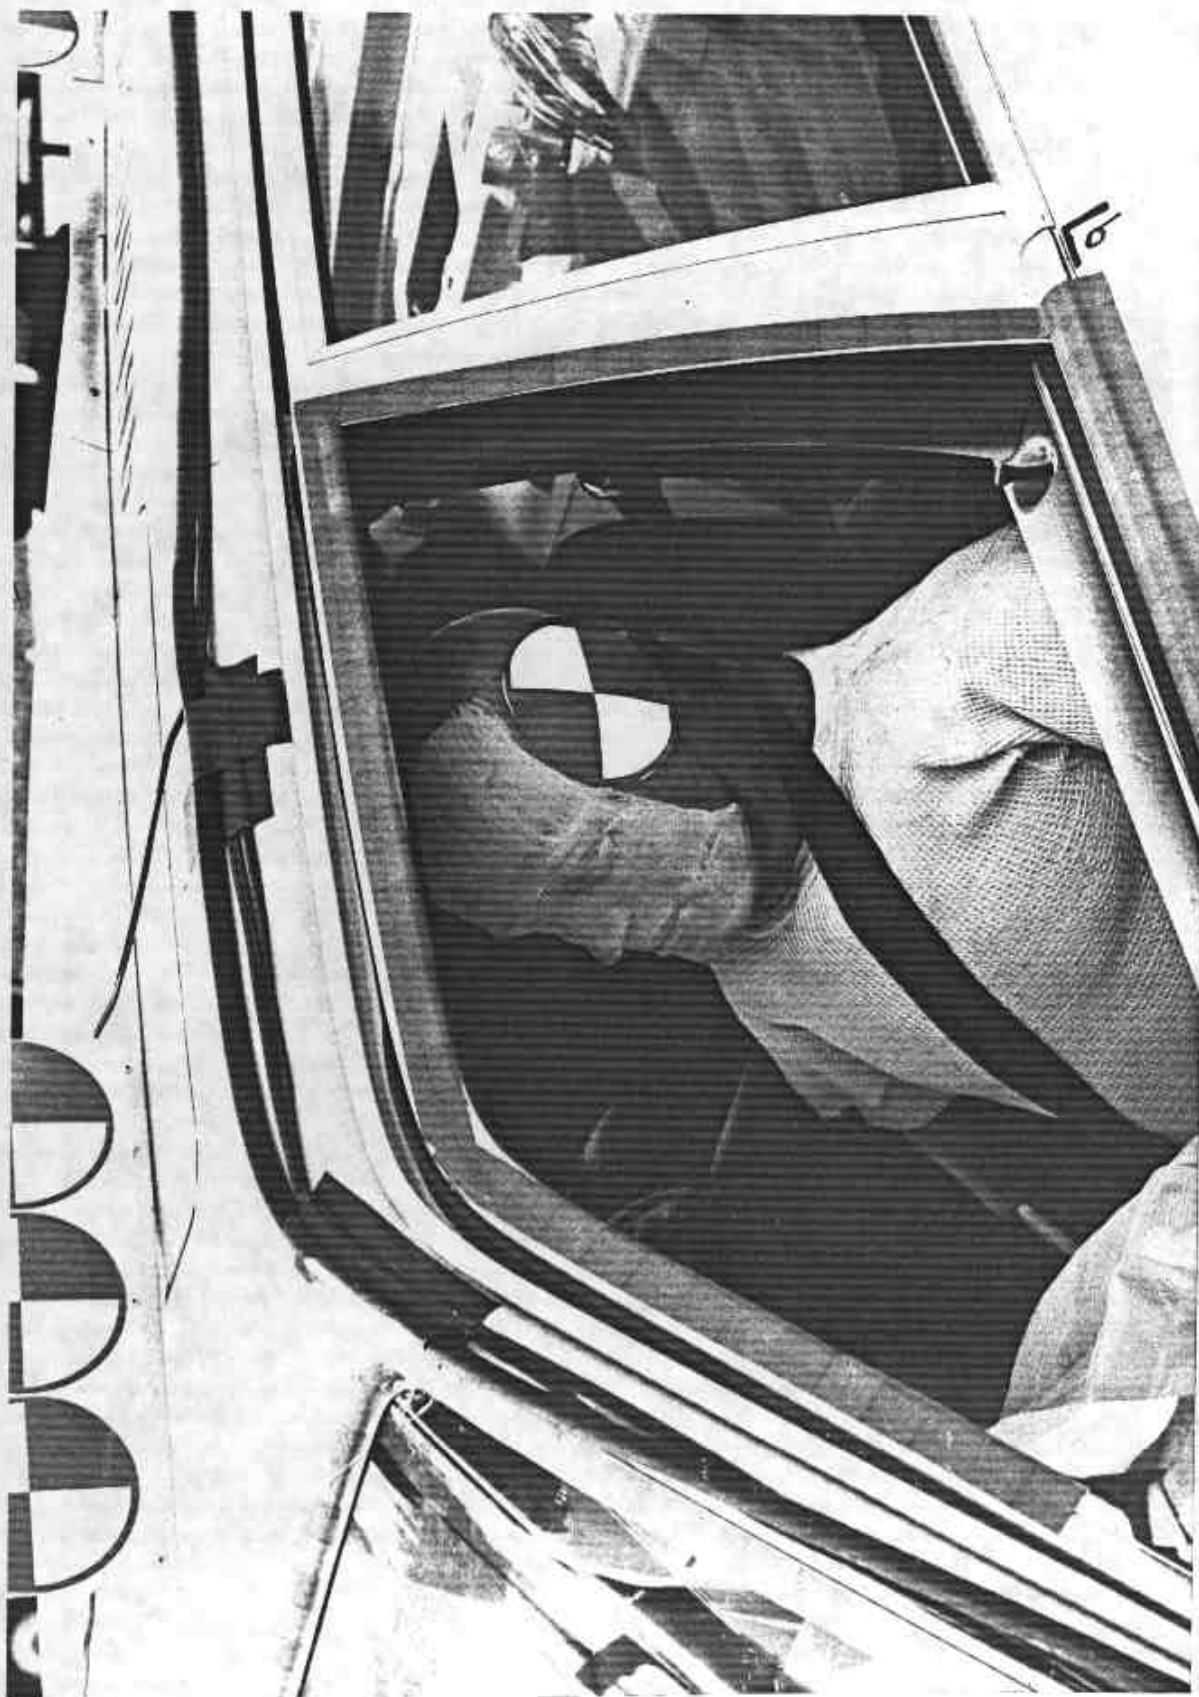
Figure A-24 POST-TEST DRIVER POSITION VIEW

| | <u>Driver</u> | <u>Passenger</u> |
|---|---|---|
| Left Knee | <u>Dash Panel</u> | <u>None</u> |
| Right Knee | <u>Dash Panel</u> | <u>None</u> |

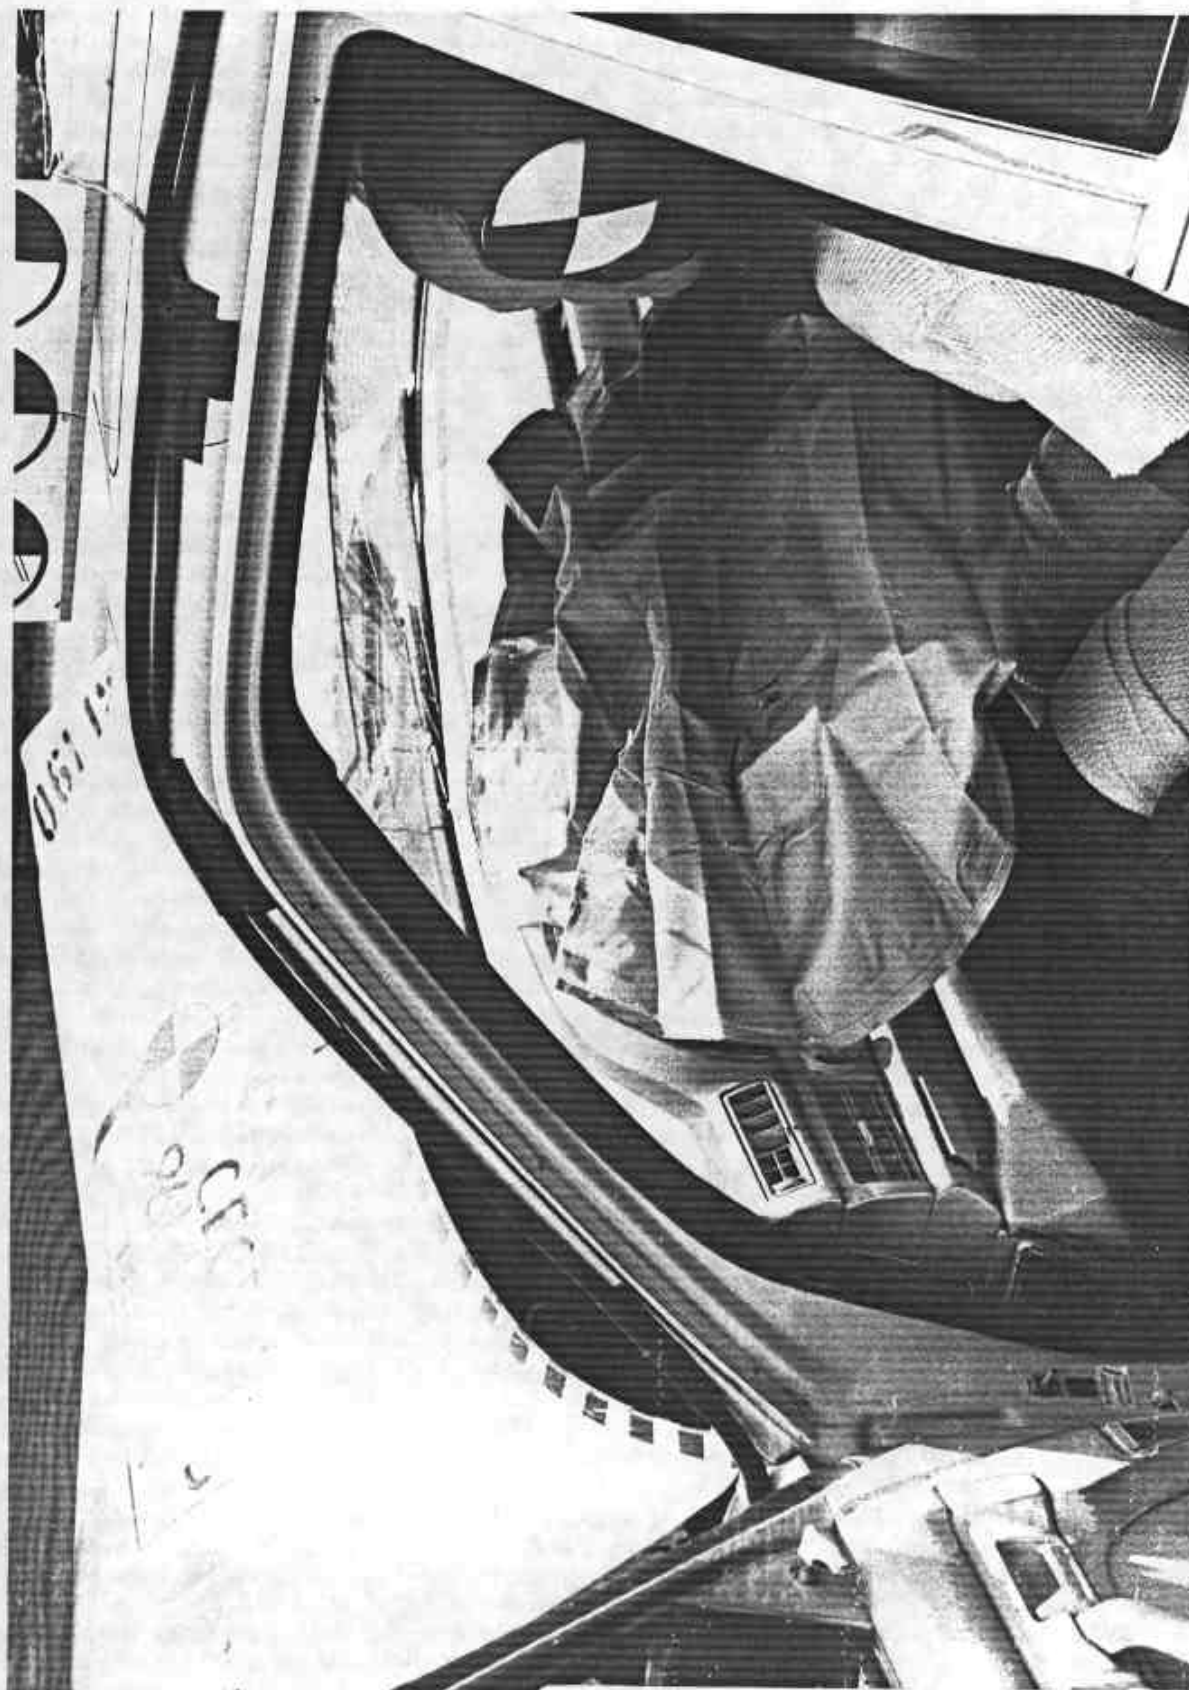
Figure A-26 POST-TEST DRIVER AND INTERIOR VIEW

| | <u>Driver</u> | <u>Passenger</u> |
|---|---|---|
| Head | <u>Air Bag</u> | <u>None</u> |
