NHTSA NEW VEHICLE ASSESSMENT AND
STANDARDS ENFORCEMENT INDICANT TESTING

FMVSS 212 AND 301-75

ISUZU MOTORS LTD.
1984 ISUZU IMPULSE
2-DOOR HATCHBACK

NHTSA NO. ME5701
CALSPAN TEST NO. 7103-V-26

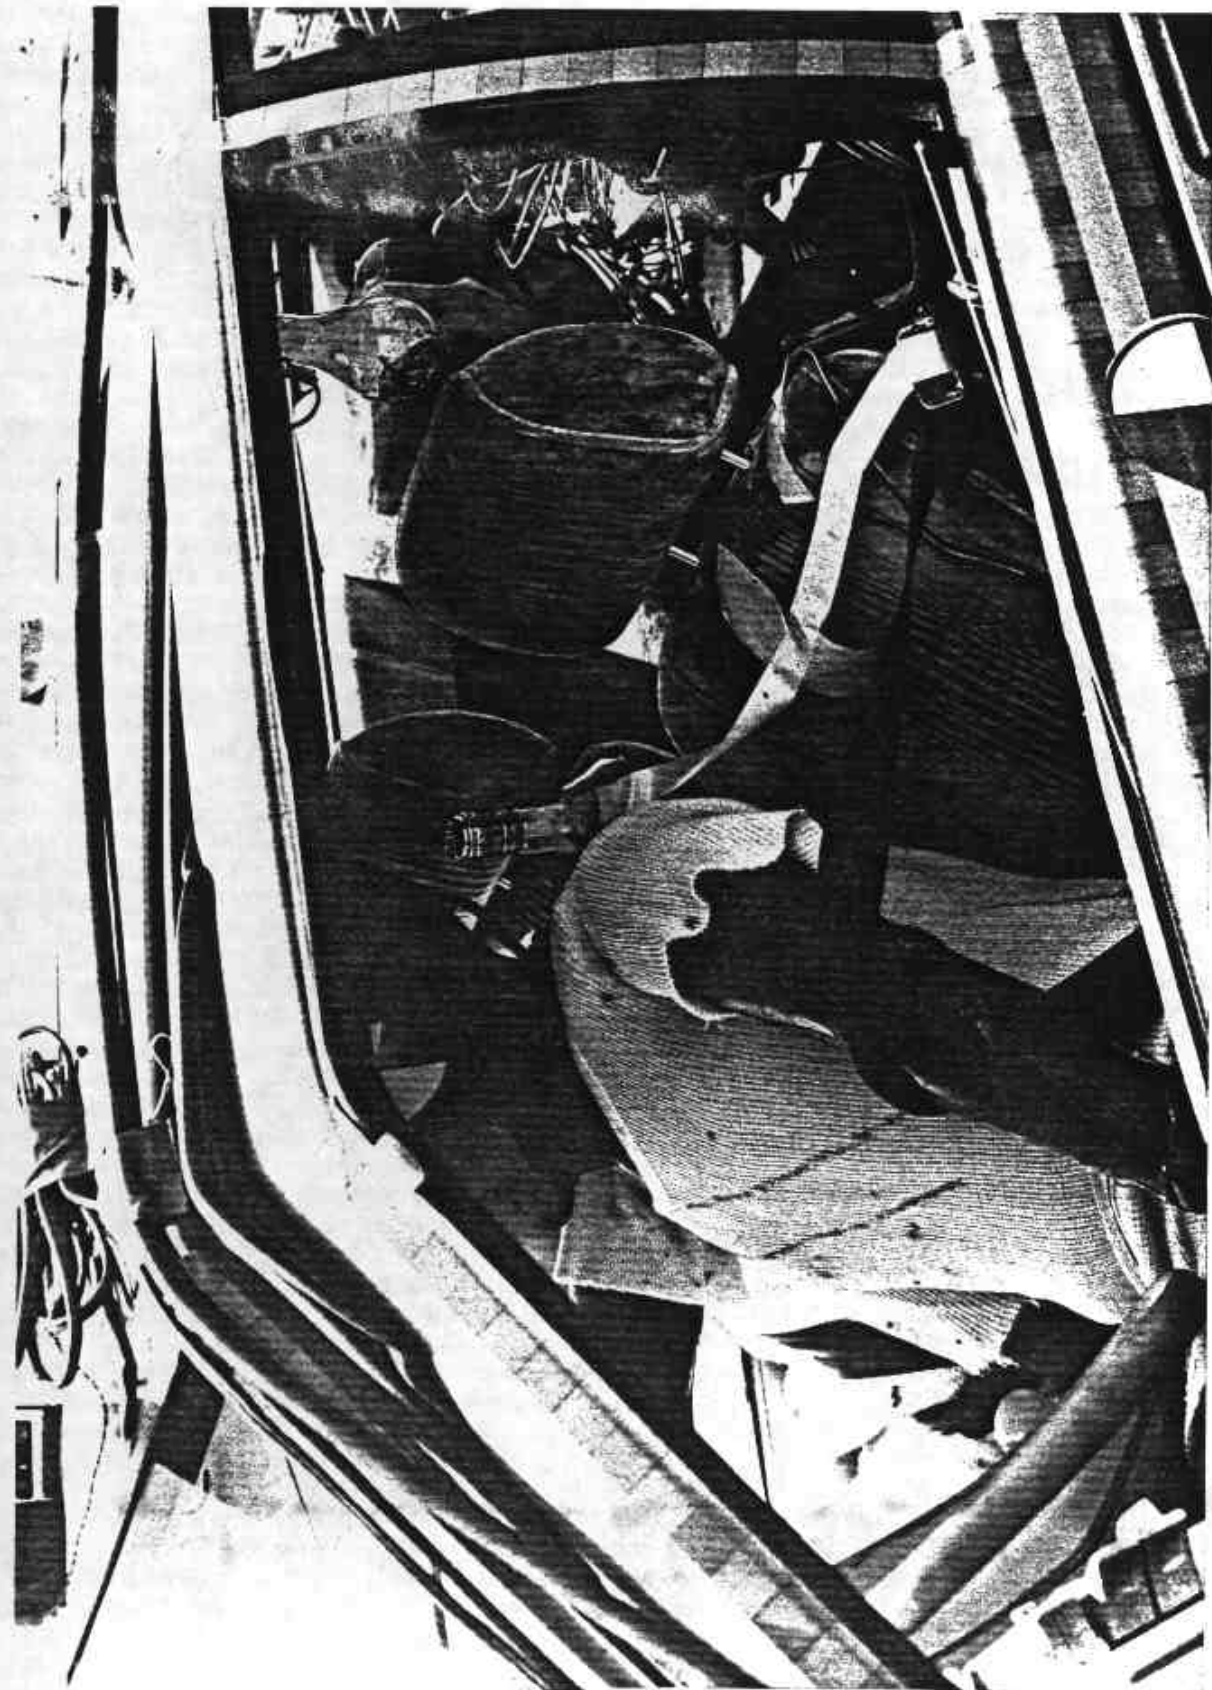
Figure A-24 POST-TEST DRIVER POSITION VIEW

The driver's head struck the upper steering wheel rim and center hub. The driver's HIC was 1769.2. The maximum chest deceleration over 3 milliseconds was 45.5 g's, and the femur loads were 1530 (right) and 850 pounds (left). On rebound the driver rolled in-board and it appears his right arm struck the belt buckle release button, releasing his lap and shoulder belt.
