# NEW CAR ASSESSMENT PROGRAM (NCAP)

## FRONTAL BARRIER IMPACT TEST

1986 MAZDA B 2000 TRUCK PICKUP

NHTSA No. CG0601

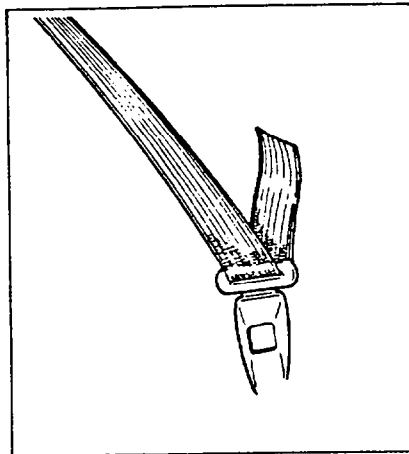
### WARNING

Do not wear the shoulder belt under the arm, across the neck or over the inside shoulder. Any of these practices can reduce effectiveness of the restraint system.
