FEDERAL HIGHWAY ADMINISTRATION CONTRACT  
DTFH61-83-C-00140

**IMPACT ATTENUATORS  
A CURRENT ENGINEERING EVALUATION**

Test Results Report for  
Test #1625-B-01-84  
Task B

ENSCO, Inc.  
Applied Technology and Engineering Division  
5400 Port Royal Road  
Springfield, VA 22151

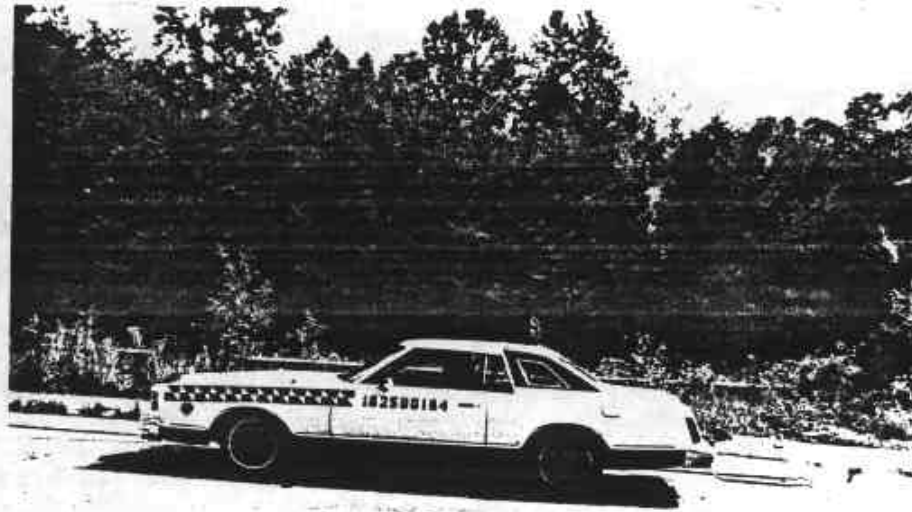
Figure 2-9 Pre-Test Photograph of Test Vehicle, Side View

The test vehicle was a white 1979 Ford LTD II, (see Figure 2-9 and 2-10) corresponding to the NCHRP 230 classification of 4500S. The initial weight of the vehicle was 3915 pounds. The vehicle was prepared for testing by removing the gas tank, battery and back seat. The weight of the vehicle after incorporating the instrumentation and 380 pounds of ballast was 4312 pounds. The weight distributions of the vehicle with and without occupants are given in Tables 2-1 and 2-2.

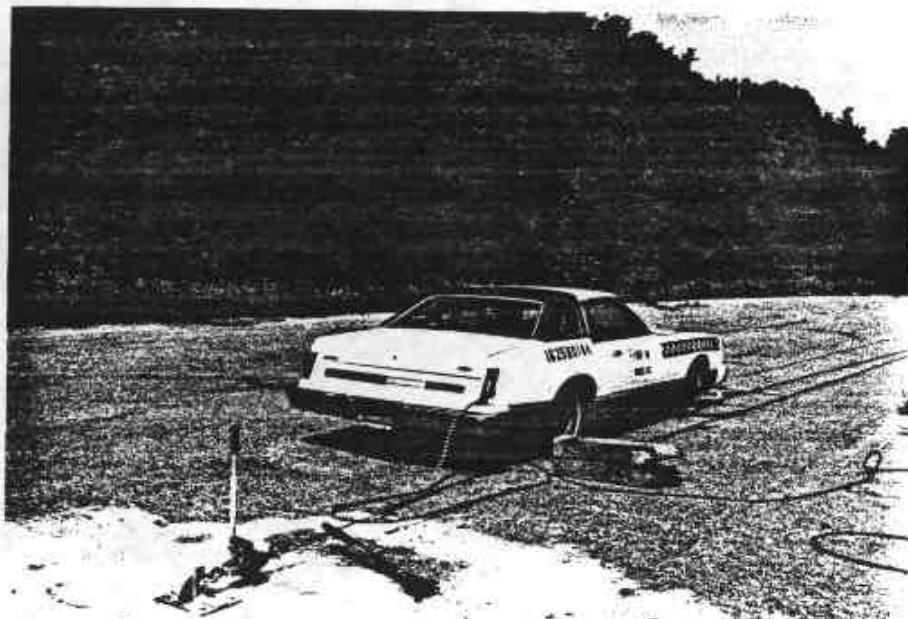
Figure 2-10 Pre-Test Photograph of Test Vehicle, Rear View

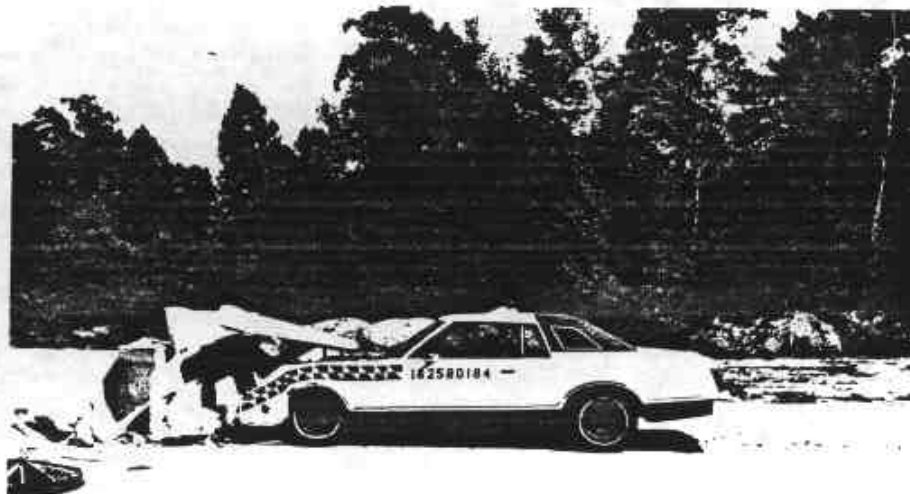
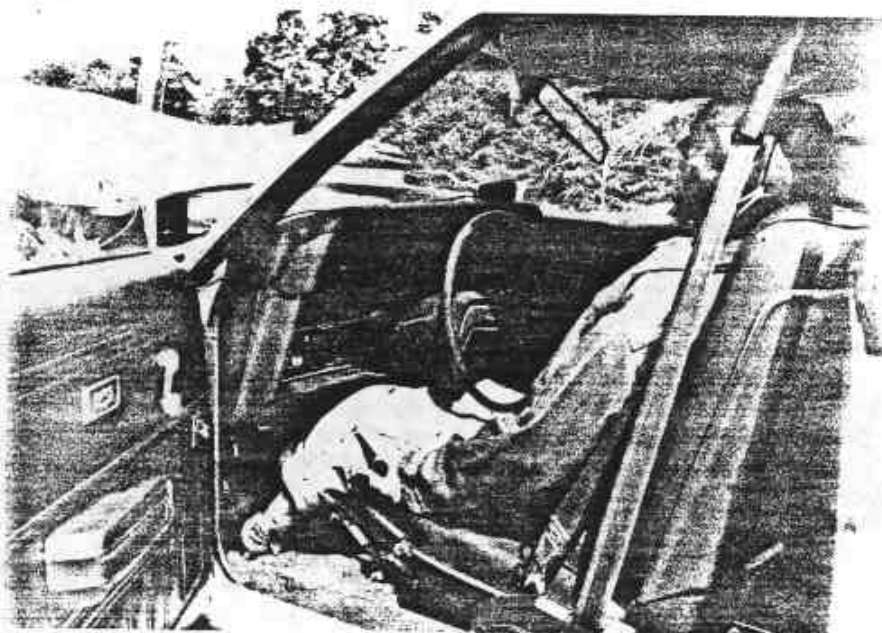
Figure 3-2 Post Test Photograph of Test Vehicle, Side View

Damage to the vehicle occurred in a fairly uniform half-oval shape to the front end, as shown in Figure 3-2 and 3-3. Using the NHTSA vehicle damage measurements shown below in Figure 3-4, the following measurements were made:

Based on the Society of Automotive Engineers recommended practice J224a, "Collision Deformation Classification", the vehicle was rated 12FDEW2. It should be noted that the hood of the vehicle disengaged immediately upon impact with the second barrel and it raised to a vertical position by the fifth barrel row. Since it did not damage the vehicle windshield, this vehicle type is recommended for subsequent large sedan tests under this contract.

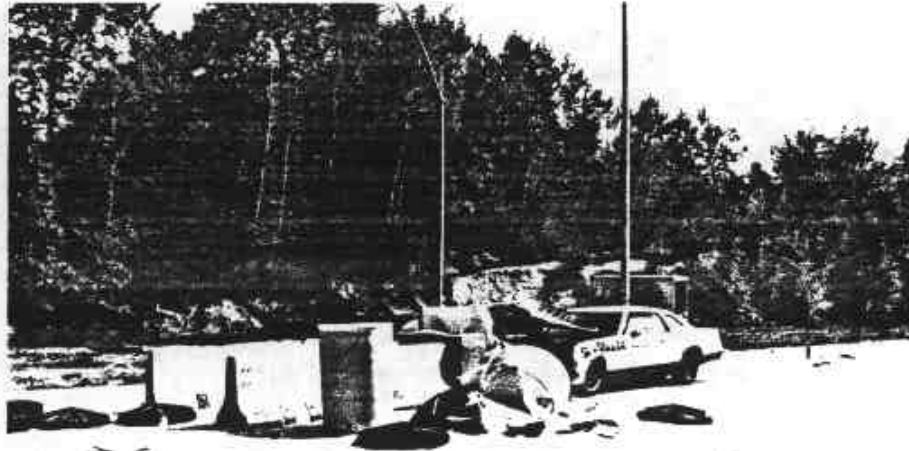
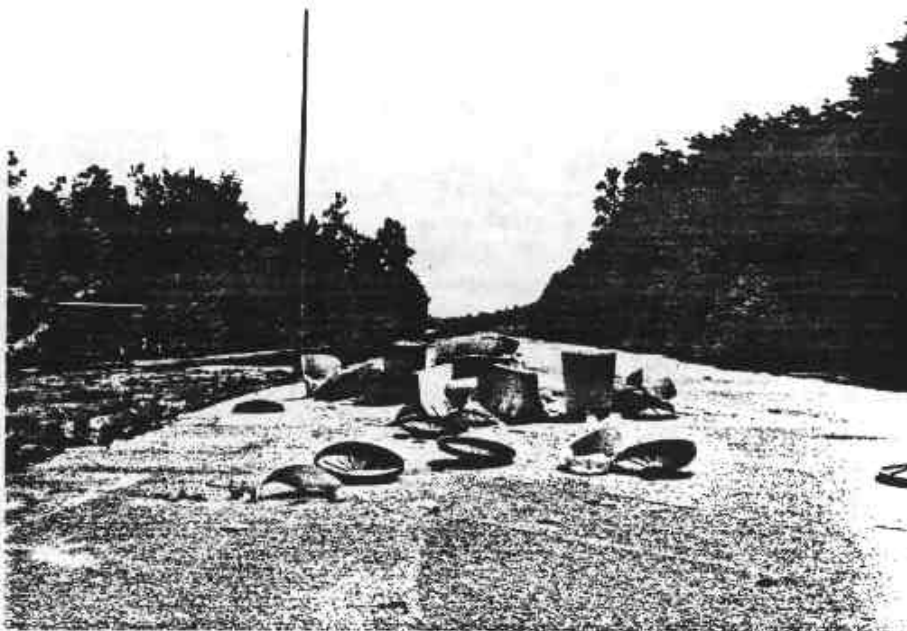
Figure 3-5 Post Test Photograph of Inertial Impact Attenuator,  
Side View

The Energite III system performed exactly as it was designed. Thirteen of the fifteen barrels were ruptured during the impact and pea gravel was thrown a considerable distance. As stated in Section 3.1, barrel fragments and lids were thrown as high as 20 feet and as far as 100 feet. Figures 3-5 and 3-6 are photographs

of the Energite III system after the crash. The pea gravel remained concentrated in a 36' x 37' teardrop shaped area starting from the first row of 1400# barrels. Most of barrels fragments were logged between the vehicle front and the imitation gore face. Two 2100# barrels were left standing approximately 3 feet away from their initial position.
