NEW CAR ASSESSMENT PROGRAM (NCAP)

FRONTAL BARRIER IMPACT TEST

1985 FORD E-150 CLUB WAGON

NHTSA No. CF0630

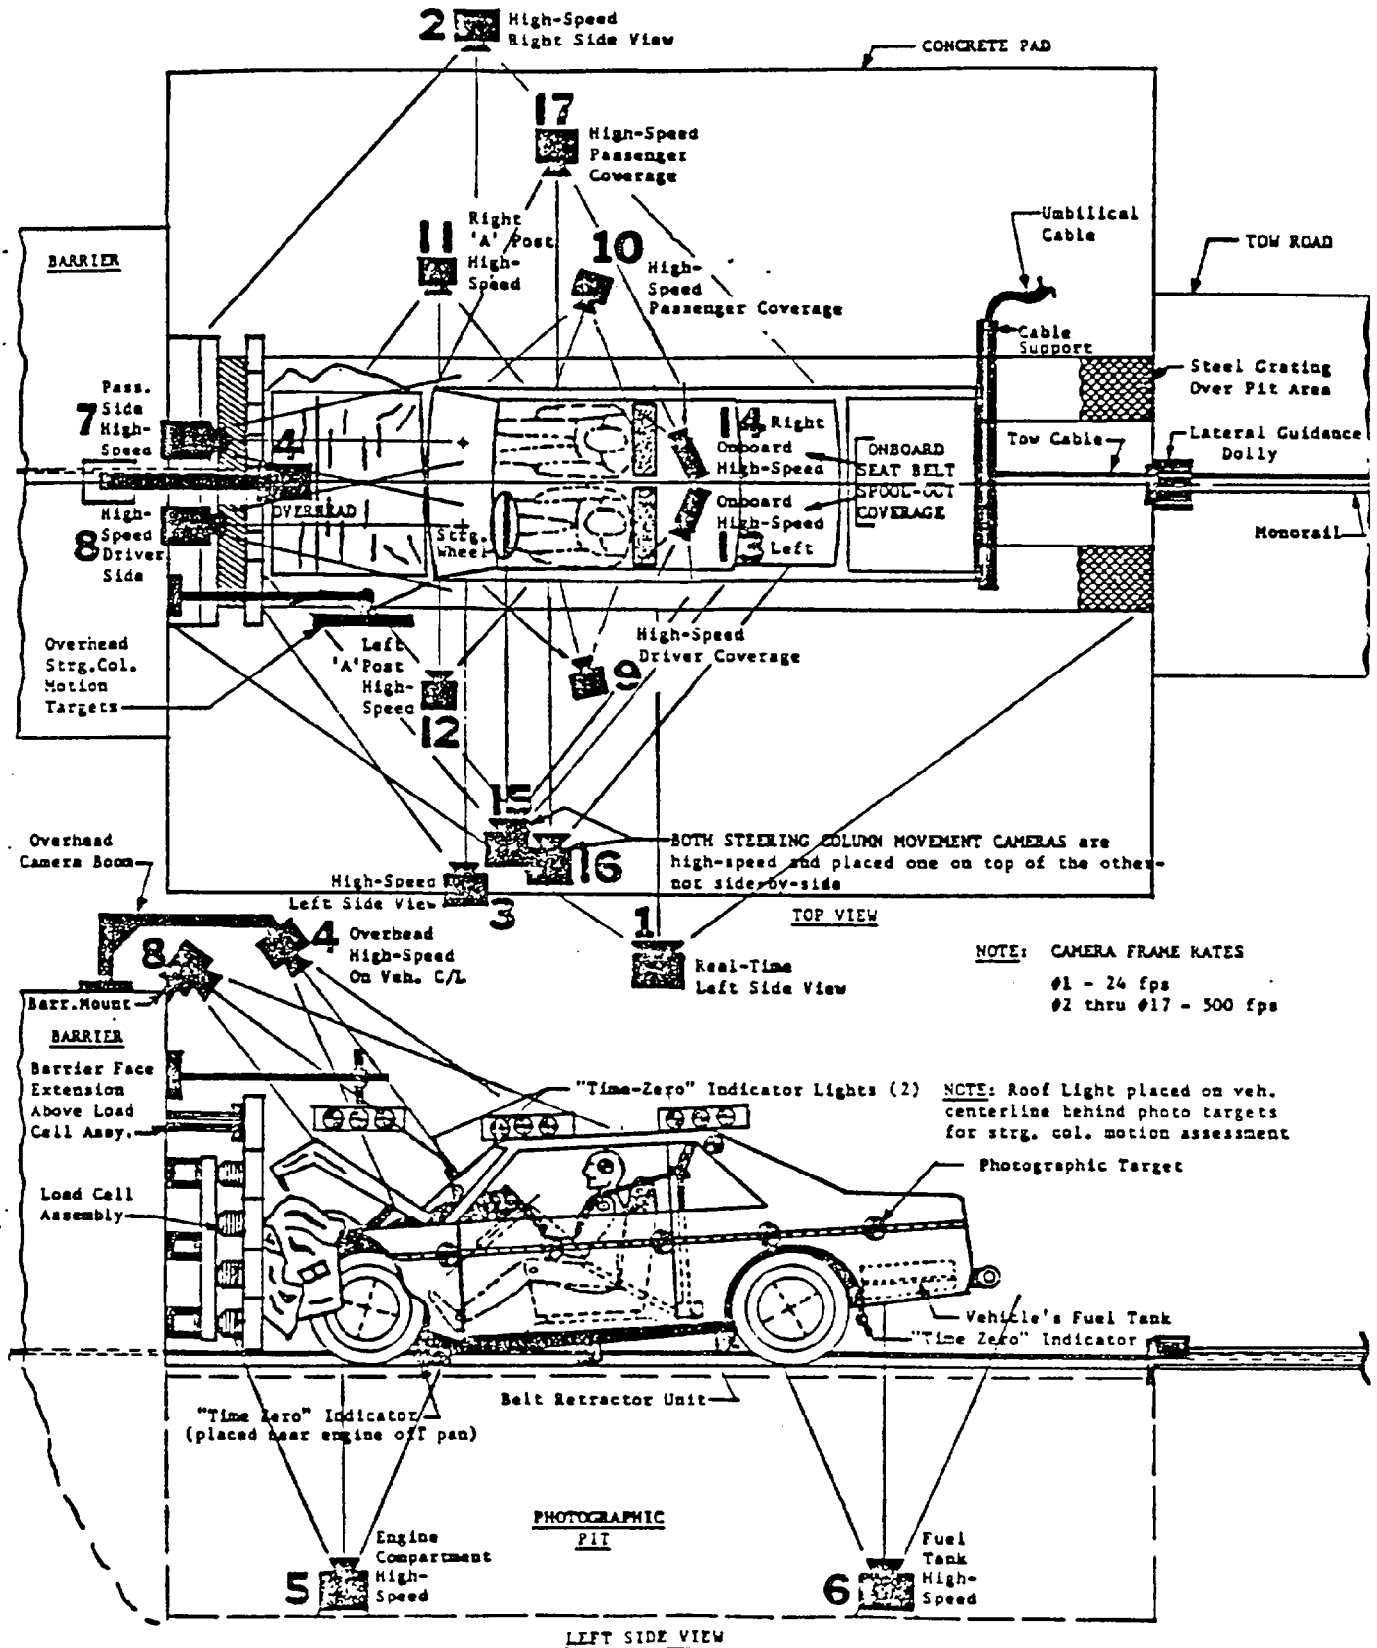
Data Table No. 11 (Con't) Camera Location Data

CAMERA REQUIREMENTS FOR 35 MPH FRONTAL BARRIER IMPACT ASSESSMENT PROGRAM TEST

The frontal impact event was documented by one (1) real time camera and sixteen (16) high-speed cameras. Camera number eleven (11) functioned during the in-run, but the film jammed and the camera stopped prior to the impact event. The camera location data are presented in Table 11.

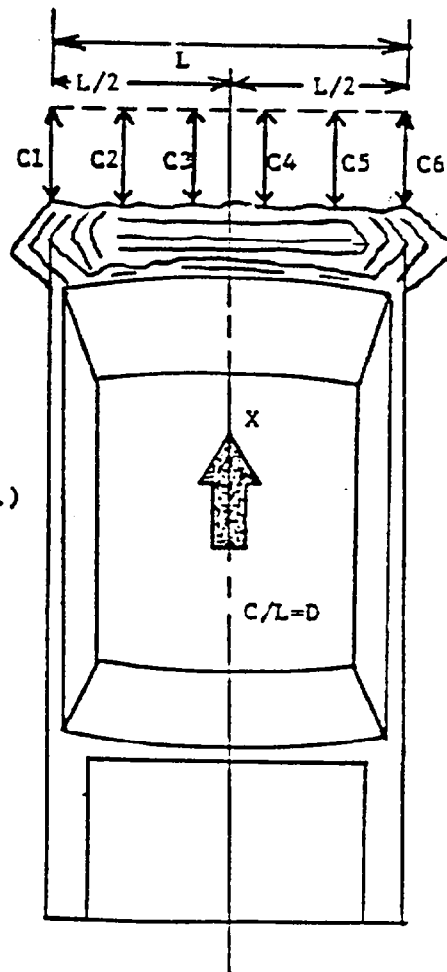
MIDPOINT OF DAMAGE: D = Vehicle Centerline (Longitud.)

LENGTH OF DAMAGED
REGION: L = 71.0 inches

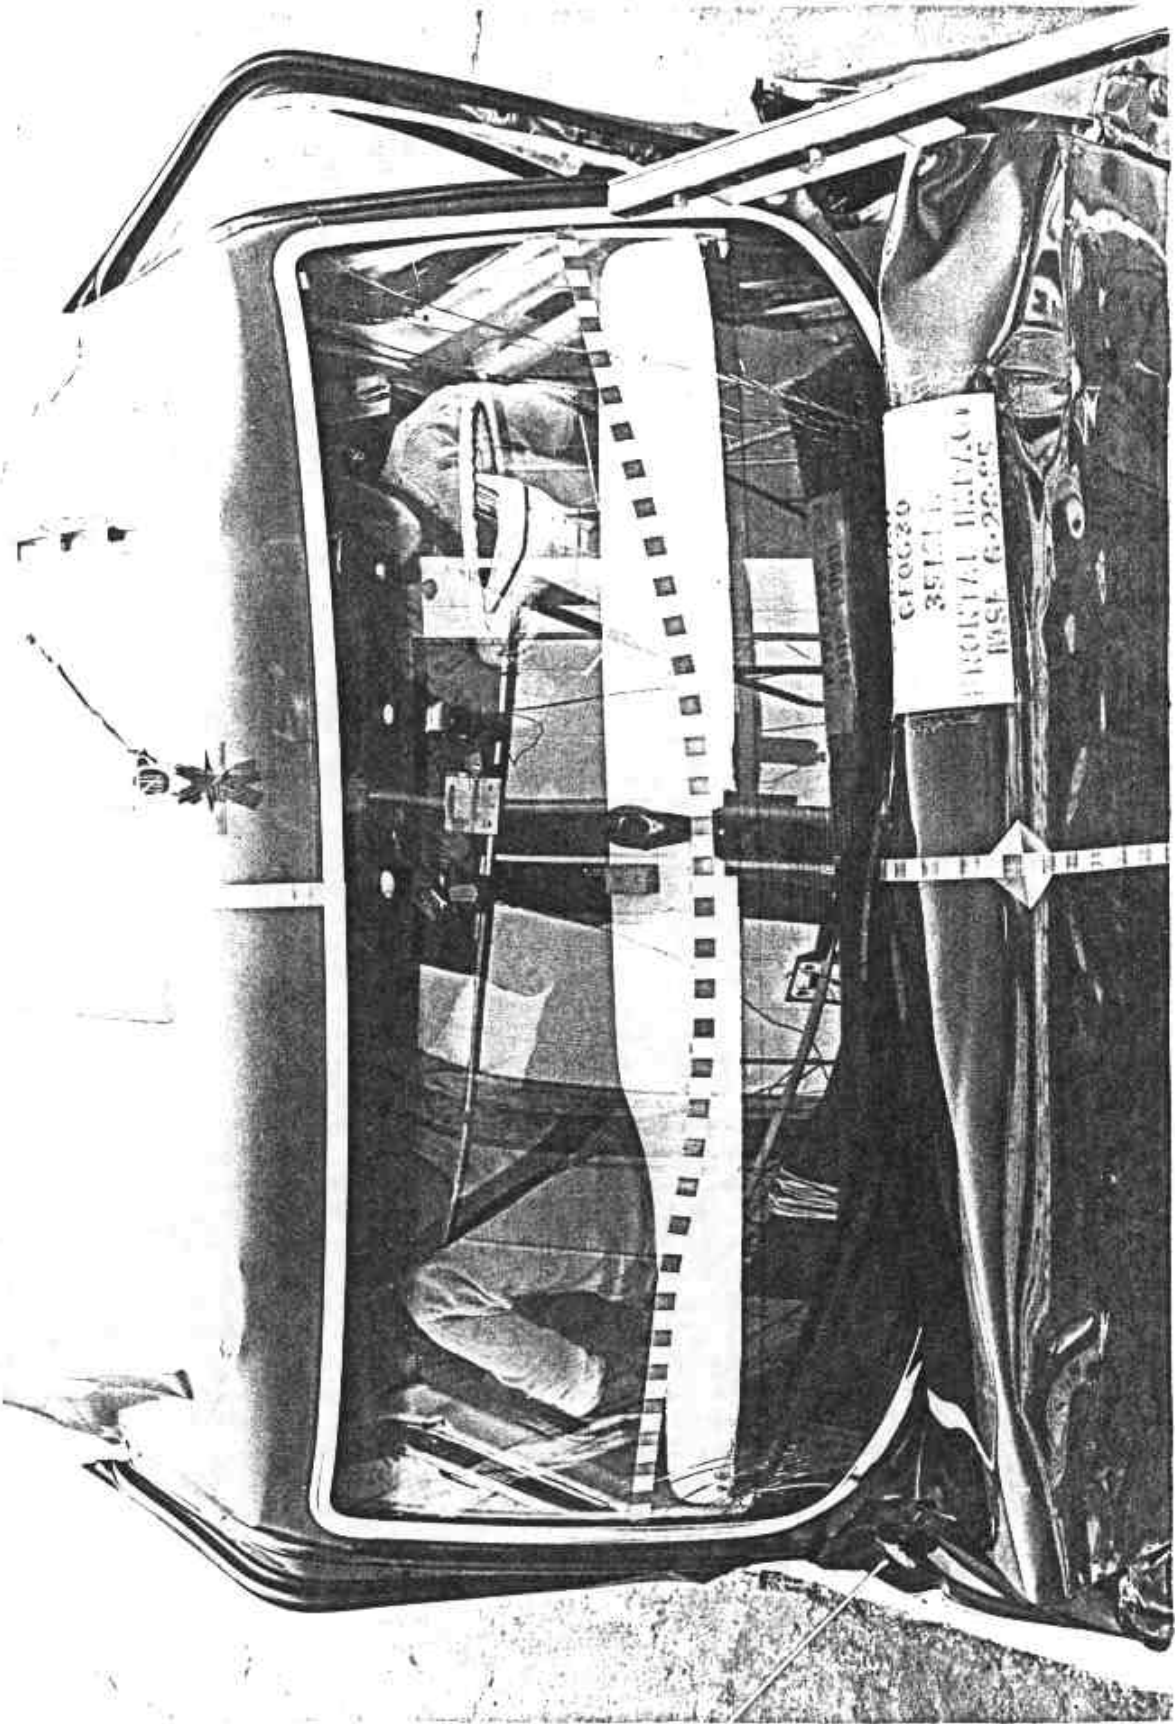
A maximum static crush for the vehicle of 19.5 inches occurred at the center of the front bumper. The windshield was cracked but all vehicle glazing remained intact. Both the driver's and passenger's doors were jammed and required tools to open them.

POST TEST WINDSHIELD VIEW

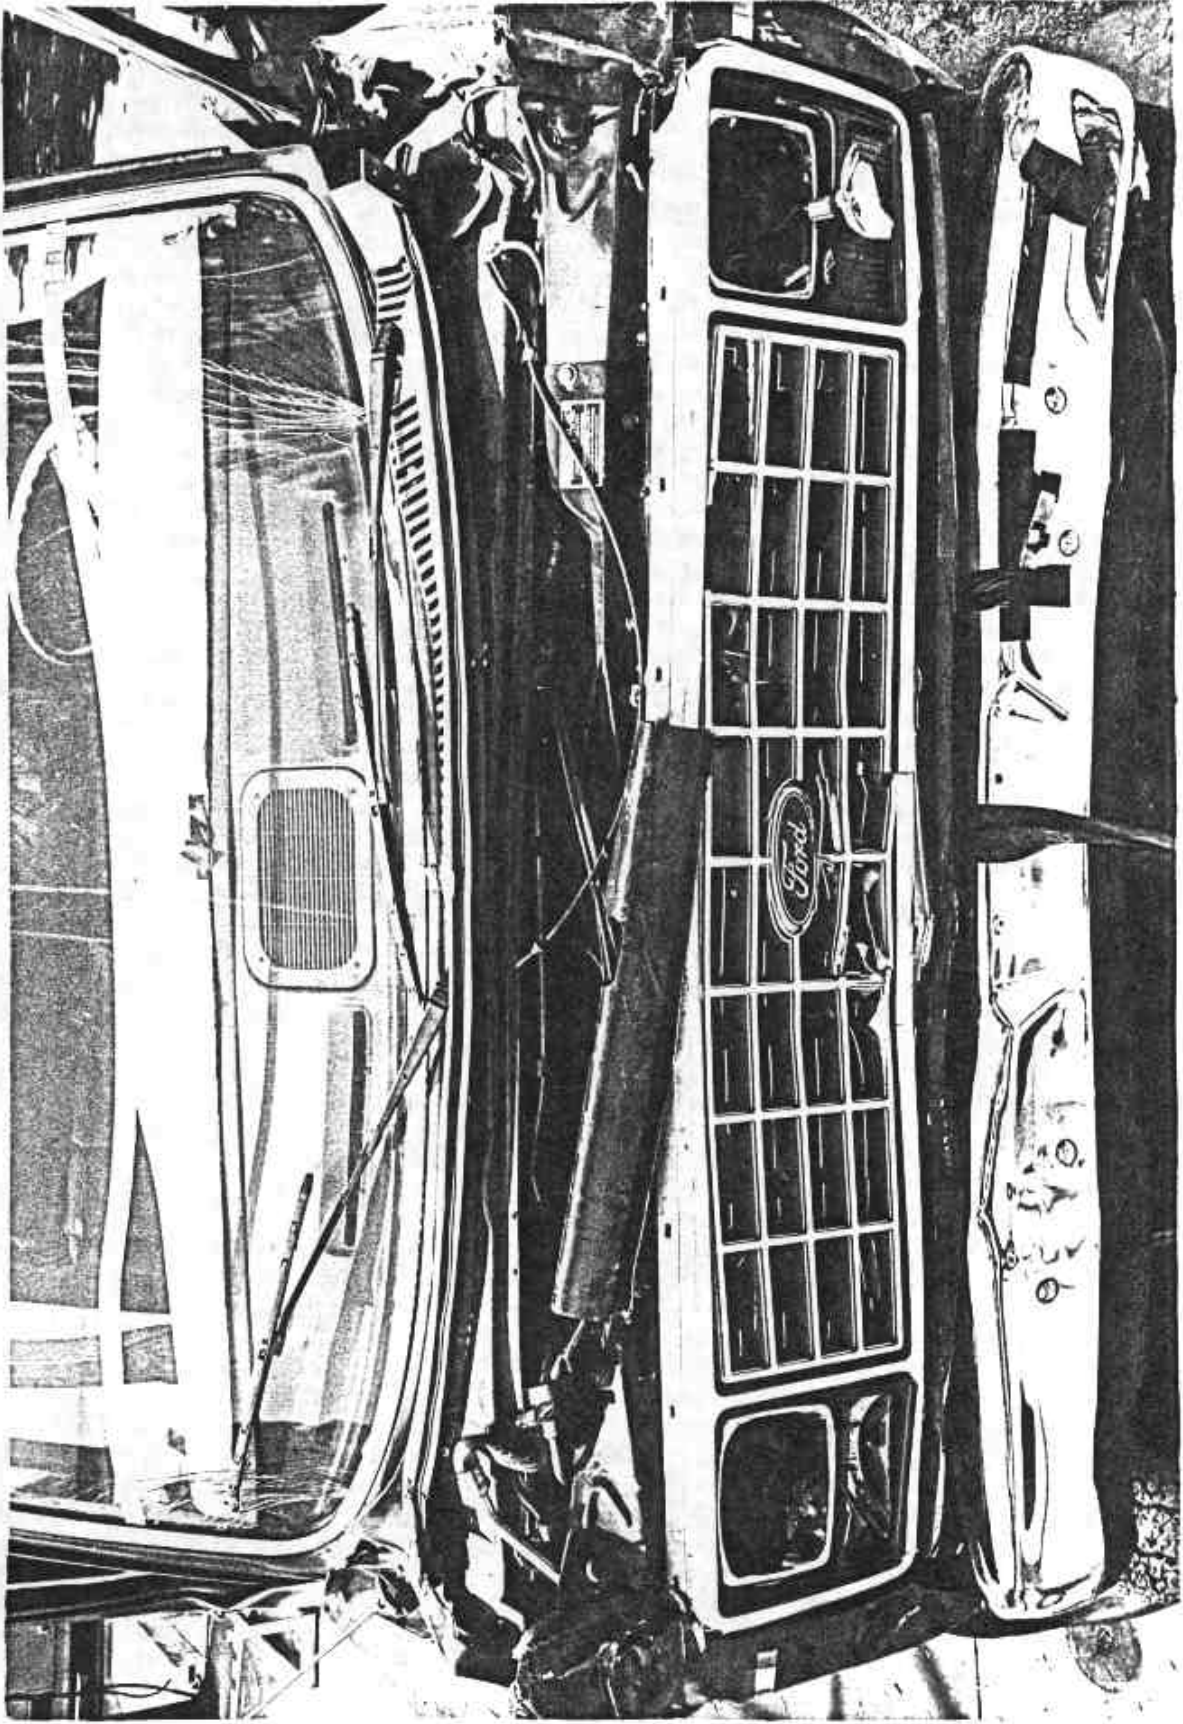
POST TEST ENGINE COMPARTMENT VIEW

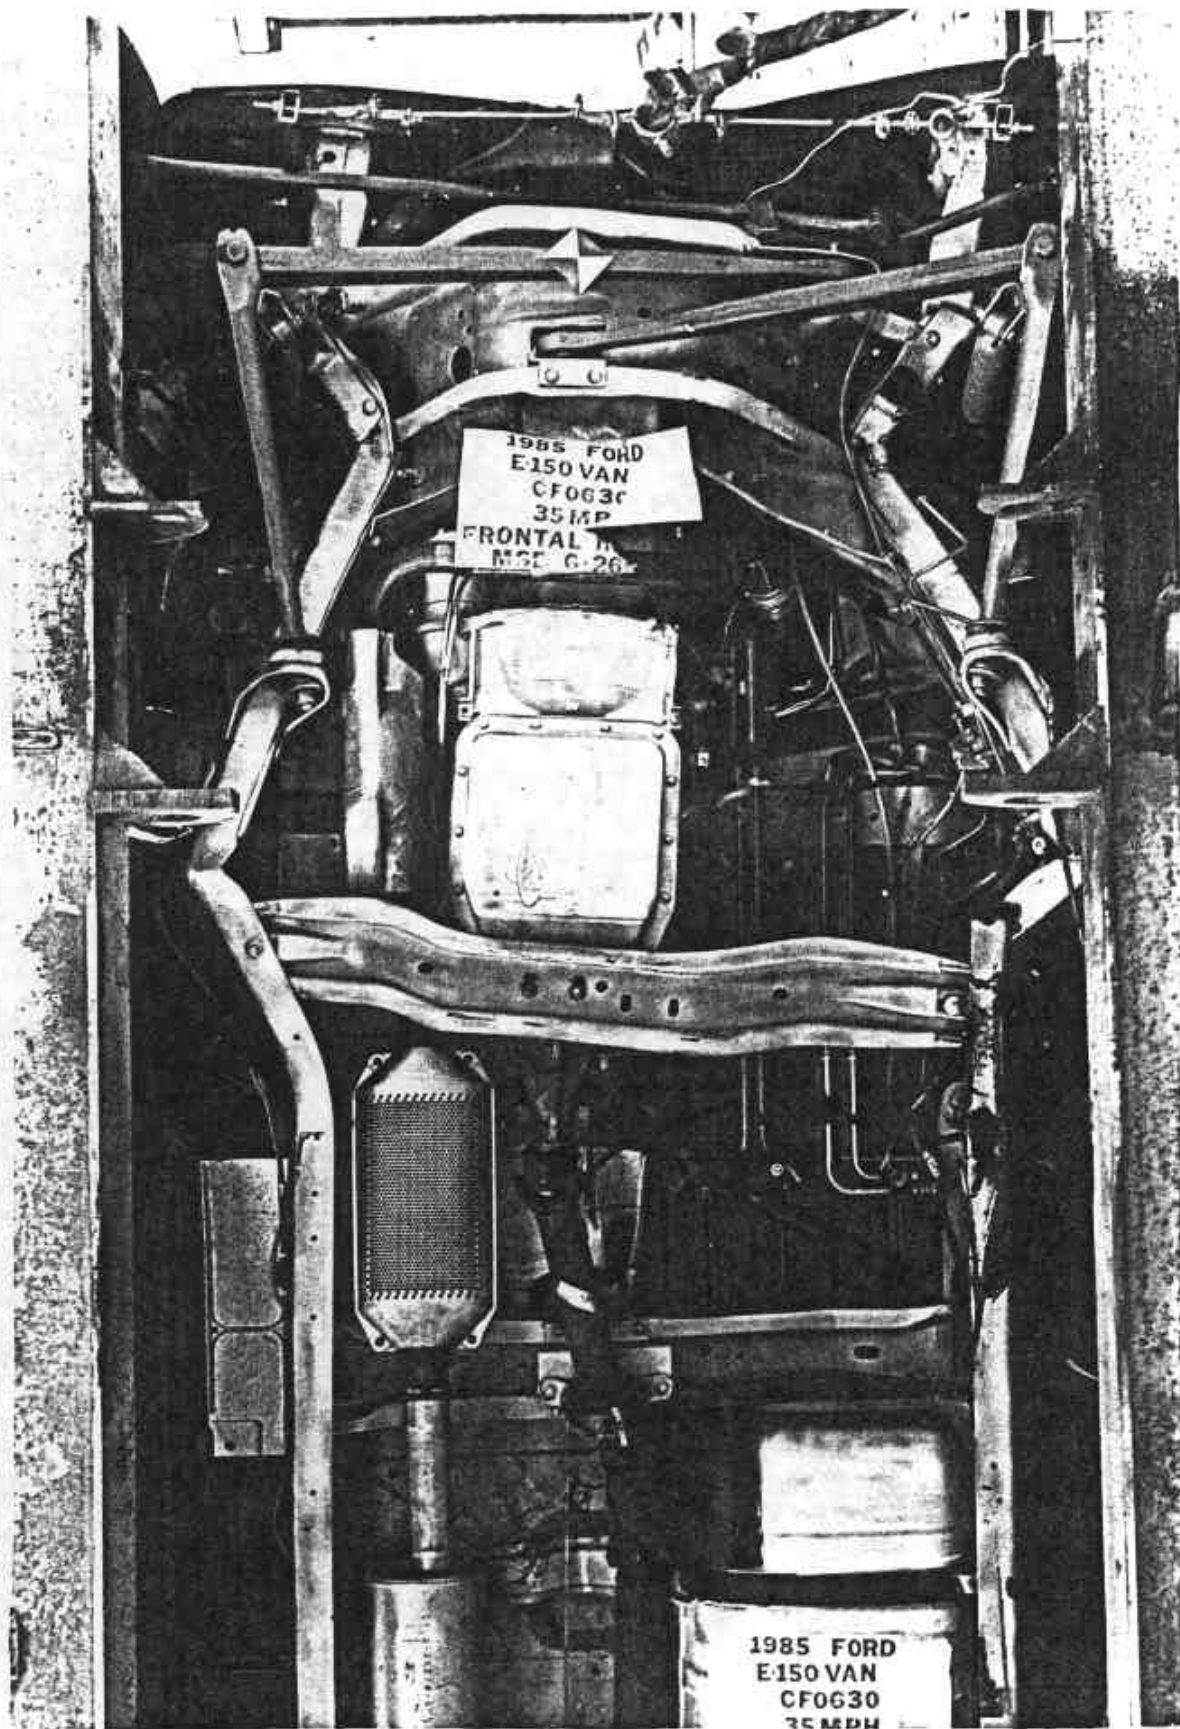
POST TEST FRONT UNDERBODY VIEW

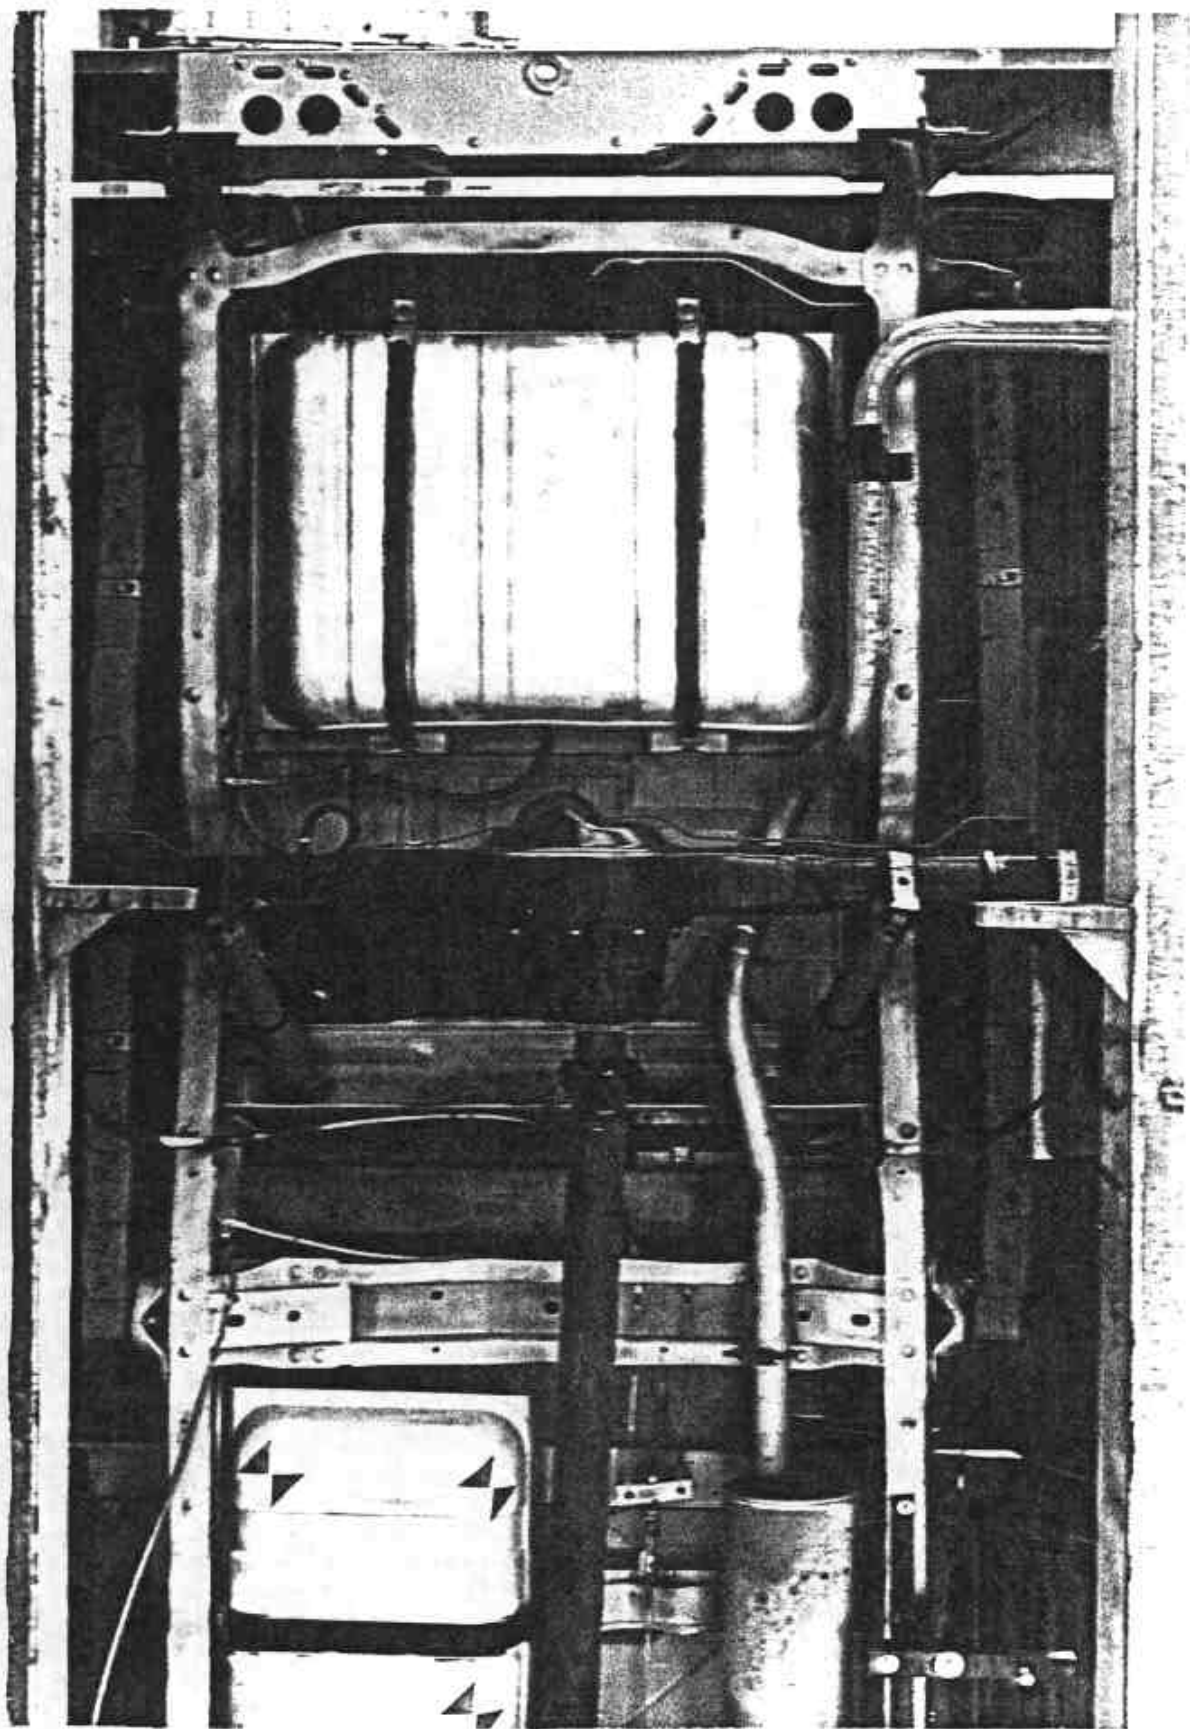
POST TEST REAR UNDERBODY VIEW

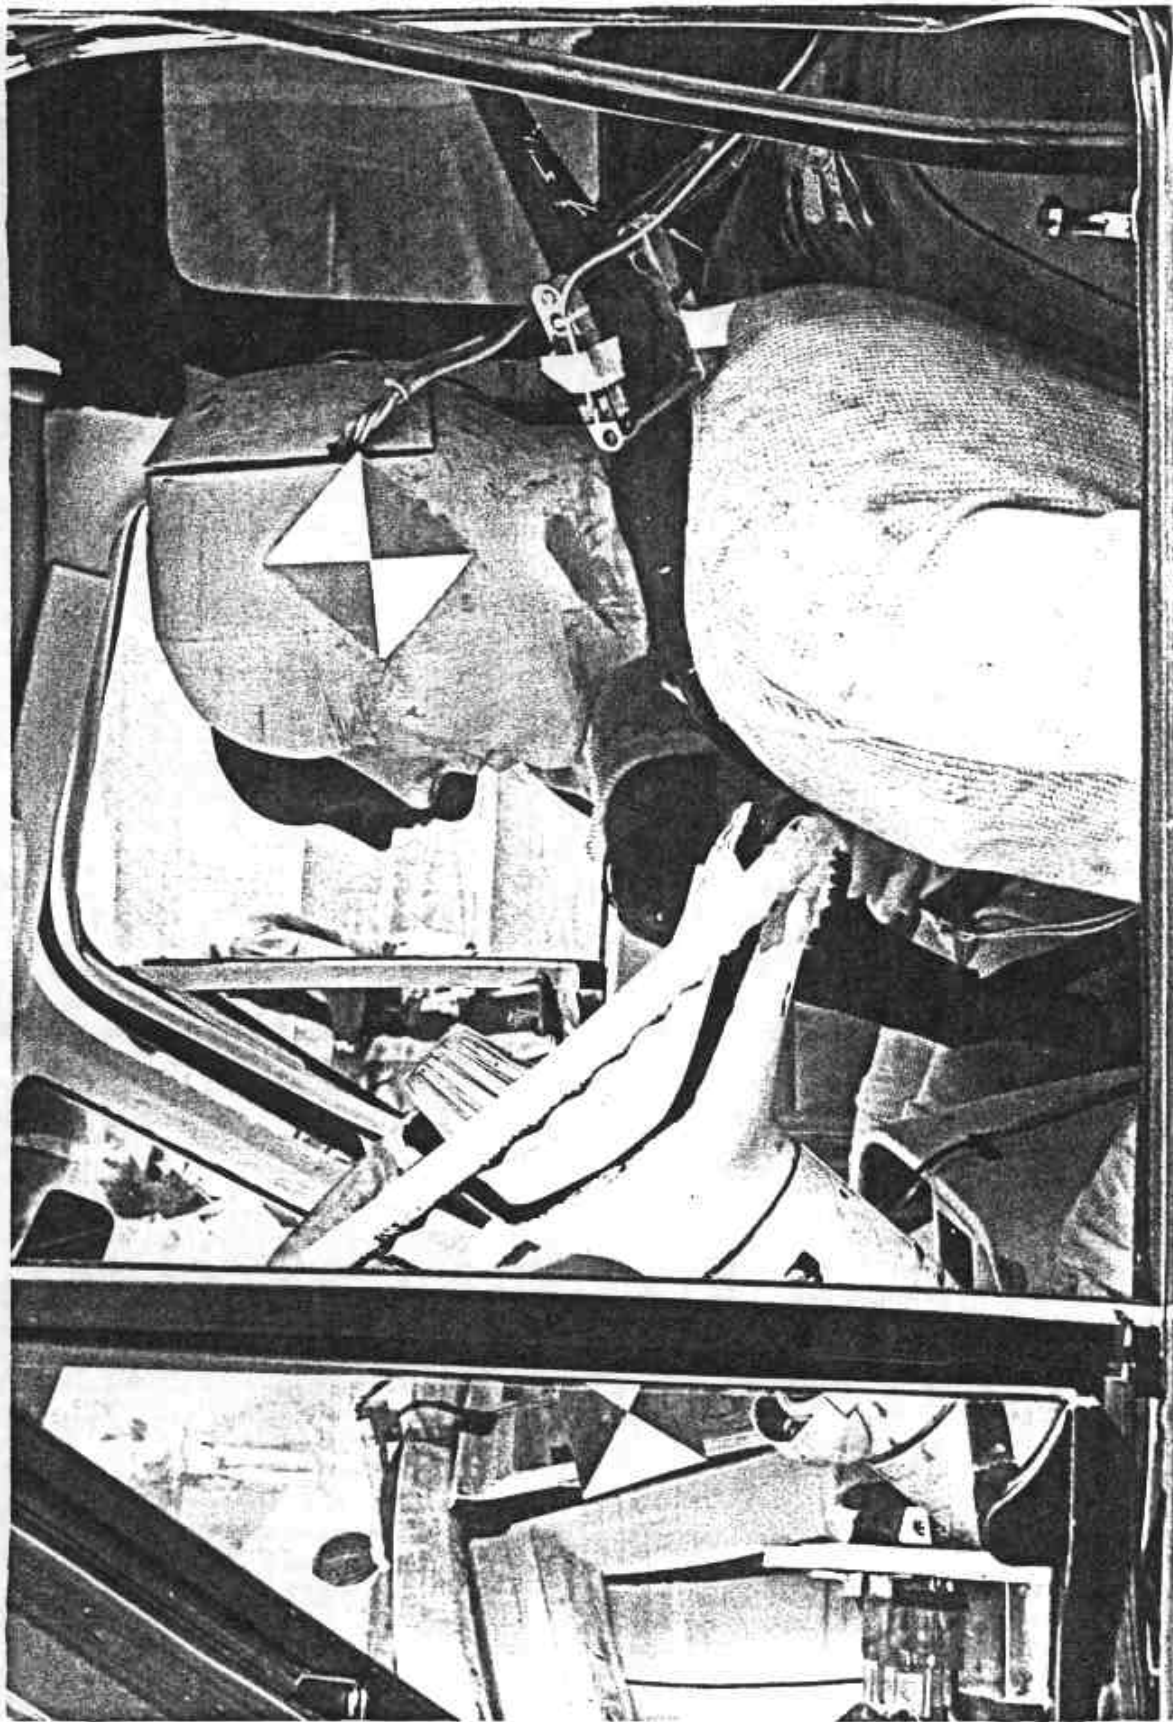
POST TEST DRIVER DUMMY POSITION VIEW

It appears that during the impact, the driver's outboard track latching device failed and the seat shifted forward 1.3 inches on the outboard side; the inboard track had no latching device and the seat shifted forward 1.3 inches on the inboard side. It appears that during the impact, the passenger's inboard track latching device failed and the seat shifted forward 1.8 inches on the inboard side; the outboard track did not have a track latching device and the seat shifted forward 1.8 inches on the outboard side.

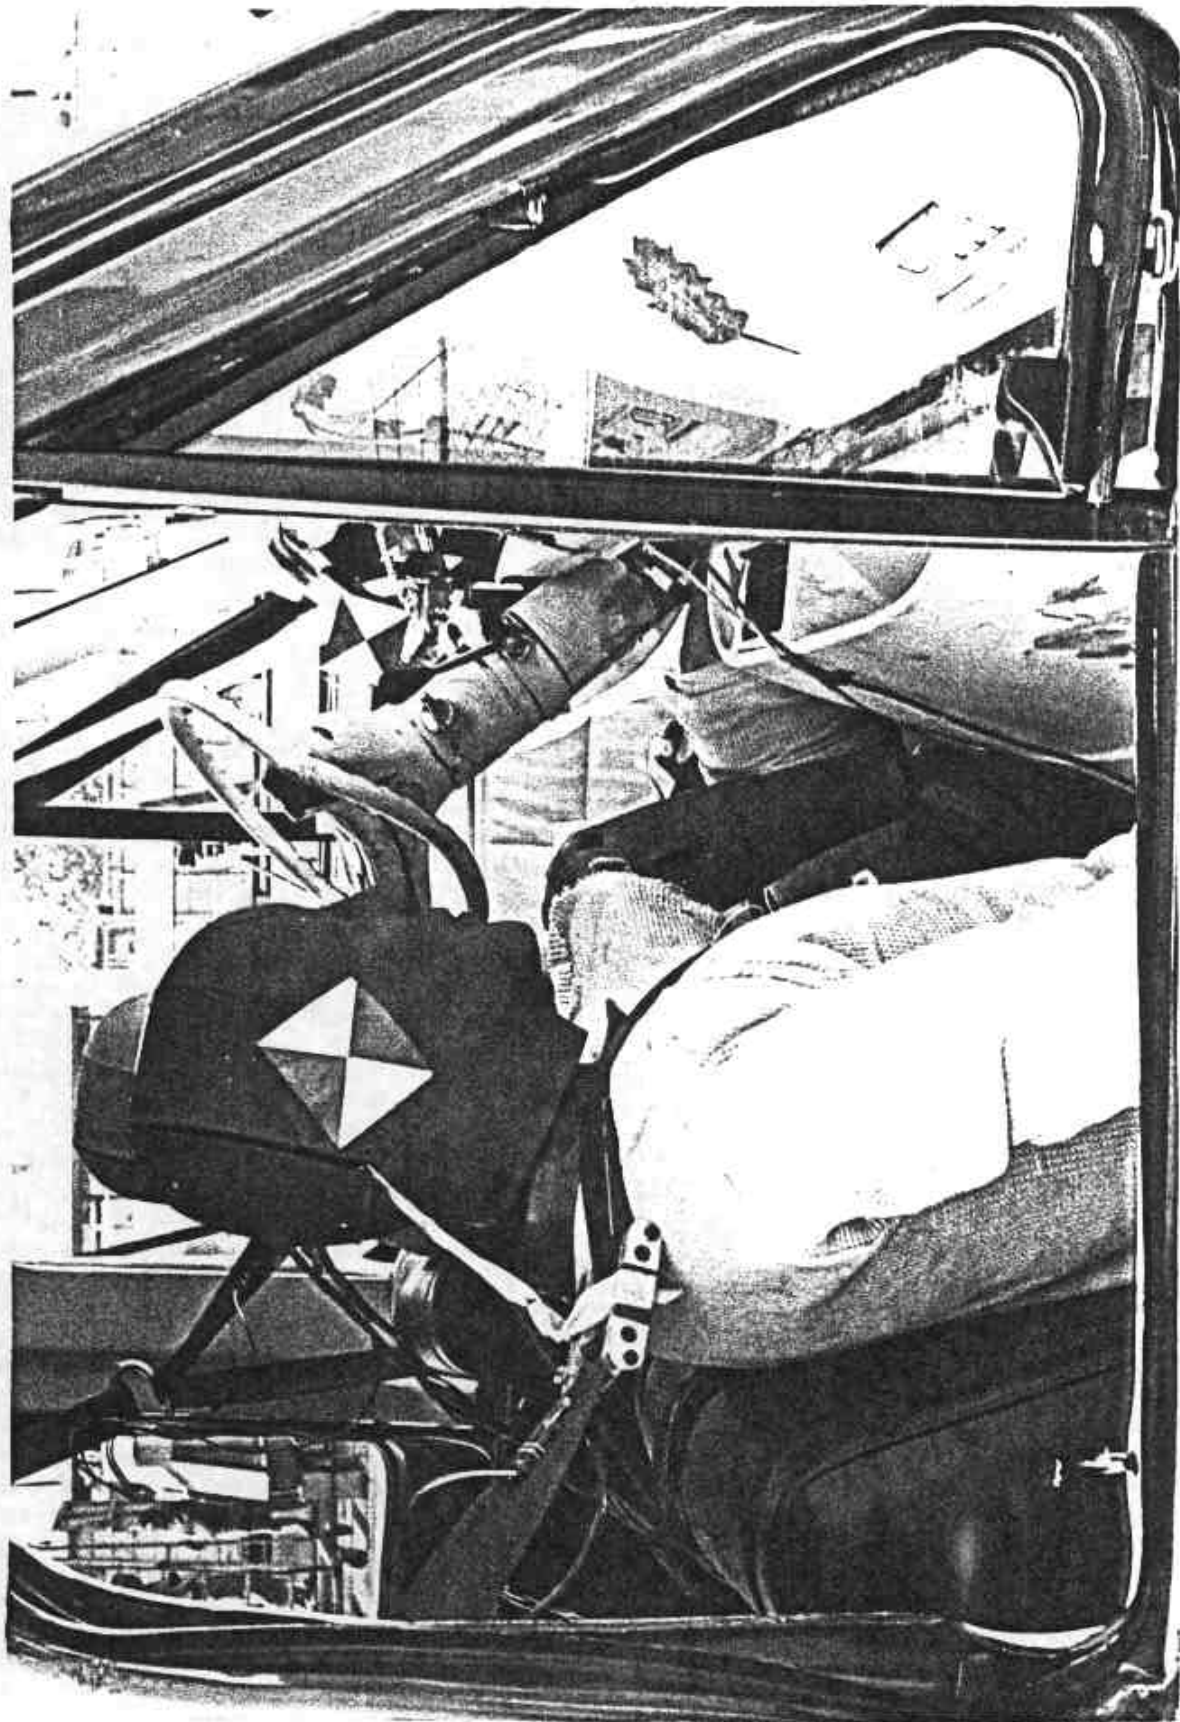
POST TEST PASSENGER DUMMY POSITION VIEW

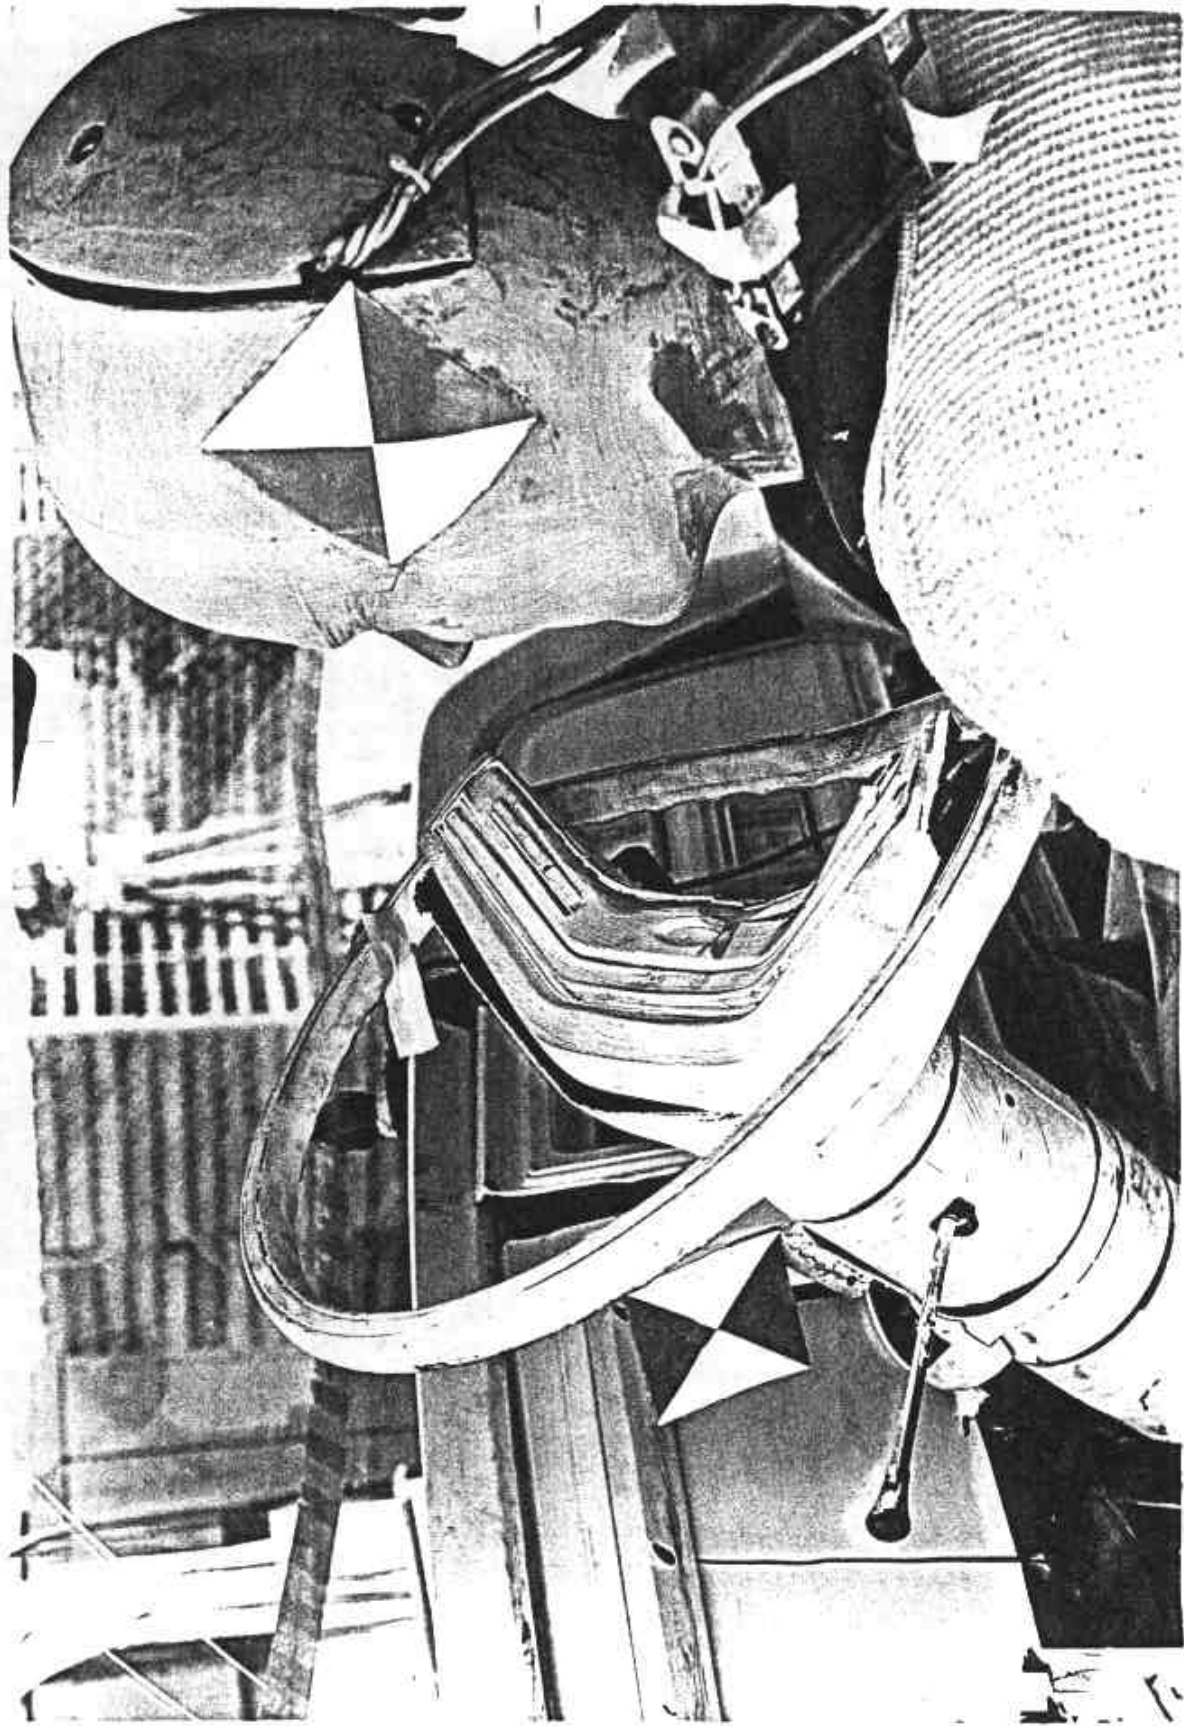
The driver ATD's head hit the steering wheel lower rim and the center hub. His knees hit the dash panel, and his right knee also hit the steering column. The driver ATD had a HIC value of

POST TEST STEERING COLUMN HUB/R/HI CONTACT BY DUMMY DRIVER

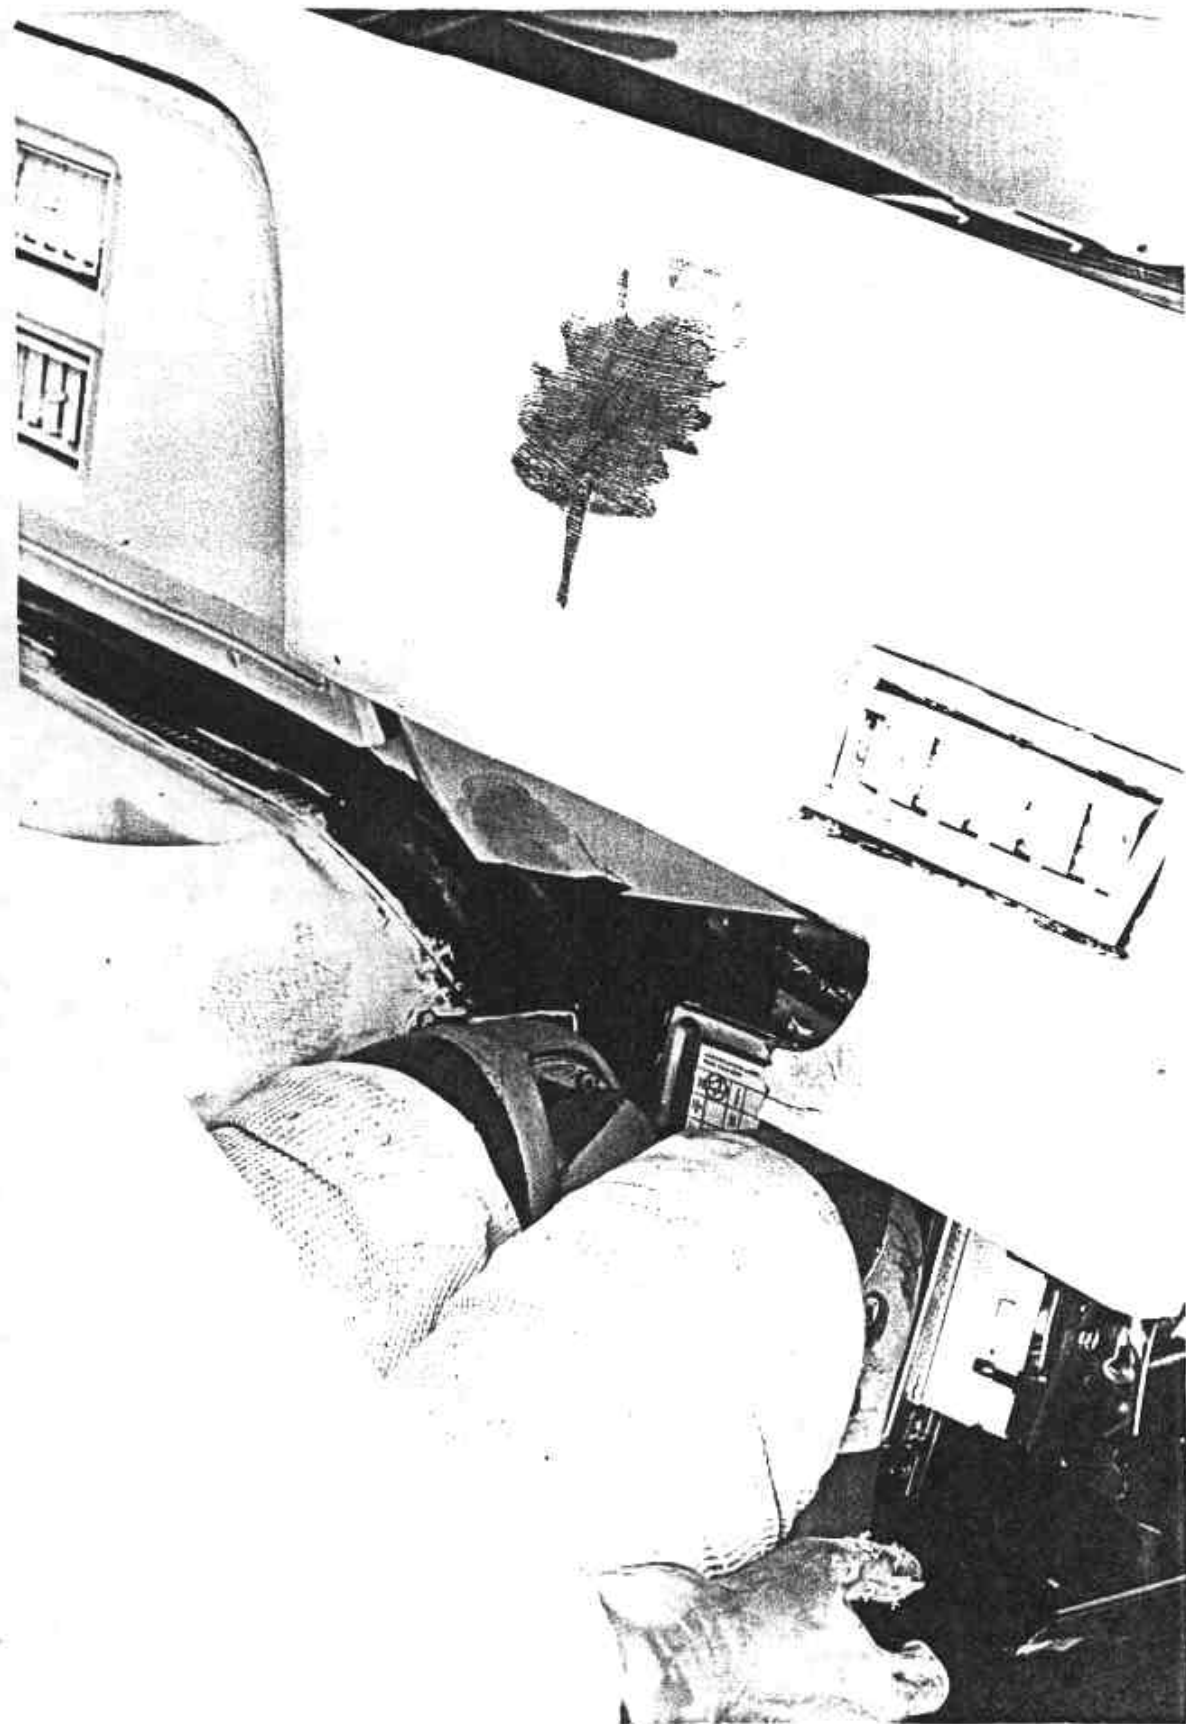
The passenger ATD's head hit the dash panel. Both of his knees hit the glove box door. The HIC value for the passenger ATD was 1198; maximum chest acceleration (resultant clipped) was 50.0 g; maximum femur loads were 1065 and 1806 pounds.

POST TEST PASSENGER DUMMY HEAD/KNEE CONTACT

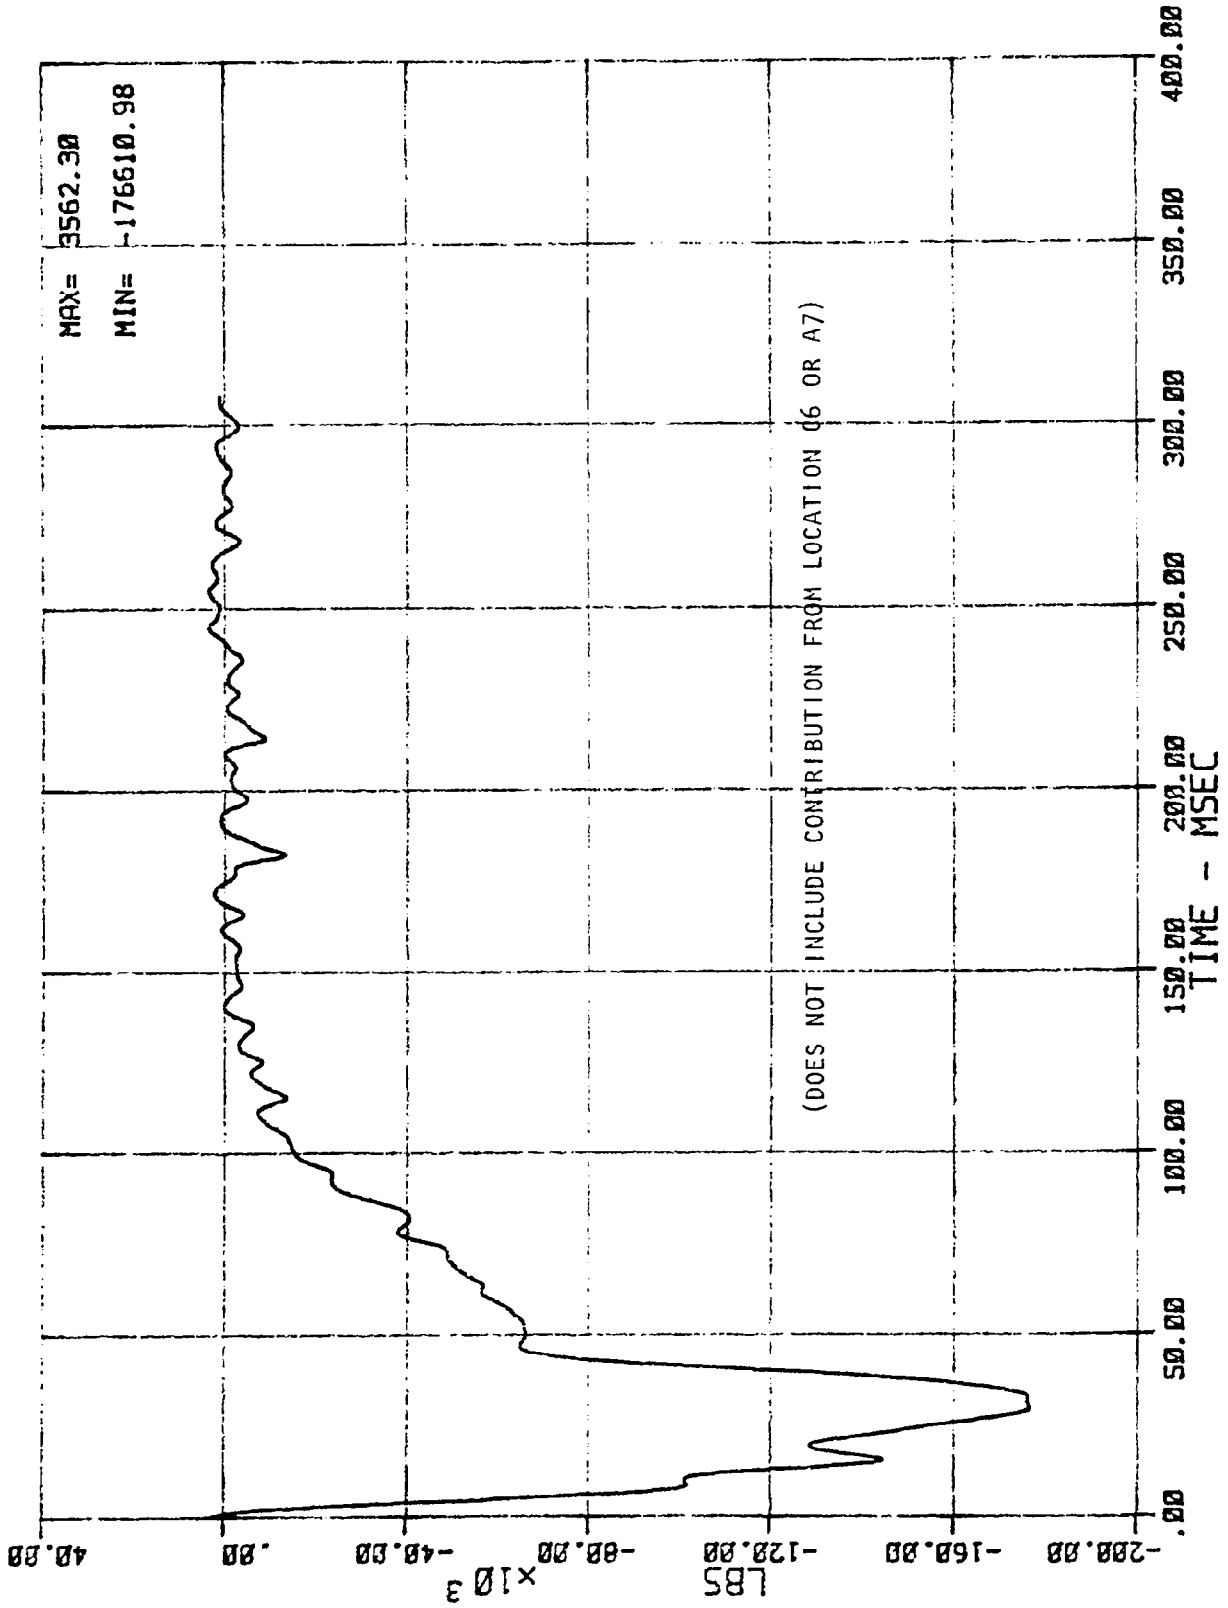
NOTE: No data was recorded from load cell locations A7 and C6 which had active load cells installed. Thus the sum data do not reflect the true total load for the affected groups (Group 2 and Group 6). The A7 location probably did not experience significant loads in this test. However, C6 does see a significant load which is not included.

TOTAL SUM, LOAD CELL BARRIER FORCE
MSE N02055 1985 FORD E-150 CLB VGN 06/26/85
