MVMA SIDE IMPACT TESTING

MDB-TO-CAR SIDE IMPACT TEST OF
A 26° CRABBED MOVING DEFORMABLE BARRIER
TO A 1985 FORD LTD
AT 33.6 MPH

TEST REPORT

TEST NO.: 850529

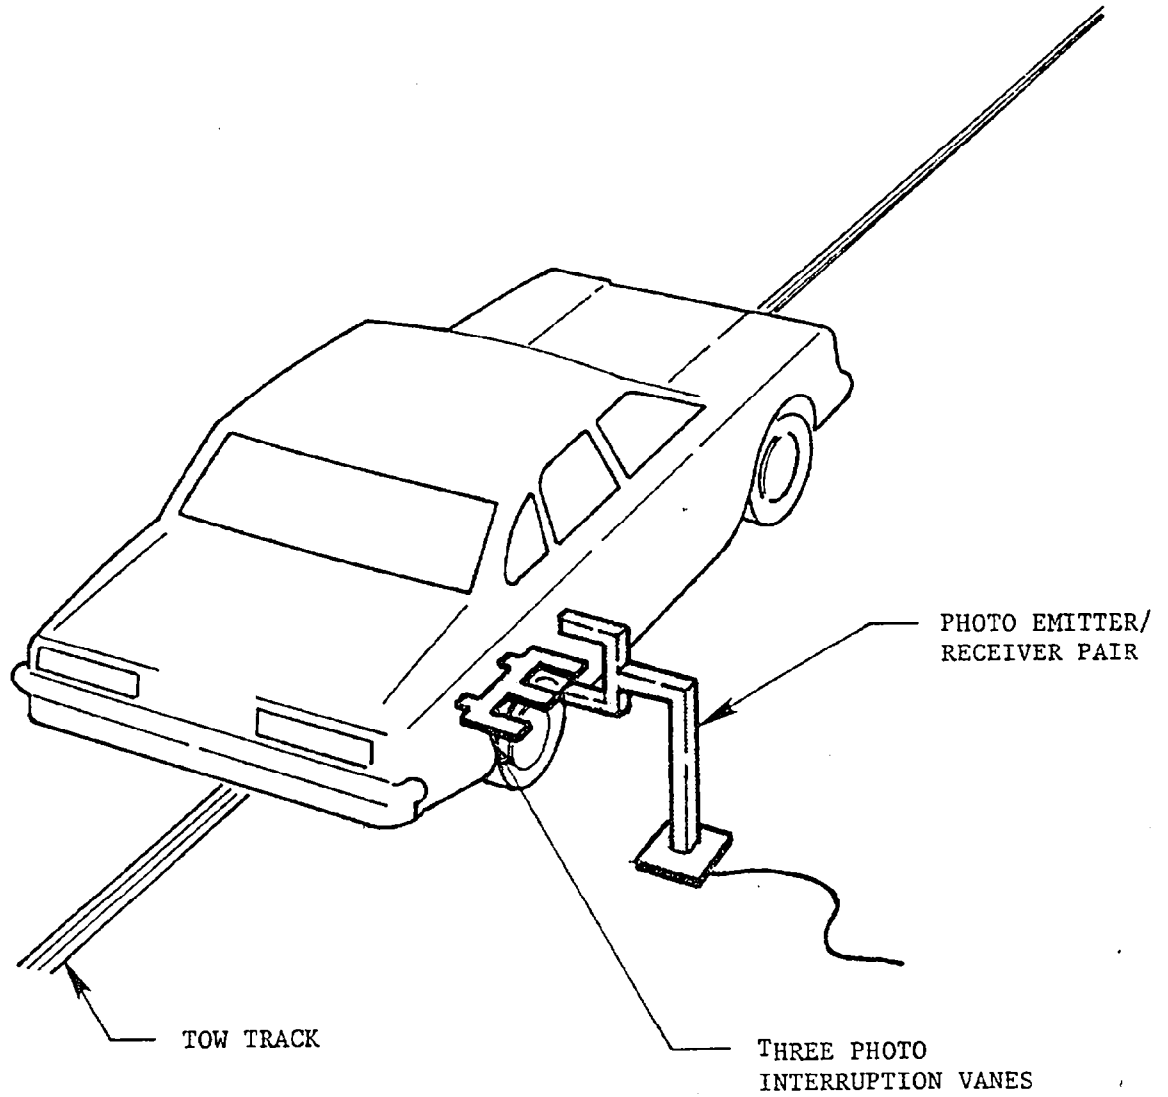
IMPACT VELOCITY MEASUREMENT SYSTEM

The final vane clears emitter/receiver two inches before impact.

The vanes have one foot spacing.

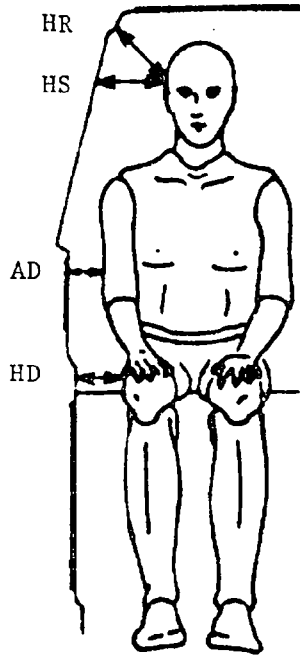
DUMMY LATERAL CLEARANCE DIMENSIONS

PASSENGER

HR	4 3/8
HS	4 3/4
AD	0
HD	1

ALL MEASUREMENTS IN INCHES

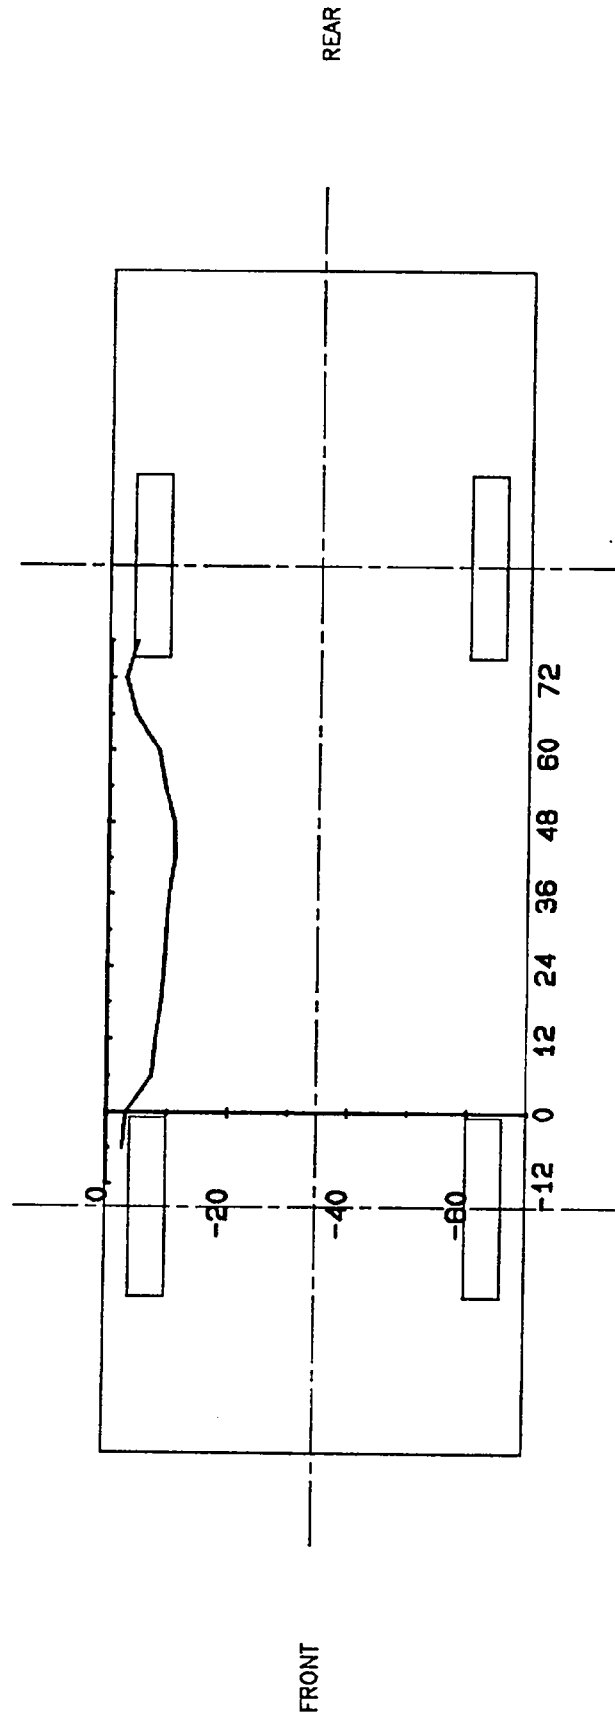
VEHICLE EXTERIOR STATIC CRUSH PROFILE

PROFILE LEVEL EQUALS WINDOW SILL HEIGHT WHICH IS 35.6" ABOVE GROUND LEVEL
(0,0) EQUALS PROJECTED IMPACT POINT
SCALE FACTOR EQUALS 0.033

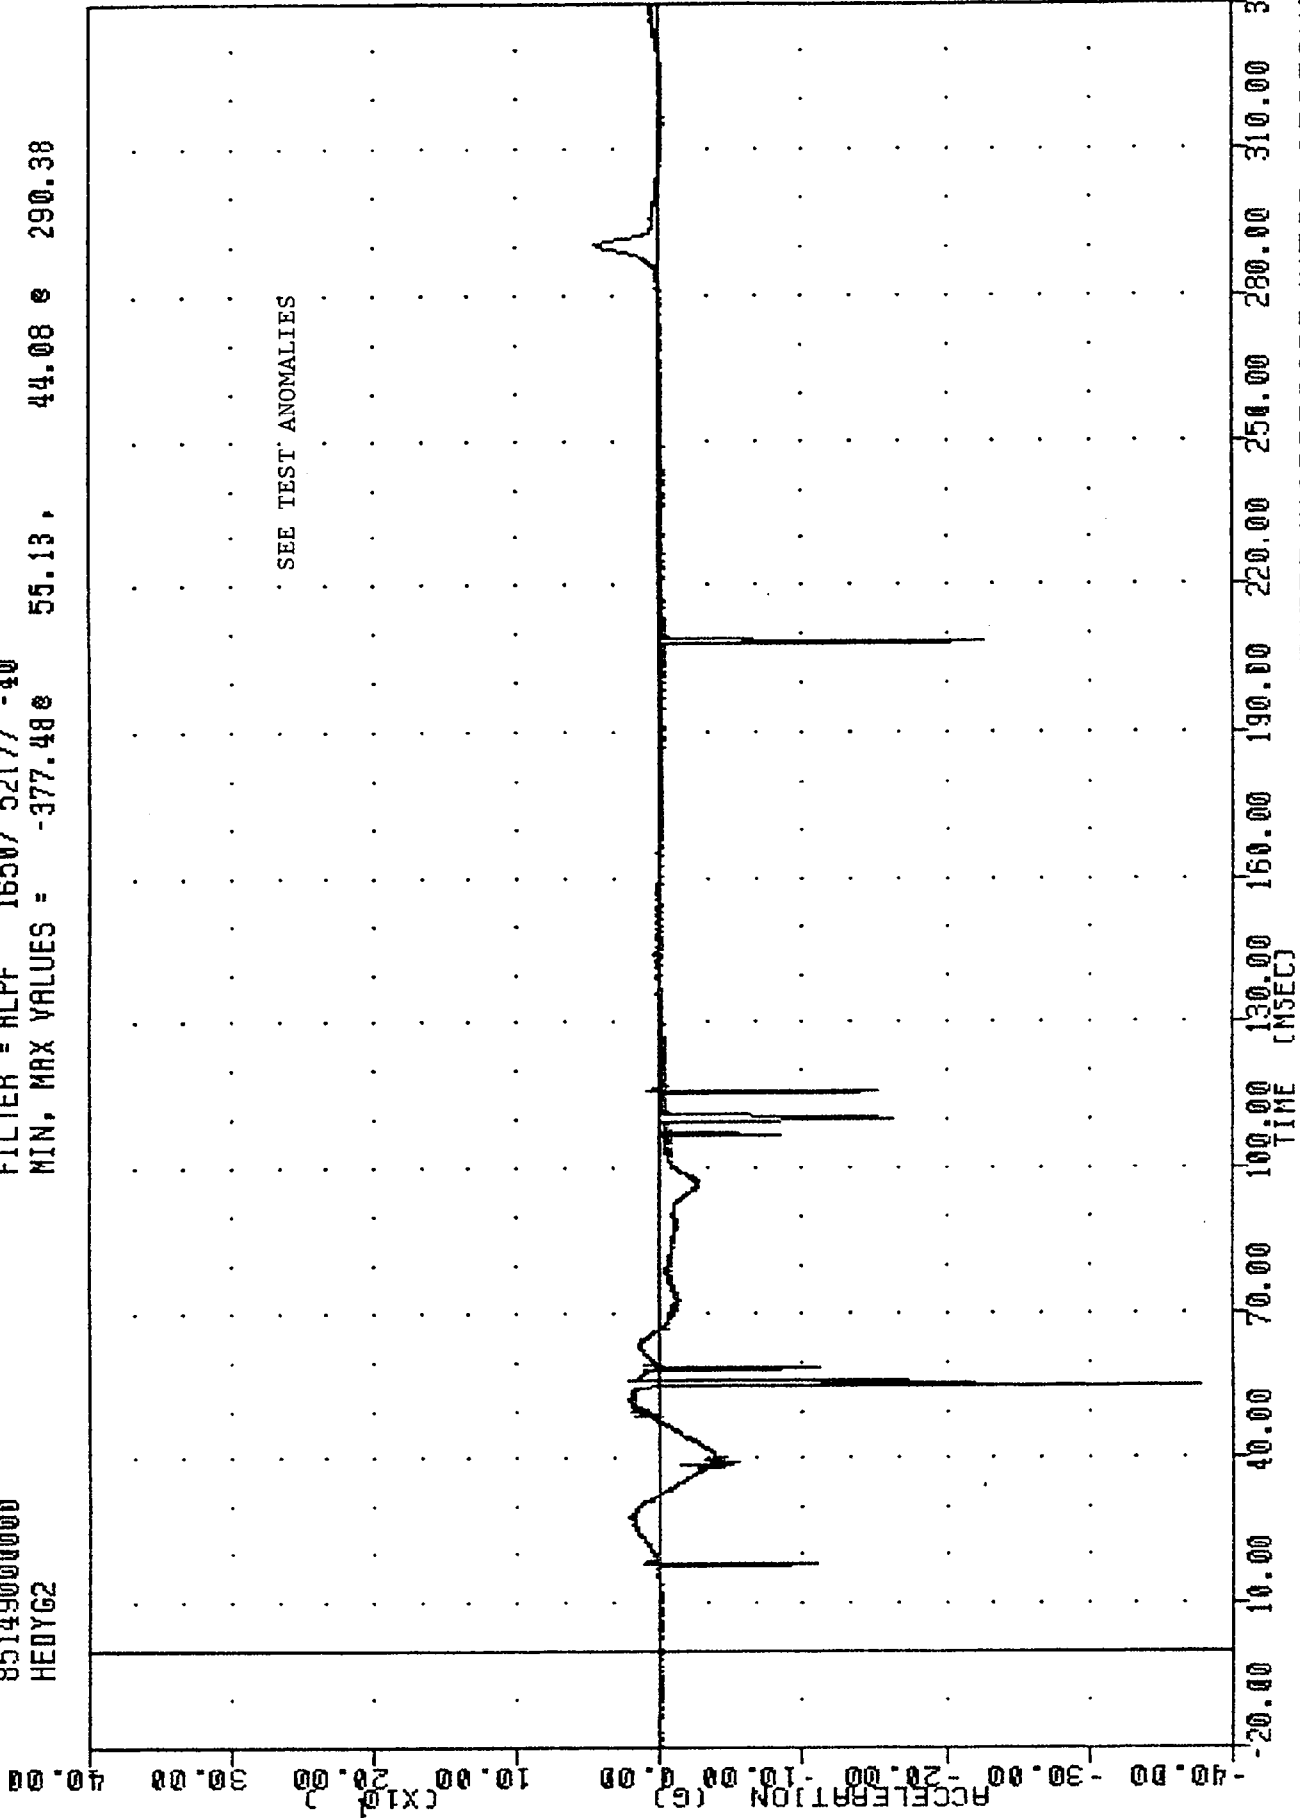
MVMA SIDE IMPACT TEST -- BASELINE STRUCTURE/HARDBOARD/NEAR SEATING
PASSENGER HEAD ACCELERATION Y AXIS

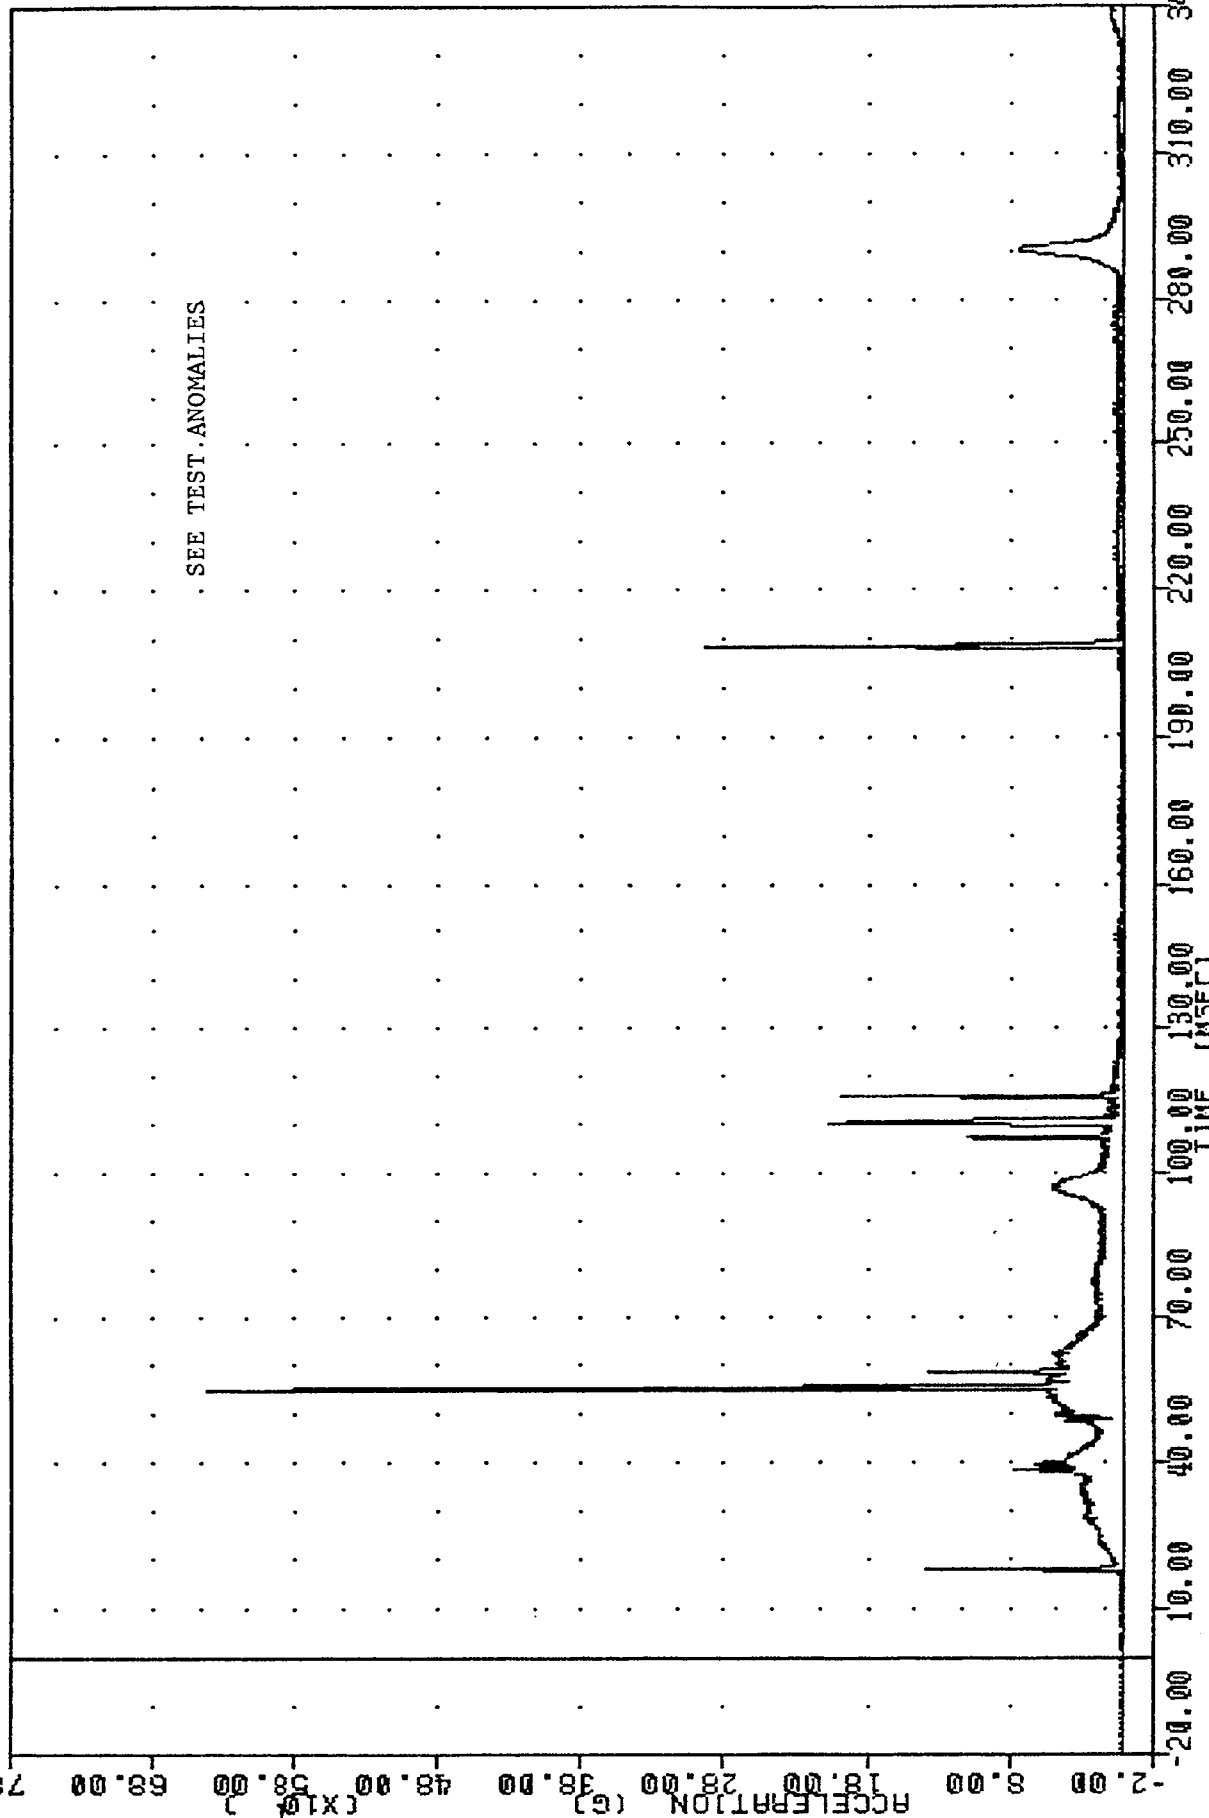
MVMA SIDE IMPACT TEST -- BASELINE STRUCTURE/HARDBOARD/NEAR SEATING
PASSENGER HEAD RESULTANT ACCELERATION

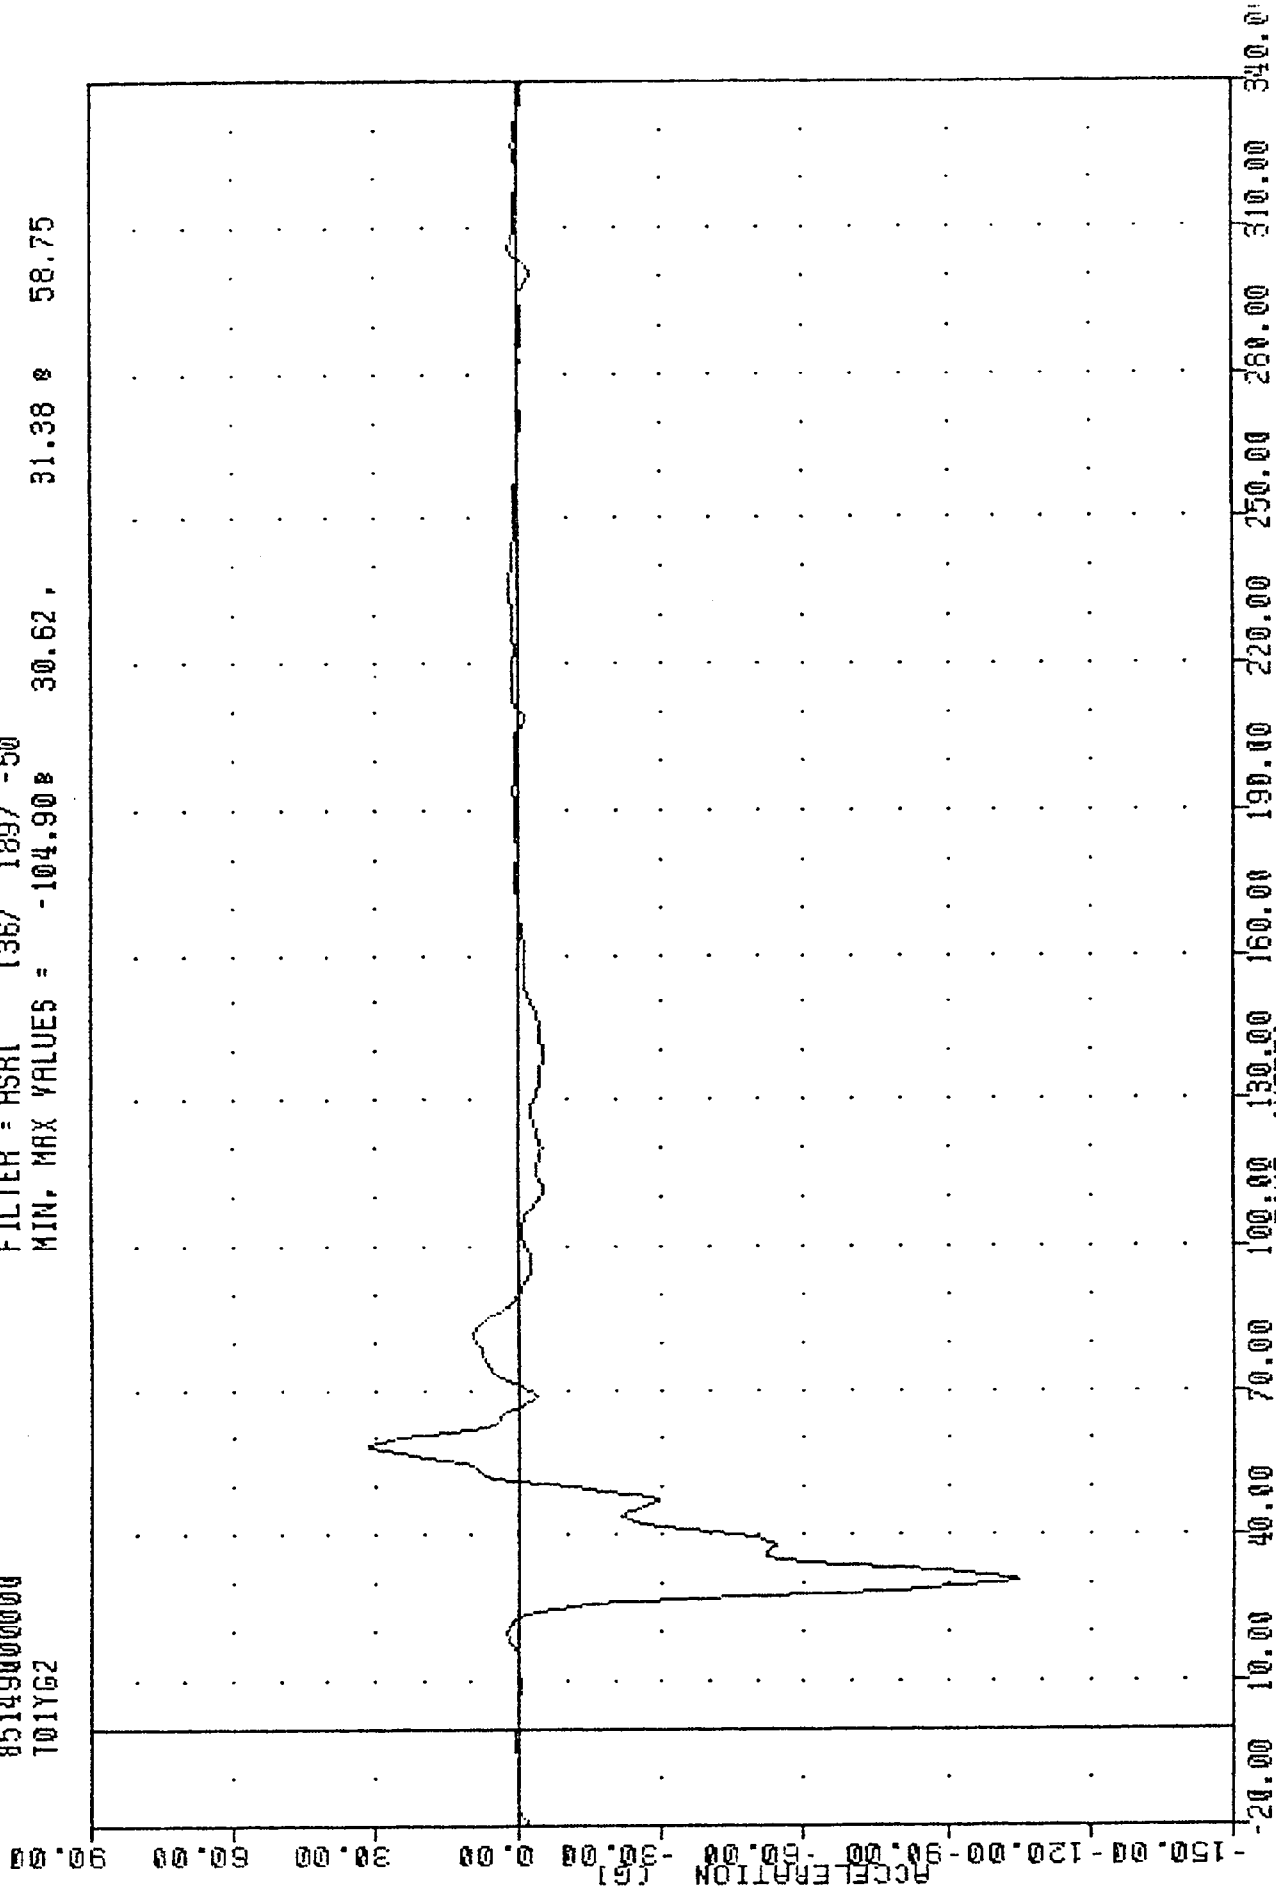
NYMA SIDE IMPACT TEST -- BASELINE STRUCTURE/HARDBOARD/NEAR SEATING
PASSENGER UPPER SPINE ACCELERATION Y AXIS

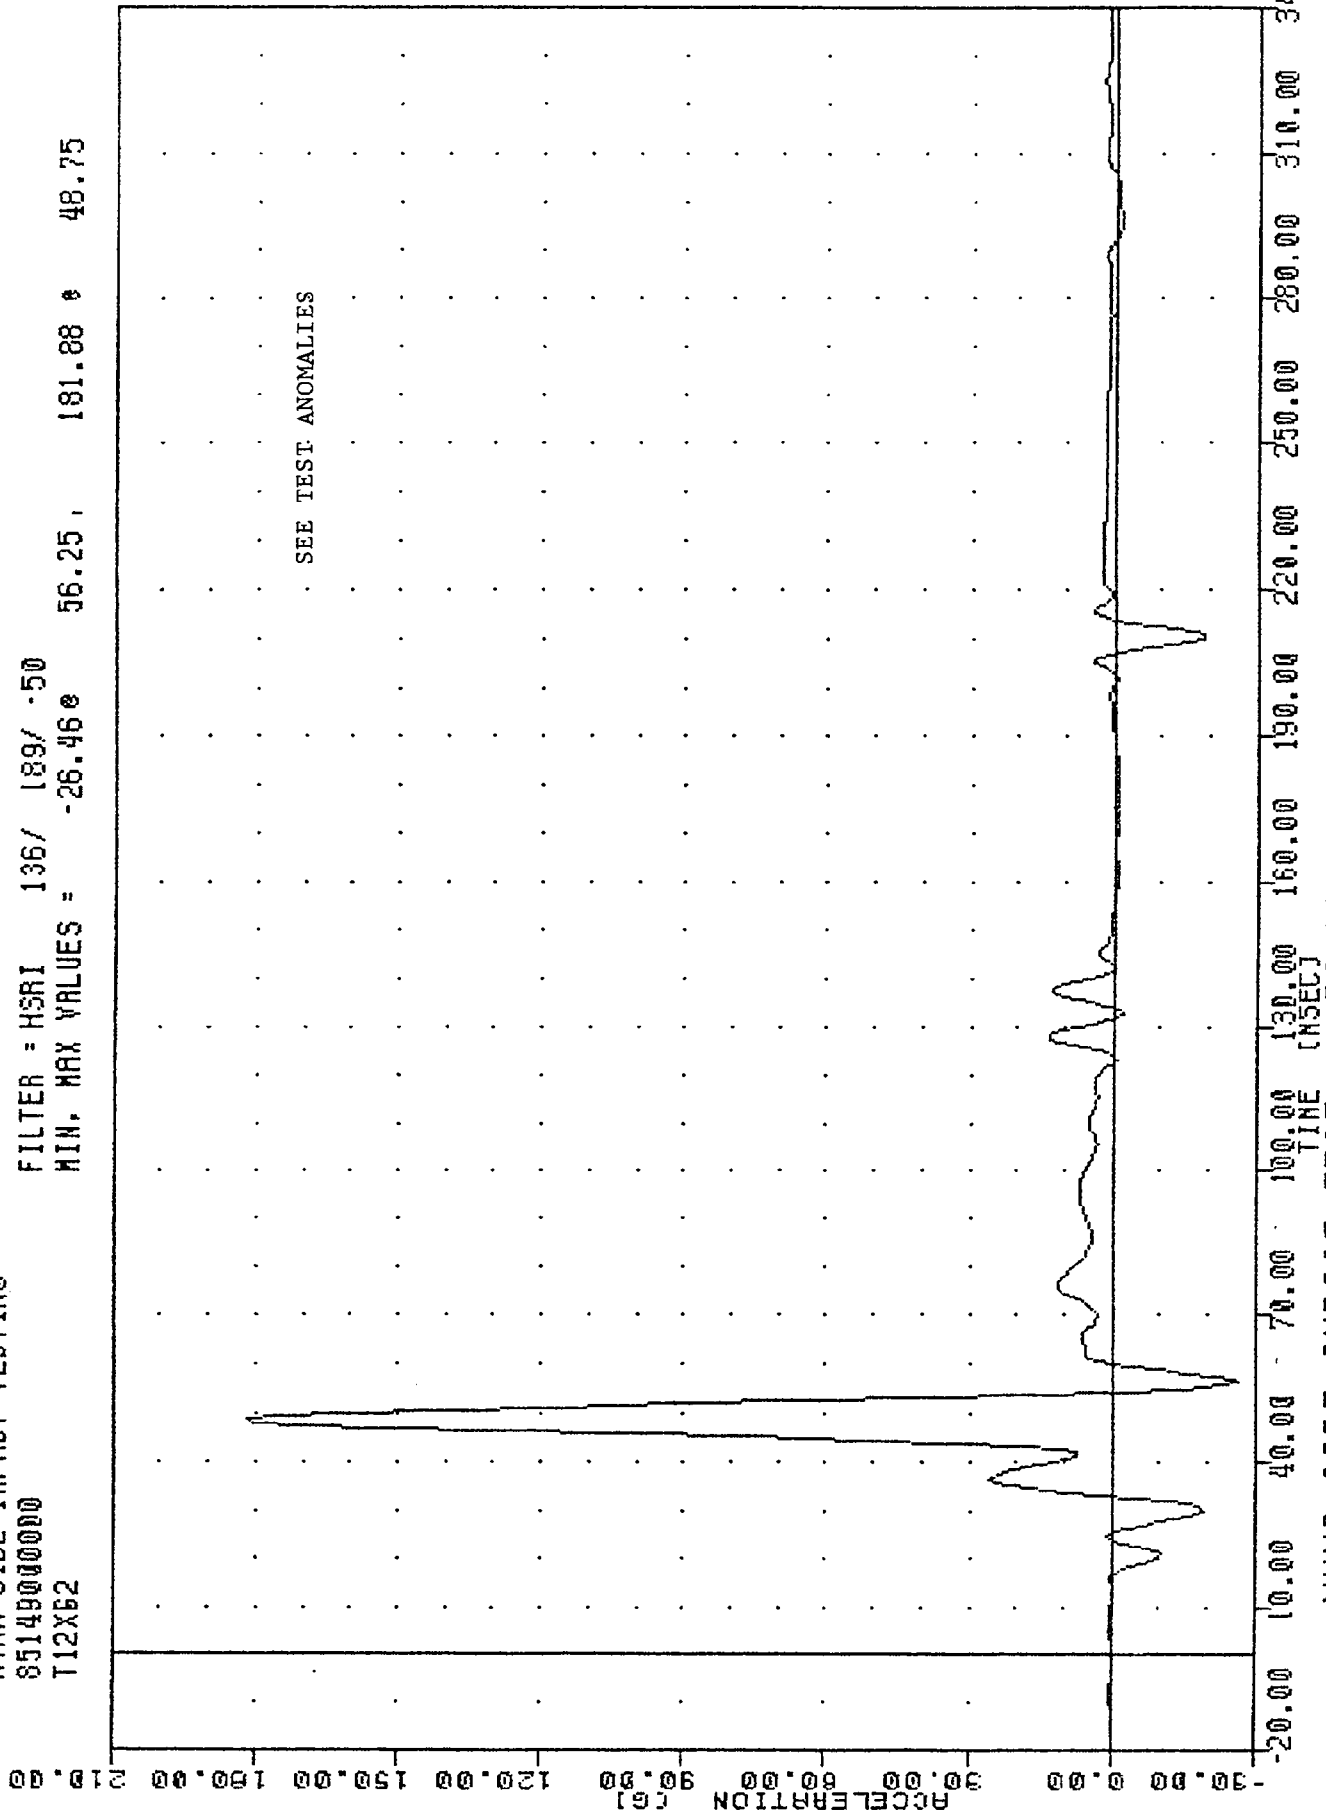
MVMA SIDE IMPACT TEST -- BASELINE STRUCTURE/HARDBOARD/NEAR SEATING
 PASSENGER LOWER SPINE ACCELERATION X AXIS

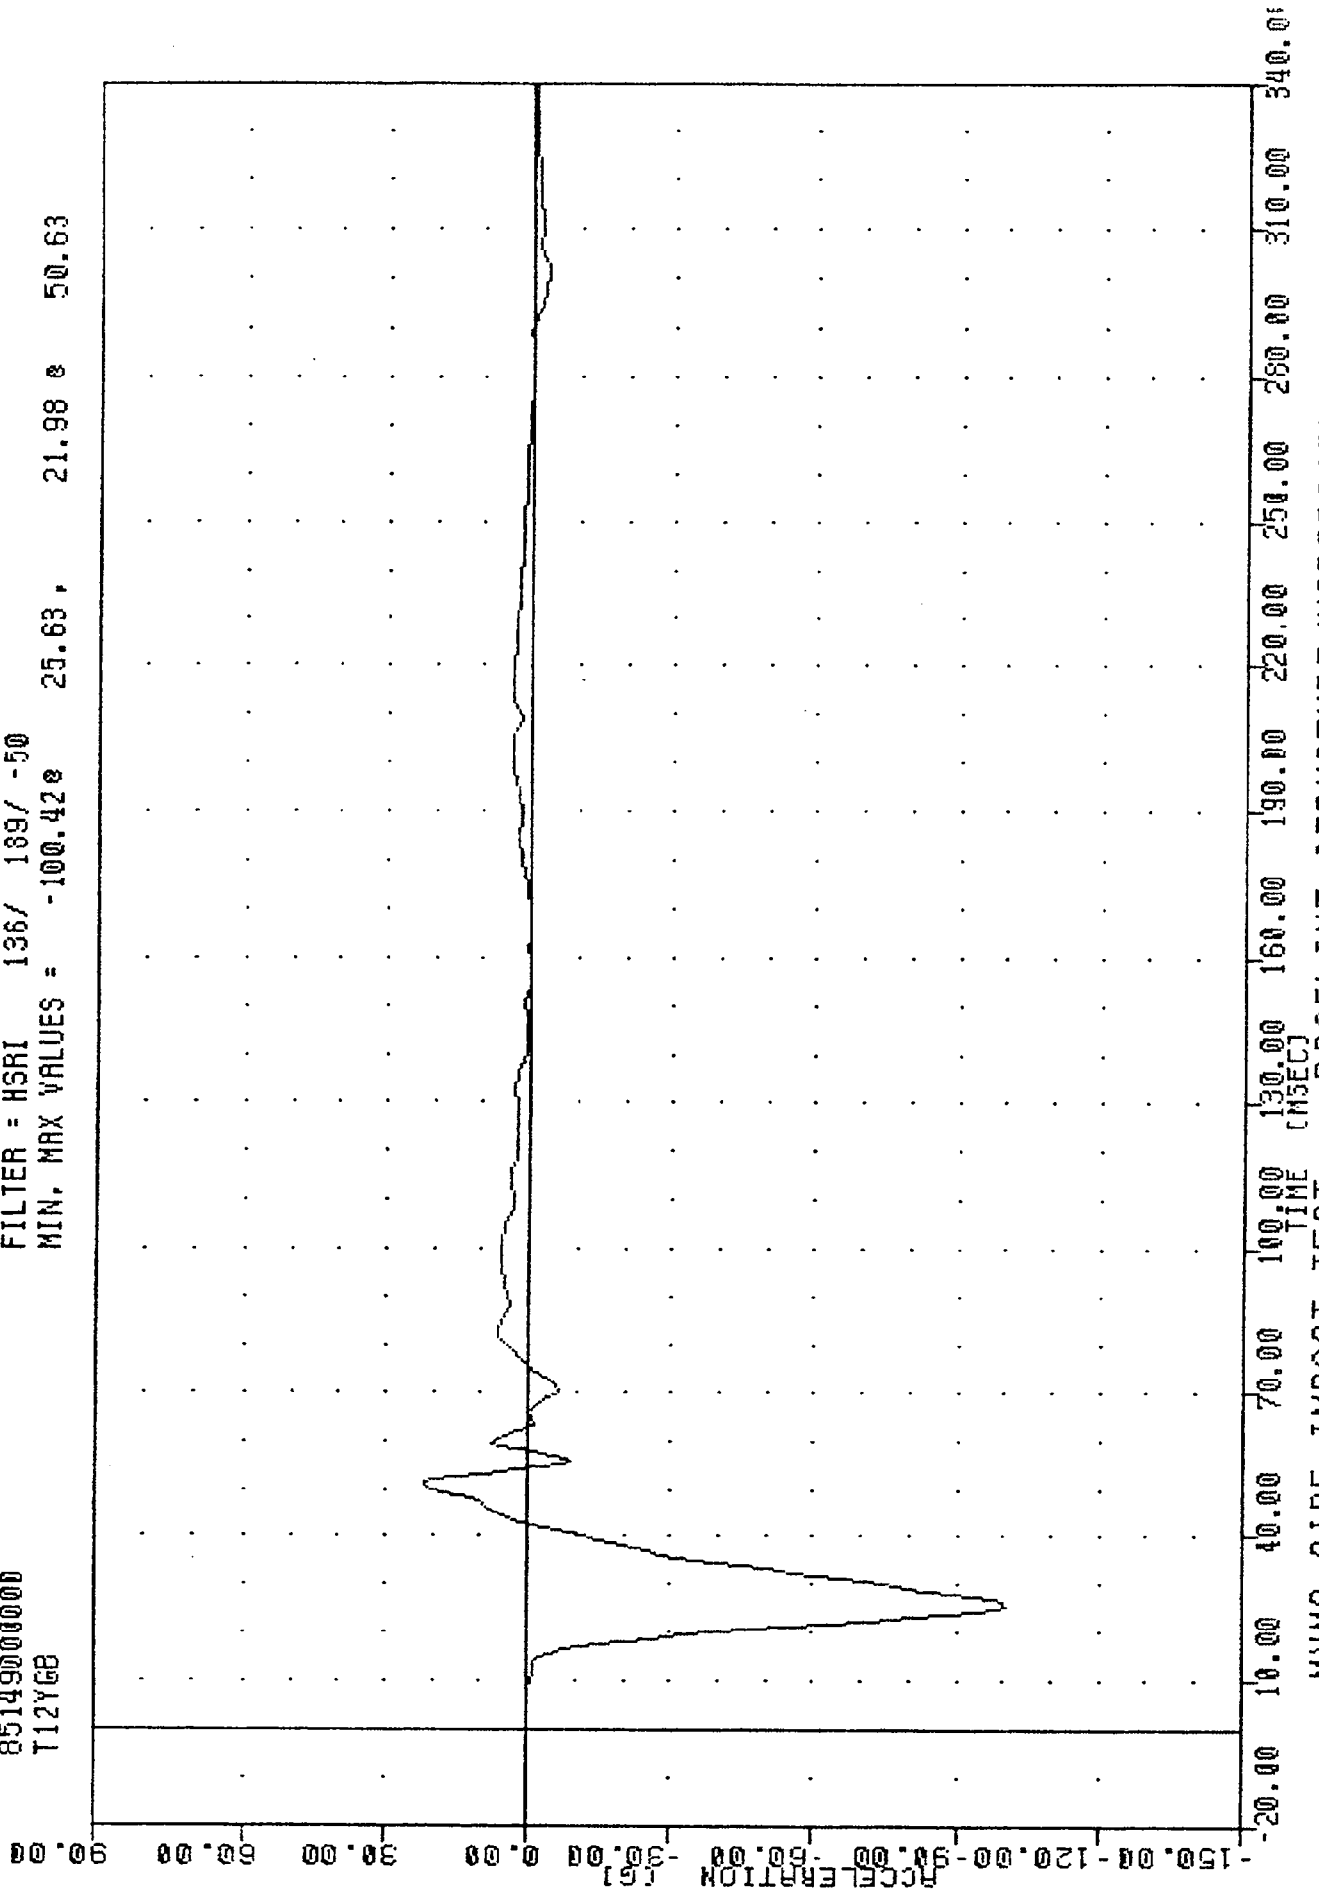
MVMA SIDE IMPACT TEST -- BASELINE STRUCTURE/HARDBOARD/NEAR SEATING
 PASSENGER LOWER SPINE ACCELERATION - Y AXYS

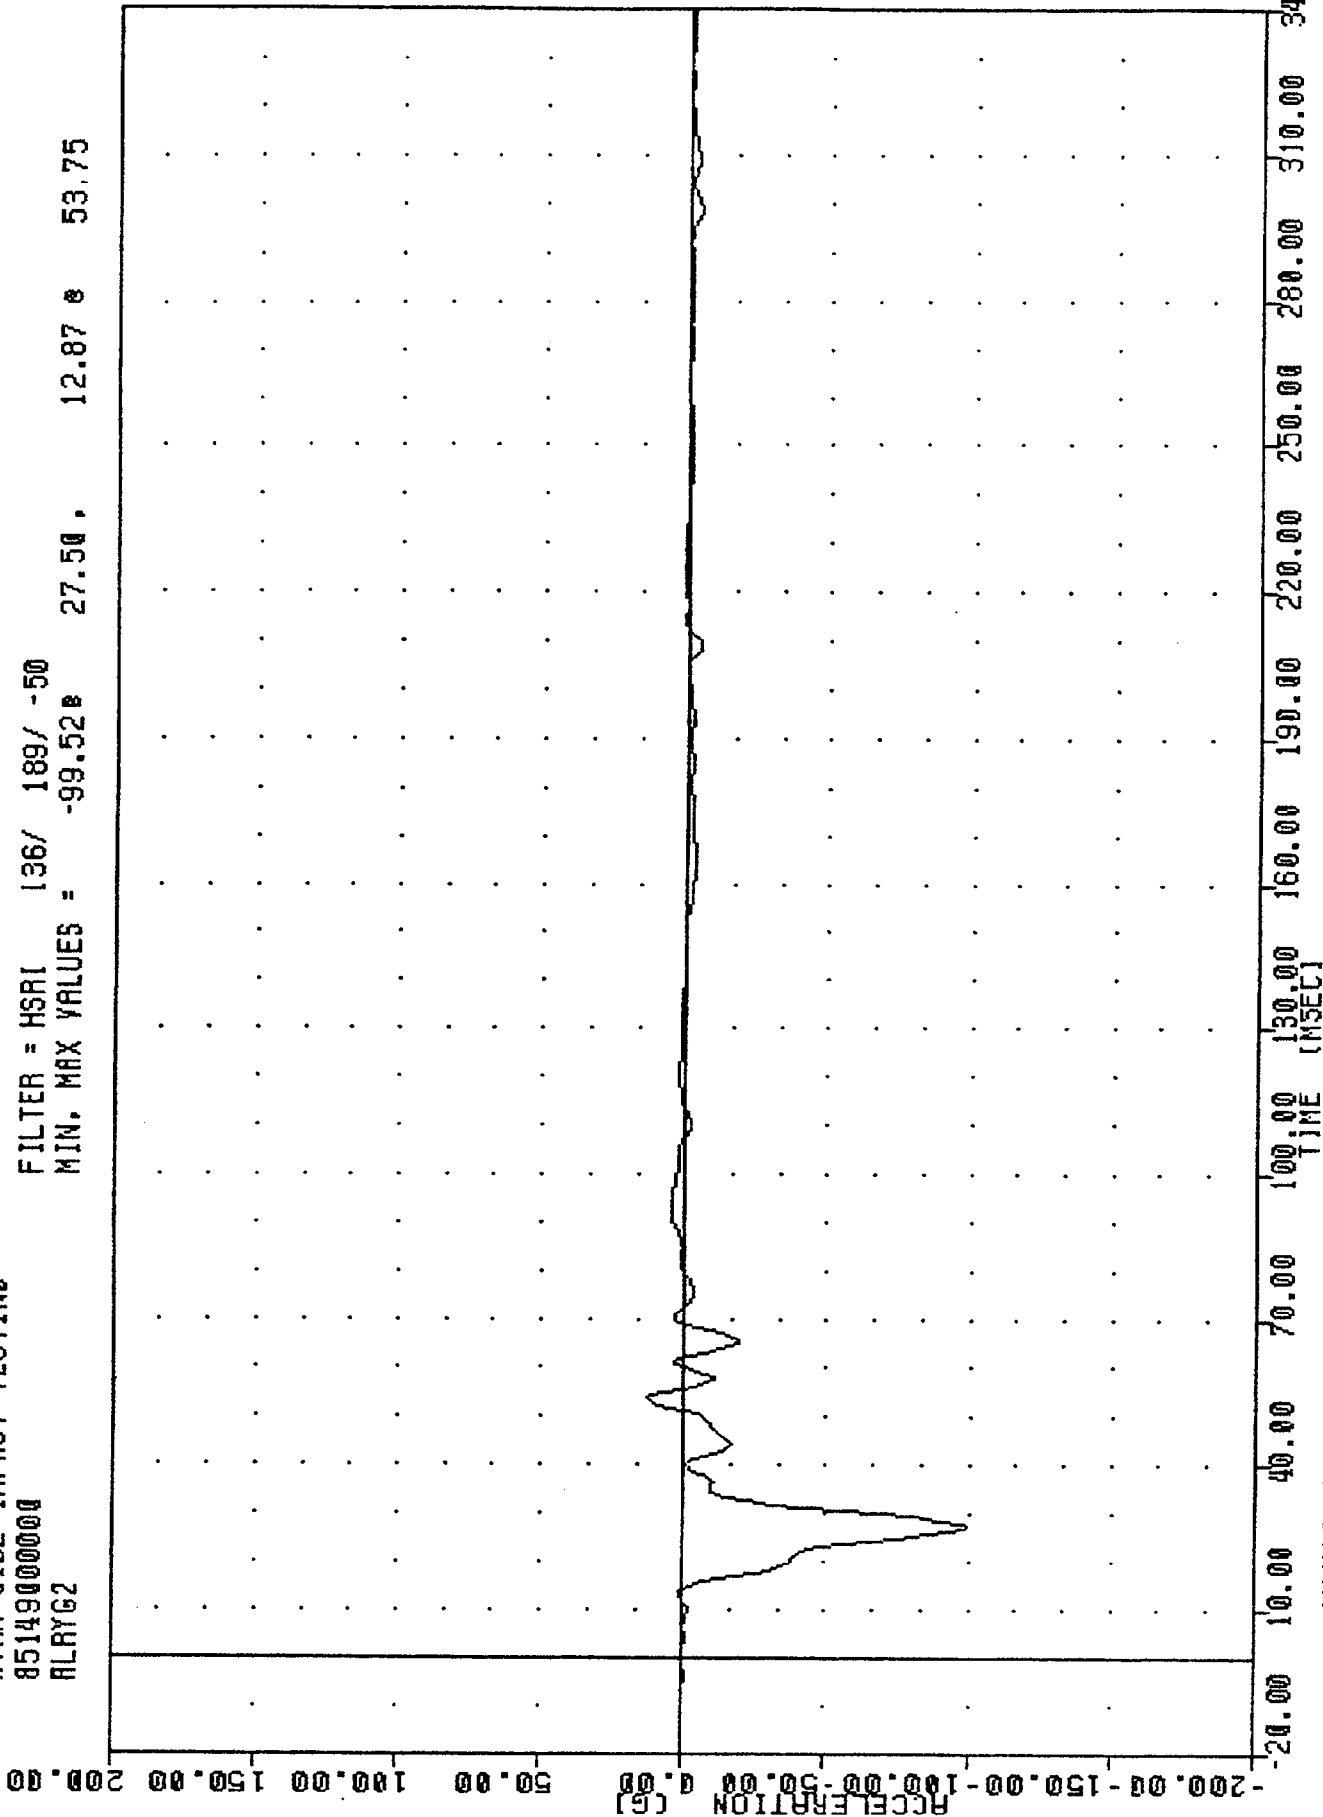
NVMA SIDE IMPACT TEST -- BASELINE STRUCTURE/HARDBOARD/NEAR SEATING
 PASSENGER RIGHT LOWER RIB ACCELERATION Y AXIS

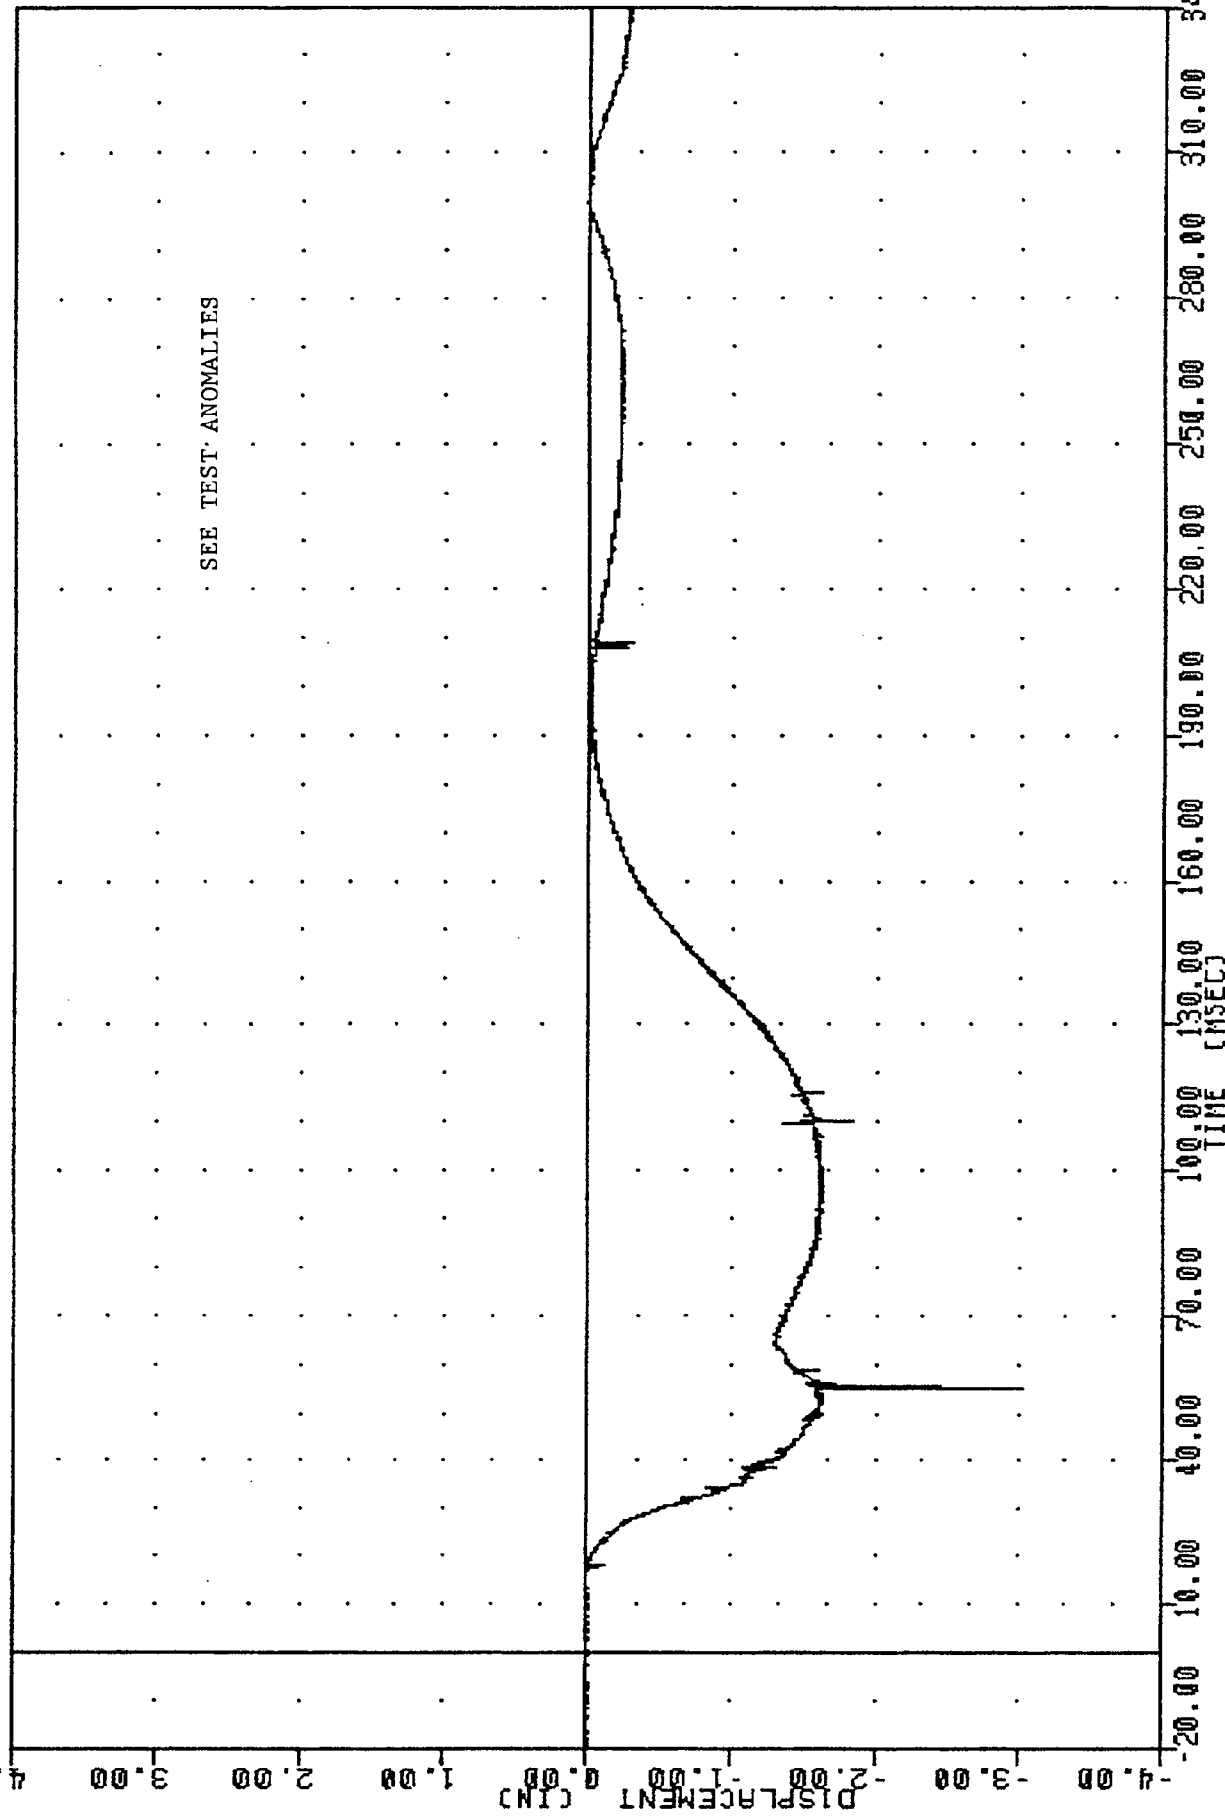
MVNA SIDE IMPACT TEST -- BASELINE STRUCTURE/HARDBOARD/NEAR SEATING
 PASSENGER RIGHT RIB TO SPINE DISPLACEMENT INCHES

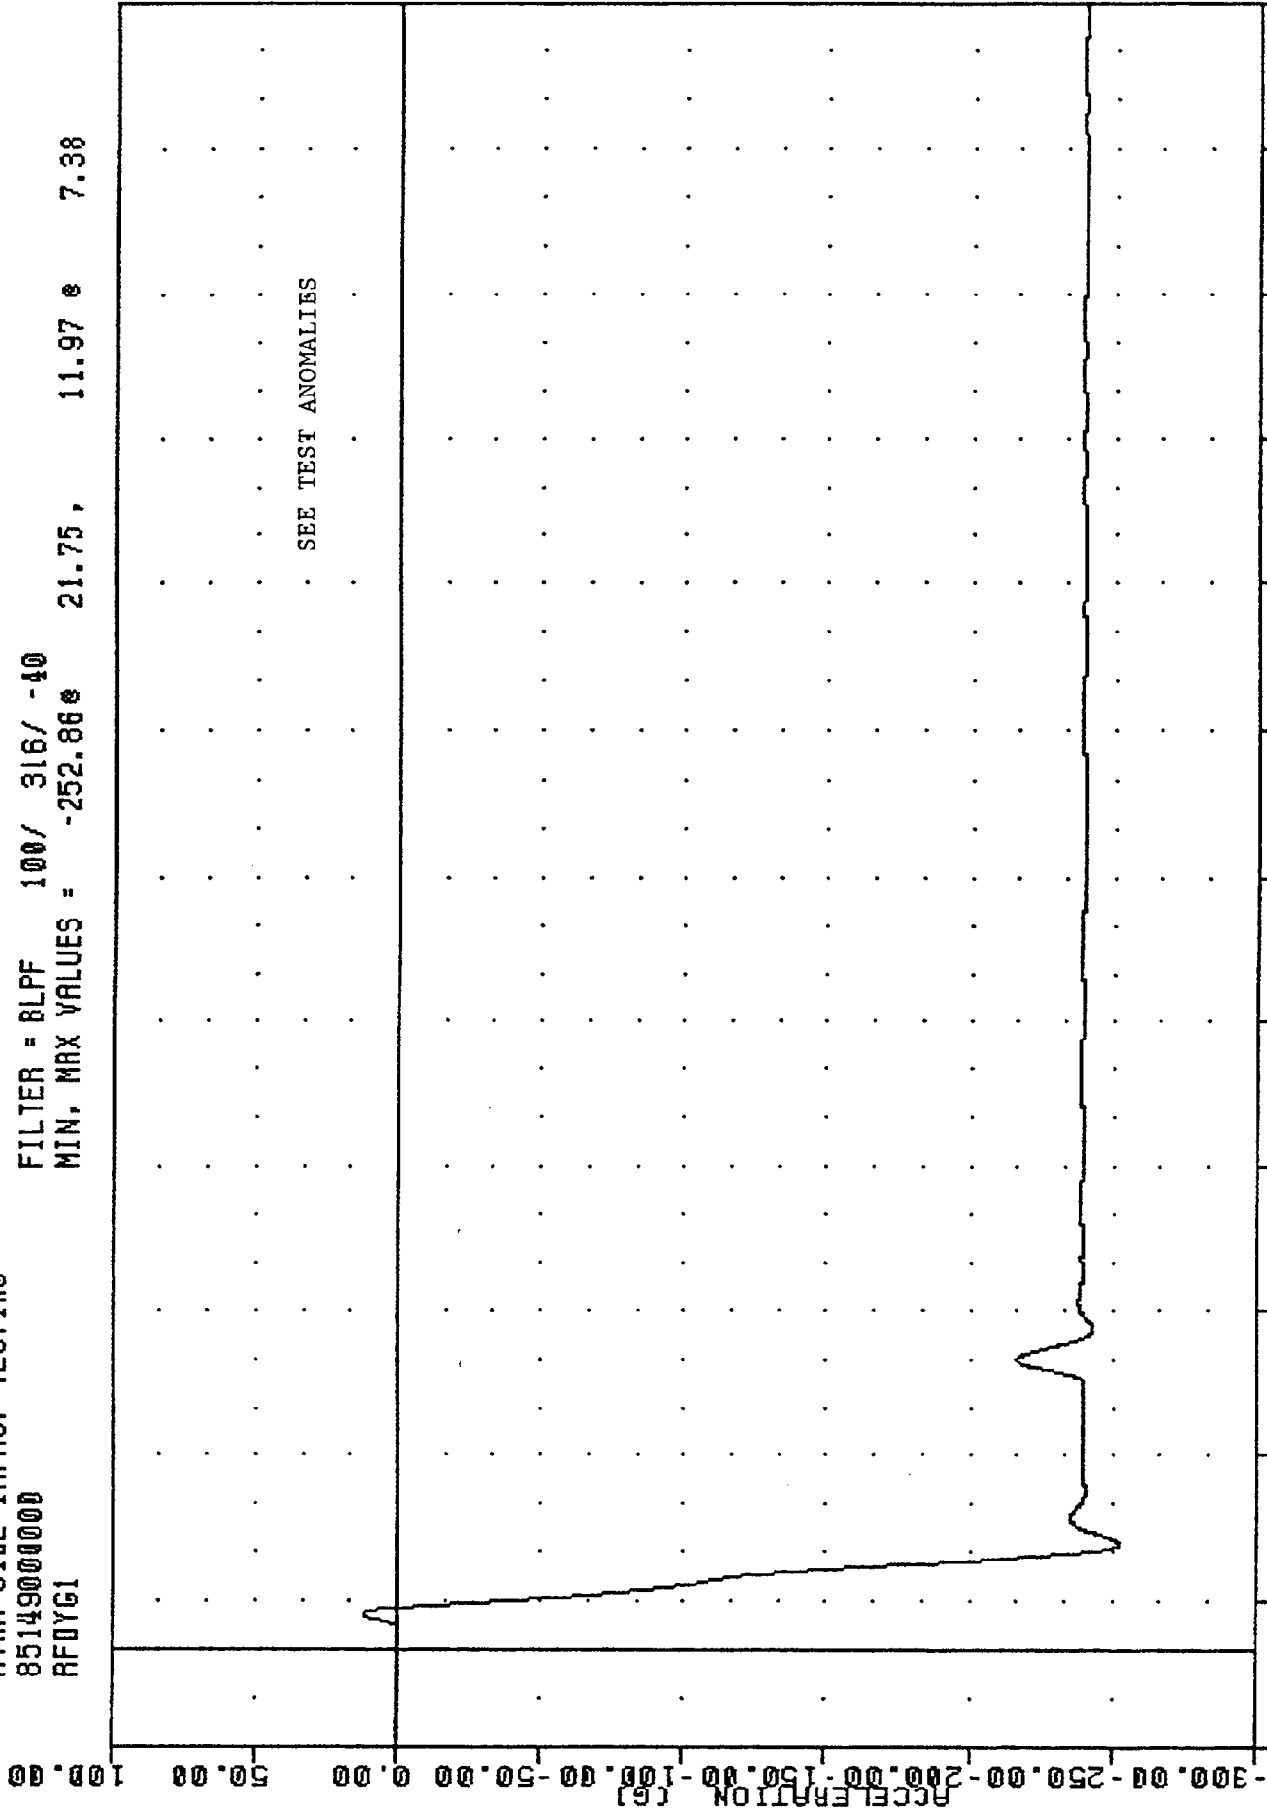
SEE TEST ANOMALIES

The right front door position 1 accelerometer, RFDYG1, did not record any data due to a broken transducer.
