MVMA SIDE IMPACT TESTING

MDB-TO-CAR SIDE IMPACT TEST OF
A 26° CRABBED MOVING DEFORMABLE BARRIER
TO A 1985 FORD LTD
AT 33.6 MPH

TEST REPORT

TEST NO.: 850529

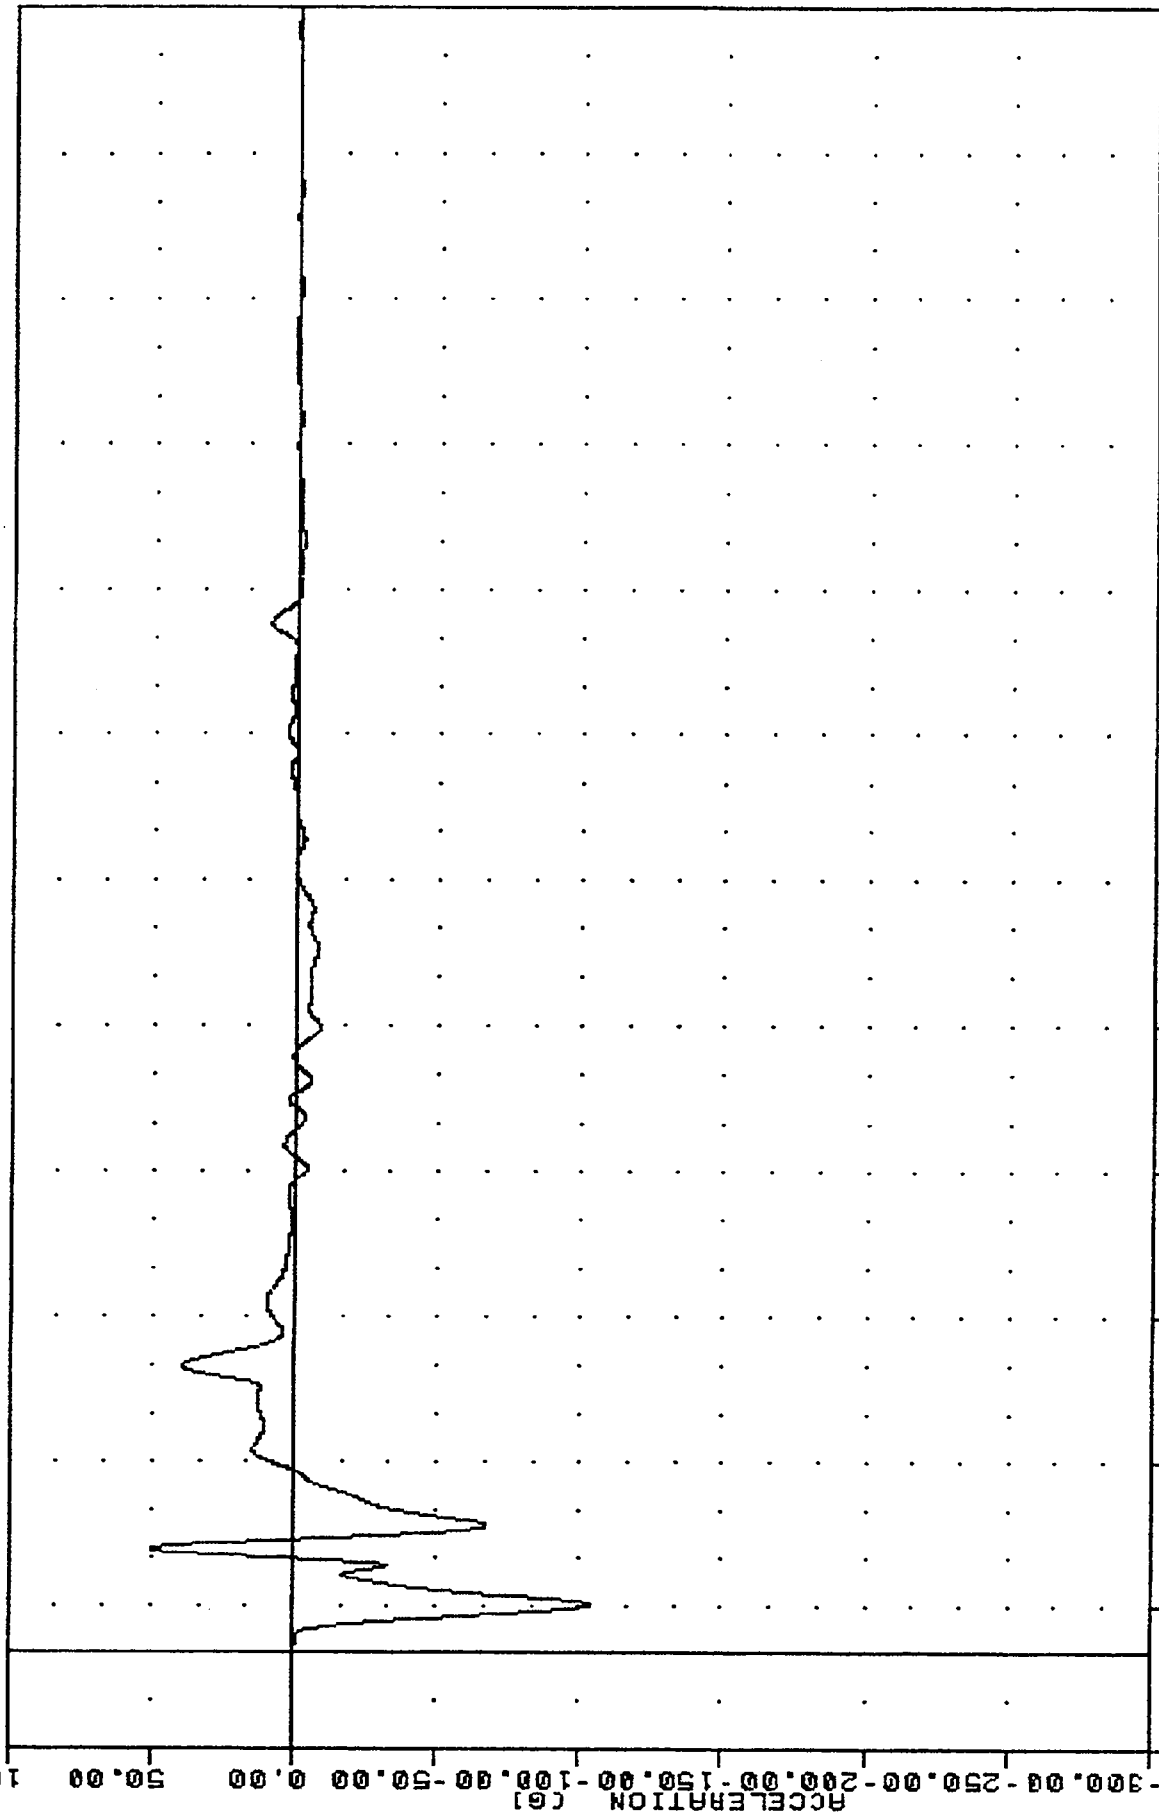
TIME (msec) 100.00 130.00 160.00 190.00 220.00 250.00 280.00 310.00 340.00
MVMA SIDE IMPACT TEST -- BASELINE STRUCTURE/HARDBOARD/NEAR SEATING
VEHICLE RIGHT FRONT DOOR (POSITION 2) ACCELERATION Y AXIS

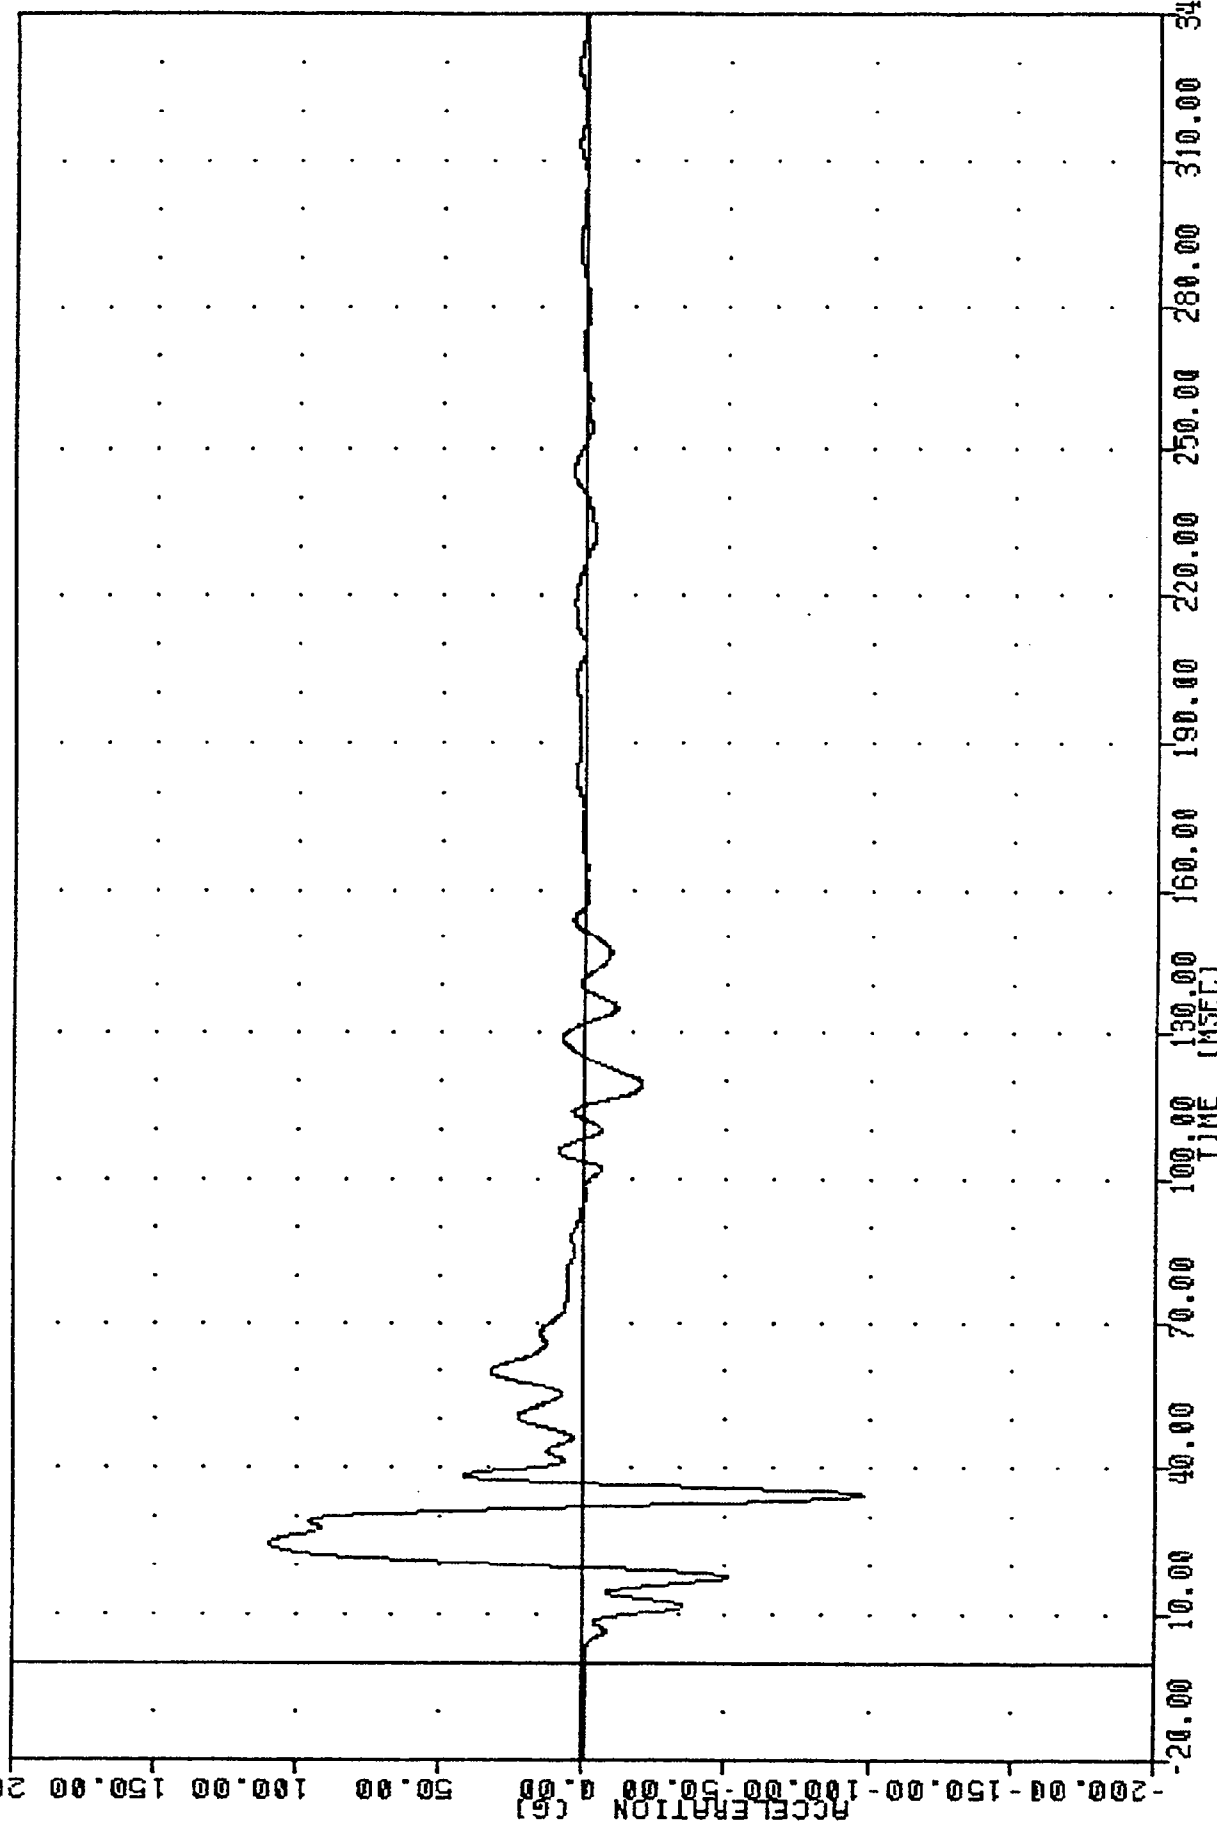
MVMA SIDE IMPACT TEST -- BASELINE STRUCTURE/HARDBOARD/NEAR SEATING
VEHICLE RIGHT FRONT DOOR (POSITION 3) ACCELERATION Y AXIS

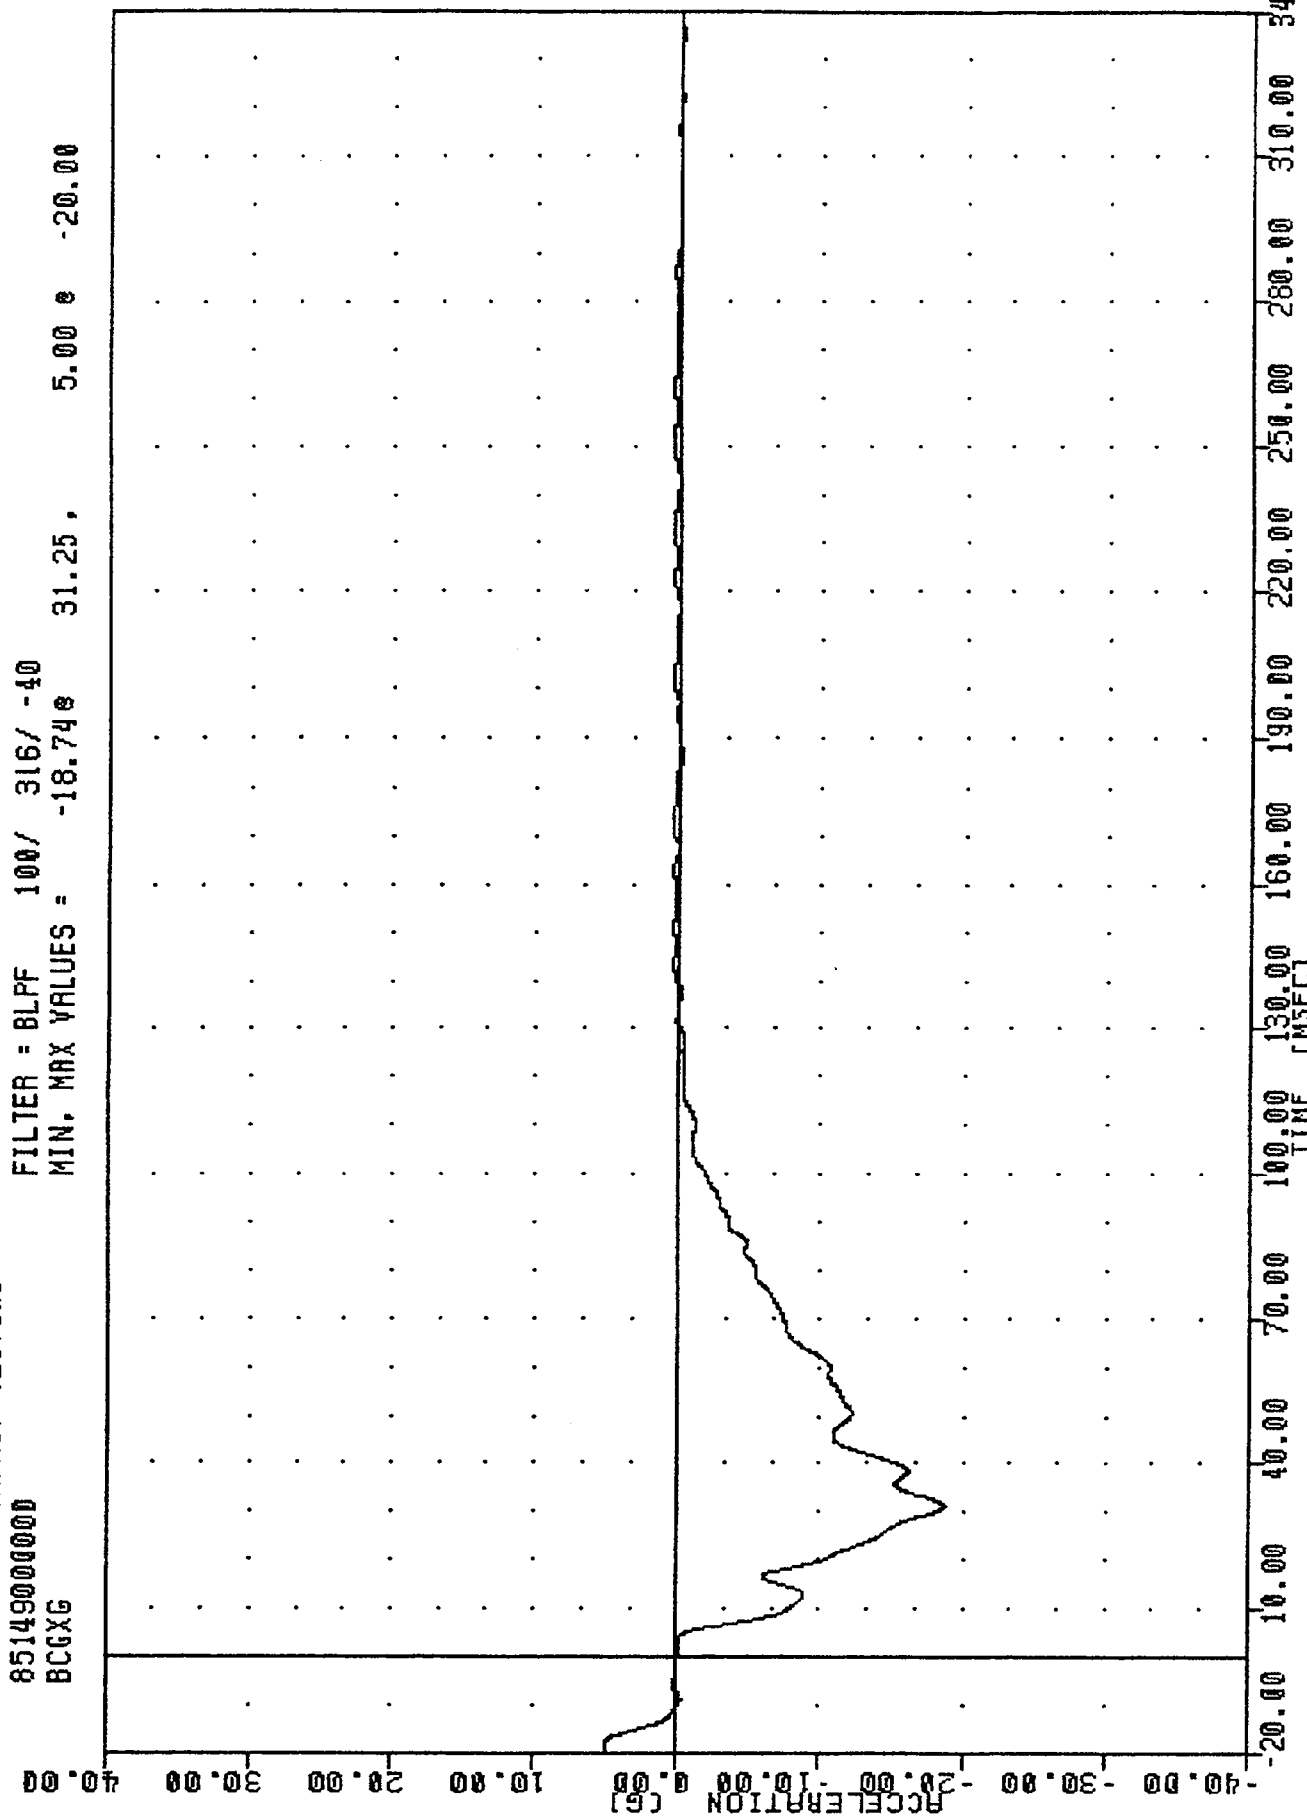
MVNA SIDE IMPACT TEST -- BASELINE STRUCTURE/HARDBOARD/NEAR SEATING
 BARRIER CENTER OF GRAVITY X AXIS

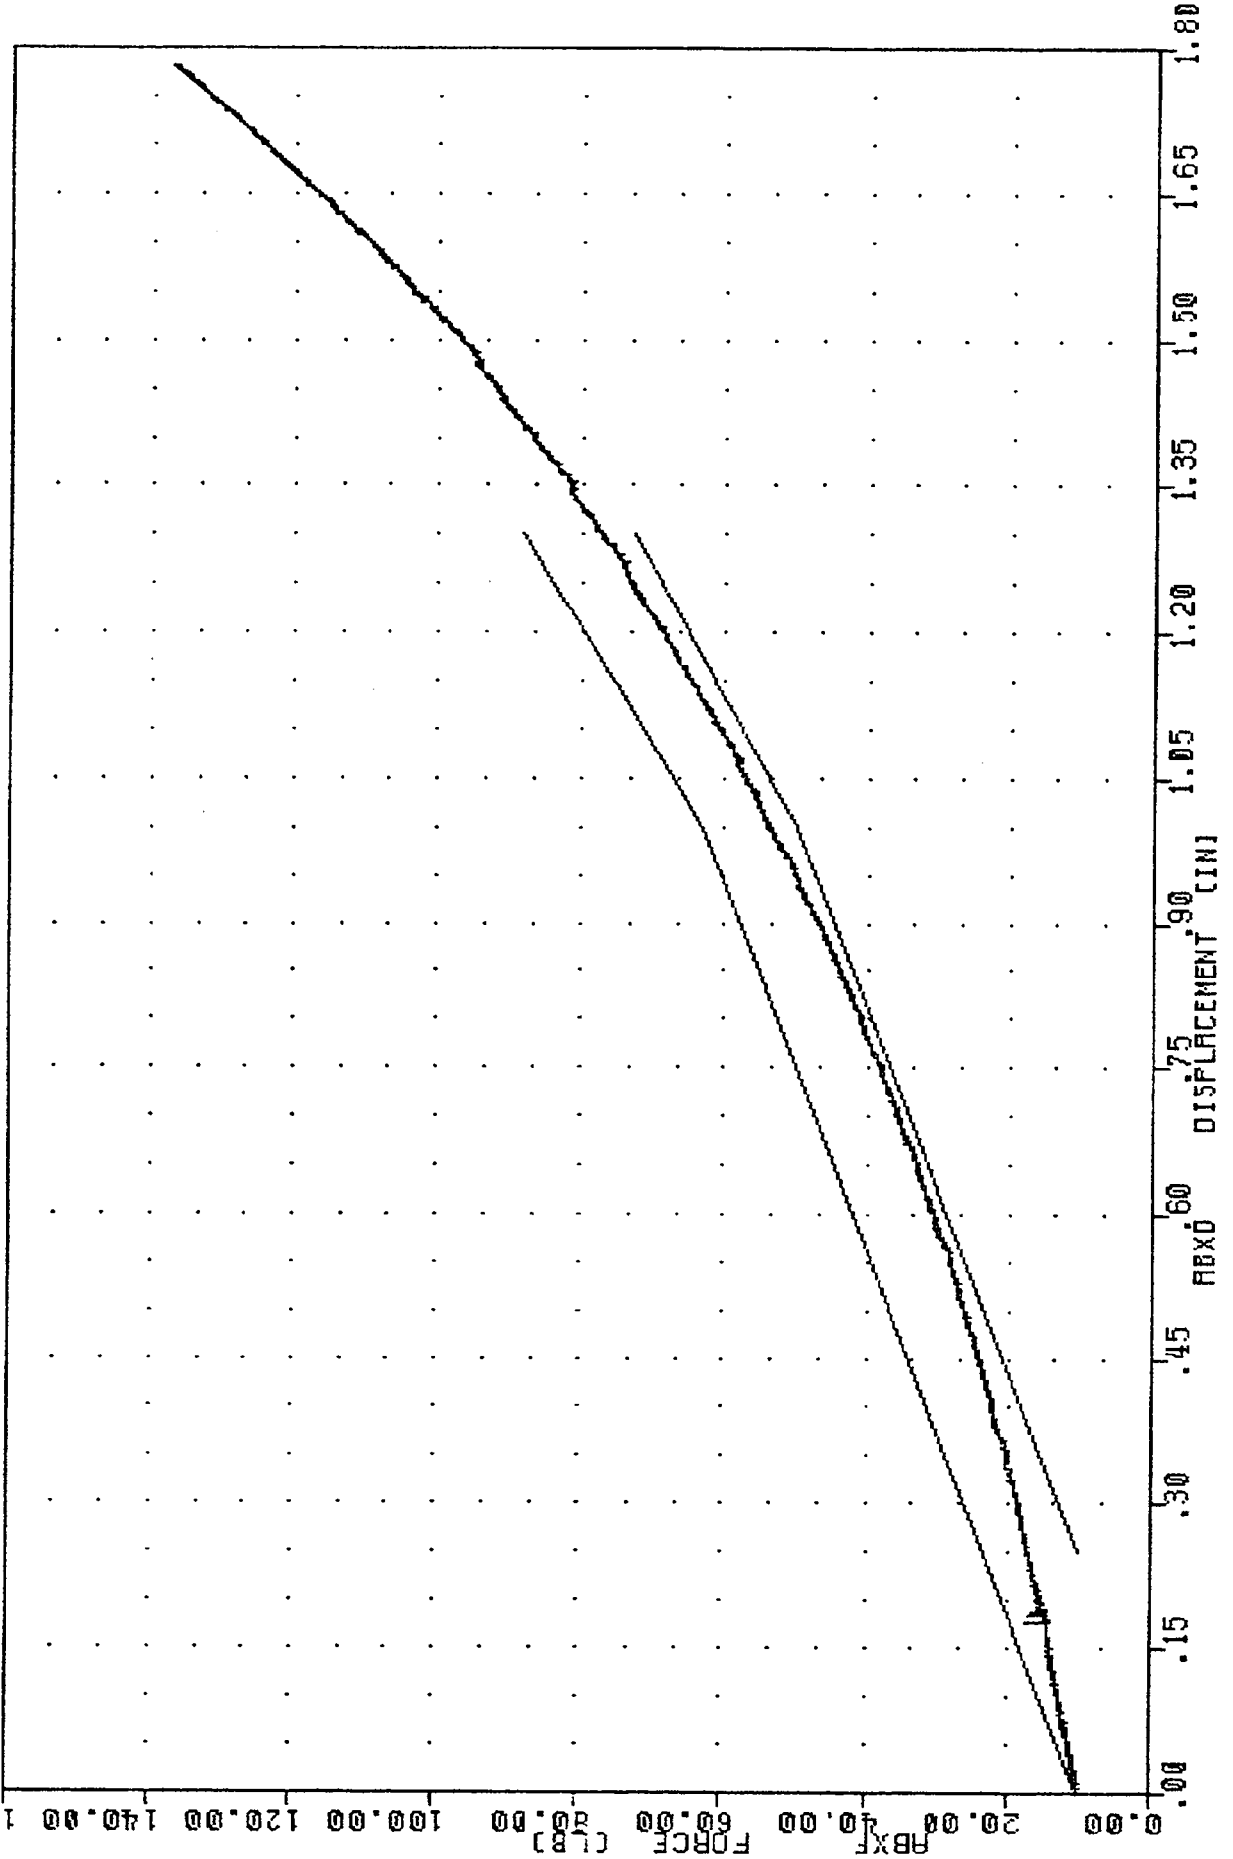
ABDOMINAL COMPRESSION VS DISPLACEMENT
